Tree Condition Survey

Client: Milestone

Site: opposite 63 High Street Chippenham CB7 5PP

Scope: Arboricultural Tree Condition Survey

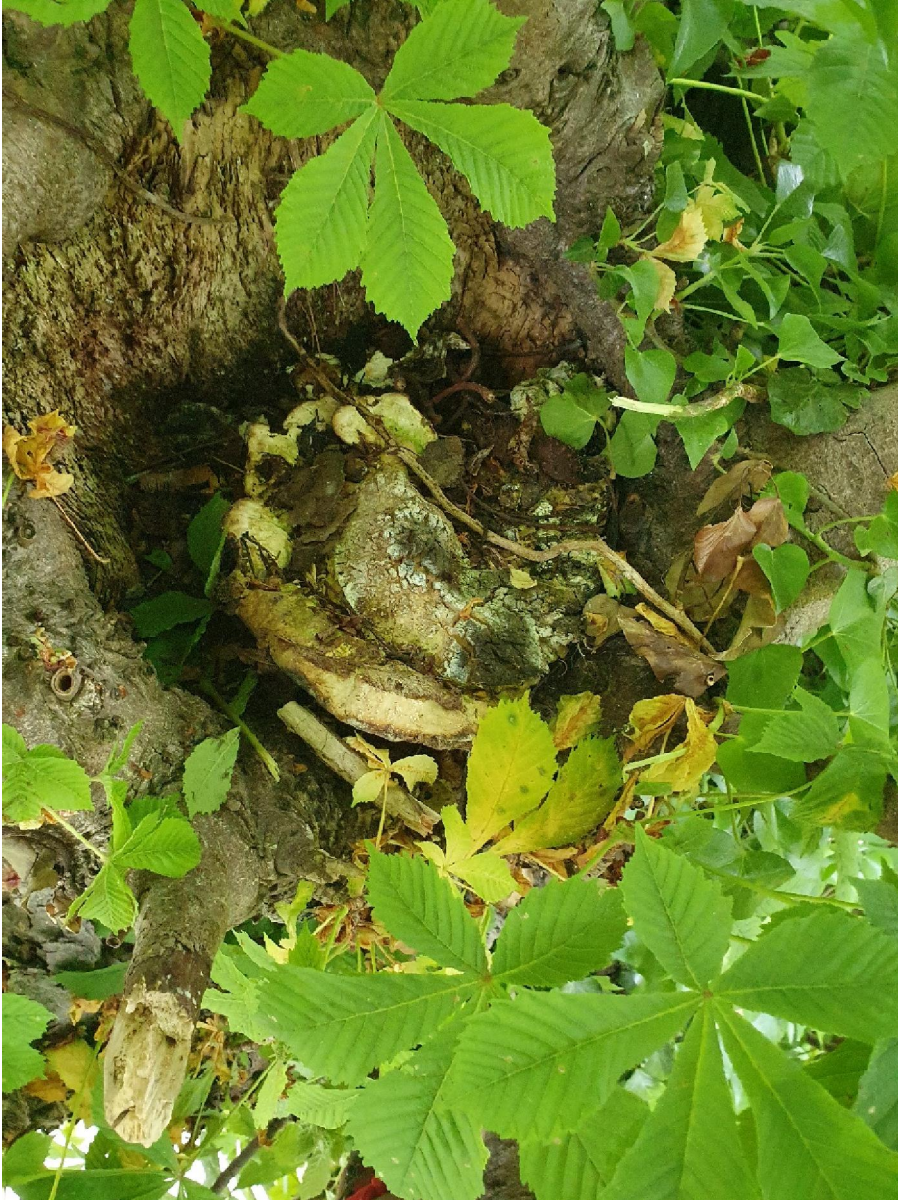
Also found in one of the rot pockets and on the main stem was fungal fruit bodies believed to be *Ceriporus squamosus* or *Ganoderma applanatum* with my thoughts being it is more likely to be *Ceriporus squamosus*. Which is usually found around areas of dysfunction, it is associated with selective white rot of the wood and causes cavity formation.

Photo of Fungal fruiting body approx. 4m agl in old pollard head

T1 – Repollard to previous points

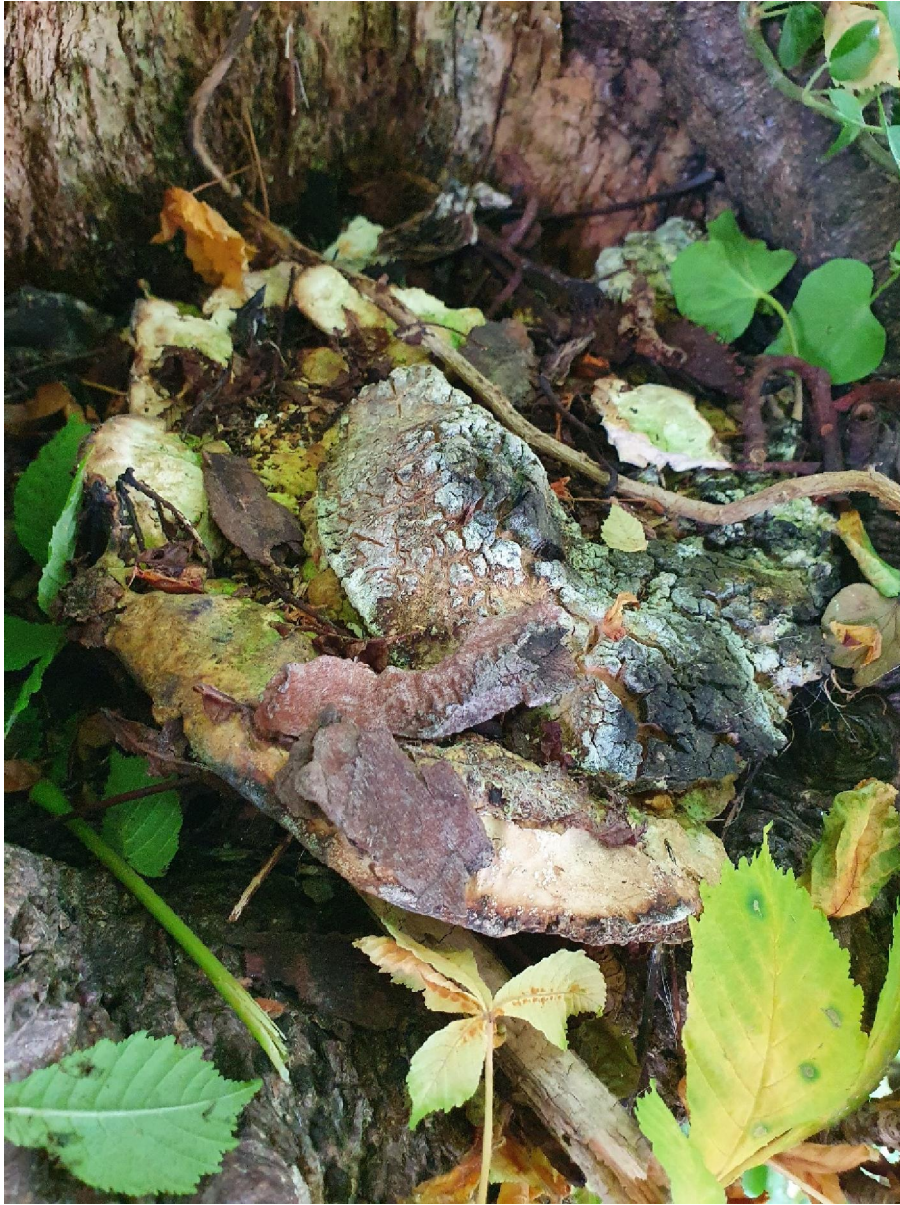
Photo of Fungal fruiting body approx. 4m agl in old pollard head

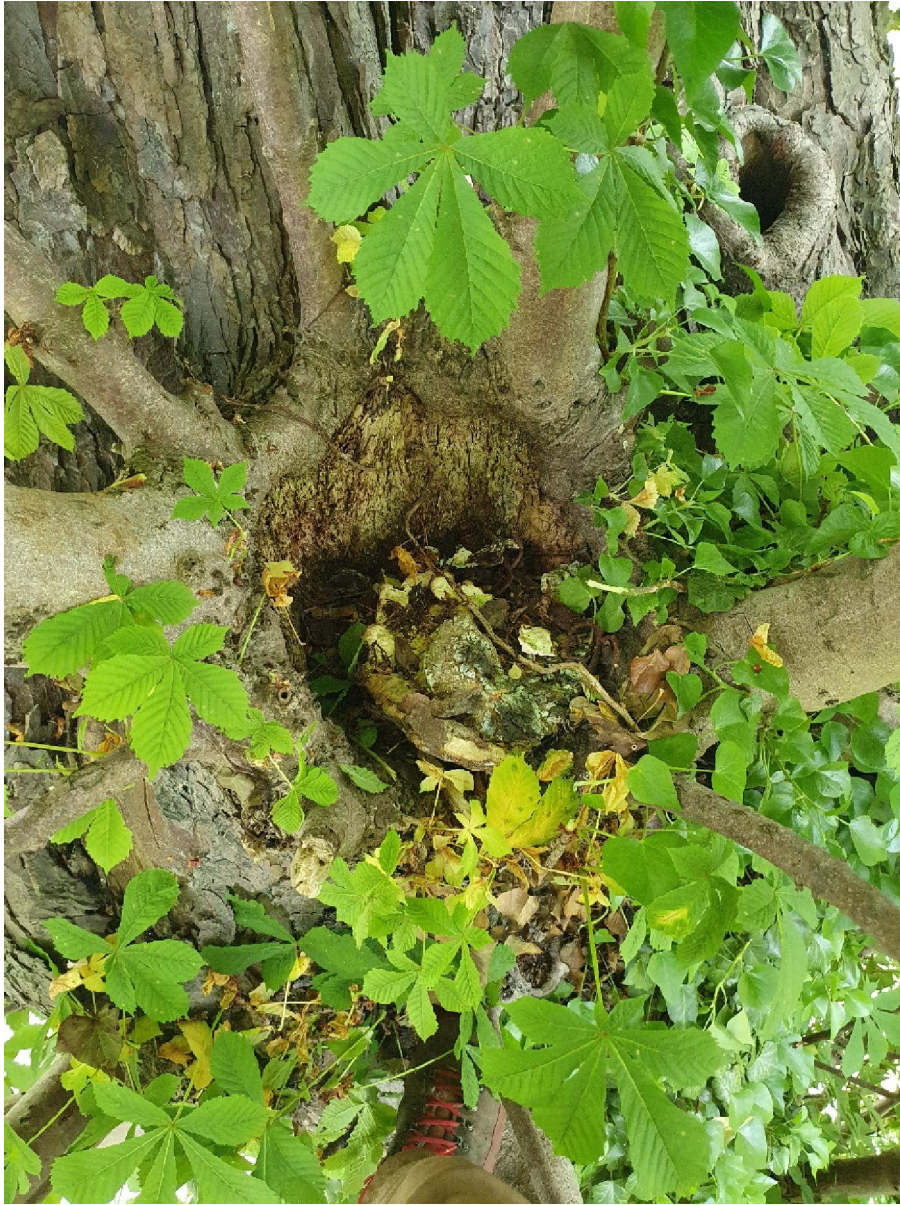
Photo of Fugal fruiting body approx. 4m agl in old pollard head

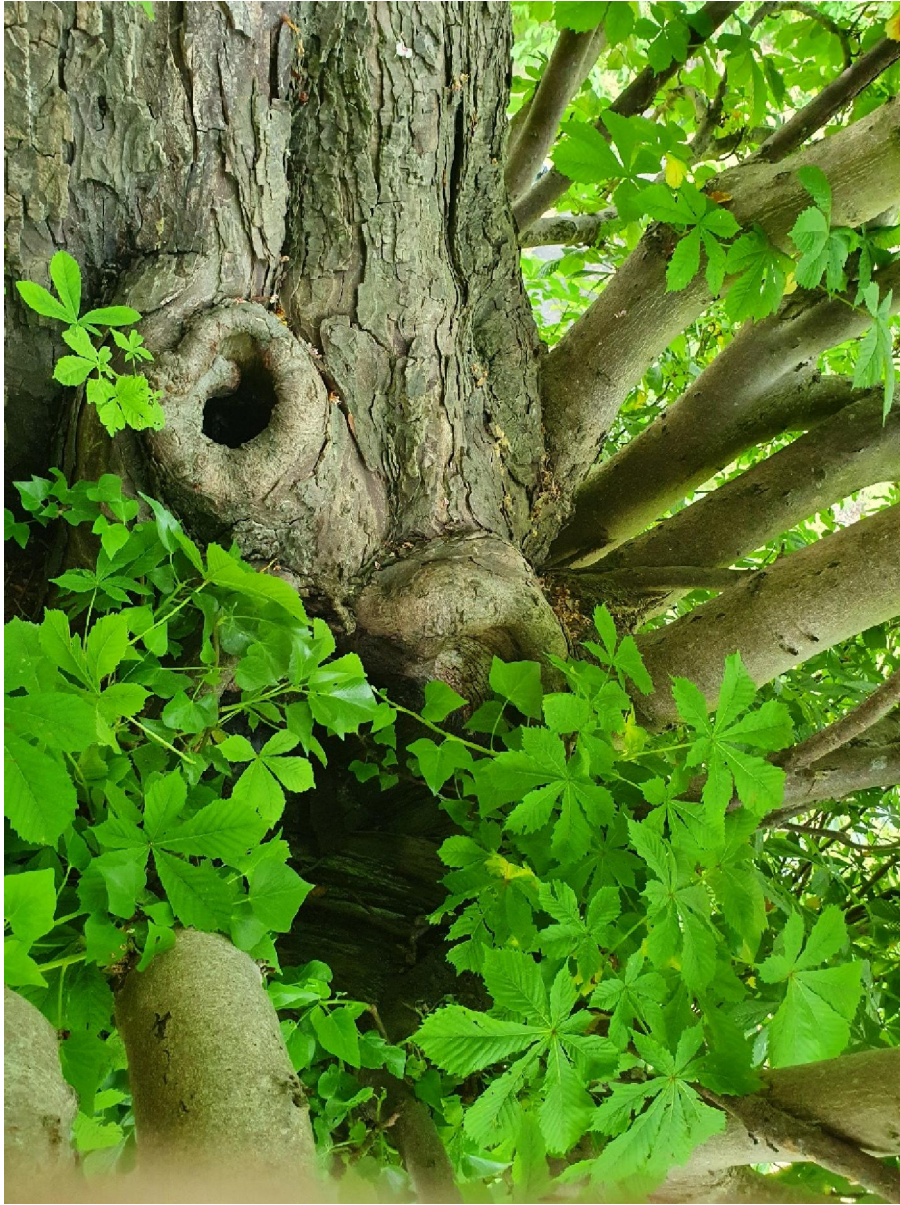
The areas of dysfunction are large and have rotted down a good distance in places as much as 60cm from the old pollard head. The amount of residual wall in some places is below the 1/3 t-r ratio that is usually accepted but with the pollard heads not being all the way round a stem at the same height it is unclear how much residual wall is left on the other side.

Photo showing old pollard head and regrowth the small hole meets up with the large cavity

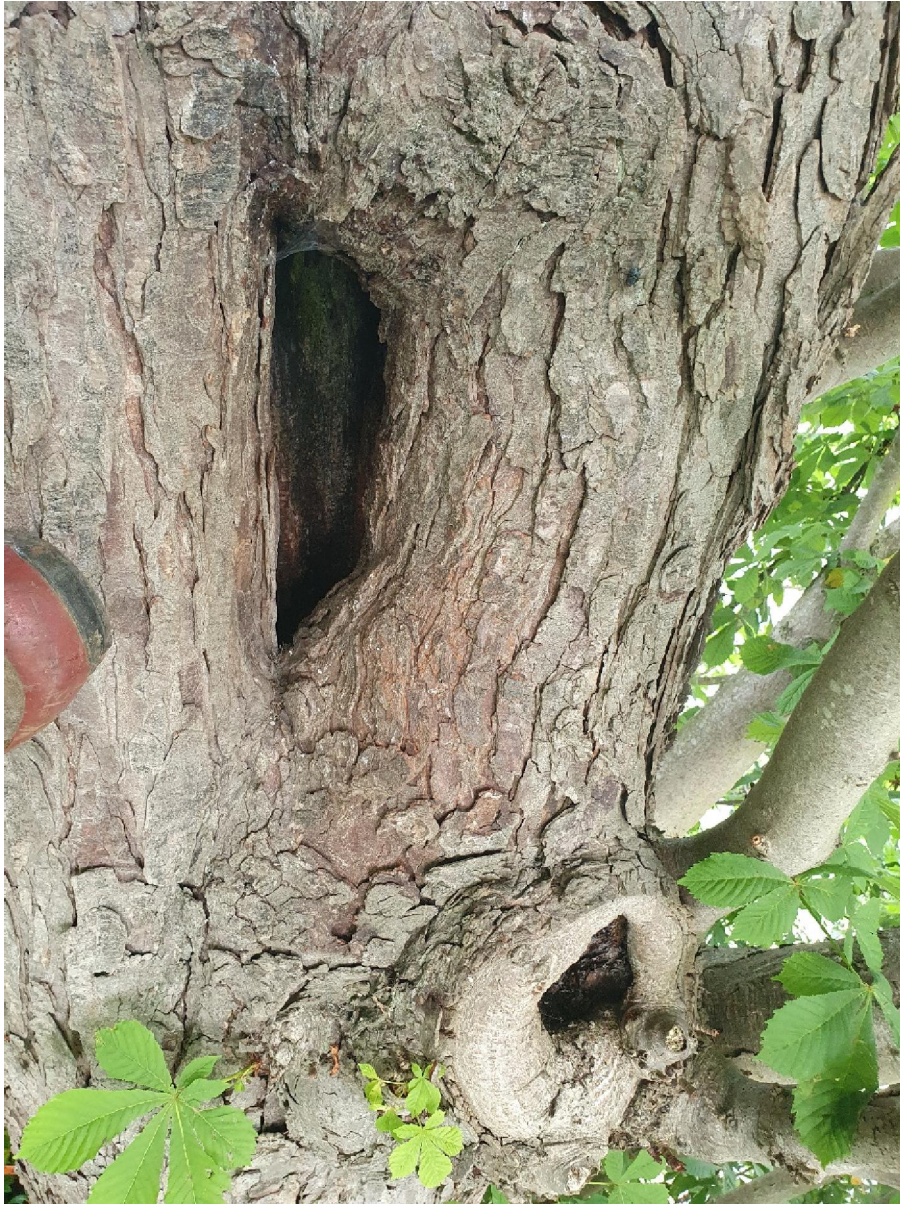
T1 appears to have good vitality of the leaves and good form with the structure of the tree being the bigger concern. The areas of dysfunction have in places joined up from pollard heads of different heights leading to large areas of dysfunction and hollowness. This I feel is compromising the residual wall and strength of the stem. With the context of the tree I do not feel that re-pollarding would be enough as we would be in this same situation in a few year's. Consideration has been given to not just re-pollarding but to monolith or reducing the height of the stem to reduce the lever arm but with the context I do not feel these are suitable options. After speaking with the local council tree officer who requested we only repollard the tree I am happy to accept the proposal.

Photo showing cavity on main stem above another old pollard head cavity looks like they link up.

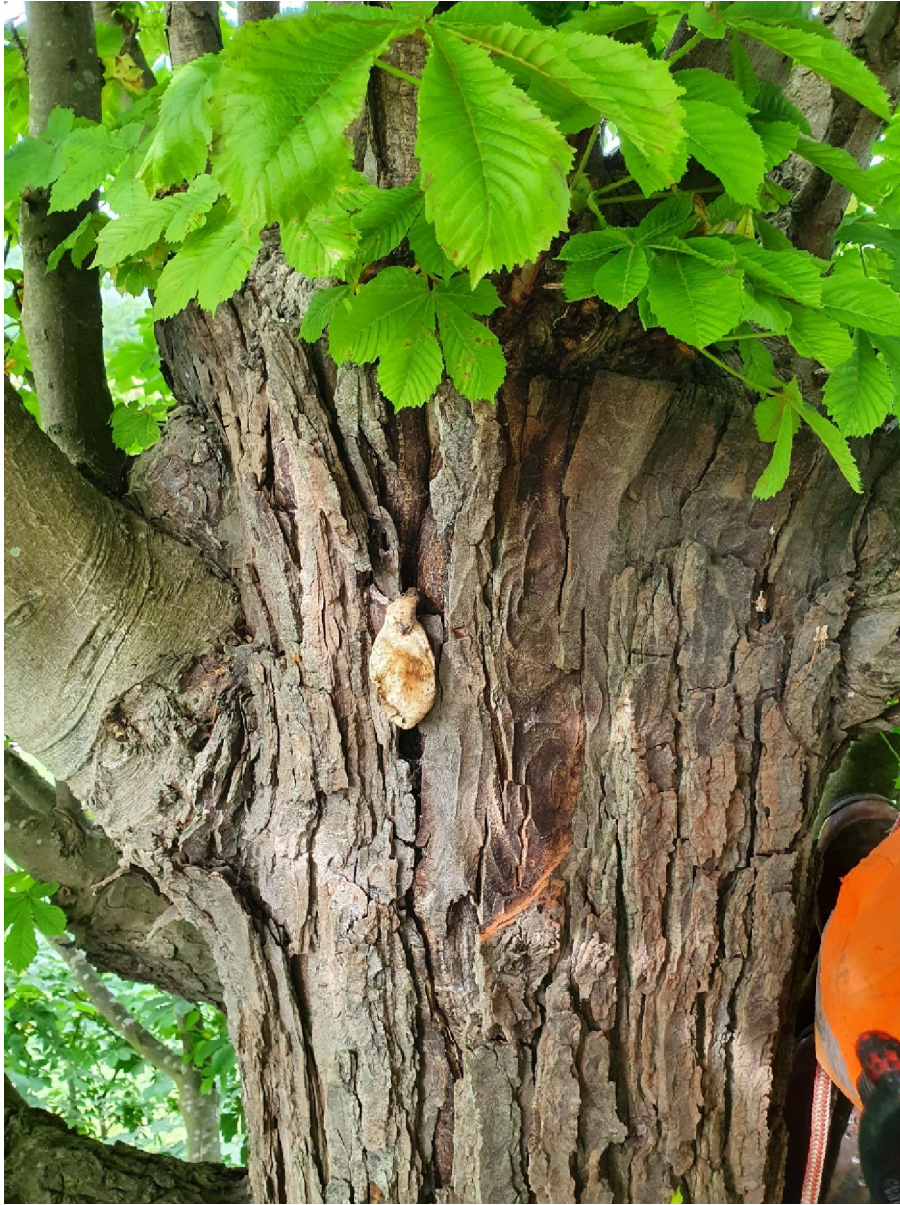
Fungal fruiting body at top of main stem where has been previously pollarded

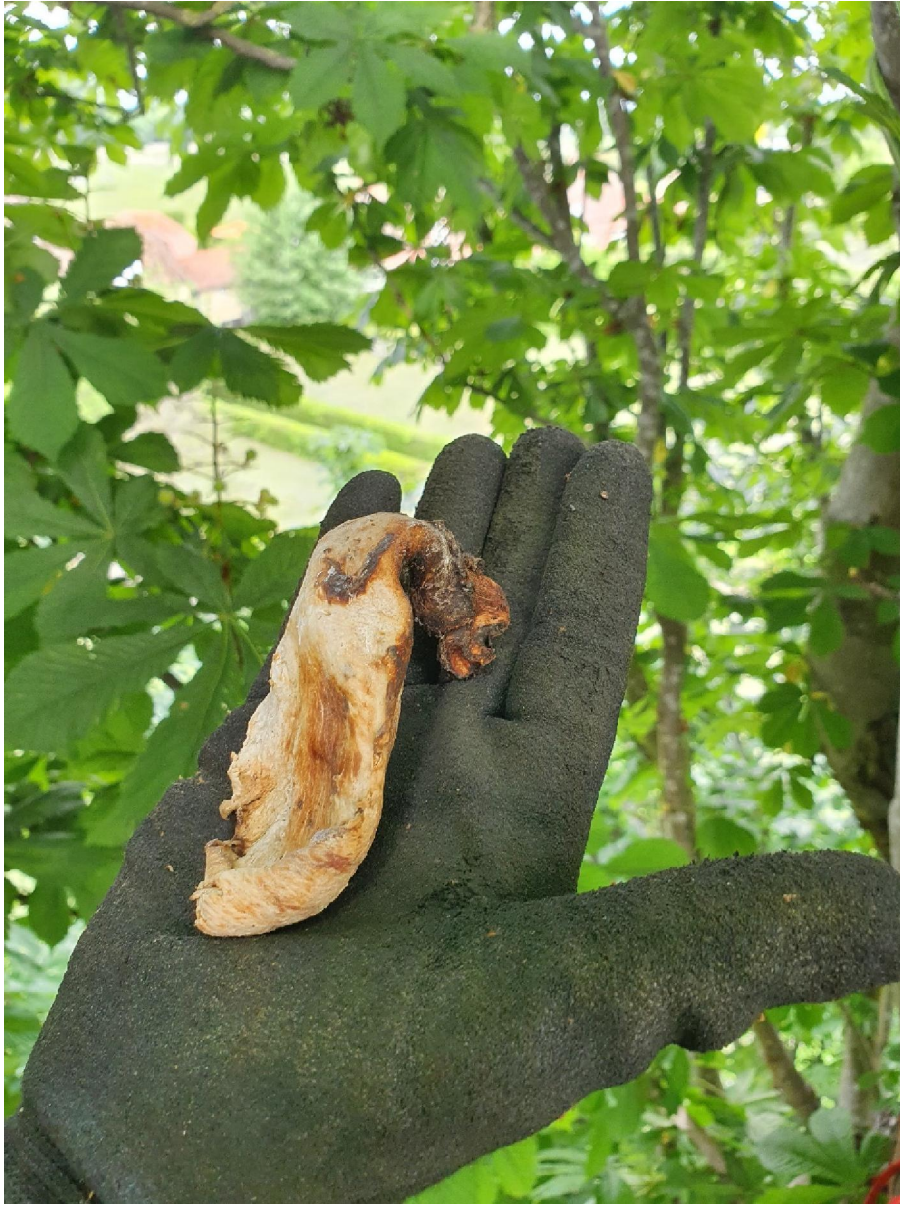
Closer photo of fungal fruiting body to aid identification

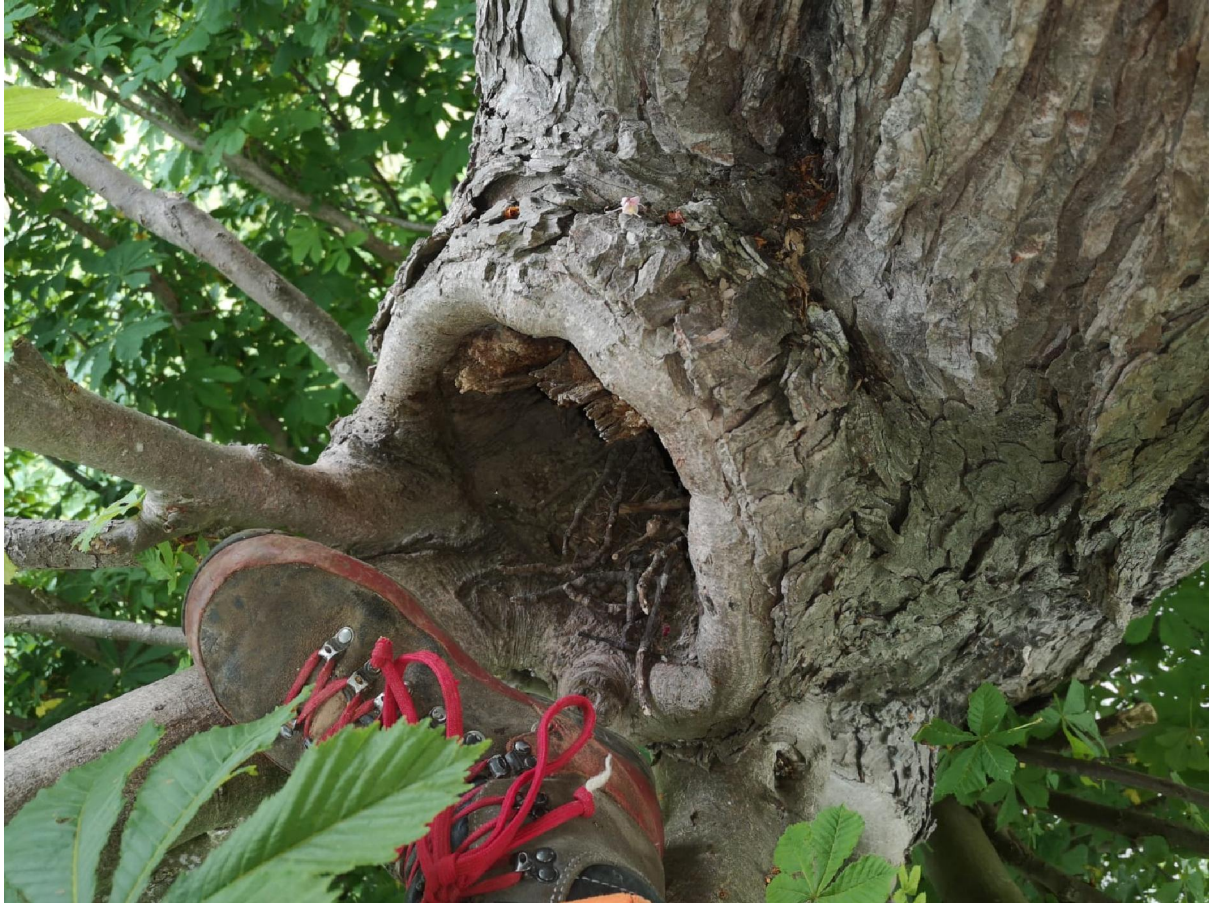
Large cavity just below the top of the main stem.

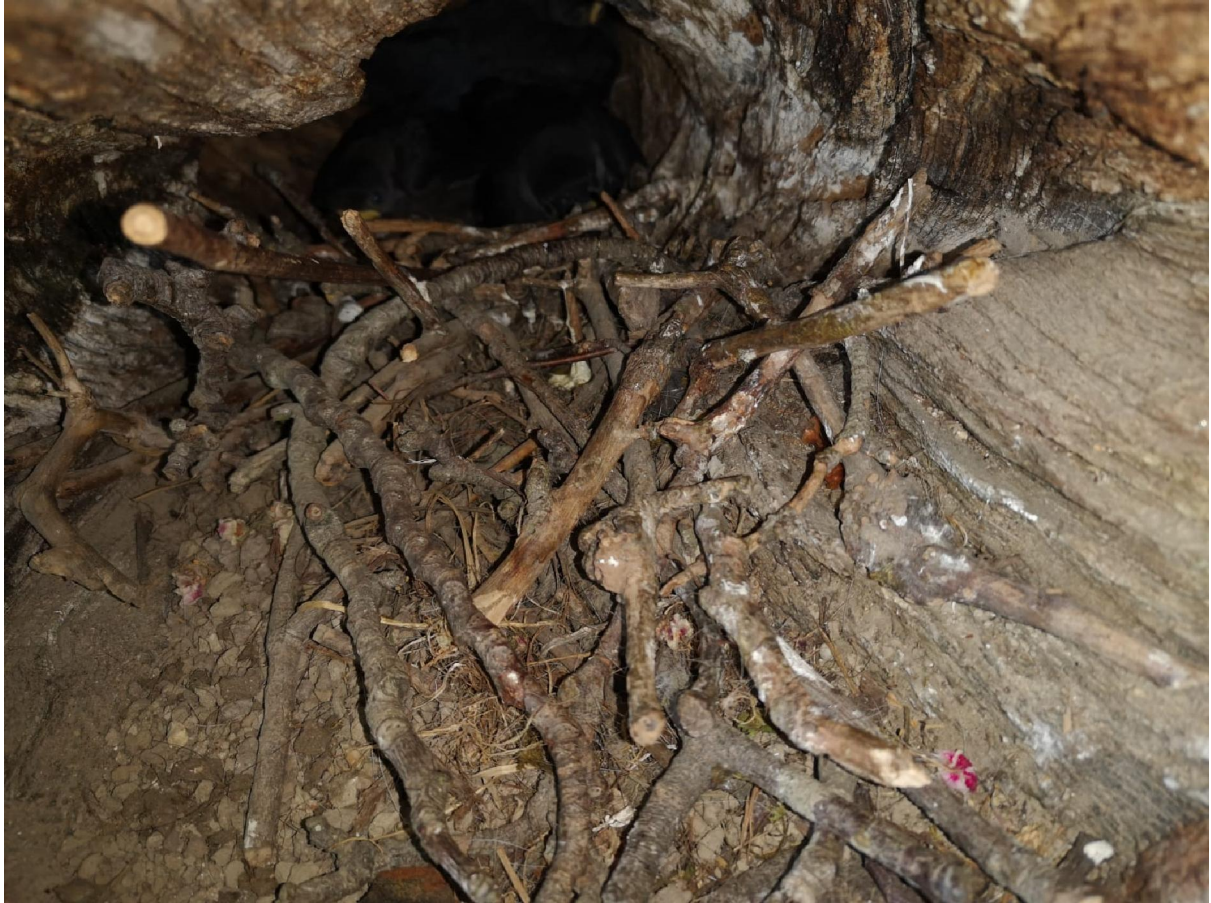
Photo showing depth of cavity.
