04 December 2019  
NS19/012/DC/AH

## ROOK HILL FARM BARN, OFFTON, SUFFOLK – STRUCTURAL ENGINEER'S INSPECTION REPORT

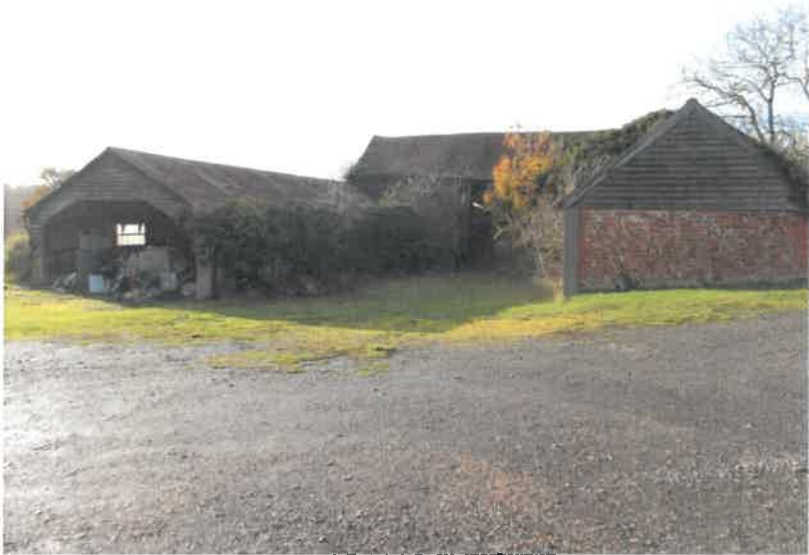
Photograph 1

To the north of barn 1 young elderberry trees are present within the recess between barn 1 and 2 and a mature deciduous tree is located approximately 3m north of this point. Vegetation is extensive along the north wall of barn 2 with extensive ivy growth over, obscuring much of the wall and roof behind, in conjunction with a young sycamore tree sprouted from the east end of the range. Ivy growth is generally more concentrated at the western end of barn 2, diminishing towards the east. Similar heavy vegetation growth is present throughout the courtyard area, with ivy growing over the south roof slope and wall of barn 2, extending across the north end of barn 1, and extensive growth across the north facing wall of barn 3 (see photograph 1).

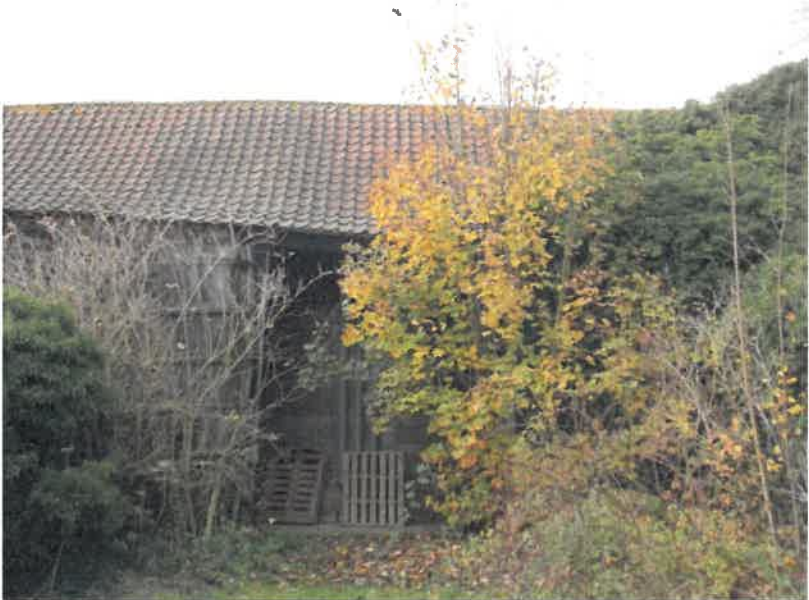
Photograph 2

The roofline presents as an undulating plane with deflection of both the ridge and the roof plane itself occurring along the structure. Dipping of the roof plane around the purlin location can be observed to the south of the elevation with further dipping occurring over the main door entrance (see photograph 2).

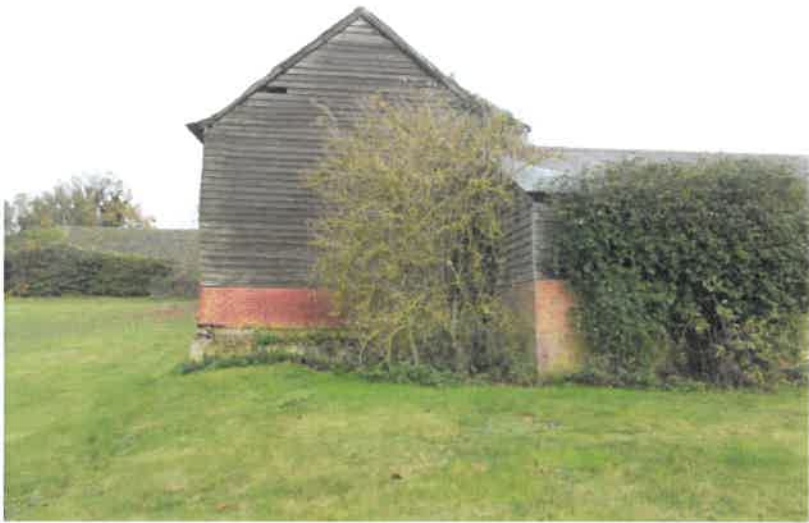
Photograph 3

The south elevation is the gable end of barn 1 which is substantially clad in timber weatherboarding (see photograph 3). This arrangement at the south end appears to be a relatively modern construction with timberwork supported on an improved plinth of modern red brickwork laid in sand and cement mortar and in stretcher bond coursing. This assembly is supported on the concrete floor slab of the barn, which suggests that the barn has been shortened in length at this location. The remains of the original brick plinth can be observed to the south of the floor slab, suggesting a modern intervention and probably replacing decayed original south gable end at some point. The original brick plinth has deteriorated, with the whole rotating outwards and southwards at the top, with extensive open joints, loss of bricks, cracks and spalling occurring along the length. This has permitted an inspection of the modern concrete slab edge and this too shows signs of damage, with pockets and voids being apparent beneath the slab edge, possibly due to rodent activity or washout from the splashback of rainwater. Whilst this does not appear to have affected the brick plinth and timber gable ends supported above, this would need reviewing in any conversion plans (see photograph 4).

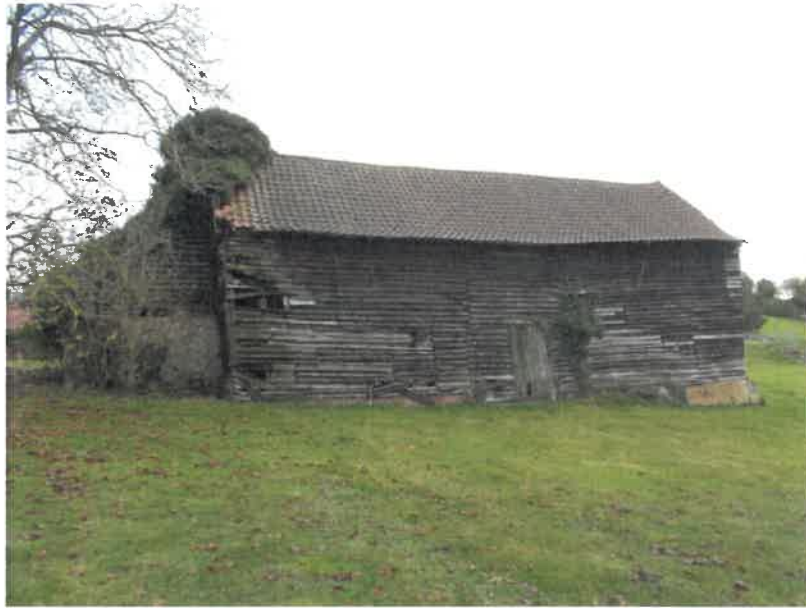
Photograph 5

The roof presents in an undulated fashion as per the east elevation, however, the dipping of the roof plane is less apparent on this face with only the ridge undulation most obvious (see photograph 5).

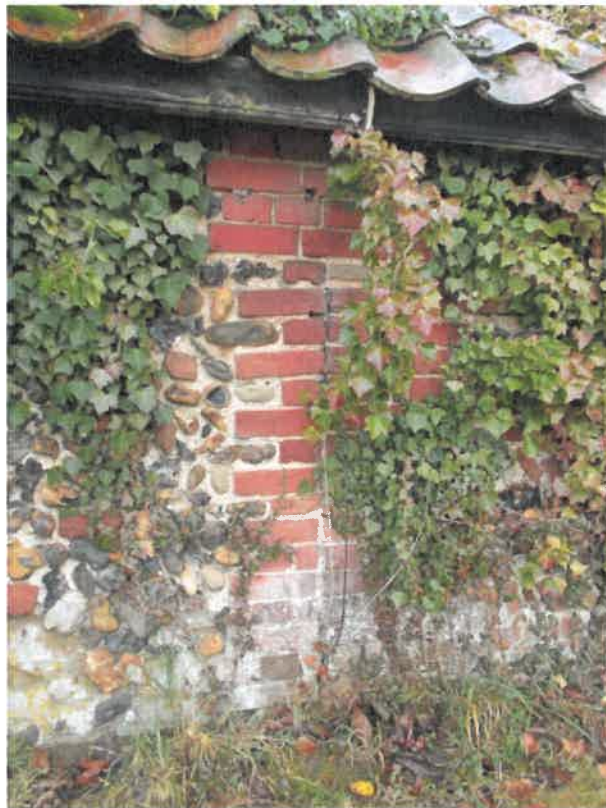
Photograph 6

The north elevation is substantially obscured by ivy growth and with the visible wall portions at eaves level showing bricks in conjunction with flintwork panels. Flint cobbles have been laid unknapped generally, in a lime mortar matrix. This construction continues for the entire length of the north elevation. The roof is supported directly onto the walls via a timber wall plate and with the roof construction comprising clay pantiles overlying timber rafters and purlins. The roof generally presents as reasonably uniform with minor ridge undulation where visible and with a reasonably level eaves line. As previously noted this elevation supports the lateral pressure from the ground as barn 2 is partly embedded into the slope at this location. The wall presents in reasonable condition with minor loss of flintwork towards the eastern end of the elevation and with relatively minor mortar loss where the wall is visible (see photograph 6).

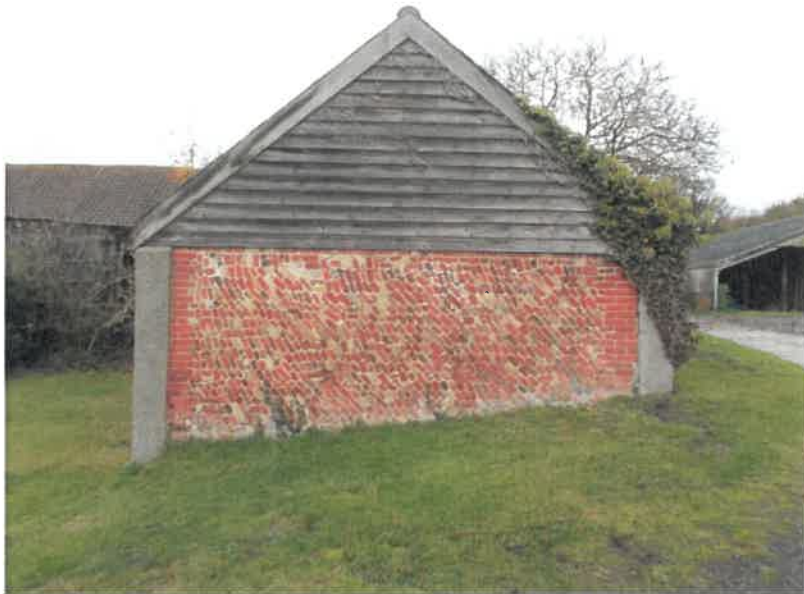
Photograph 7

The east elevation presents the gable end. The gable itself is typical weatherboarded and presenting in good condition. There is evidence of historic ivy growth, mainly on the weatherboarding. The gable is supported on a red brick wall beneath with the external face of brickwork presenting in a random bond with bricks laid vertical and diagonally along the elevation. These are set between red brick quoins at each end of the elevation. The quoins have been augmented with the addition of sand and cement facing. There is minor loss of mortar in random areas across the elevation and with minor fracturing present towards the northern end of the location of an imbedded metal fixing. Bricks appear in good condition generally with relatively minor spalling and rounding due to weather action (see photograph 7).

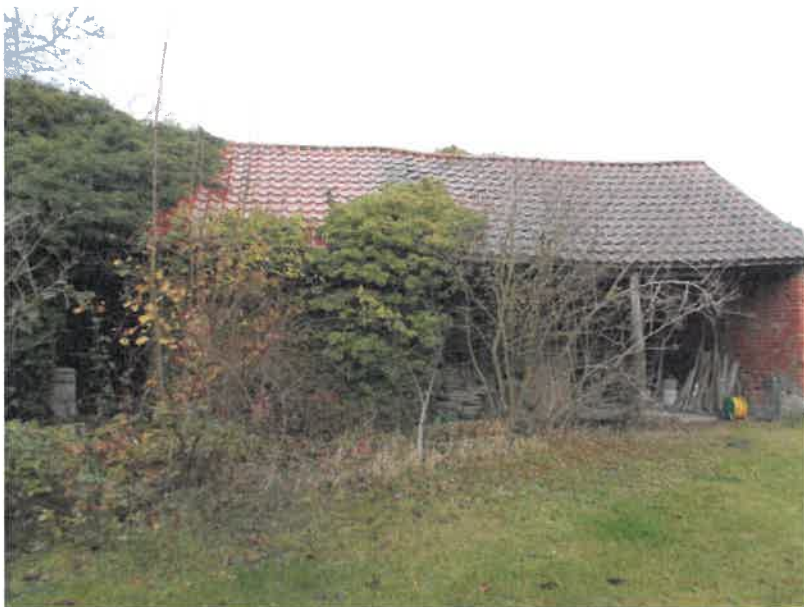
Photograph 8

The west end of this elevation is largely obscured by ivy growth and therefore cannot be commented upon. The roof generally undulates, as previously advised, with dipping in the cart lodge area apparent (see photograph 8).

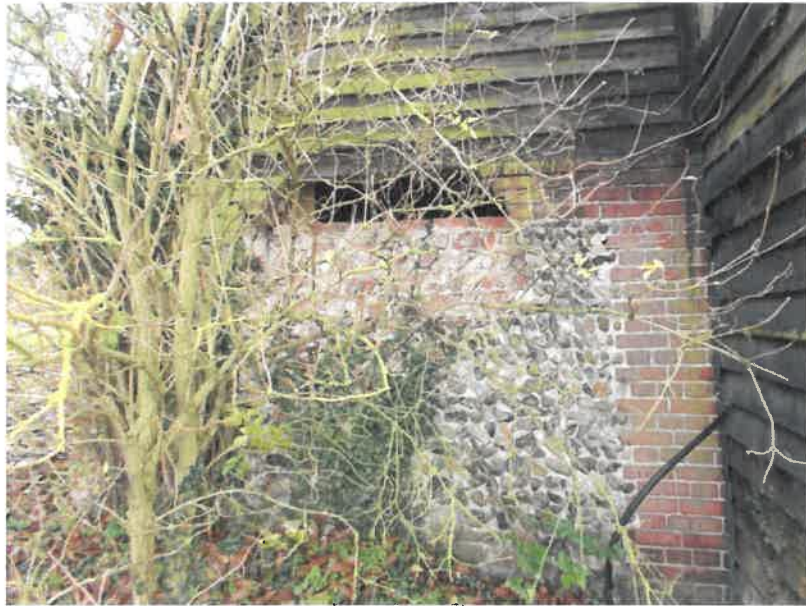
Photograph 9

The west elevation presents a small area of structure comprising a timber clad gable overlying brick walling beneath. A large portion of the flintwork panel has collapsed outwards revealing the inner brickwork lining. The remaining flintwork and brickwork are in good condition with the flint cobbles generally unlapped, laid in lime mortar as elsewhere (see photograph 9).

A small area of flint panelling has collapsed in the west gable of barn 2, however the internal brick lining, which is laid in the diagonal bond, featured on the east elevation, remains as a backing and the flintwork can be usually reinstated using traditional techniques.

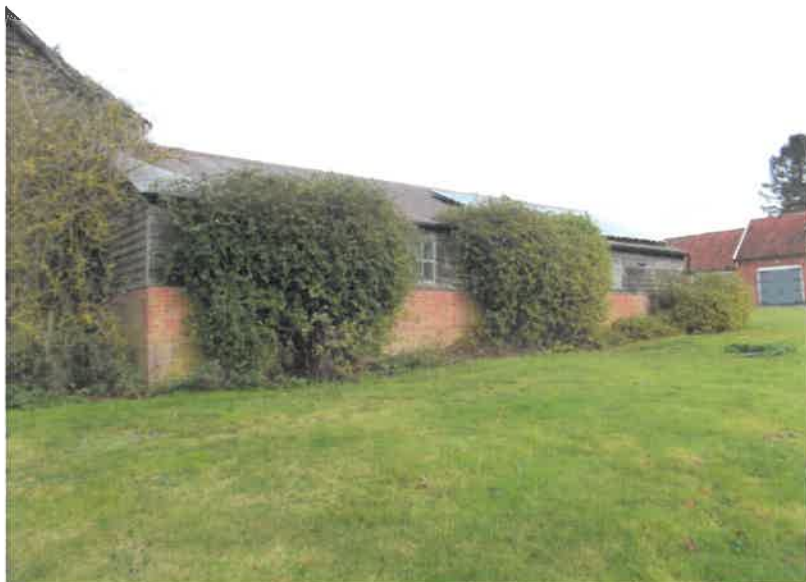
Photograph 10

The south elevation comprises a similar roof construction as before with walls of weather clad timber framing built above a brickwork plinth. The brick plinth is in good condition where visible (see photograph 10).

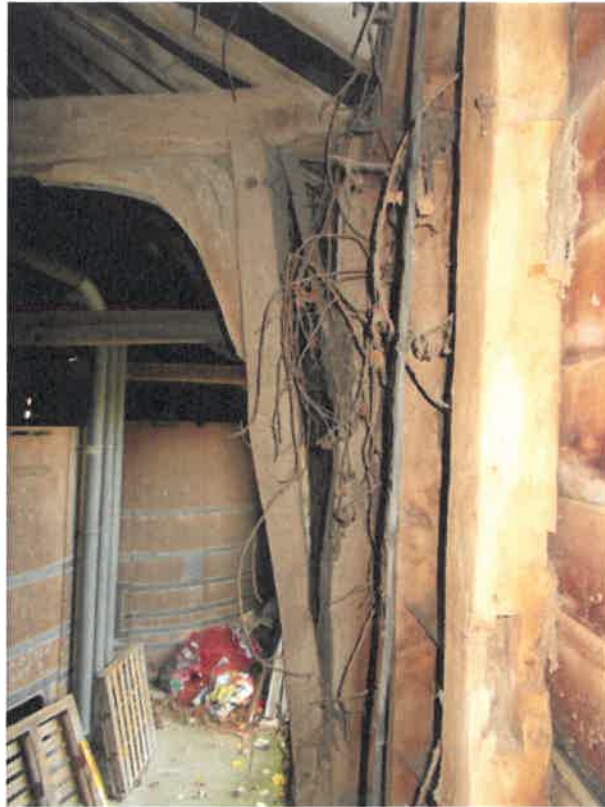
Photograph 11

There is obvious movement in the timber frame as predominantly occurring on the west elevation where the outward roll of the brick plinth has caused the base of the studs to move similarly and tending to drag the base of the bay post and studs with them. This has led to an opening up of the joints between the bay posts and the tie beams at eaves level. Movement in some areas is quite extensive and has led to splitting of the jowled post tops and this is noticeable at locations A3, B3, C3, D3 and E3 (see photograph 11).

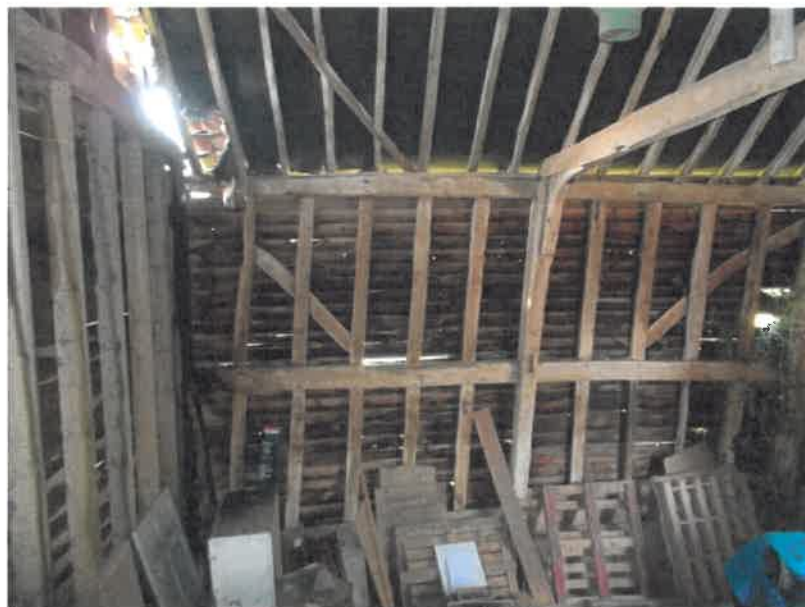
Photograph 12

Racking of the timber frame here occurs in a norther direction and measures approximately 3° from vertical. Lateral movement measures approximately 1.2° to 1.6° from vertical (see photograph 12).

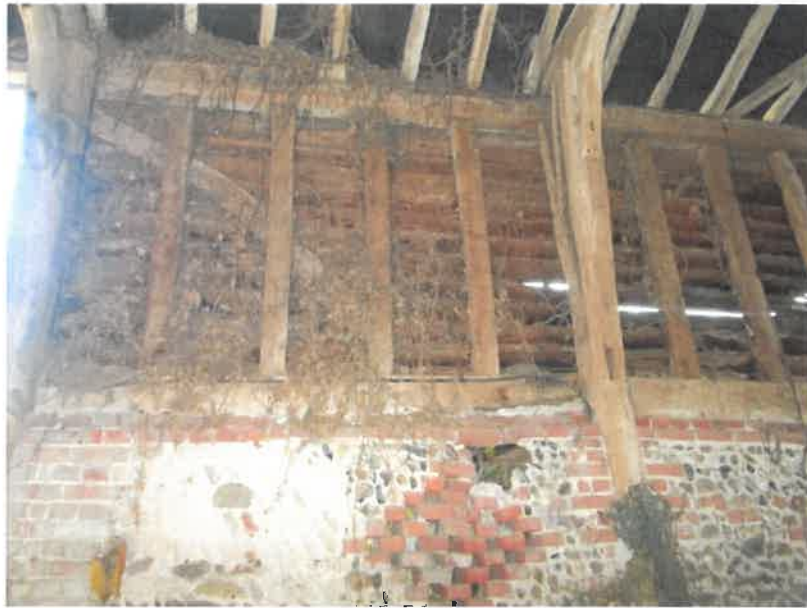
Photograph 13

On the west elevation it would appear that the historic timber frame between the ground level and girt beam had at some point decayed warranting reconstruction in the brick and flintwork walling which is present up to the girt beam. This is visible both internally and externally and presents in reasonable condition. Towards the southern end of the building traditional diamond ventilation slots are present, although these have deteriorated in places leading to partial collapse of the brickwork assembly. Flint cobbles are laid in a lime mortar matrix in between red brick quoins. There is minor evidence of movement in this assembly, however this is within expected condition parameters (see photograph 13).

It appears that the west elevation of barn 1 has received significant alteration with the studwork between the sole plate and girt beam / rail having been replaced with flintwork panelling and brickwork quoins. This is likely due to deterioration of the former timber elements and their subsequent replacement is performing adequately. There is minor dislodgement of brickwork forming the ventilation diamond in the flintwork panel, however this can be readily corrected in the course of the conversion process.

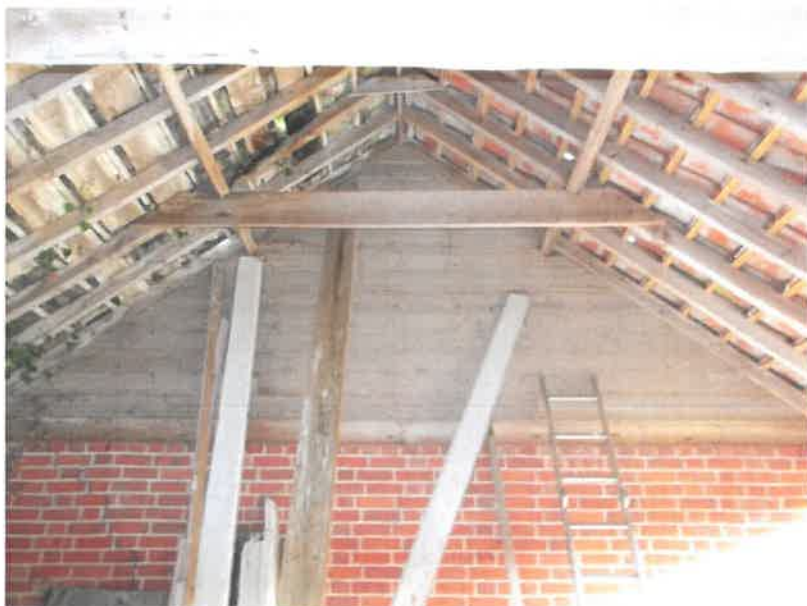
Photograph 14

The cart lodge features a vaulted roof construction comprising common rafters bearing onto an a symmetrically located purlin towards the ridge, as previous. This is in turn supported laterally by intermediate collars located on every fifth rafter as per barn 1. At the collar locations the rafters have been increased in width to 60mm to add to the form of principal rafter. A central circular section tie beam, approximately 200mm diameter is present, tying the wall plate on the north side to the plate on the south side. An isolated area of moisture has occurred in the north eastern corner of the roof although relatively small scale (see photograph 14).

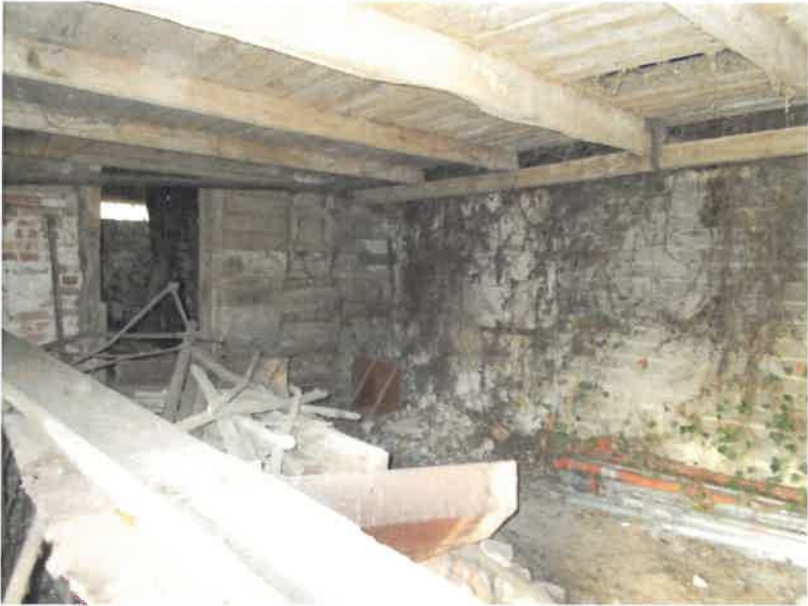
Photograph 15

The northern wall presents the flintwork panels in between the soft red brickwork quoins and this appears in good condition, albeit partially stained with moss growth due to historic moisture ingress at this location. At the division wall between the cart lodge and the adjacent cattle sheds is solid red brickwork presenting in good condition. This has a timber stud wall above supporting a gable triangle and weatherboards and this too appears in good condition. The cattle shed buildings feature a solid concrete floor in part and the presence of extensive rubble which appears to relate to the north walls. A large area of the north wall has been reconstructed in concrete blockwork and laid in sand and cement mortar. There is a partial flat ceiling above this area comprising timber boards onto timber joists. This is assumed to have acted as a feed store or similar. The remains of the cattle stalls are present towards the east end of the area. The roof cannot be observed at this location clearly however a brief inspection suggests common rafters supported on purlins and collars, as per the cart lodge end of the building (see photograph 15).

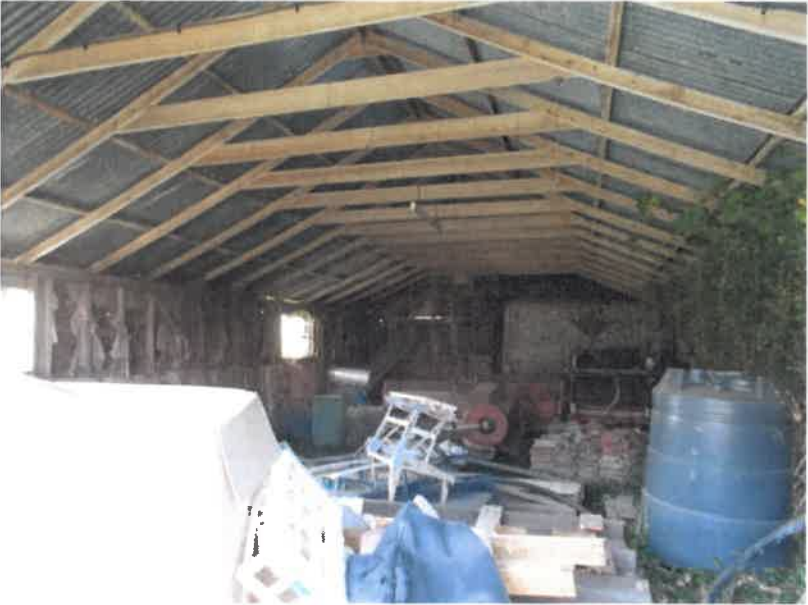
Photograph 16

Barn 3 is a simple structure comprising a raised collar tie truss roof supporting five purlins per roof slope and corrugated iron sheeting above. This assembly is supported directly on short timber frame stud walls to the externals, which in turn are supported on a brick plinth, approximately 100mm wide brickwork laid in stretcher bond and stiffened with piers along its length. The roof construction is very lightweight and the arrangement of high level collars does not adequately support the outward thrust of the roof. Consequently there has been a degree of outward movement of the timber frame walls

supporting the roof. There also appears to have been moisture ingress, as the extensive build up of silt and mud on the concrete floor was very damp and wet at the time of our inspection. This may have originated from the open gable end on the east elevation which has permitted moisture to enter the building with the affects of wind driven rain. The extent of this moisture ingress does continue through to the rear most end of this barn at its abutment with barn 1. This building was used for the storage of farm machinery, many of which are still present (see photograph 16).
