Project Title:
Wern Farm - Barn Surveys, Tredunnock, Usk, NP15 1PE

Project No:
20.4791

Client:
FCE (Wales) Ltd

STRUCTURAL APPRAISAL

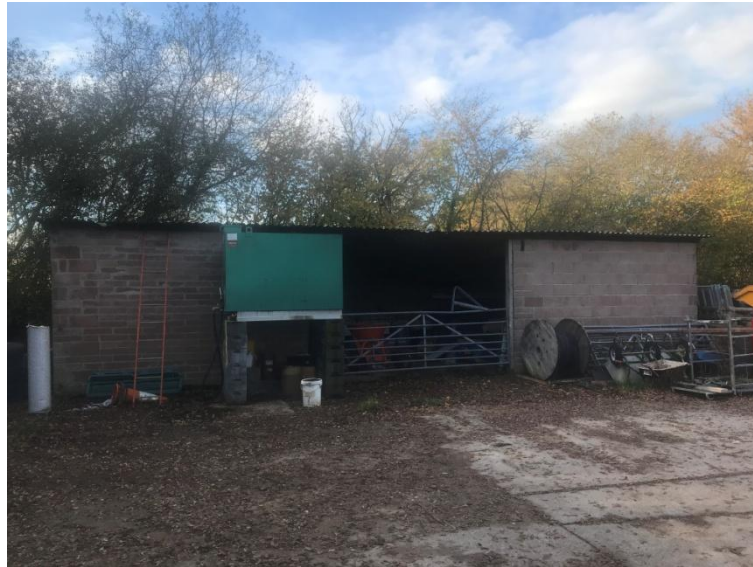
Photograph 1

- 2.4 Barn 1 (see Photograph 1) is approximately 5.8m wide, 12.7m long and the height varies from 2.9m to 2.7m. The wall panels are a mix of single skin blockwork (100mm thick) and block on flat (215mm thick), generally with stretcher bond pattern. The blockwork is generally fairfaced. There are piers which are 440mm square and positioned at a maximum spacing of 4.7m.

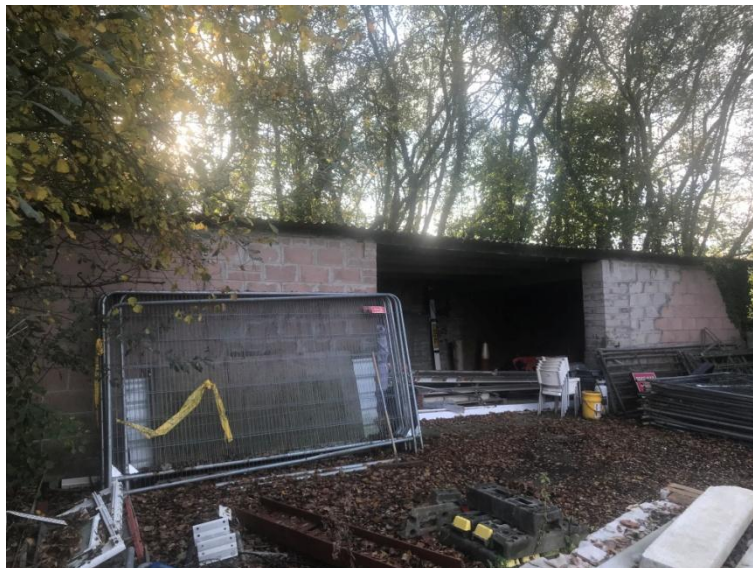
Photograph 2

- 2.5 Barn 2 (see Photograph 2) is approximately 4.35m wide, 13m long and the height varies between 2.7m to 2.4m. The wall panels are a mix of single skin blockwork (100mm thick) and block on flat (215mm thick), generally with stretcher bond pattern. The blockwork is generally fairfaced. There are piers which are 440mm square and positioned at a maximum spacing of 4.6m.

- 2.7 There are no other adjoining buildings. There is an elevated fuel tank next to the entrance of Barn 1.
- 2.8 Barn 2 has had part of the front wall rebuilt. This new section is not fairfaced blockwork.
