EXISTING

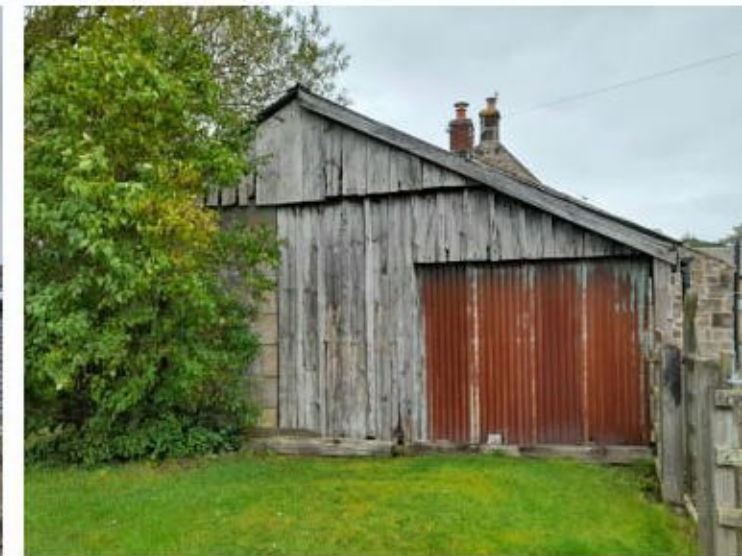
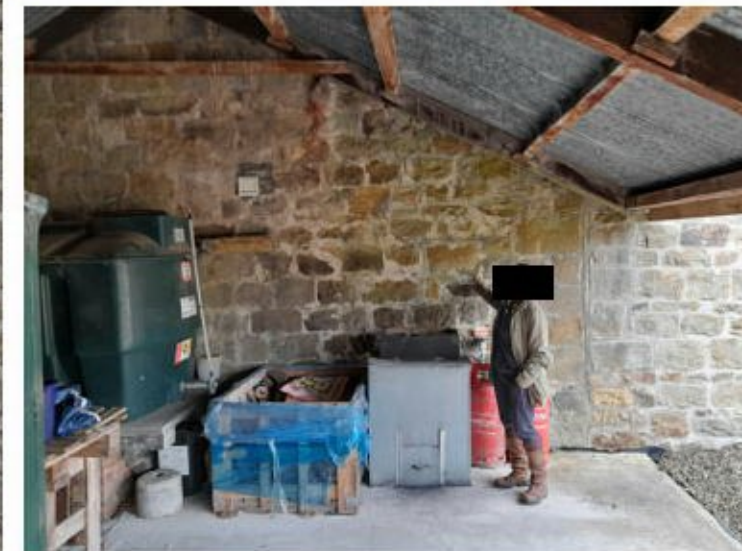
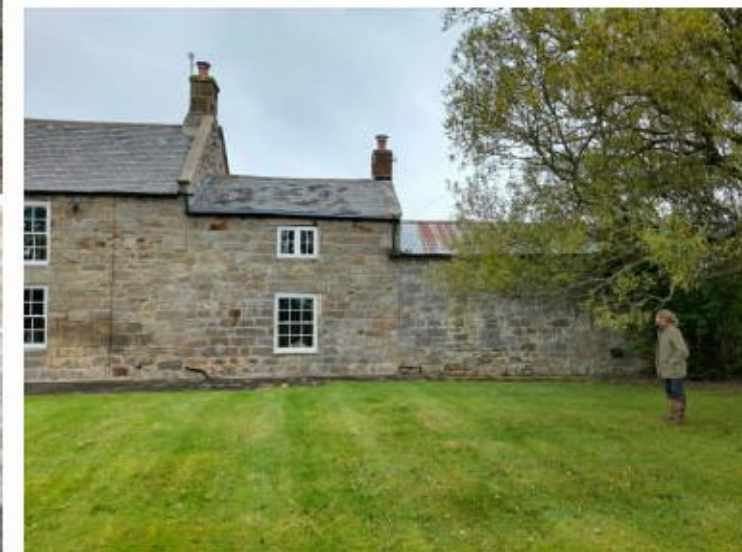
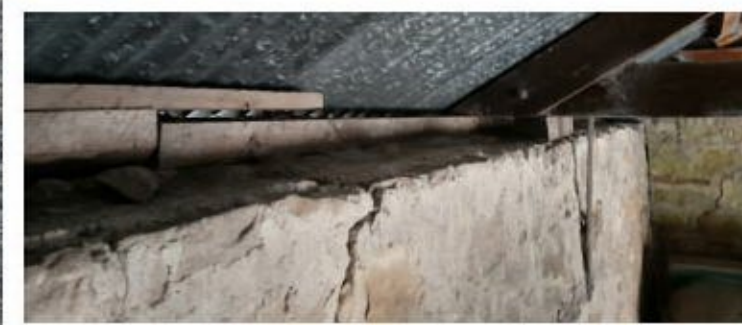
EXISTING TRACTOR LODGE HAS A CONCRETE FLOOR ON A PLASTIC DPM. STONEMWORK SHOWS STRUCTURAL CRACKS TO BACK WALL. ROOF BOWING AND SHOWING CORROSION TO METAL CORRUGATED SHEET. TIMBER COLUMNS CRACKED AND WITH EVIDENCE OF ROTTING AT GROUND LEVEL.
