Gunnerton Farm Buildings - Visual Inspection Survey

At the instruction of Norr Consultants, 3e were appointed to carry out a visual structural inspection of the stone barns/outbuildings located at Demesne Farm, Gunnerton. The inspection was carried out on Wednesday 27th October 2021. Laura MacIver from Norr Consultants carried out a site inspection together with Adrian Batey from 3e.

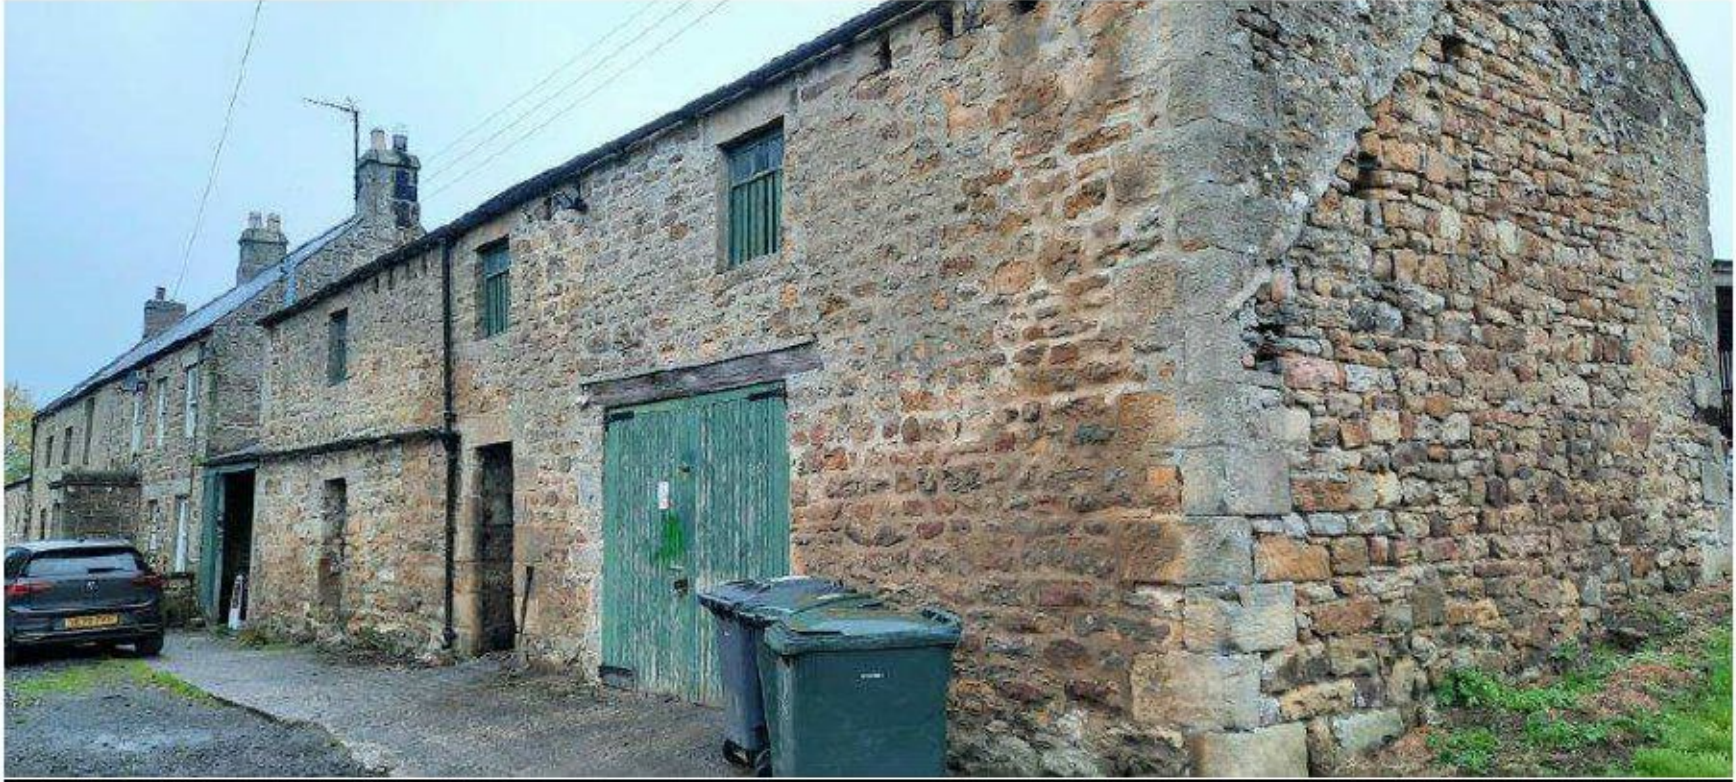
P1

Barn 1 is a two-storey solid masonry construction with a timber first floor and slate roof (P1). The roof is supported on timber rafters/purlins spanning between A-frame timber trusses (P2).

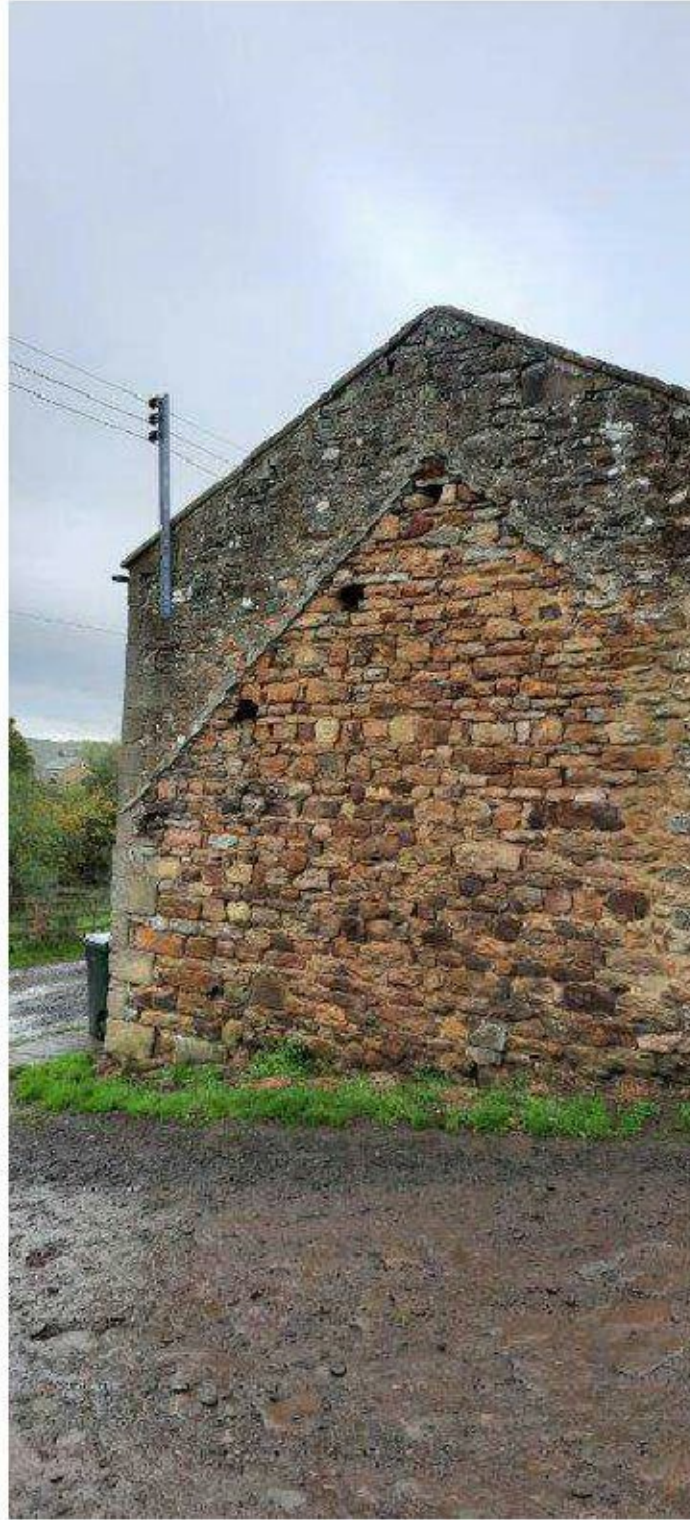
P3

There appears to have been a previous building attached to the eastern gable (P3).

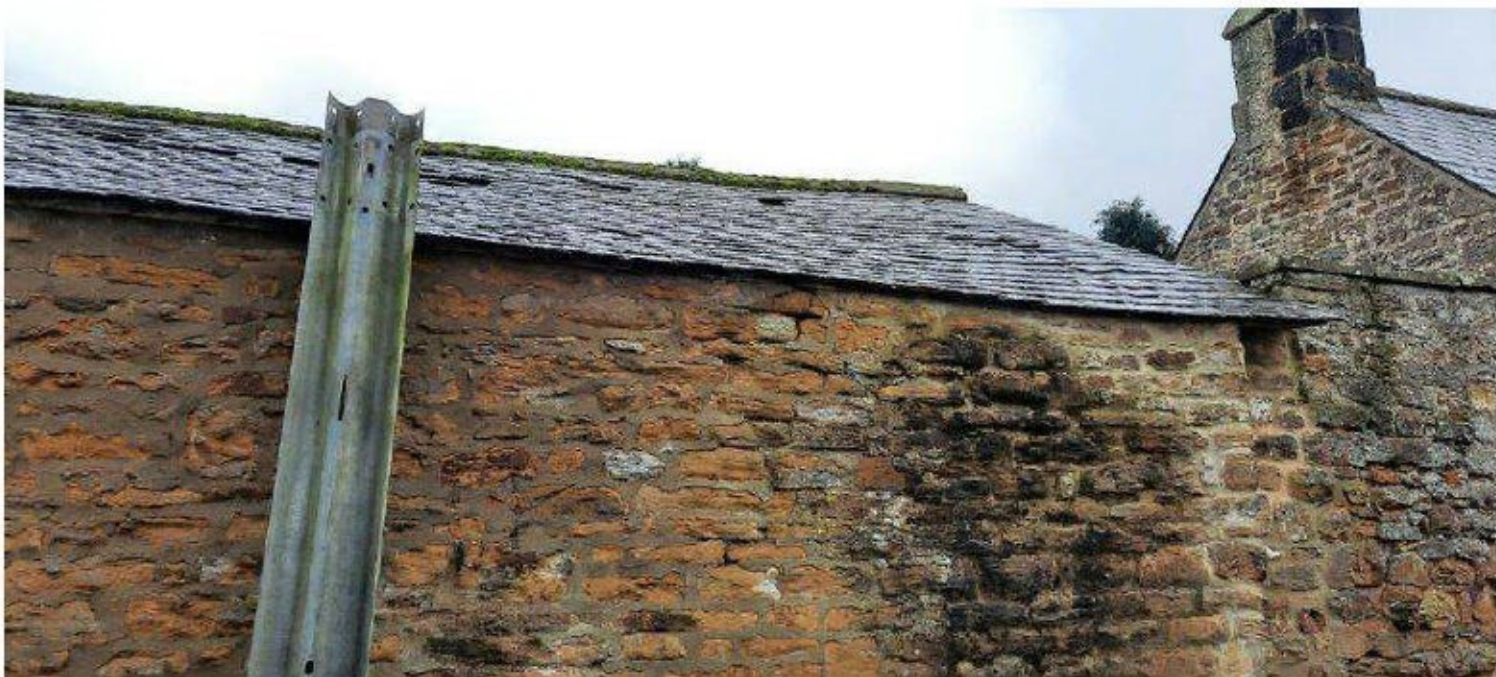
P4

Rainwater goods are in poor condition and it is not clear how this currently drains or if it is adequately connected to below ground drainage (P4).

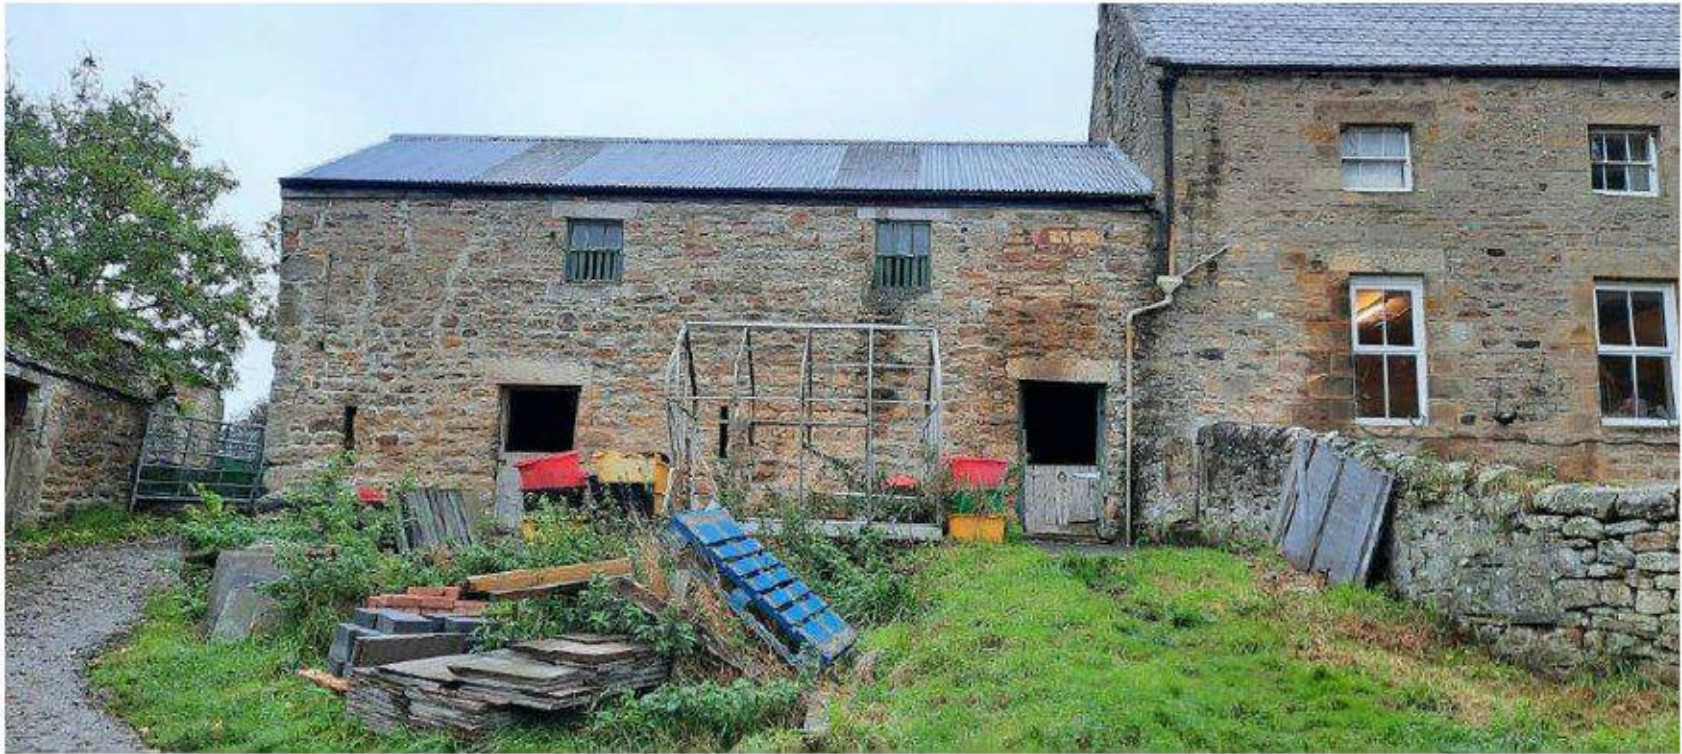
P5

The building is generally a two-storey solid masonry construction with a timber first floor (P5). There is a single storey section attached to the northern side.

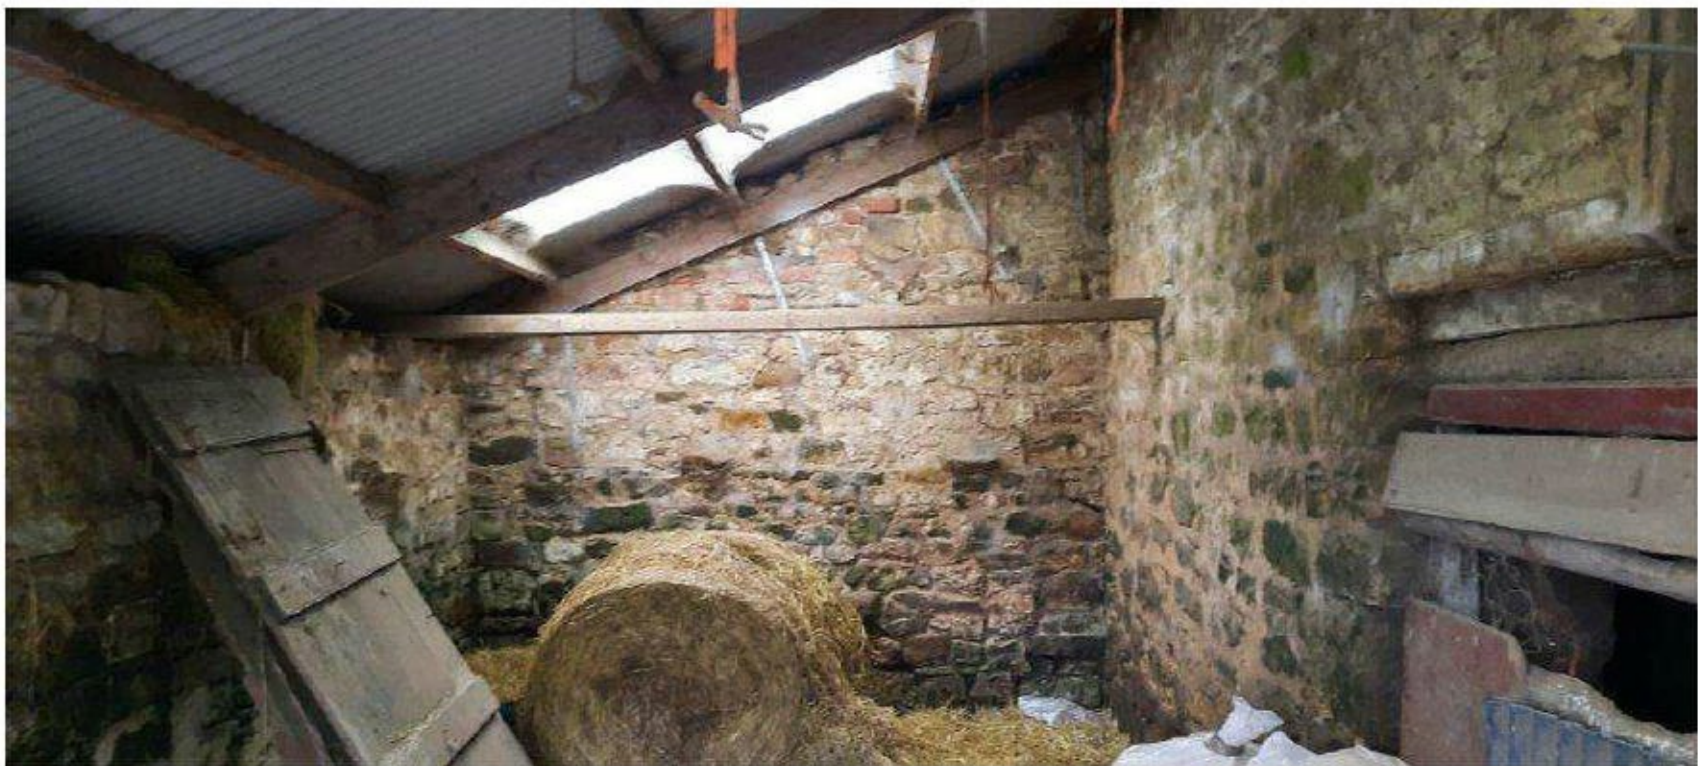
P6

Both portions of the building have been re-roofed with a corrugated metal sheet supported on the timber roof construction. Galvanised metal holding down straps are provided in a number of locations externally and internally to attempt to accommodate uplift on the lightweight roof (P6).

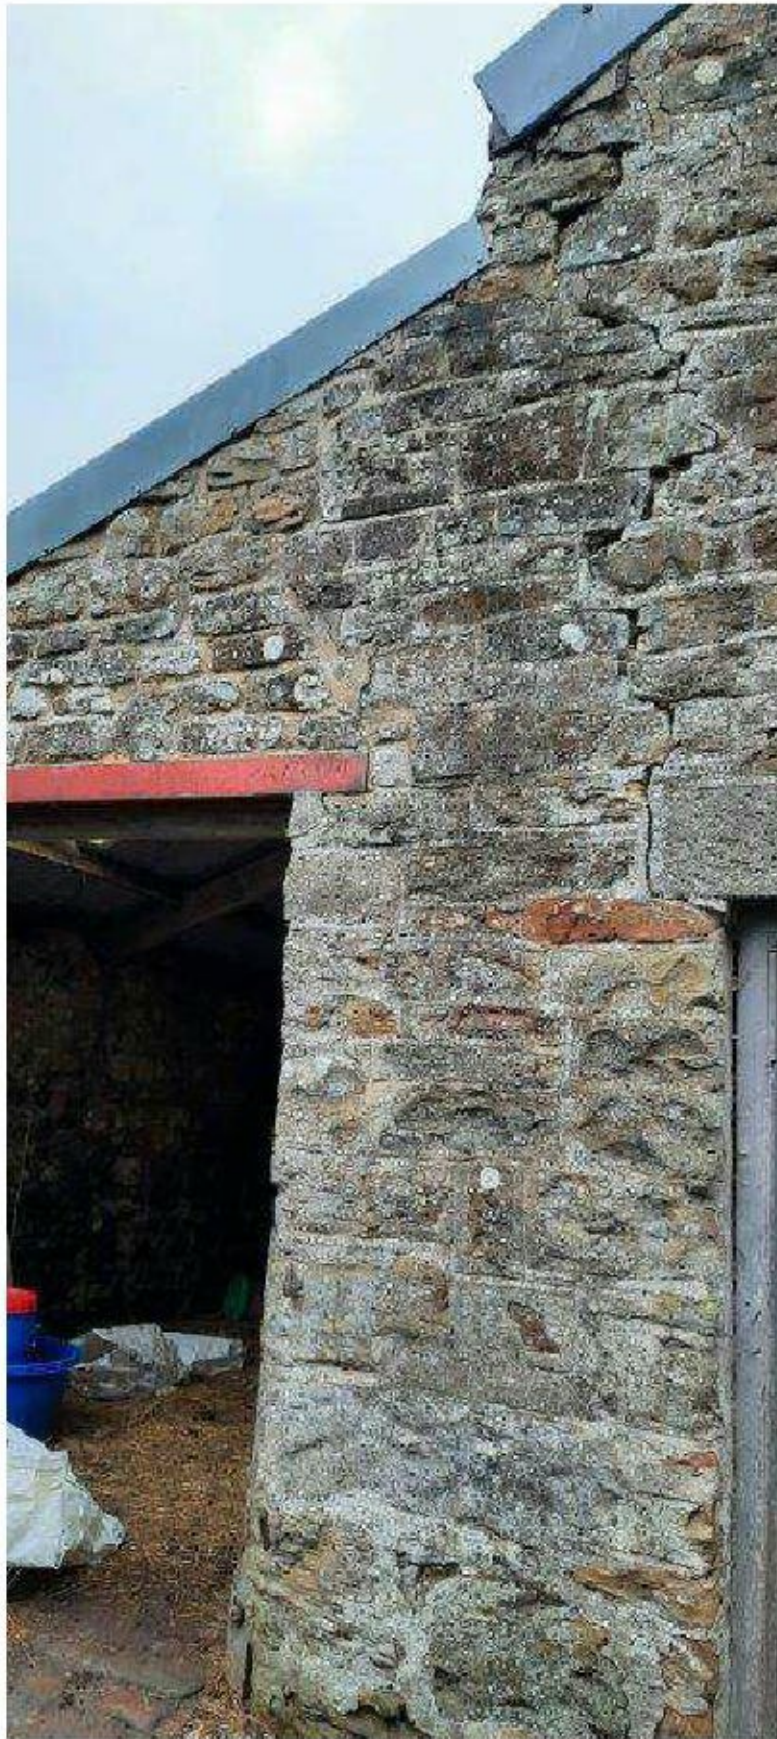
P7

There is a noticeable crack in the gable wall at the junction between the two storey and single storey section of the building (P7). There is also a large crack internally in the party wall between the two sections of the building (P8).

- Re-build existing gable to Barn 3 and Barn 4. A portion of Barn 2 is also likely to require re-building due to extent of cracking at the wall junction noted above.

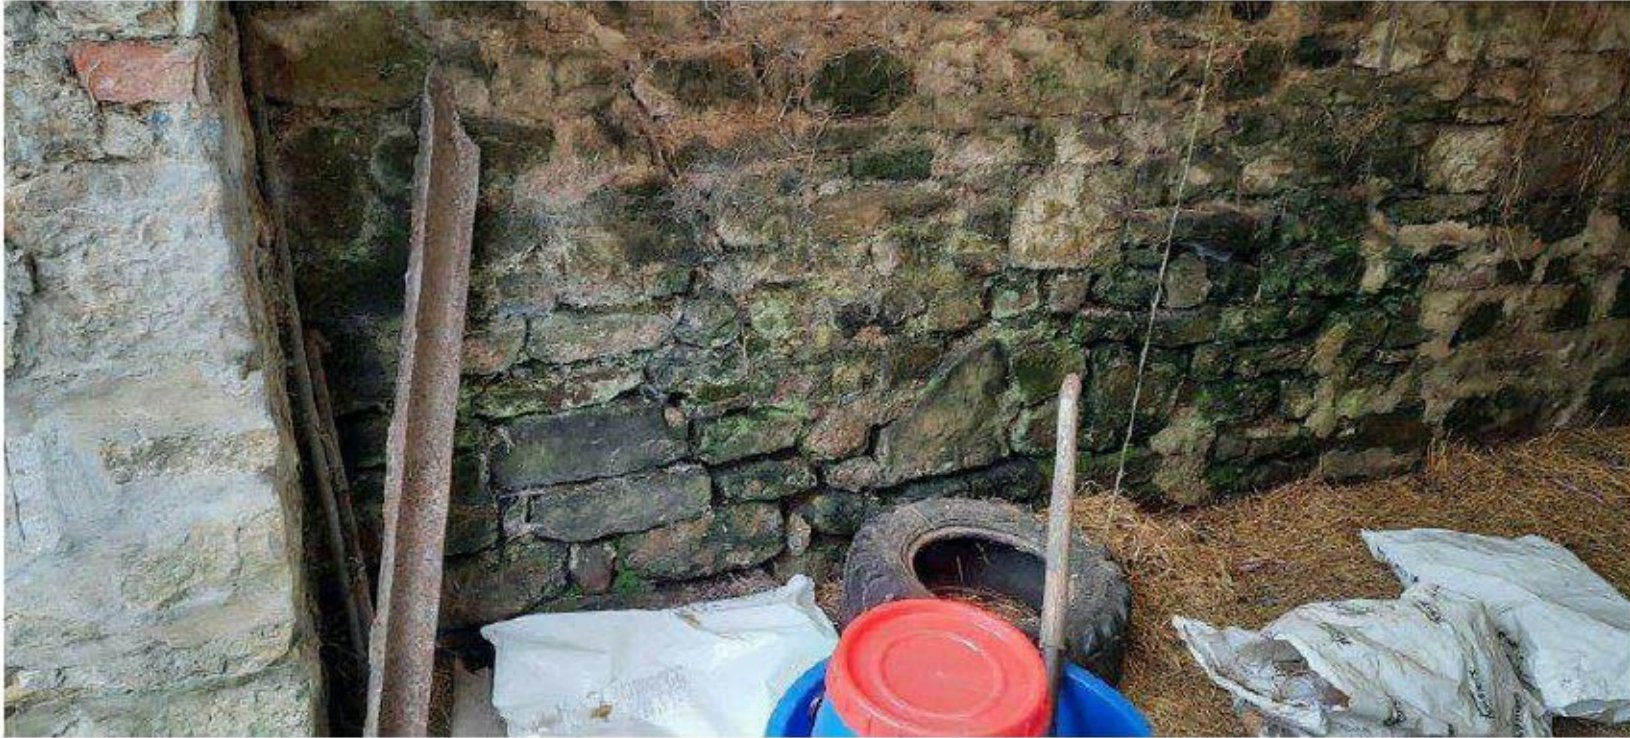
P9

There are obvious signs of damp in the walls in a number of locations and particularly at the North elevation where the wall retains the external ground level (P9). There do not appear to be any gutters or RWP's to this elevation therefore increasing risk of saturation of the ground adjacent to the property (P10).

- Review external levels to eliminate and/or minimise retaining walls on the line of the buildings.
- Check damp-proofing/tanking of external walls.
- The existing pre-cast concrete shed (Shed 2) will require a full structural survey to assess long-term stability and integrity. Any construction to create a new dwelling in this location should not rely on the current frame for vertical or lateral support.

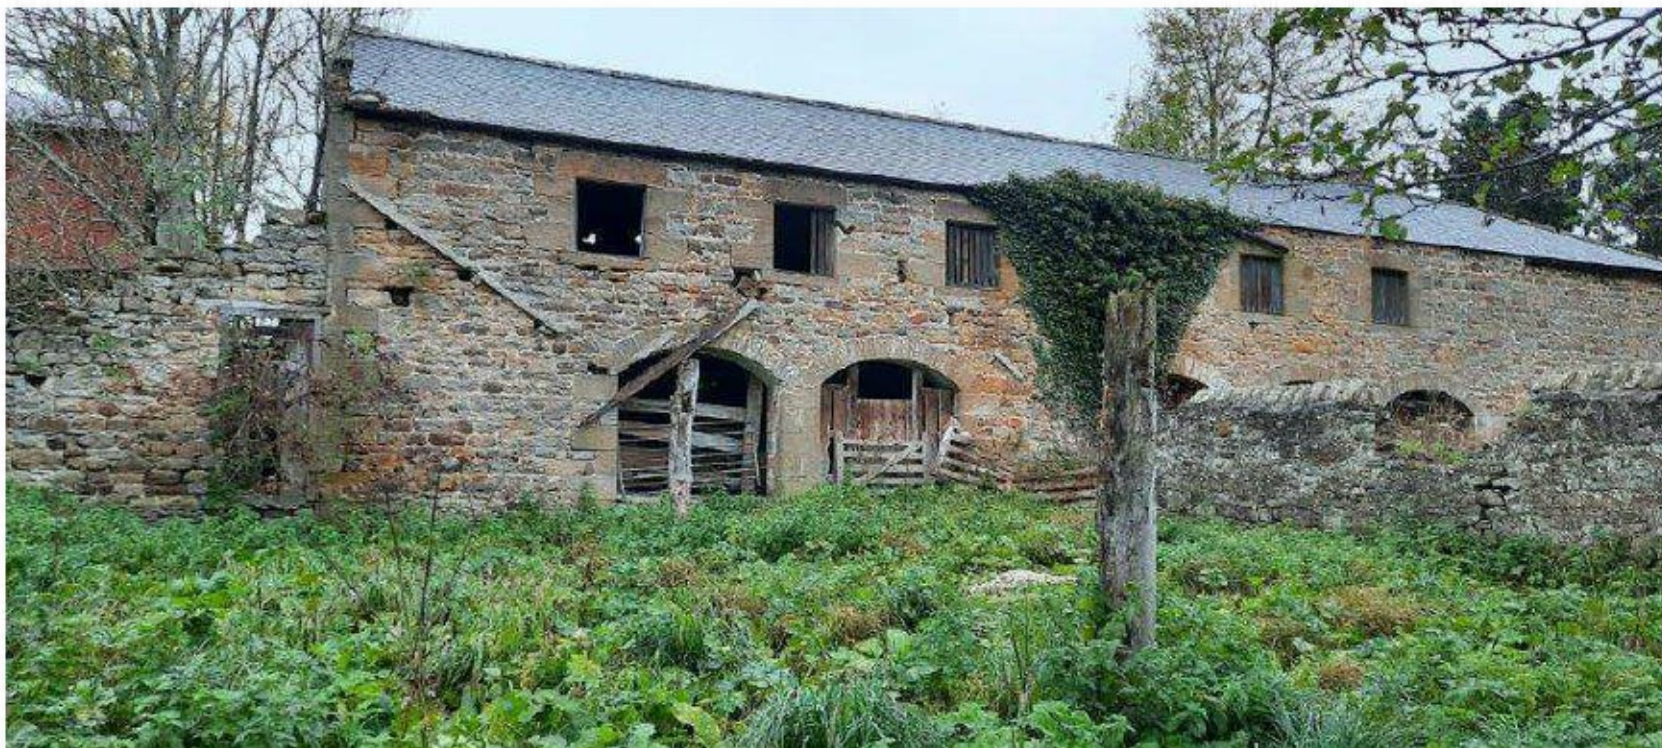
P11

The barn is a two-storey solid masonry construction with a timber floor and slate roof finish (P11). The roof structure comprises timber purlins/rafters supported on timber A-frame trusses.

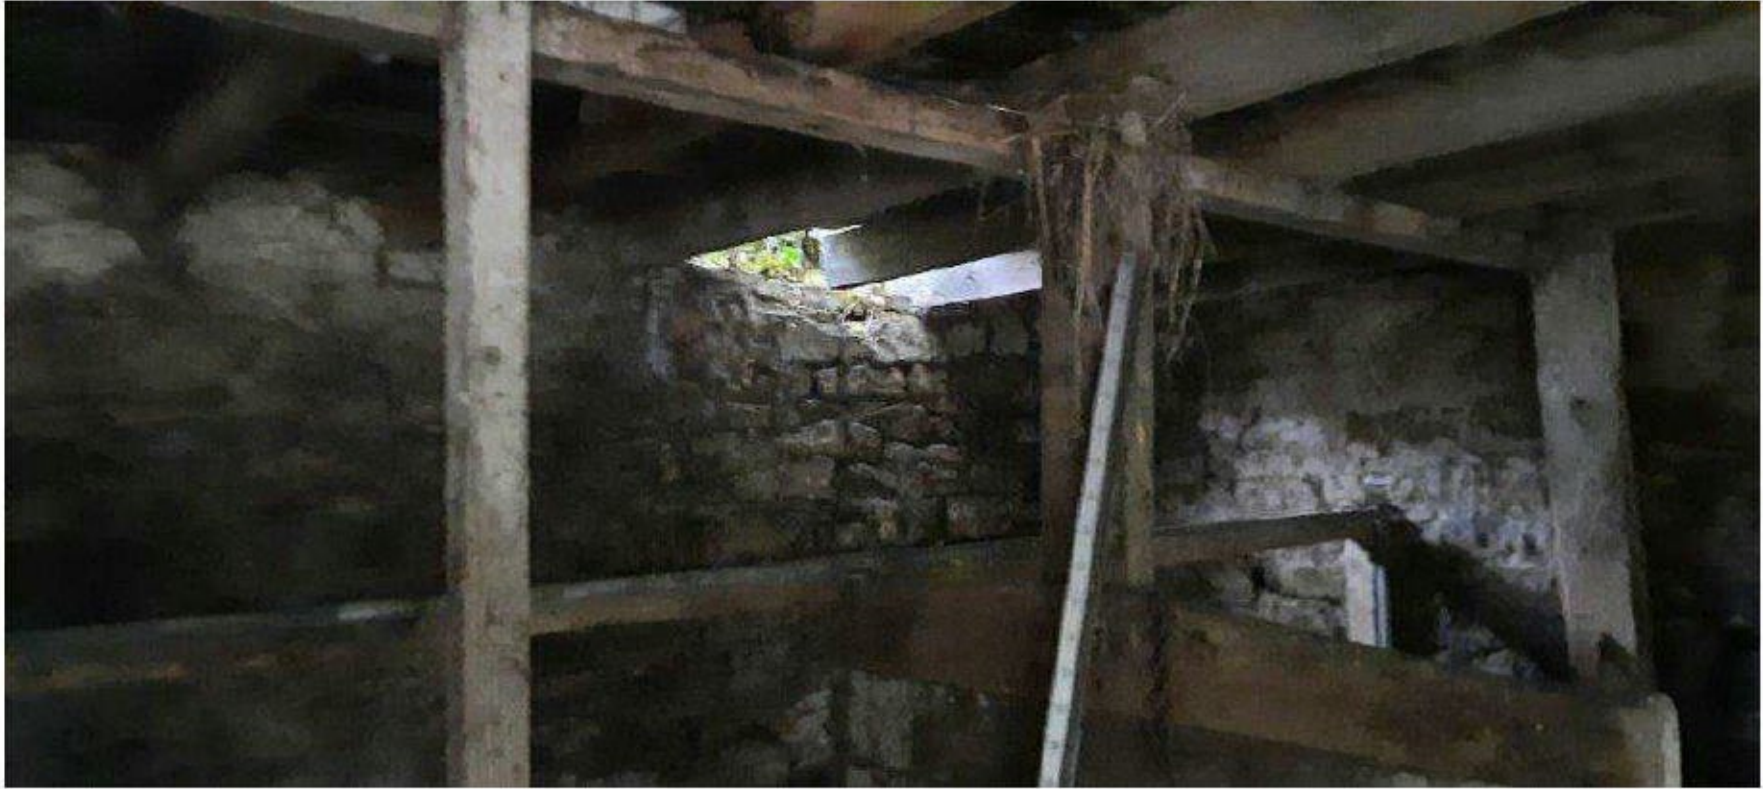
P12

The first floor was not accessible due to safety concerns as we were informed of a previous incident (P12).

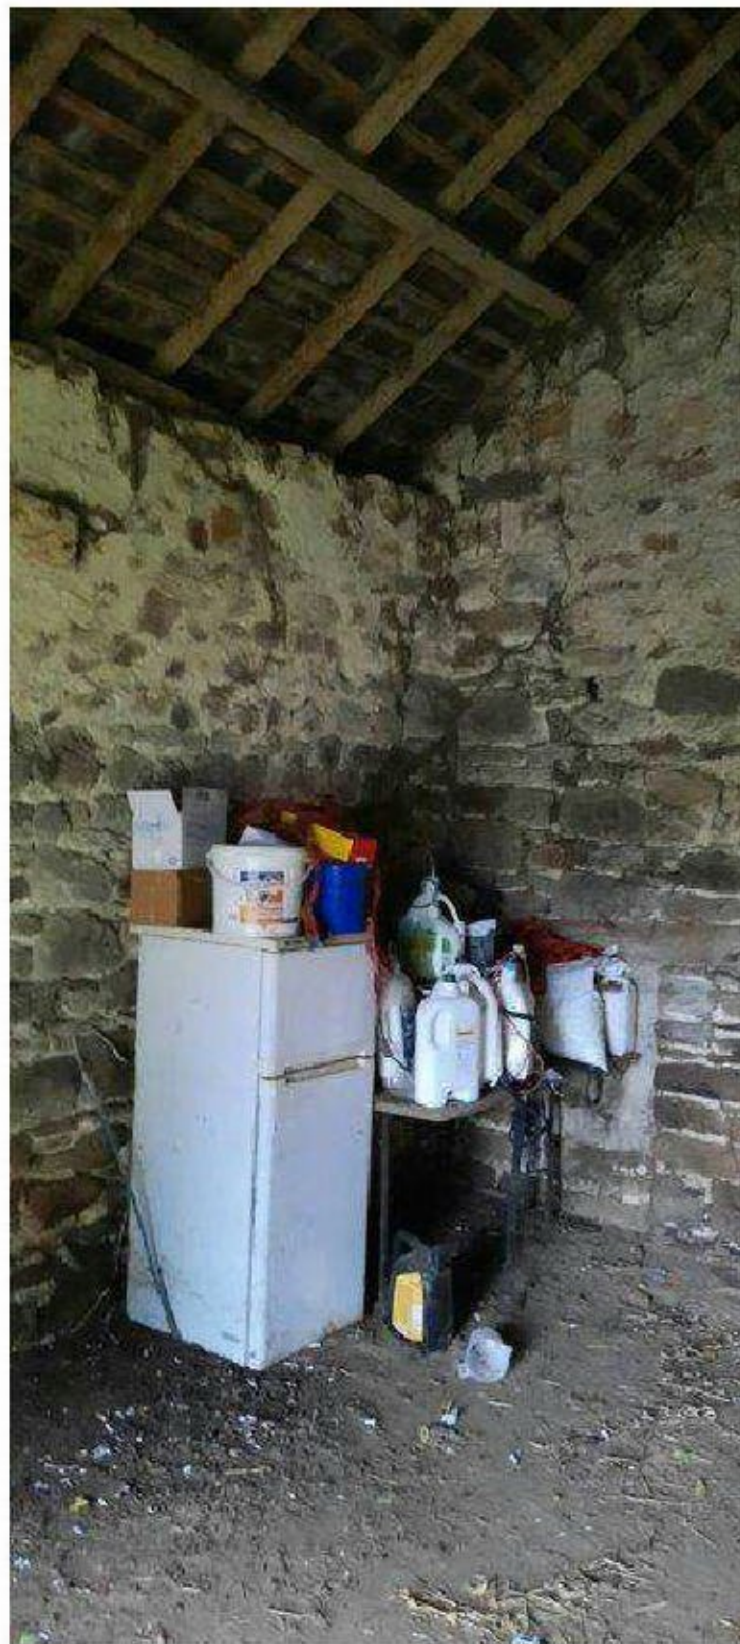
P13

Areas of cracking were noted in the external walls together with areas of damp (P13).

- Re-pointing and crack stitching where required to stabilise the external walls.
- Full timber survey. It is considered likely that all floor and roof timbers will need to be replaced.

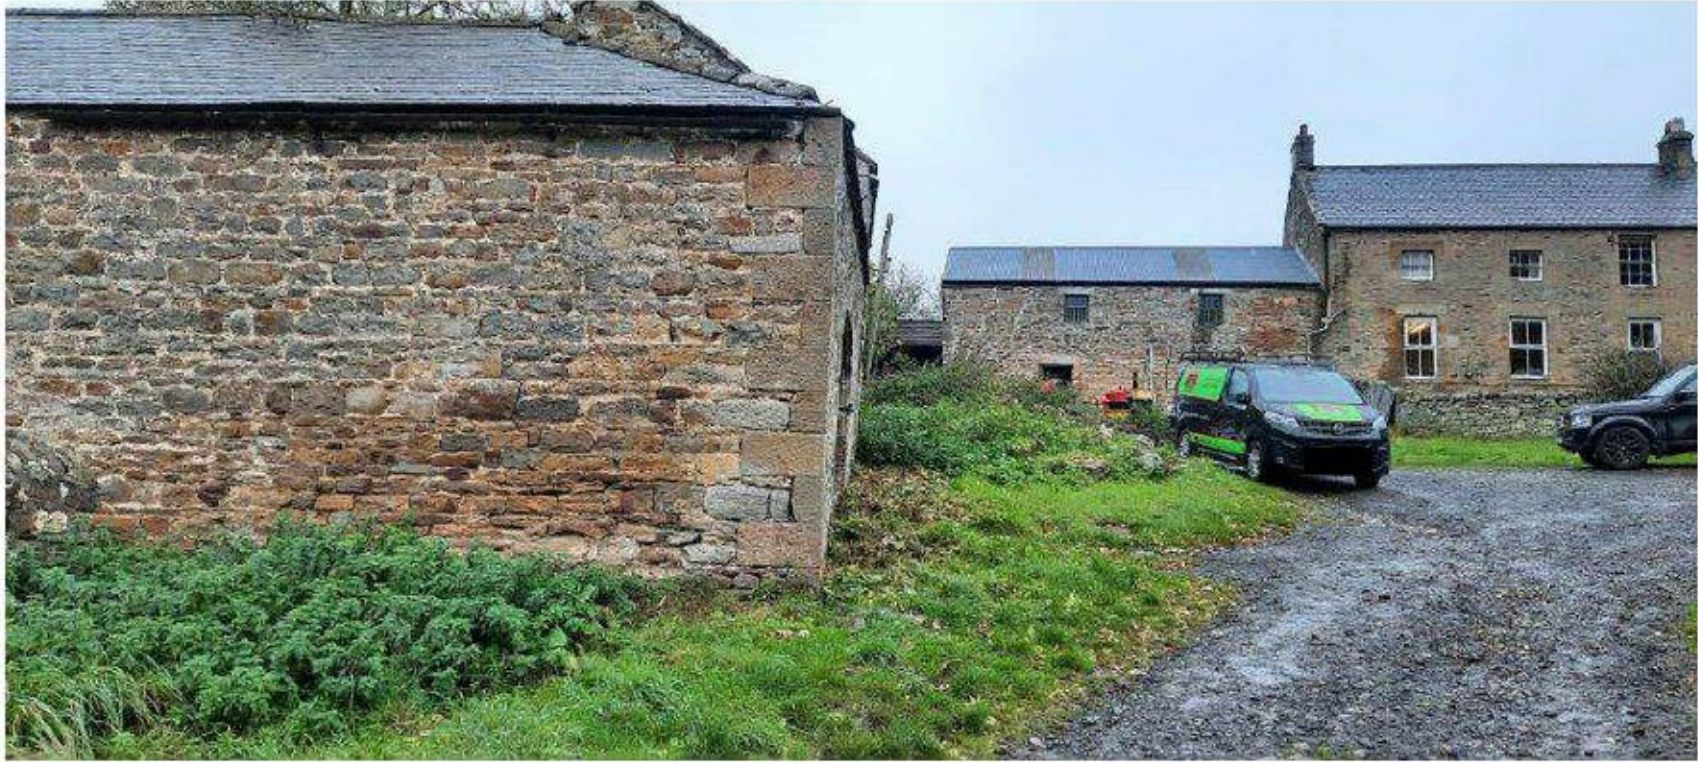
P14

The Eastern single storey gable wall is leaning outwards to a significant extent (P14).

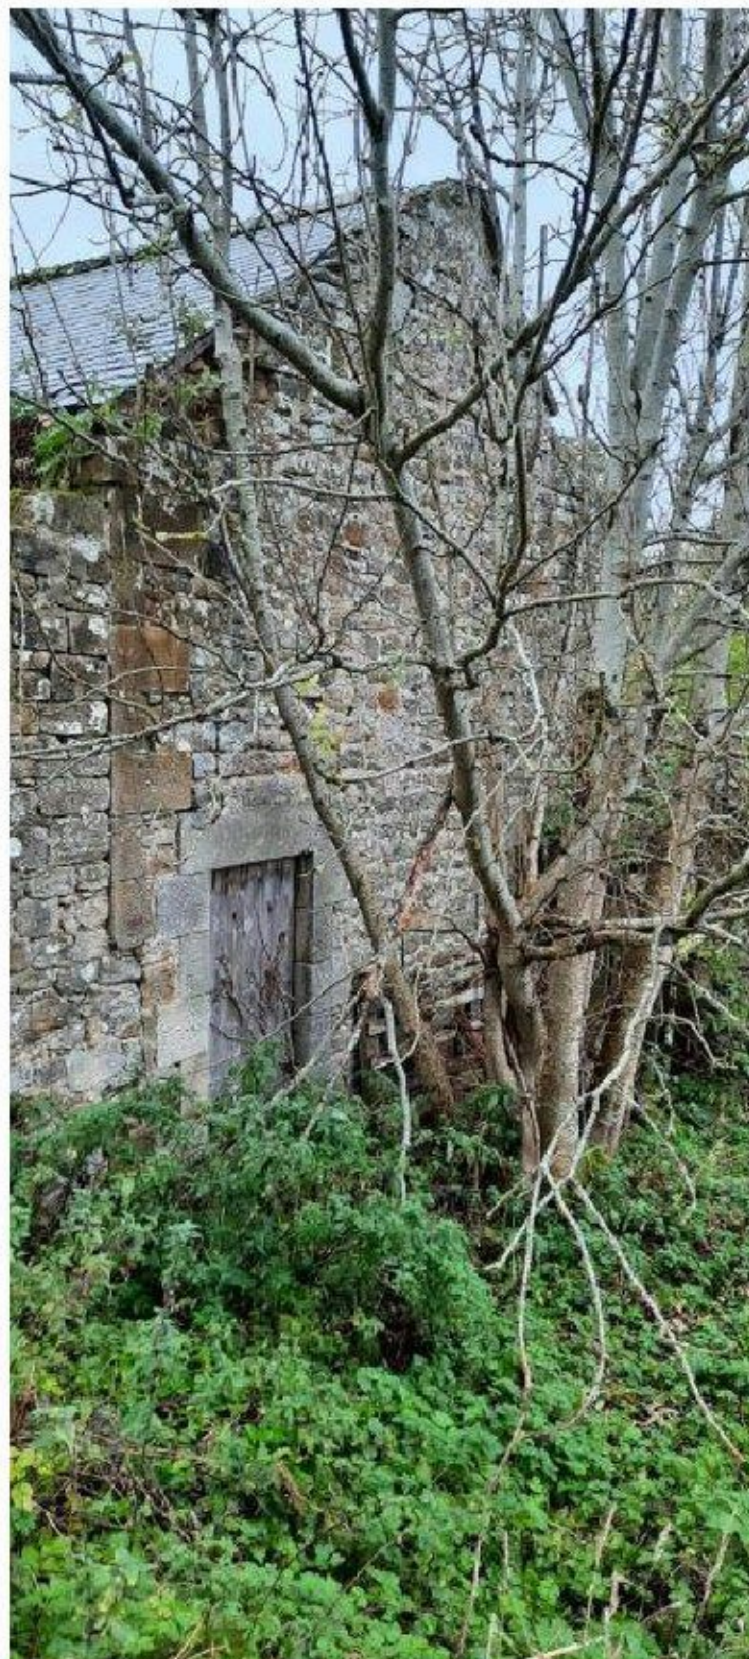
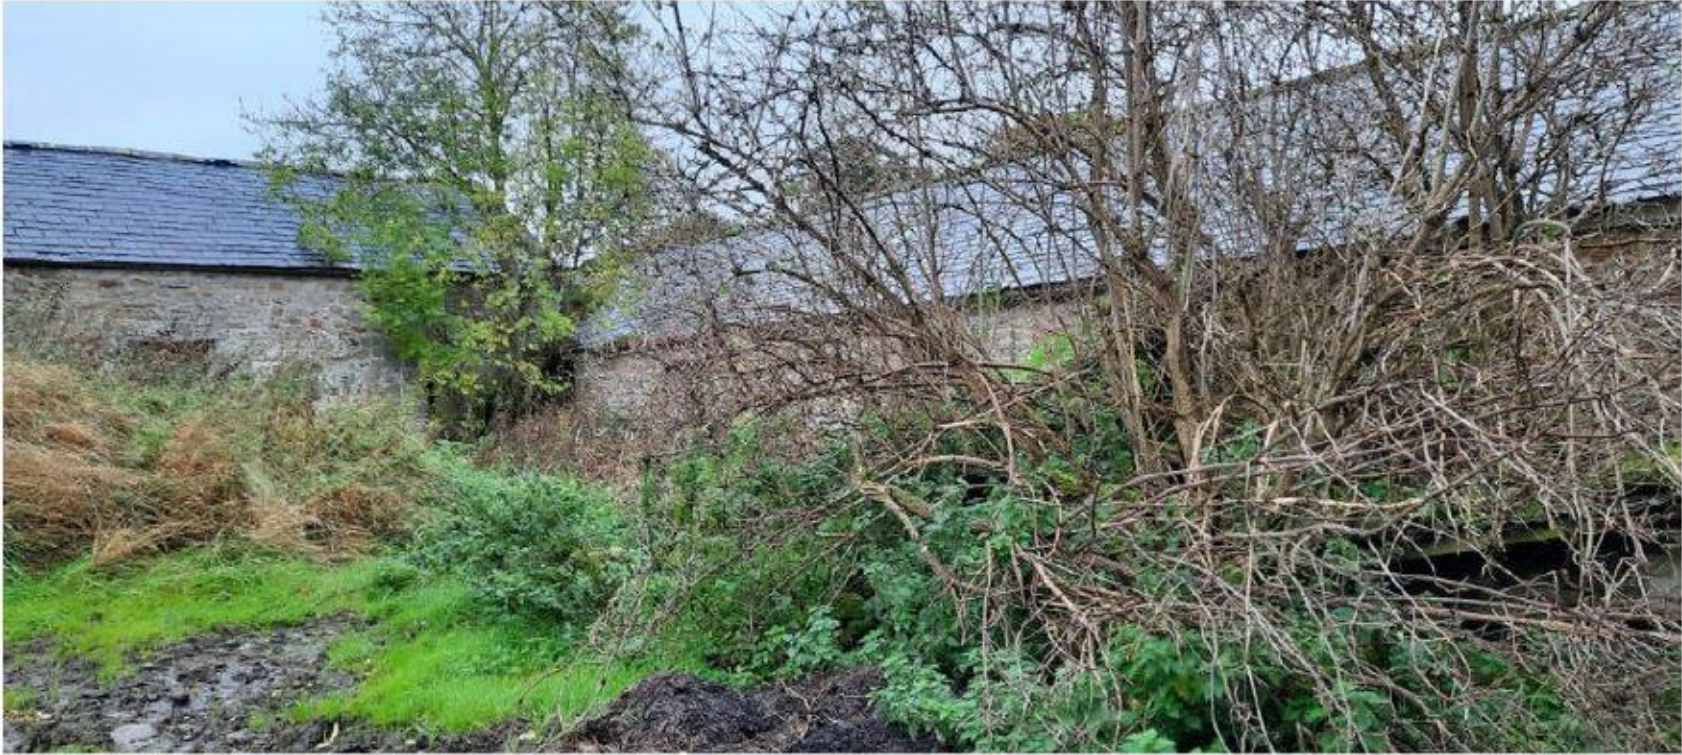
There are a number of trees in close proximity to the property (P15,16).

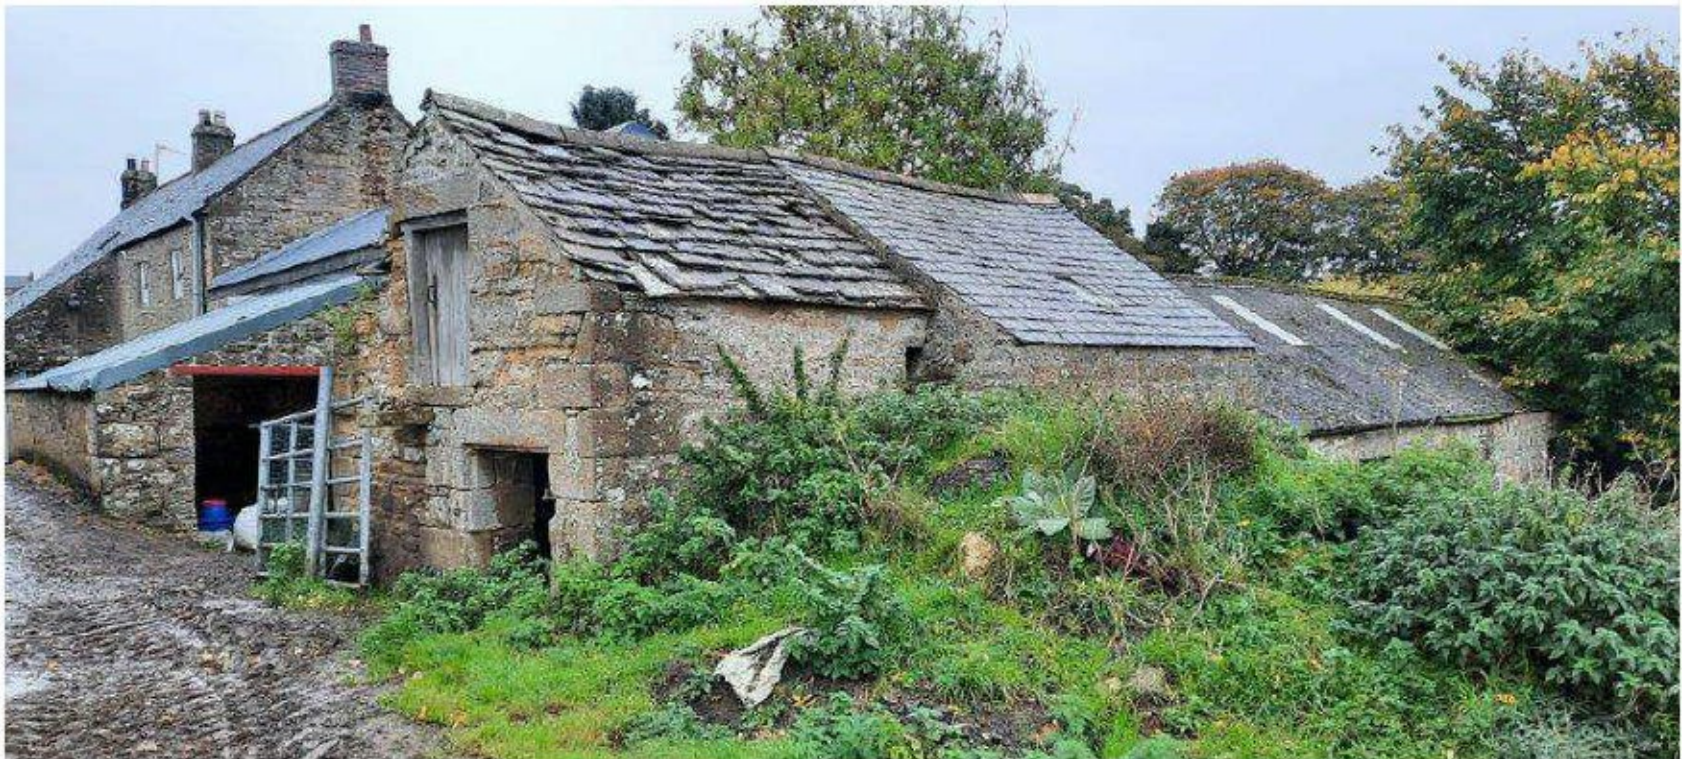
P17

Barn 4 is a single storey/two storey solid masonry construction (P17). The roof has a slate finish to the end sections with a corrugated metal roof to the central section. The roof finishes are supported on timber rafters/purlins. The Northern section has a first floor which was accessed using external steps which are no longer in place.

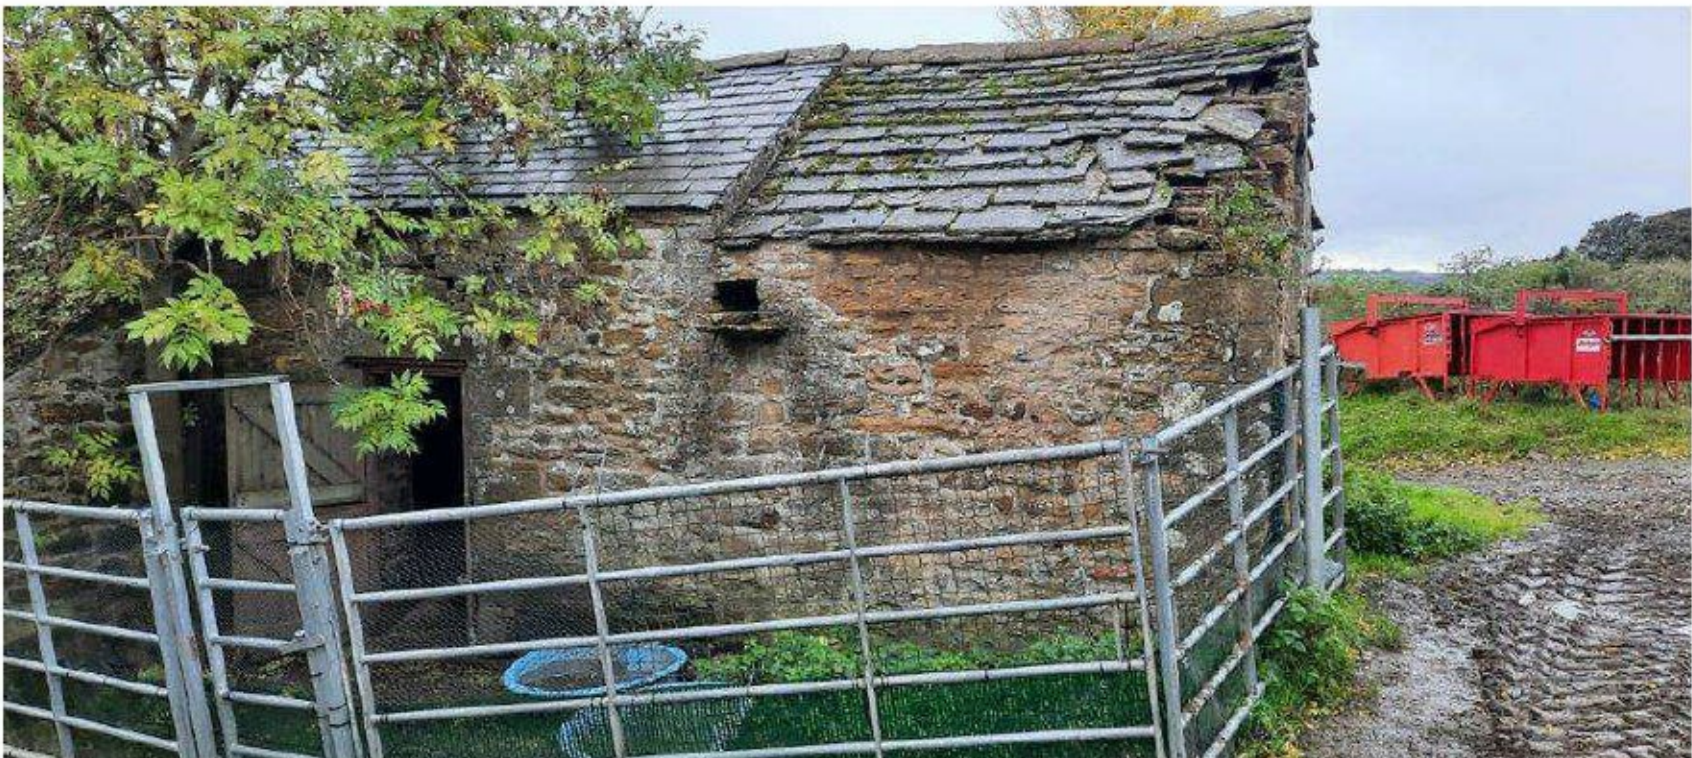
P18

The most northerly gable section of the roof is badly damaged with missing slates and damaged roof timbers. A section of the gable wall is also missing (P18).

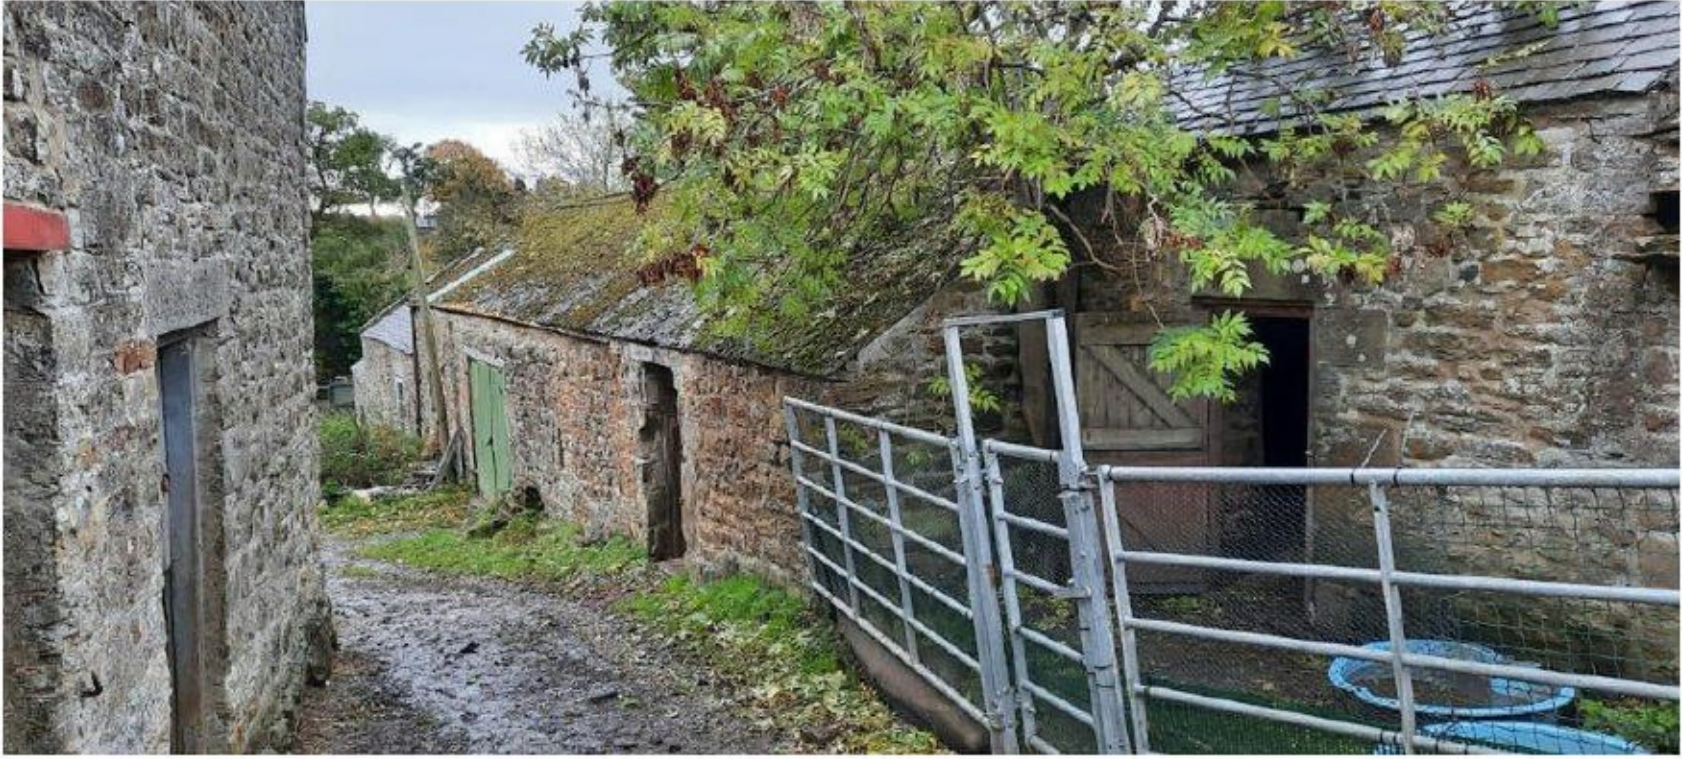
P19

There is a noticeable dip in the ridge line along the central section of the building (P19).

The building is located on a sloping section of the site with the external walls retain the external ground level in a number of locations (P19).

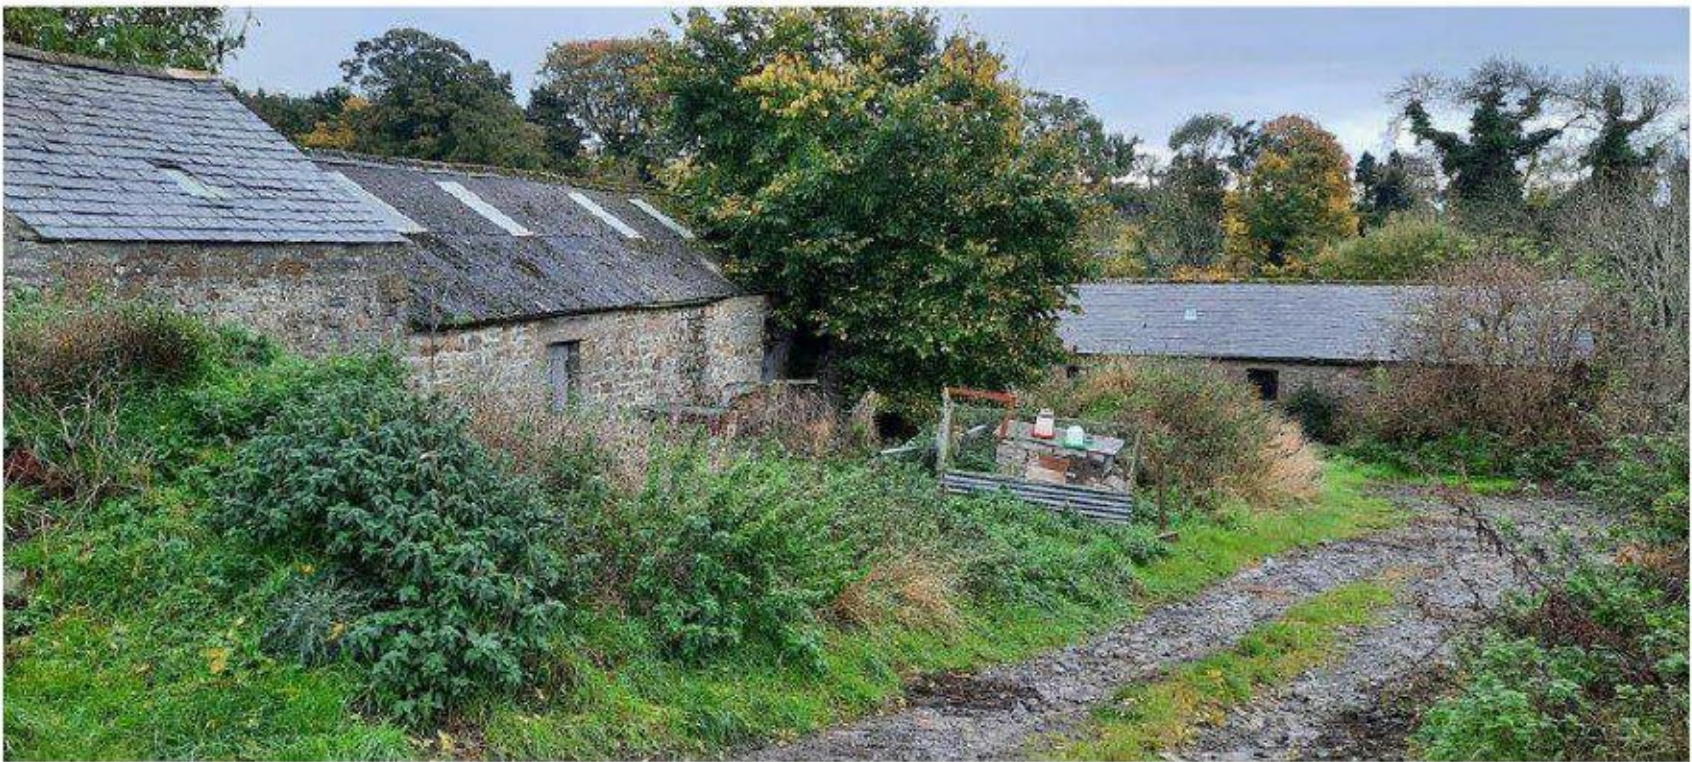
P20

There are trees in close proximity to the property on the Northern and Western elevation (P20).
