Gunnerton Farm Buildings - Visual Inspection Survey

At the instruction of Norr Consultants, 3e were appointed to carry out a visual structural inspection of the stone barns/outbuildings located at Demesne Farm, Gunnerton. The inspection was carried out on Wednesday 27th October 2021. Laura MacIver from Norr Consultants carried out a site inspection together with Adrian Batey from 3e.

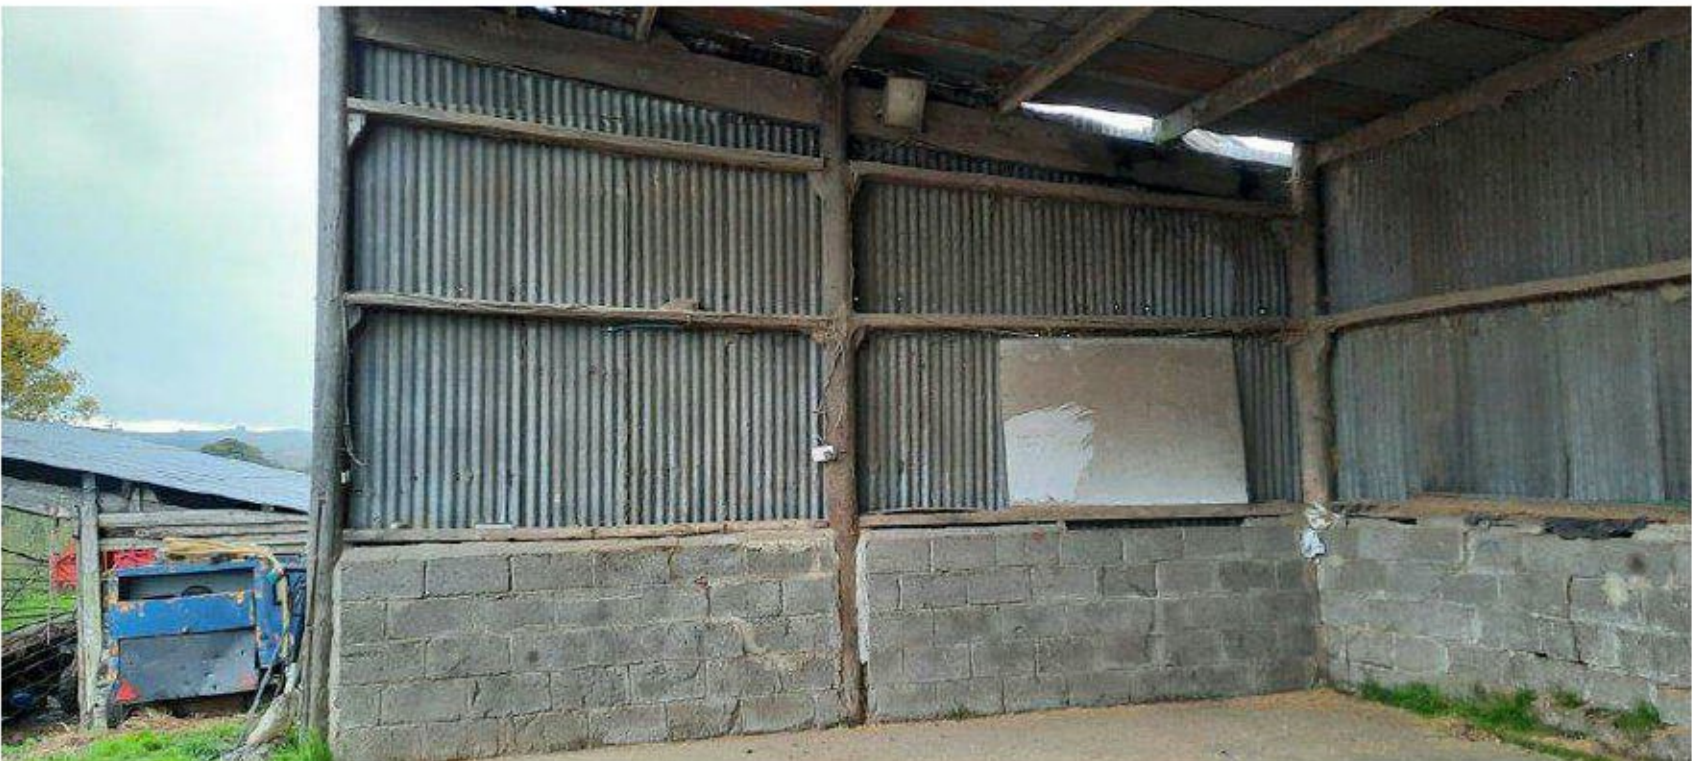
P21

The building is a timber framed construction with corrugated sheet roofing and wall cladding. A block wall is provided to the three enclosed sides to approximately 1100mm (P21). The building is considered to be at the end of it's design life and is not considered to be suitable for future conversion.

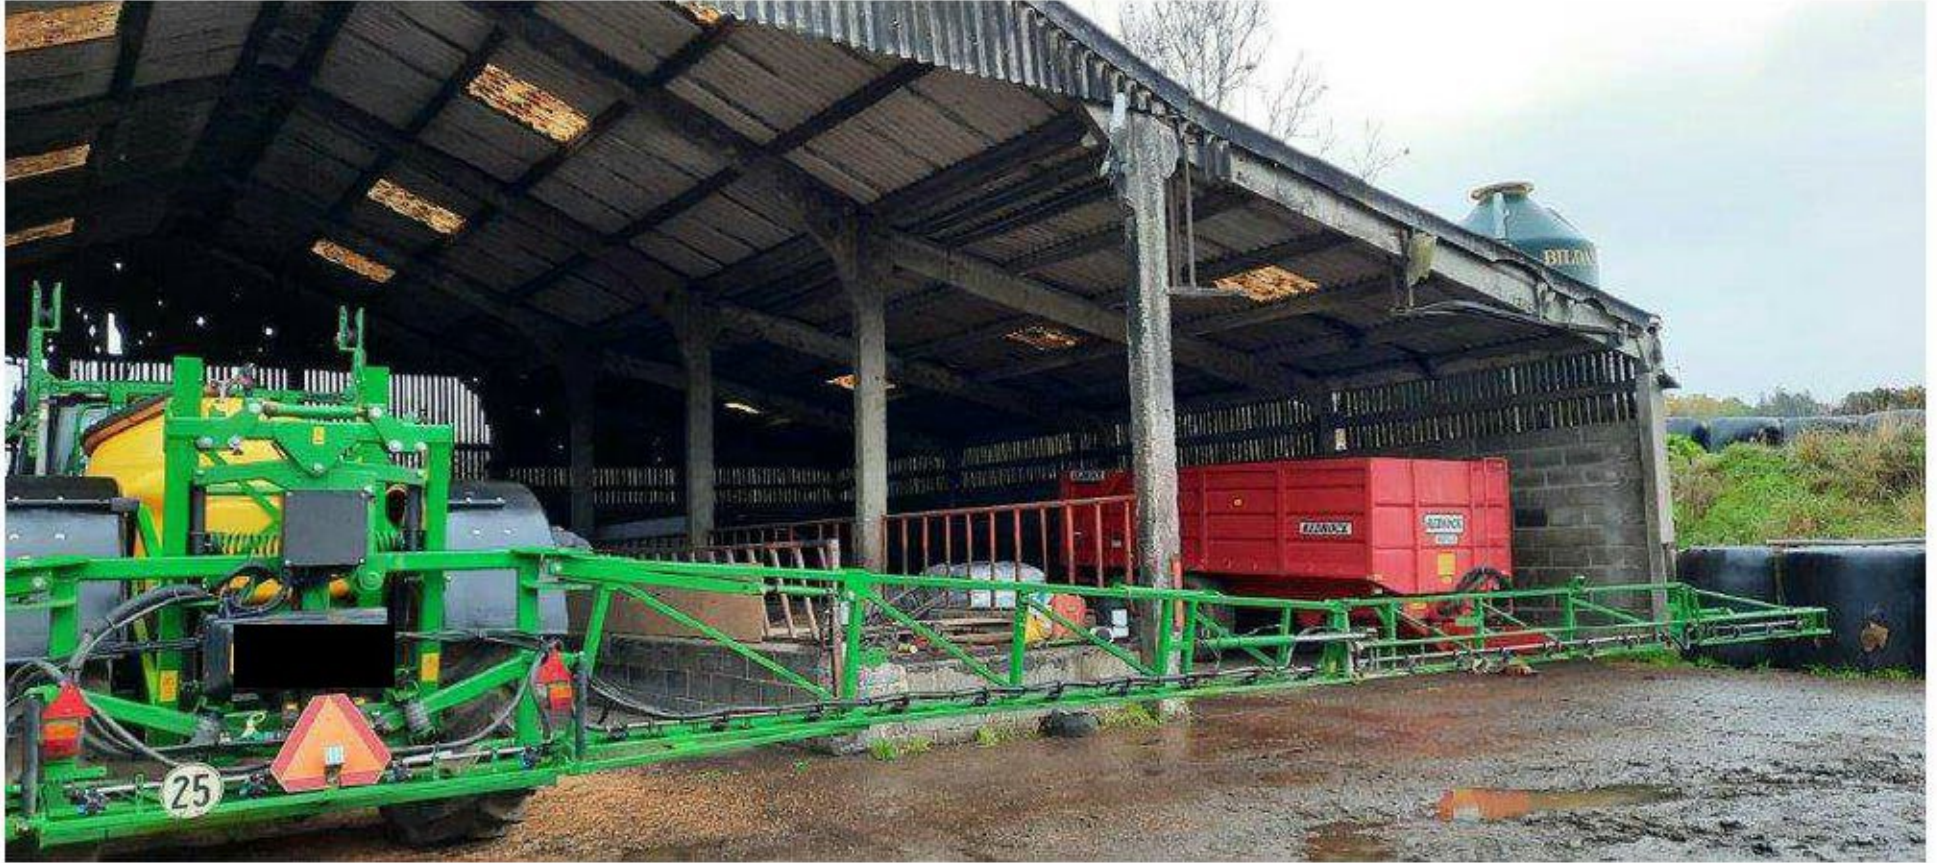
The building is a pre-cast concrete portal framed construction supporting a corrugated asbestos sheet roof (P22). The external walls to the enclosed sides are blockwork to part height with timber cladding above. It is likely that the building has been designed as an agricultural shed and as such the normally accepted design life would be 20 years. The building is likely to be at the end of it's original design life although there were no signs of major structural defects and is considered suitable for conversion subject to the relevant final design checks.

- Review external levels to eliminate and/or minimise retaining walls on the line of the buildings.
- Check damp-proofing/tanking of external walls.
- The existing pre-cast concrete shed (Shed 2) will require a full structural survey to assess long-term stability and integrity. Any construction to create a new dwelling in this location should not rely on the current frame for vertical or lateral support.
