# Tree Condition Report

Church Westcote Manor, Chipping Norton,  
Oxon, OX7 6SG

May 2022

**Ref: 21.190**

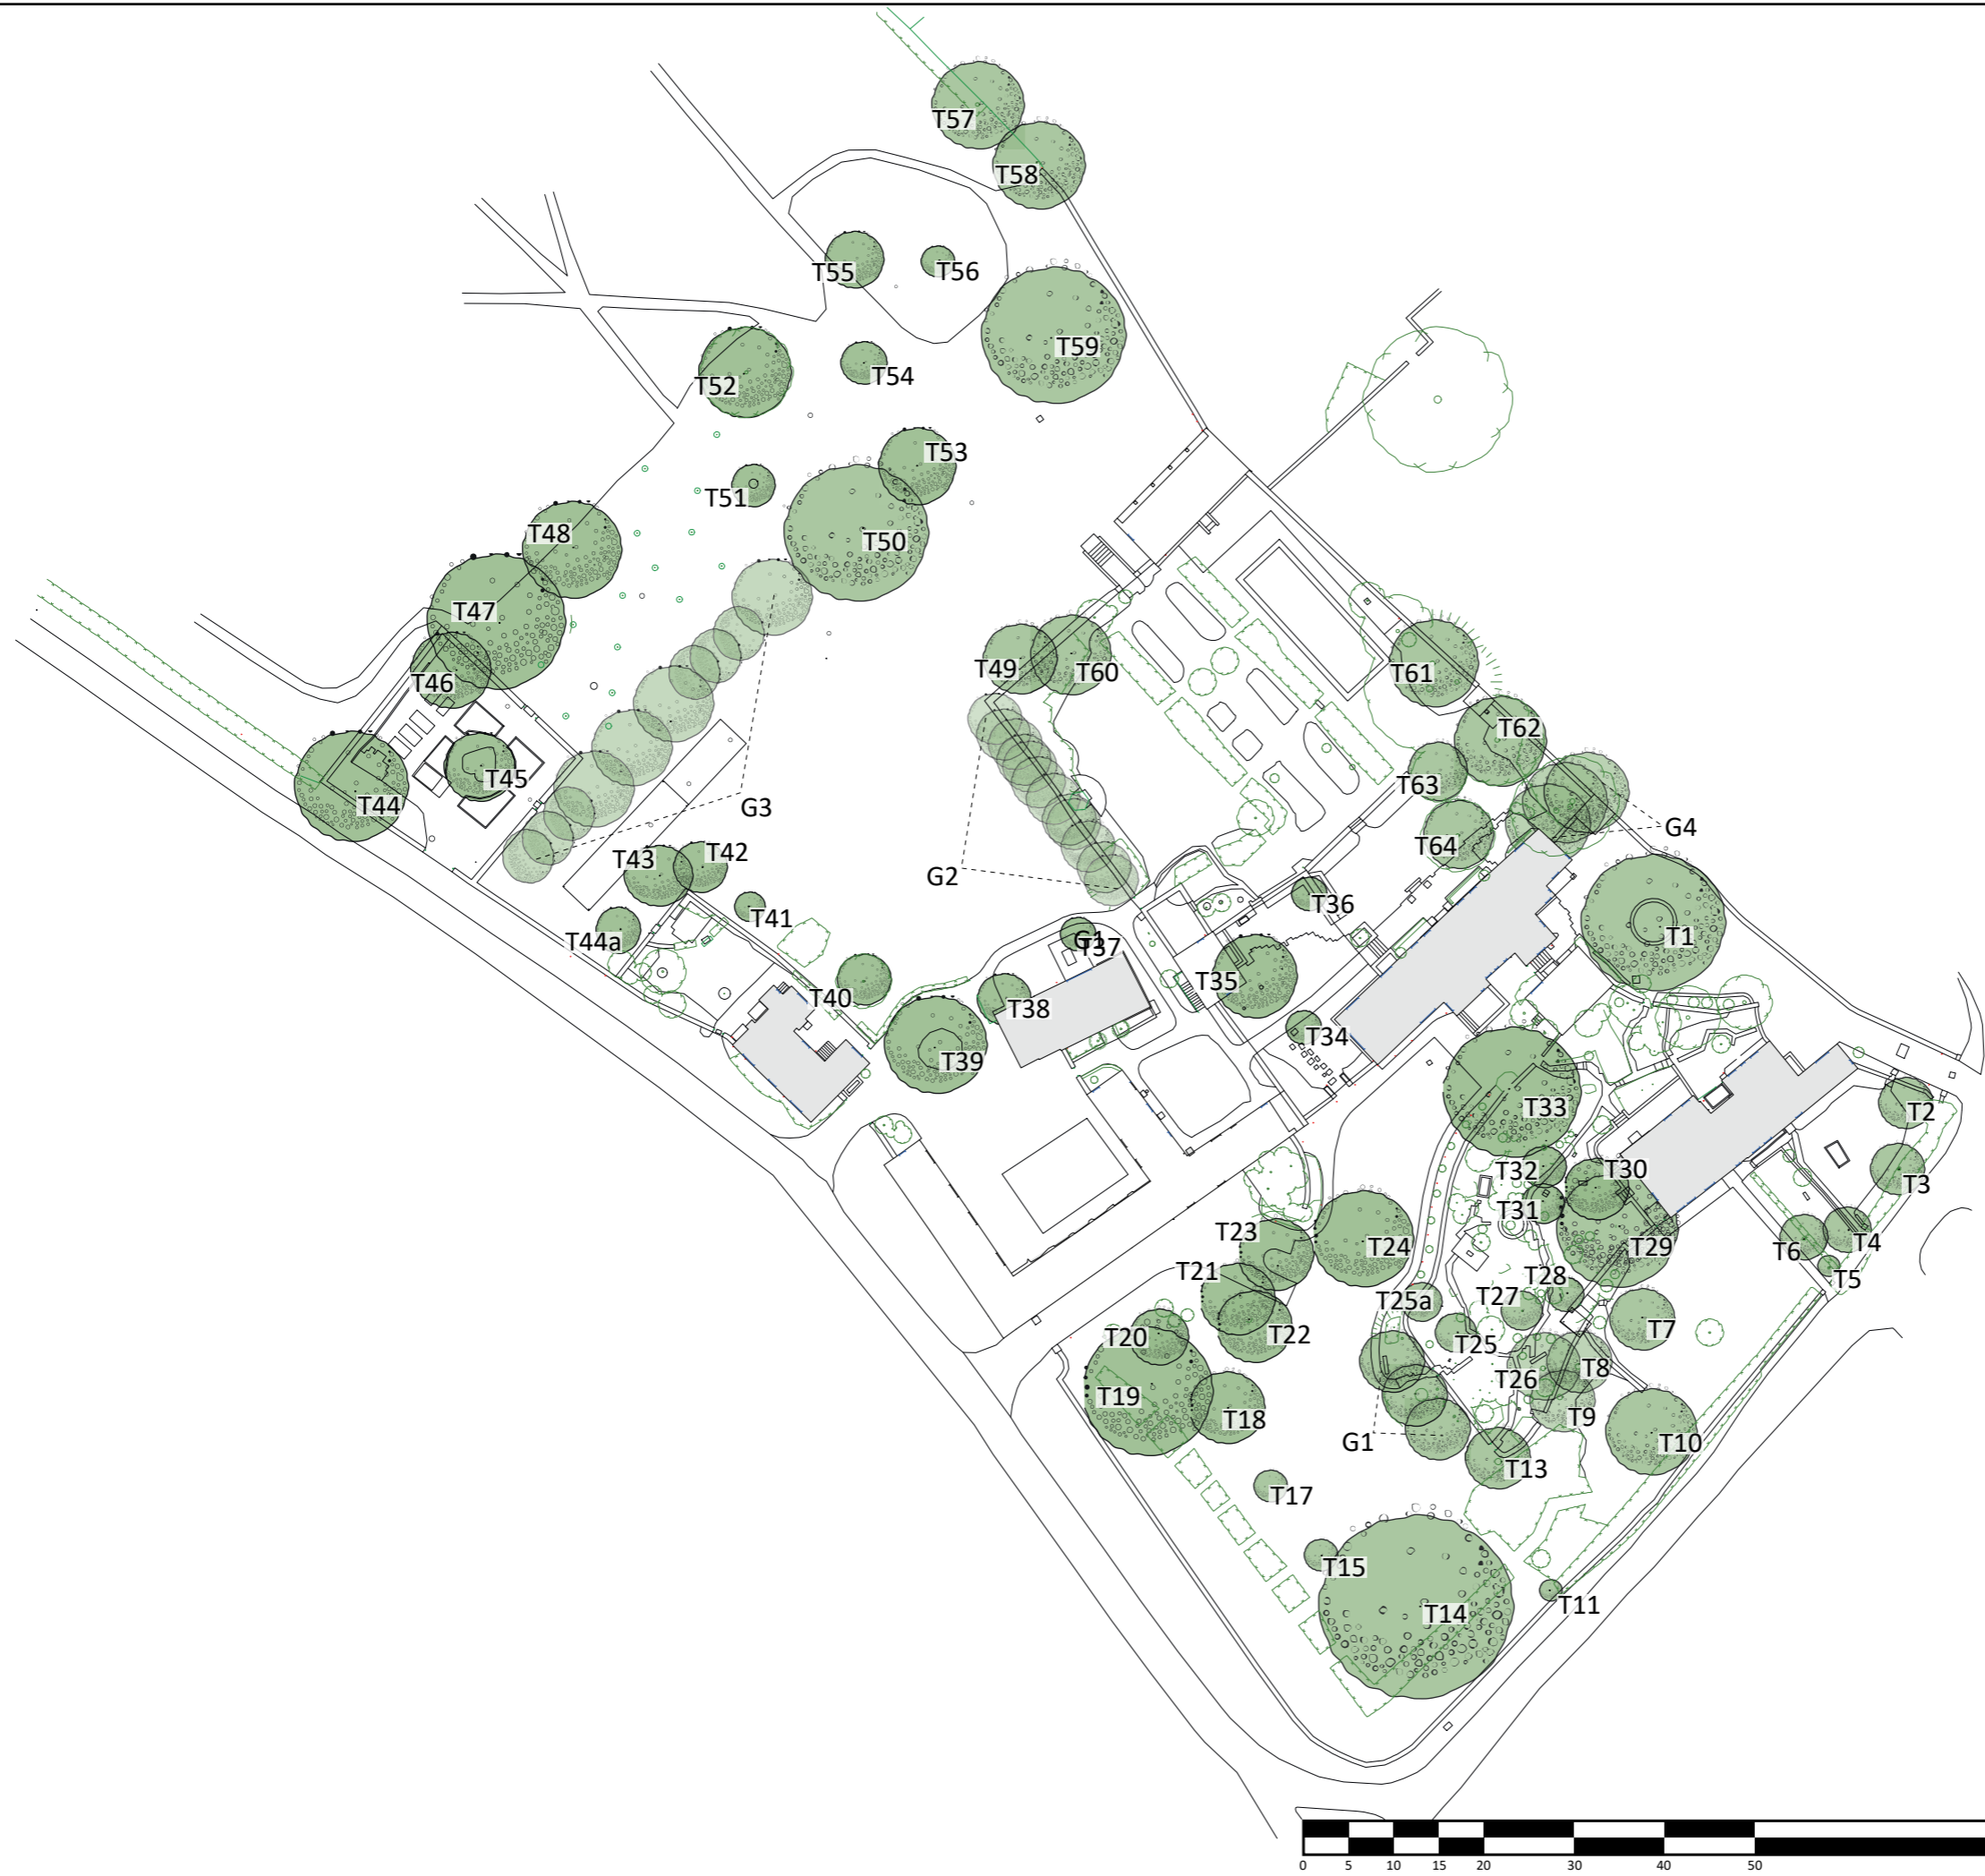
**STS-190-01 TREE LOCATION PLAN**

**1.1.5** A topographical site plan showing tree locations within the grounds of The Manor has been provided by the client. A Tree Location Plan of the site with the numbered locations of the trees cross-referenced to the survey schedule in Appendix 2 has been provided in Illustrative Material at plan STS-190-01.
