MINING RISK ASSESSMENT REPORT

BROWNIESIDE, PLAINS

Report No : 5037/IS

Issued : 07 May 2018

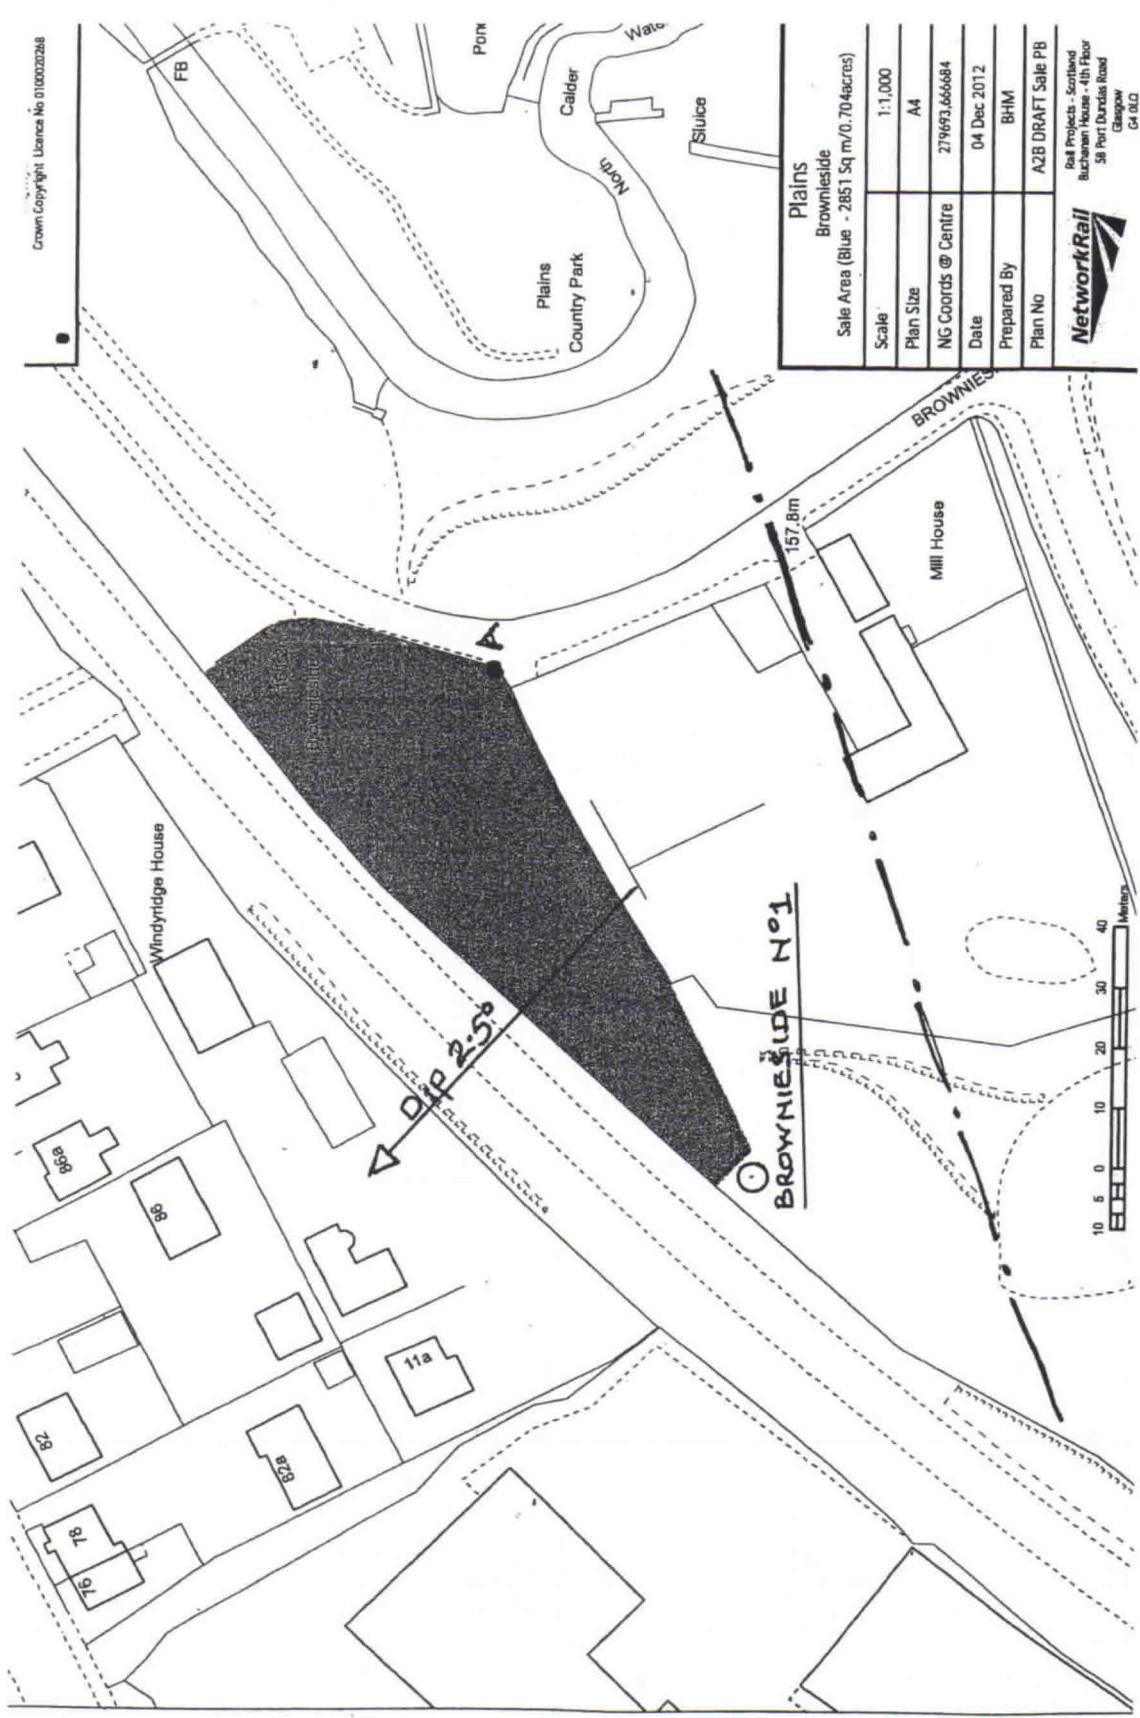
PLAN SHOWING SOLID GEOLOGY OF SITE AREA

There are no records of the Virtuewell Coal having been worked beneath the site. A quartz-dolorite sill is shown on the relevant Geological Survey map 200 metres to the south of the site, the thickness of the sill being in the order of 22 metres. This sill will be at shallow depth beneath the Virtuewell, and it is highly likely that the sill will have burnt the coal thus making it unworkable. No thicknesses in the Virtuewell are given on Plate 8, Page 69 in the Mining Memoir. This would suggest that the Virtuewell has not been worked beneath the site. However it is possible that old unrecorded workings could exist in the Virtuewell Coal, and hence we have classified as being potentially unstable due to possible workings in the Virtuewell.

Conjectural outcrop of
Virtuewell Coal

It is recommended that rotary core bores be sunk to establish the depth to the coal, and it's condition. After the bores have been sunk a report can be prepared giving recommendations as to the foundation type to be adopted for the site.

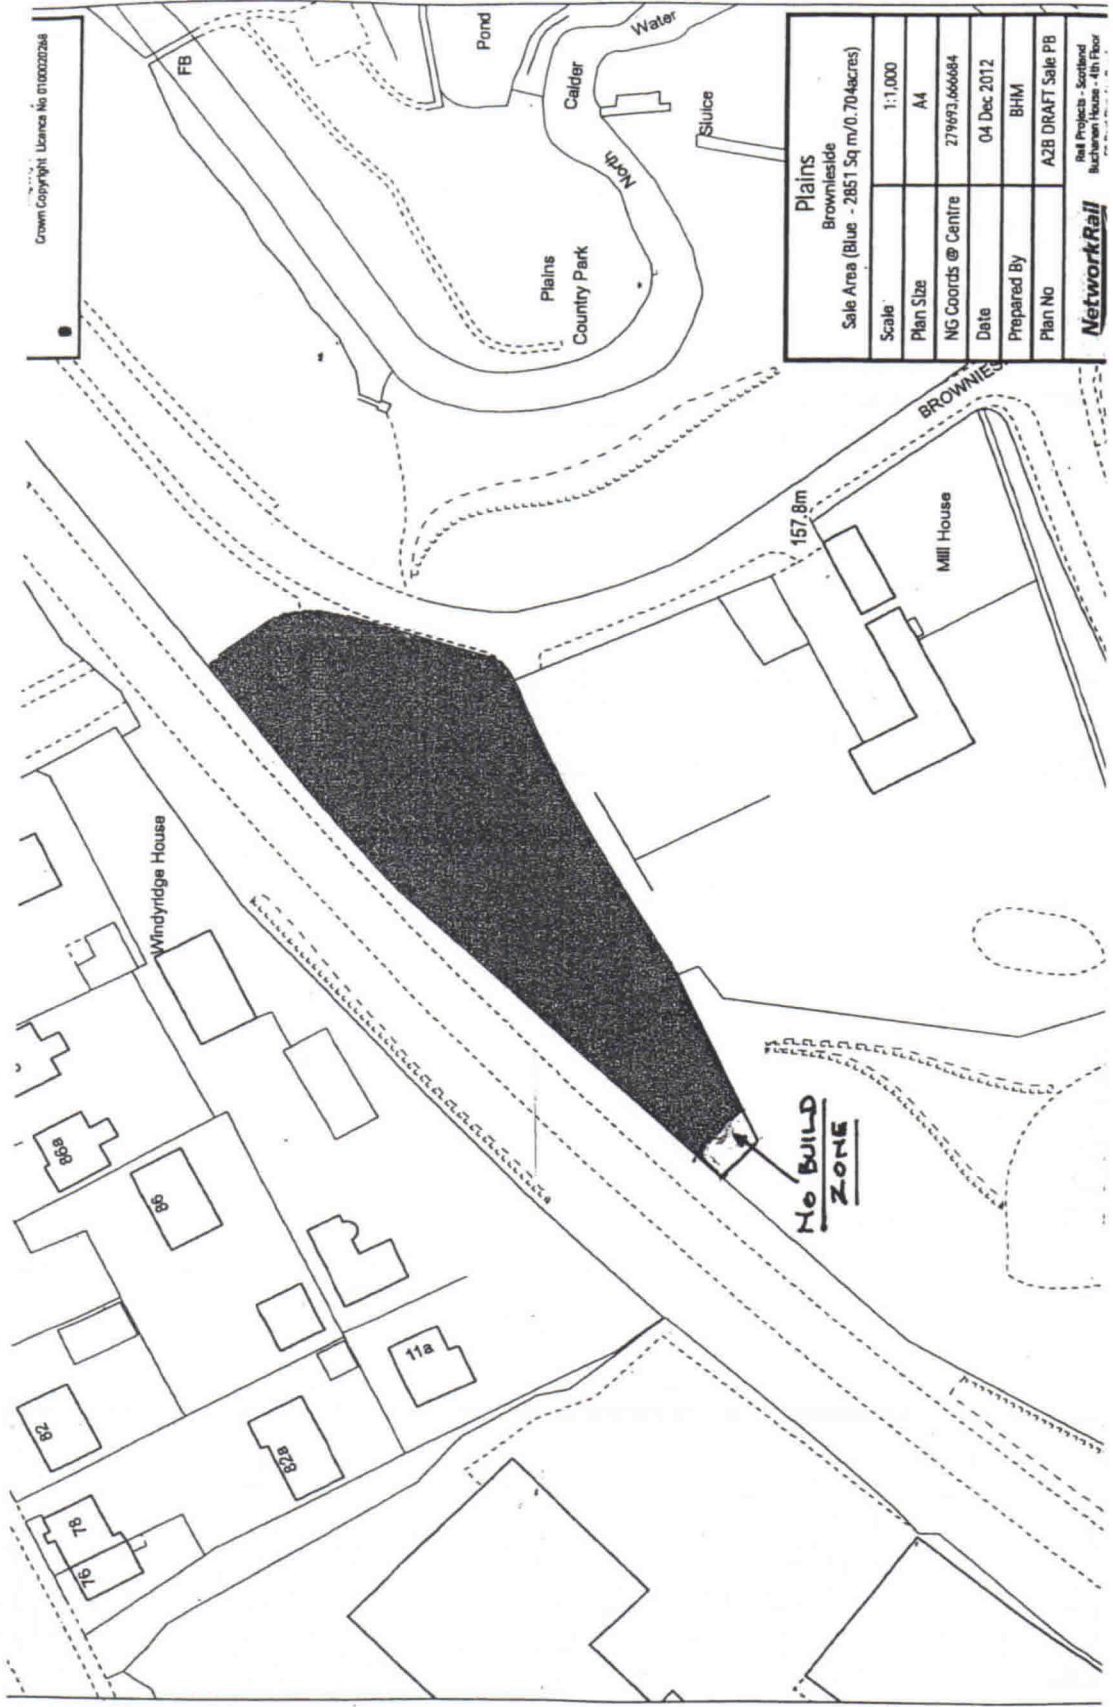
PLAN SHOWING NO-BUILD ZONE

The old Brownieside No1 shaft is situated 4 metres to the south-west of the south-west site boundary. The old shaft has already been treated and made secure by the Coal Authority. However we consider it prudent to establish a no-build zone 4 metres to the east of the south-west site boundary. Since the thickness of boulder clay is estimated to be 5 metres in this area, in the highly unlikely of a future collapse of the old shaft the no build zone should ensure that no structural damage will occur to the houses outwith this zone.

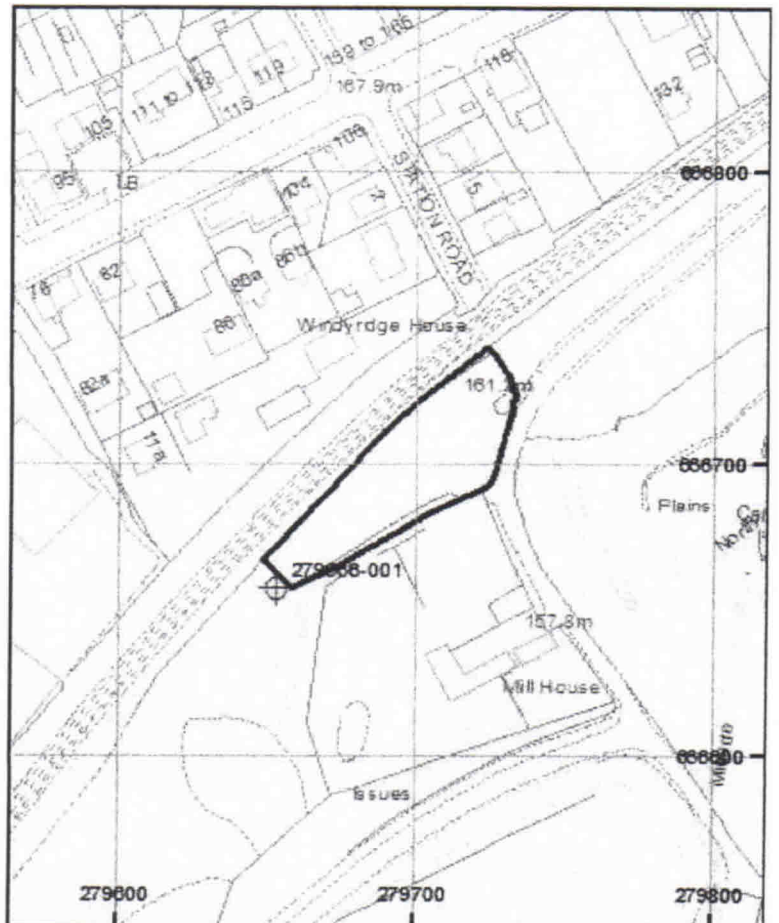
Within, or within 20 metres of, the boundary of the property there is 1 mine entry, the approximate position of which is shown on the attached plan.

279666-001. Following a ground collapse the shaft was investigated and found to be loosely filled. The existing voids were filled with hardcore and the shaft covered with a reinforced concrete cap 6 metres square and 0.55 metres thick. The cap was sited 3.5 metres below ground level. These works were completed in May 2003 by International Mining Consultants acting on behalf of the Coal Authority..
