The Old Cottages, Thrandeston.

Having completed the first phase of works during June 2022 we removed the final sections of render to clarify the extent of the remaining works. These are numbered 2, 4, 5, 6, 7 & 8 below.

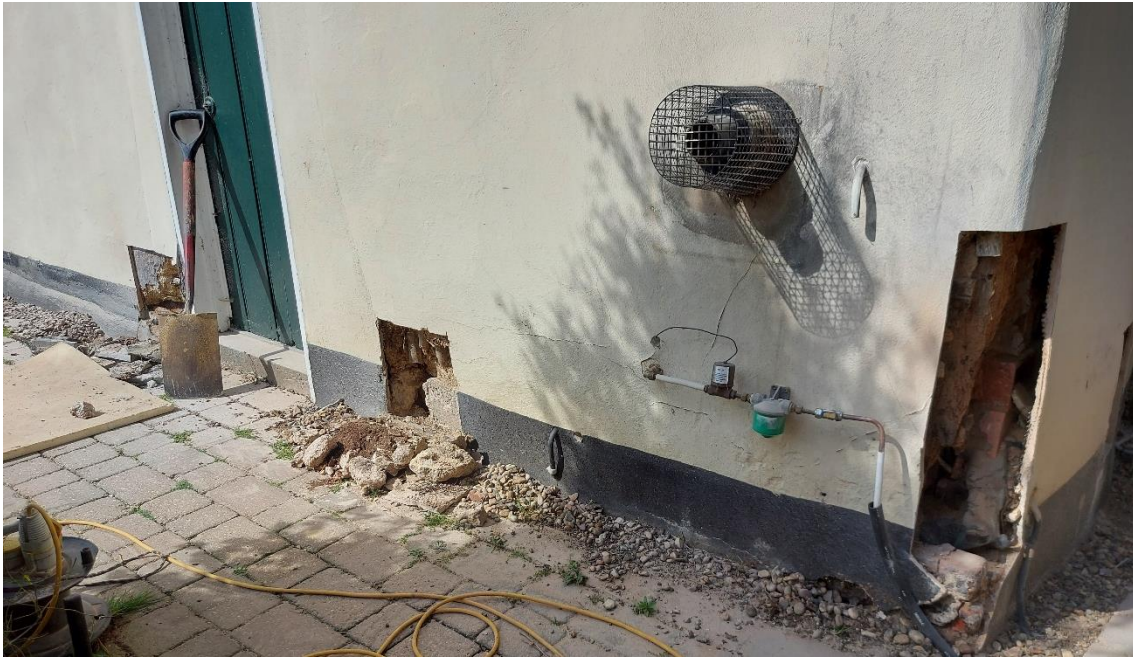
5. Behind this section of render (above) is the boiler for the central heating and hot water. There are remnants of plate at floor level (which is basically subterranean) behind the boiler but it's not easy to get a photograph, let alone one that makes sense within a document such as this. Towards the gable it has disappeared completely and this section has been filled with fletton bricks and concrete. There is a small section of wattle and daub remaining behind the staircase which has dropped and the wattles are extremely friable but most of the lower part of this wall is now cast concrete.

The oil boiler will need to be disconnected, possibly also a considerable number of pipes for the underfloor heating system as well as many cables that are all fitted within this corner. The cast concrete will be broken out and a new length of sole plate introduced of an appropriate size and fixed to the (repaired?) studs with stainless steel L-brackets. The modern brick infill panels will be replaced with sheep's wool insulation.
