HISTORICAL APPRAISAL

**MUSGROVE FARM HOUSE
DUNKESWELL,
HONITON
DEVON
EX14 4RR**

4.2 Labelled Existing floor plans:

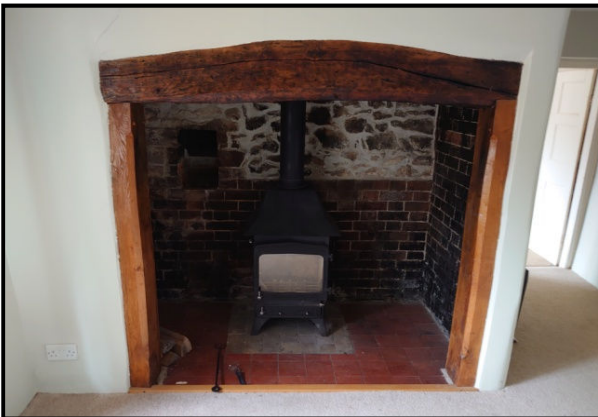
Inglenook fireplace: image 1.0

Accessed from Room 2 (kitchen) via a low doorway incorporating a 63mm step up onto a carpeted concrete floor under a low (1964mm) ceiling with central rough beam restricting height to 1873mm. A 'Front door' opens into this room although one would have to stoop to enter and it appears that this door has not been in general use for some years. A modernised Inglenook type fireplace contains a wood burning stove and the flue above is closed over. A portion of smoke blackened timber is visible on the left hand side, possible originally having hooks for smoking meats etc. The right hand side may have contained a traditional 'Bread oven', with the stairs to the first floor winding over, (a common arrangement in this locality) but if so, all traces of such were removed when the later addition of Room 4 was added. (C1850?) - (For photo of Inglenook fireplace see image 1.0 within Appendix 8.0)

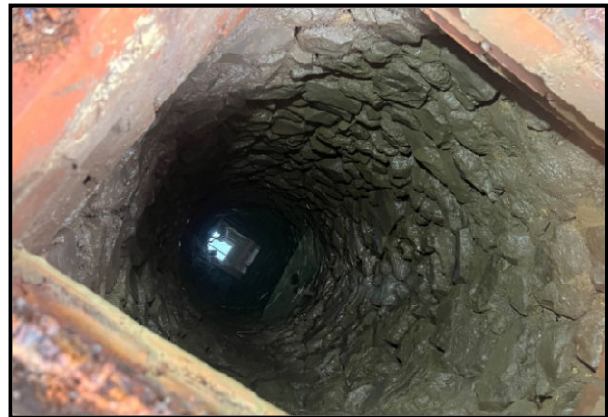
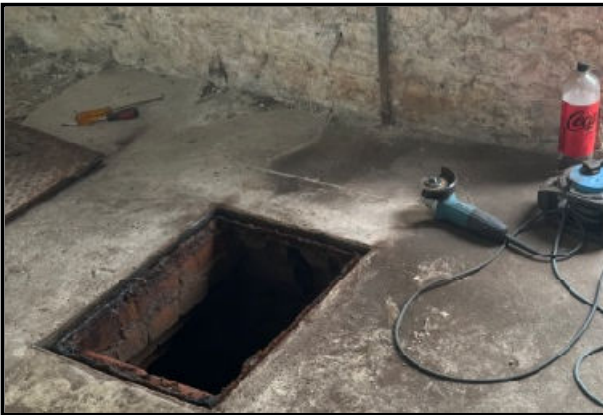
Accessed via a low door (1727mm) from Room 2 (Kitchen) these spaces are under a new slated and insulated roof extended down from the eaves of the main house roof. The roof structure is new and exposed internally without a ceiling lining. The walls are generally stone with some concrete block and a central exposed steel joist supporting the wall above the central opening. Part of the floor (space 5) is concreted level and the remainder is roughly concreted to form a sloping floor to a disused drain. A central inspection chamber in the floor covers a stone lined well approximately 7M deep. This well is disused but in restorable condition.
- (For photo of Stone lined well see image 2.0 + 2.1 within Appendix 8.0)

Stone lined well: image 2.0

Stone lined well: image 2.1

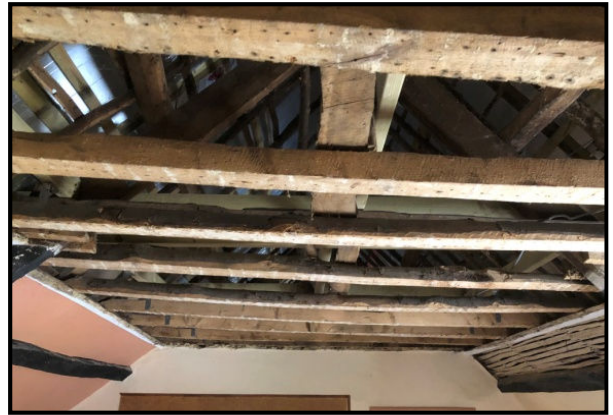
Collapsed ceiling: image 3.0

- 4.10 Room 9 (over room 3)
19th C door from Room 8 with step up at threshold. Uneven and bouncy floor requires some treatment to improve rigidity. Ceiling has collapsed exposing the roof structure above. Wall gathering of fireplace below evident and flaking wall plaster. Door and lining 19th C possibly installed circa 1850 when end room added. Triple casement 20th C window.

- (For photo of Collapsed ceiling see image 3.0 within Appendix 8.0)
- (Photo of First floor fire place see image 4.0 within Appendix 8.0)
- 4.11 Room 10 (Over room 4)
Accessed via a low doorway from landing outside room 9 at top of stairs and with single step trip hazard. 19th C cast iron fireplace and 20th C triple casement window. Some bounce in floor and strengthening required.

- 5.3 First floor ceilings that remain must be examined to ascertain their stability. Old lath and plaster ceilings should be preserved wherever possible but these ceilings are heavy and are prone to sudden and unexpected collapse, sometimes bringing large support timbers down with the plaster, as the fixings between ceiling joists and rafters have decayed over time. There is evidence that this is happening already with the two rooms already identified.

- 5.4 Where ceilings have already collapsed consideration should be given to the possibility of leaving exposed some of the original hewn timber original roof structure, such that the construction can be seen from below. Ceiling lining could be affixed to the underside of the

rafters forming the new structural roof above the original such, that much of the original is exposed. (This is a time consuming process and may be excluded by overall budget considerations.)

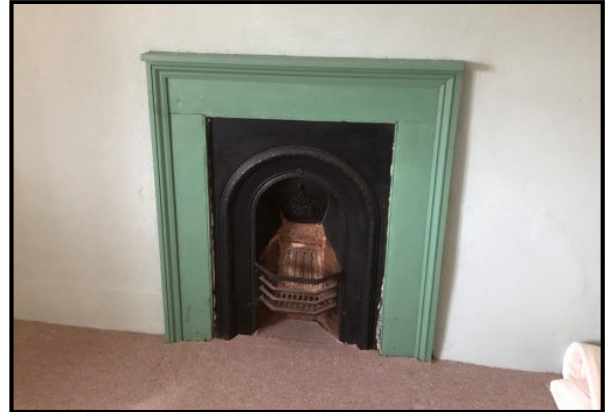
Cast iron fireplace: image 5.0

- (Photo of Cast iron fireplace see image 5.0 within Appendix 8.0)
