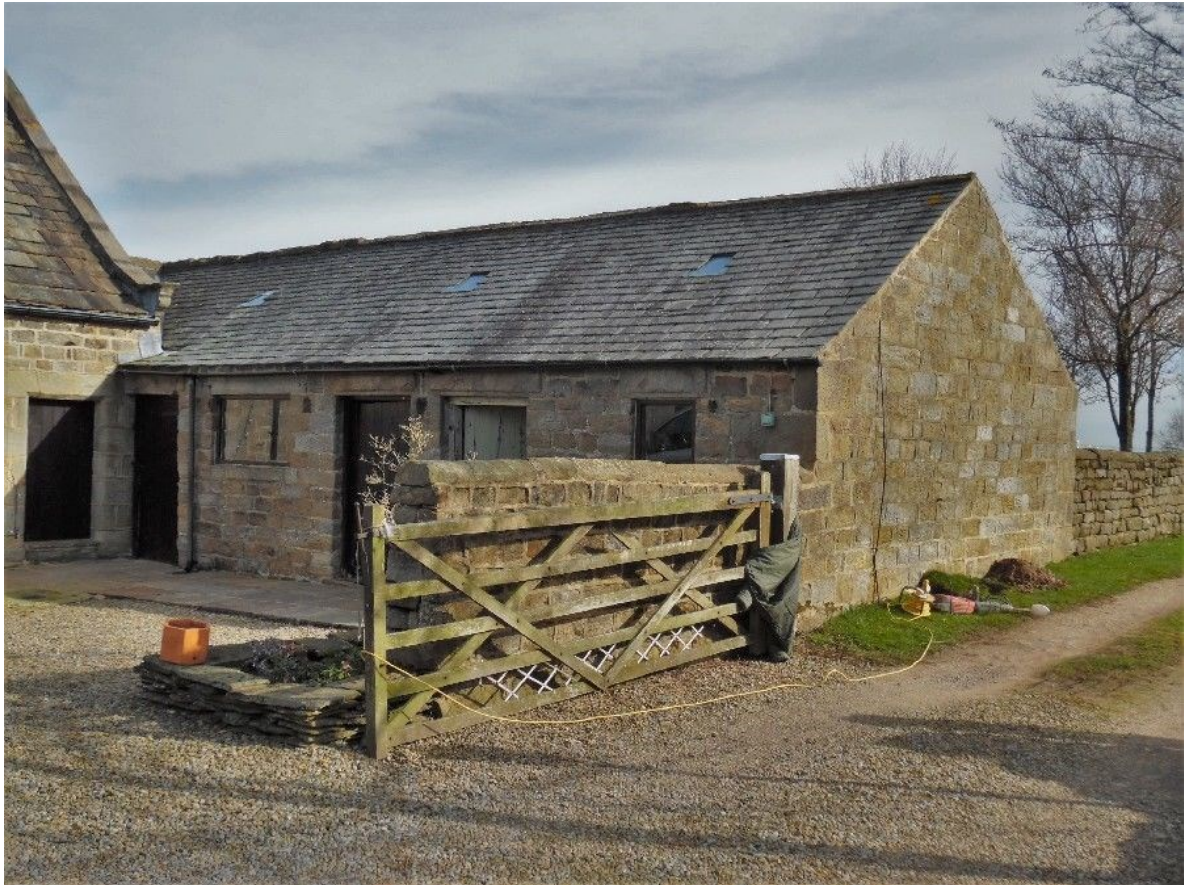
Plate 1: View of the barn from the South East.

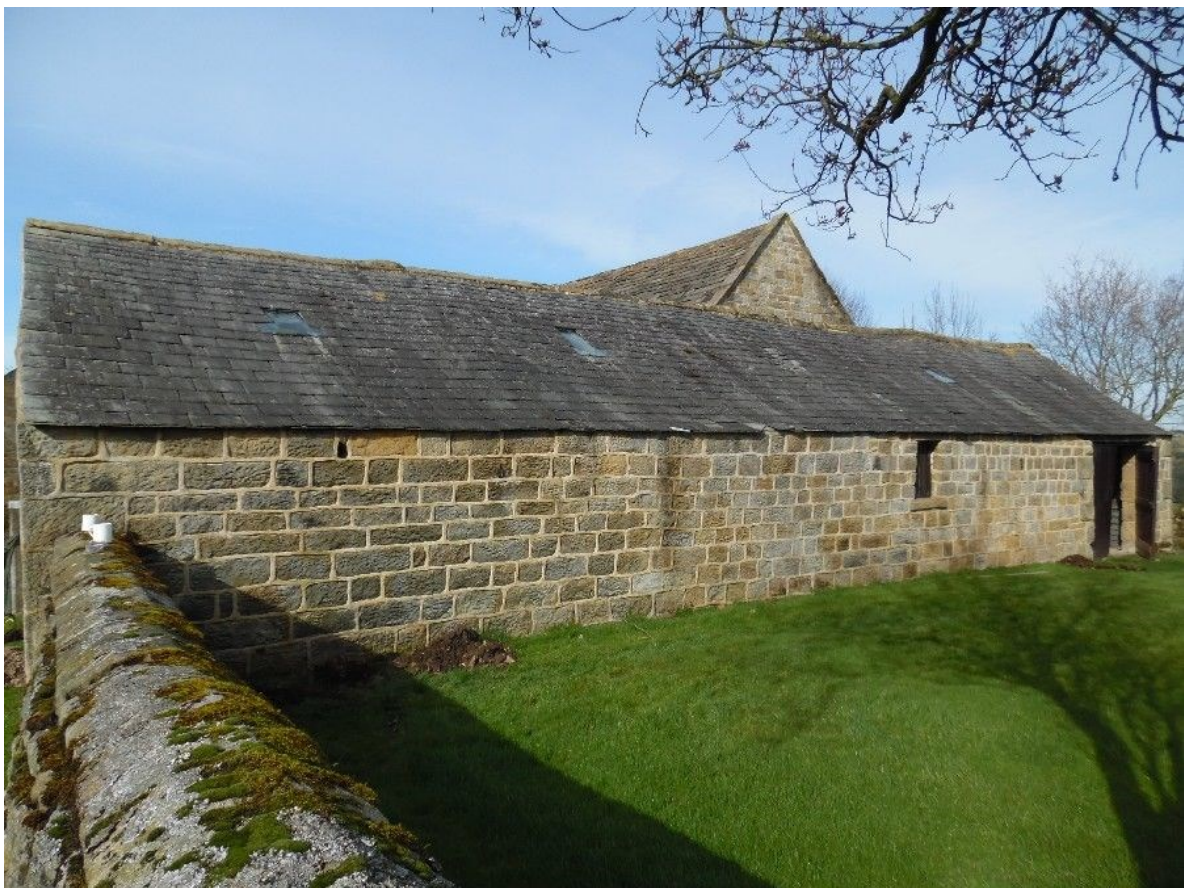
Plate 2: View of the barn from the South West.

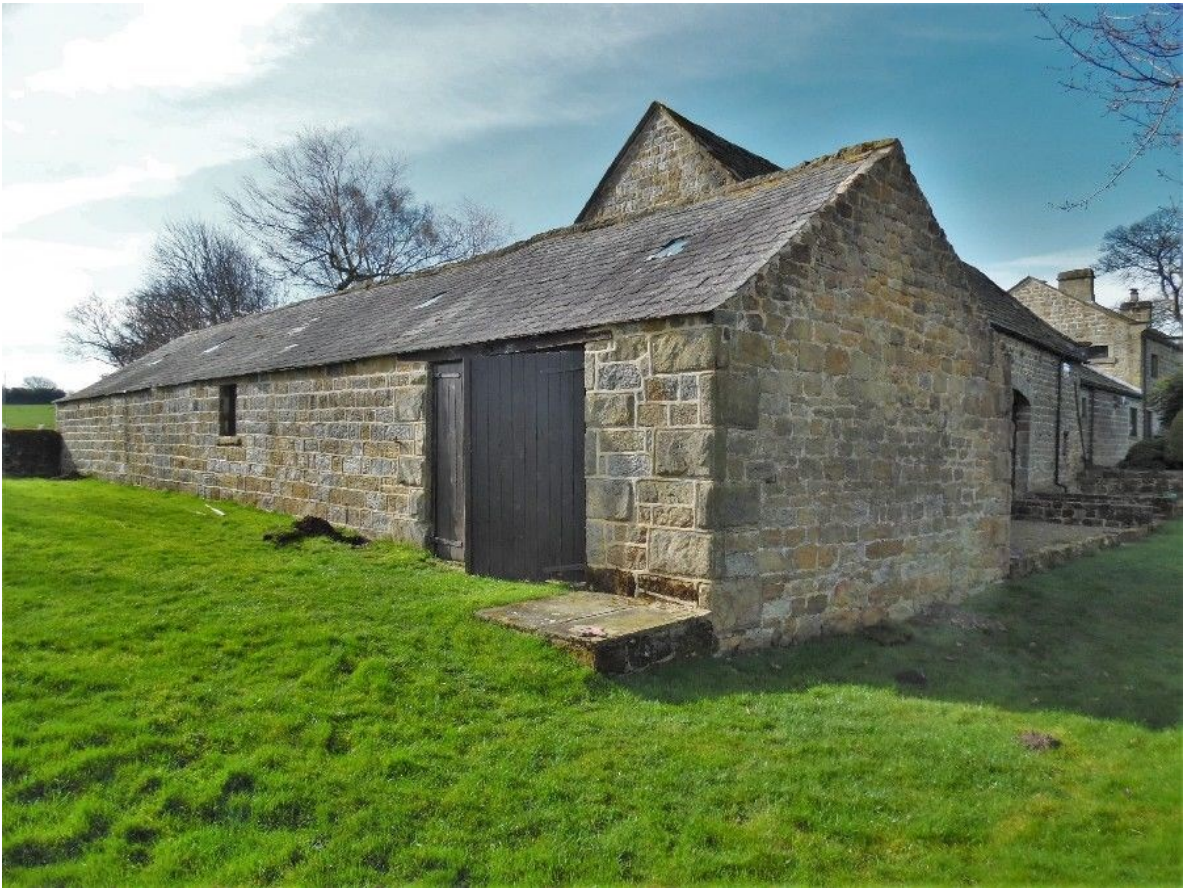
Plate 3: View of the barn from the North West. Note the slope in ground level.

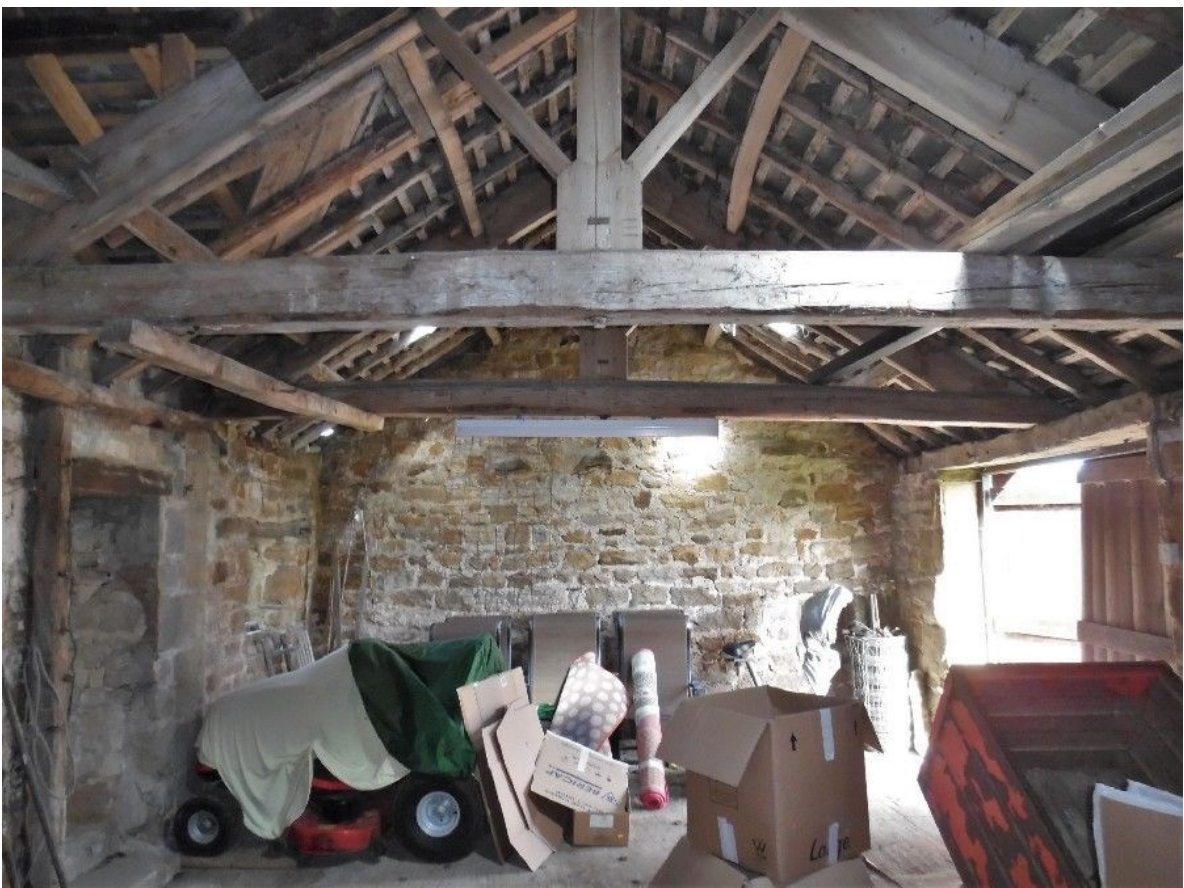
Plate 4: Internal view of the barn.

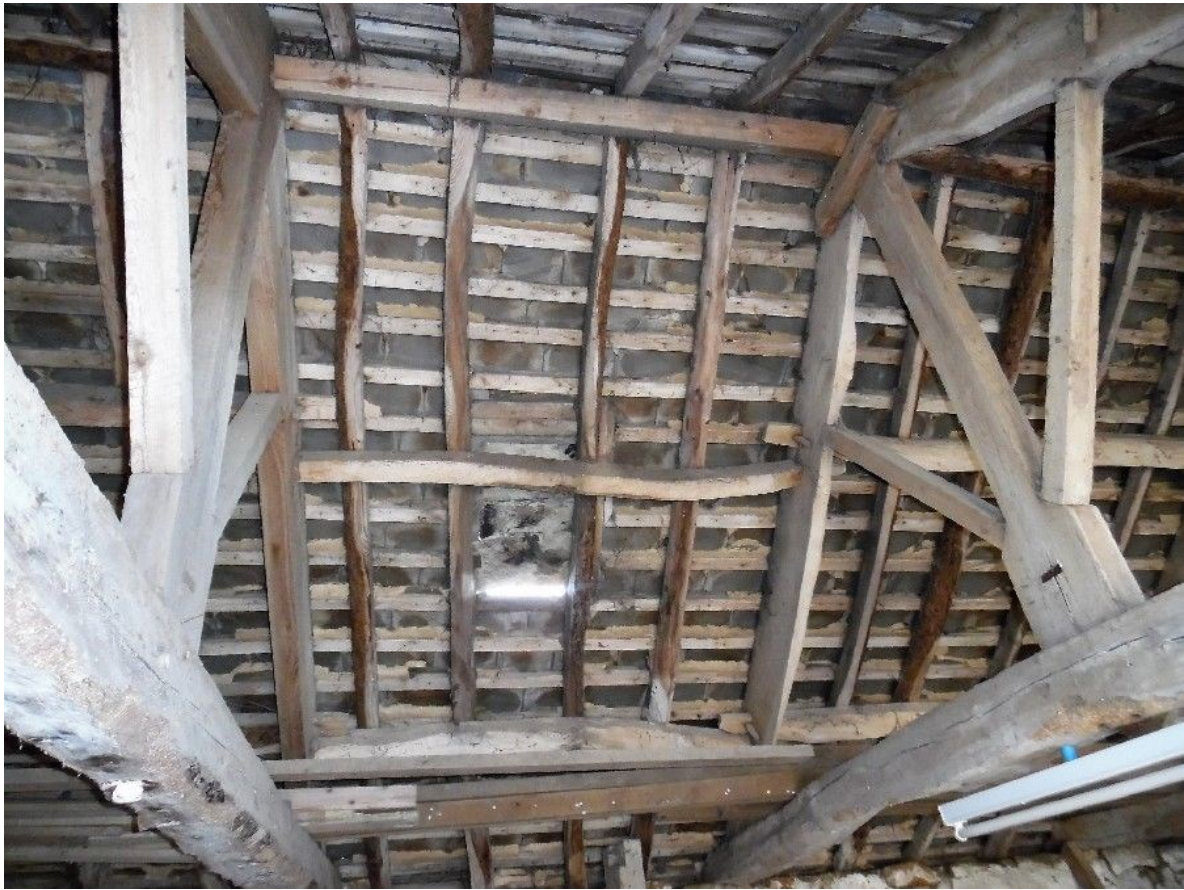
Plate 5: View of the barn roof. Note bent purlins, possibly tree branches or small trunks.

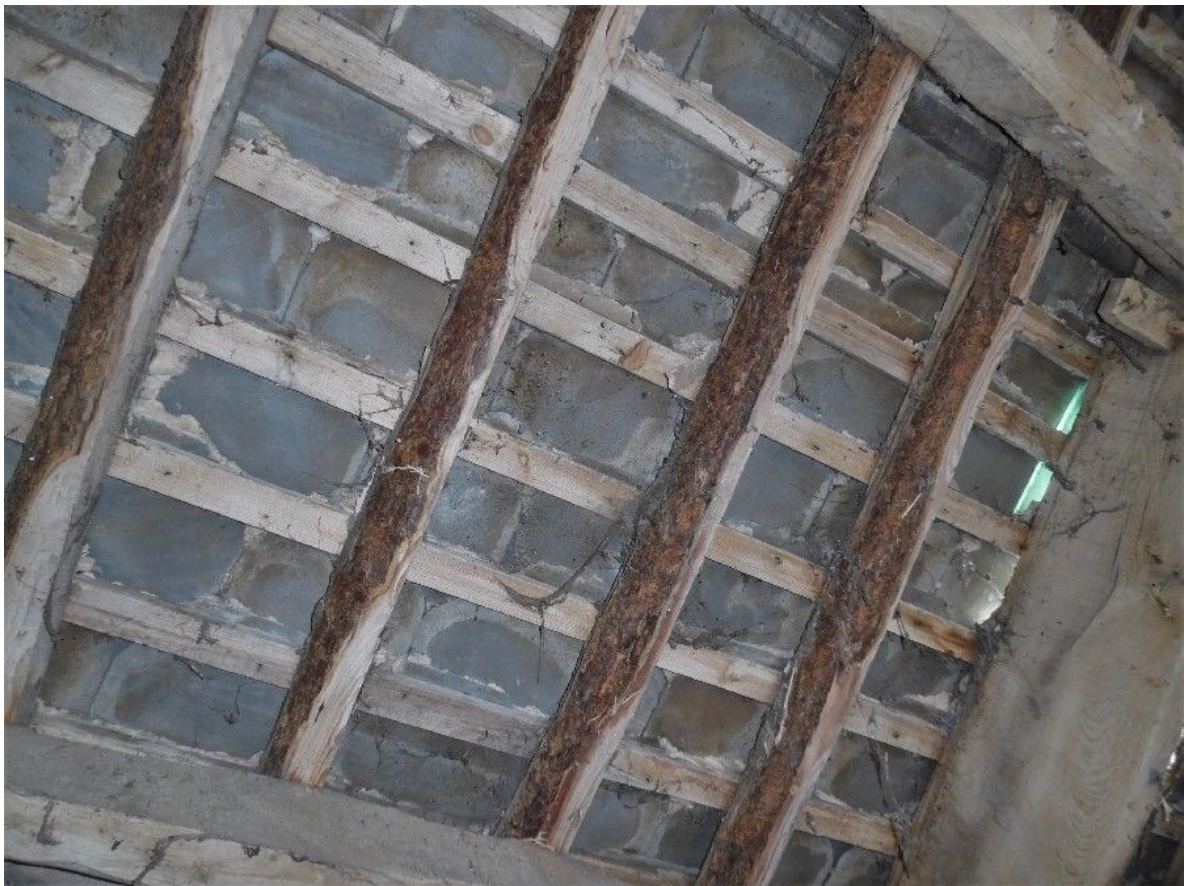
Plate 6: Typical roof rafters. Possibly tree branches or small trunks.

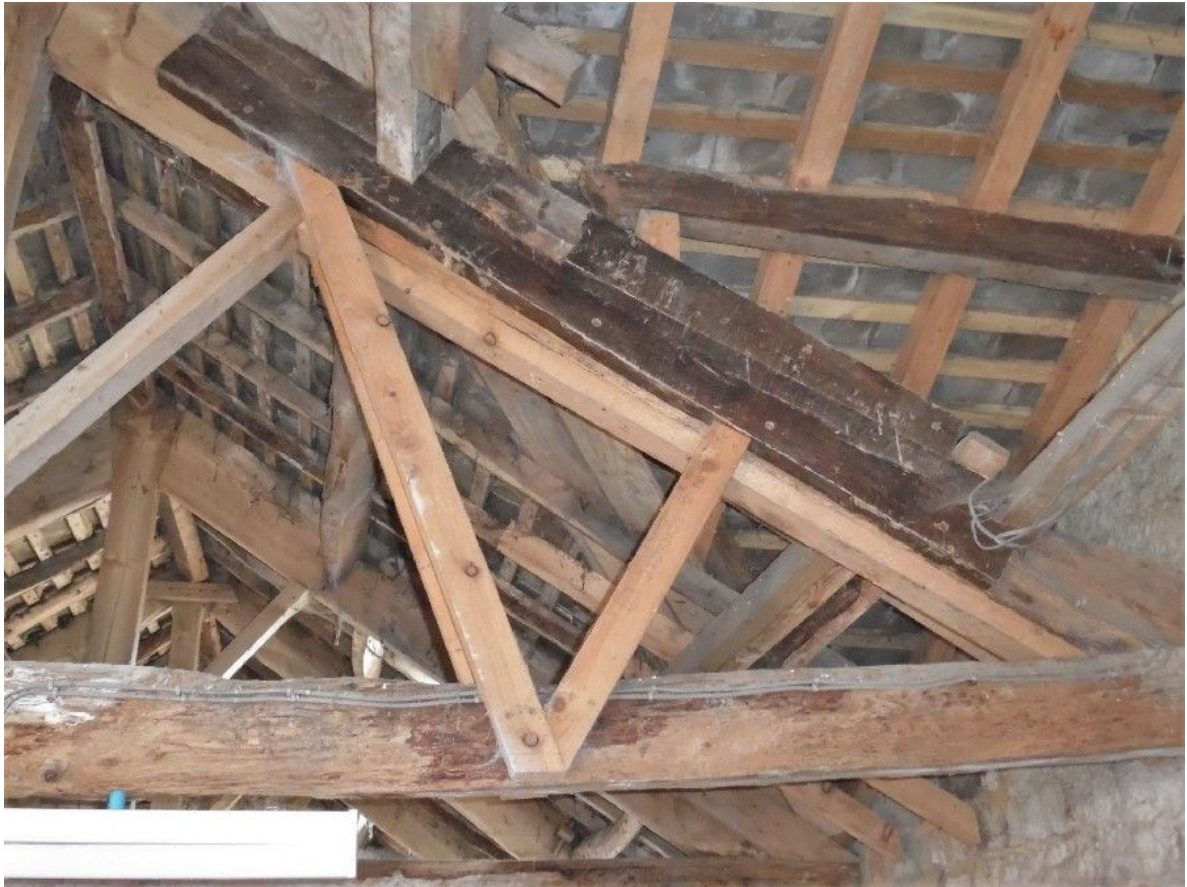
Plate 7: Strengthening of original timber king post truss.

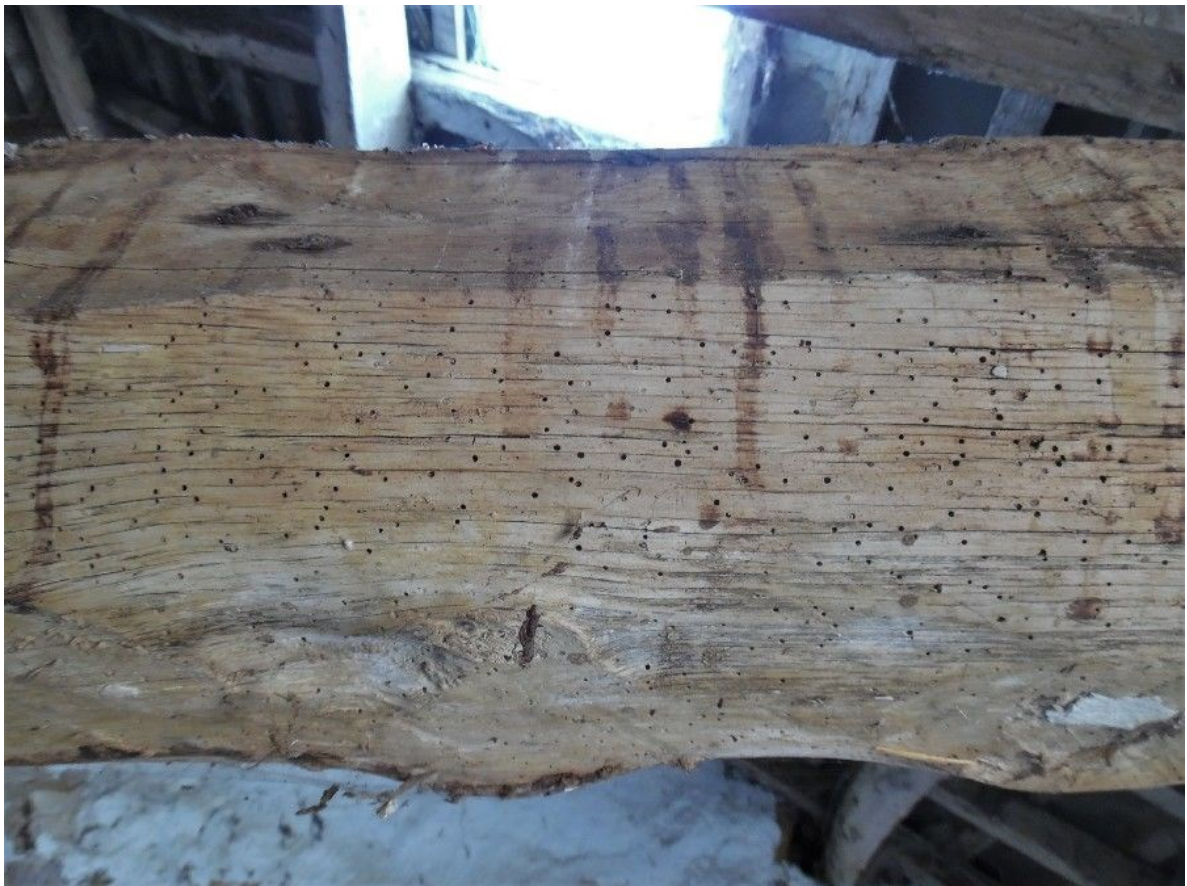
Plate 8: Insect boring attack of timber roof truss.

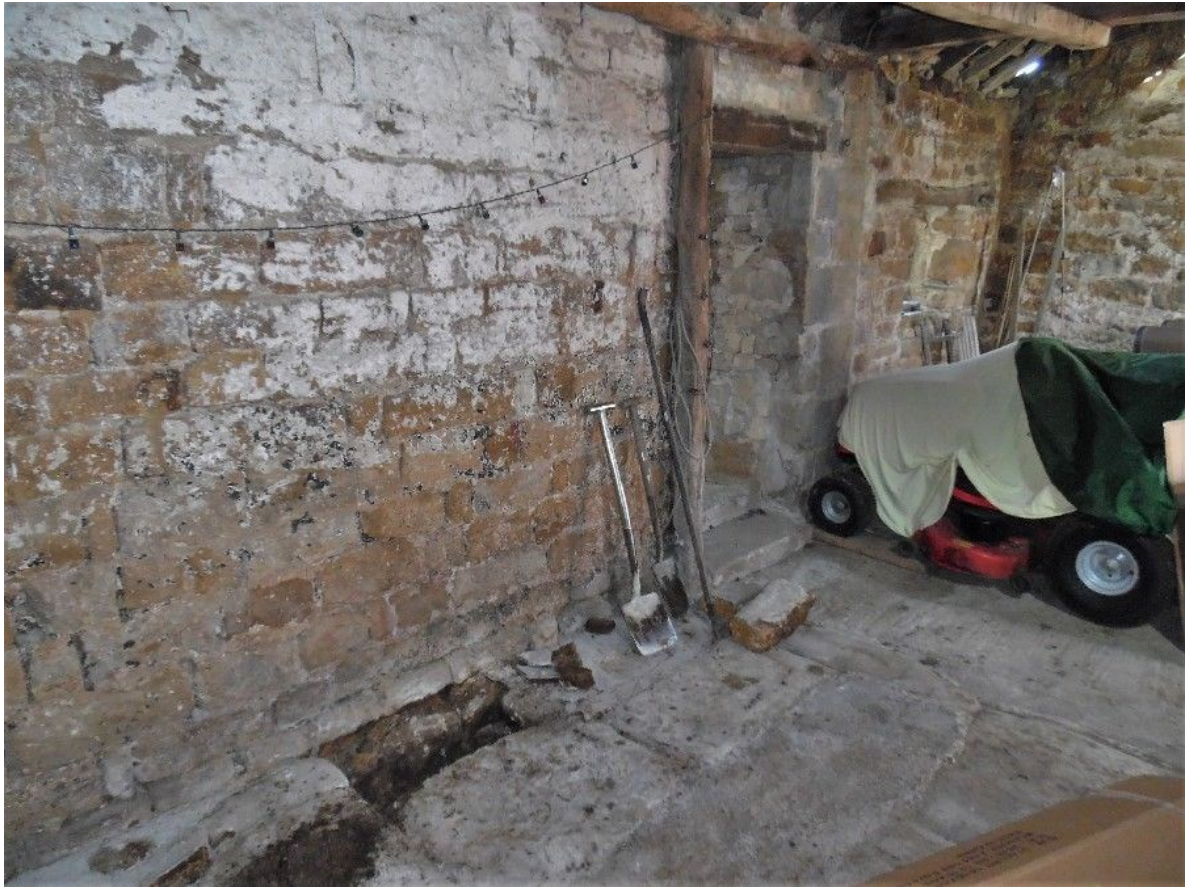
Plate 9: Slab within the barn.
