CONDITION REPORT

FISHER HOUSE  
RIVINGTON

Issue r.1 November 2021

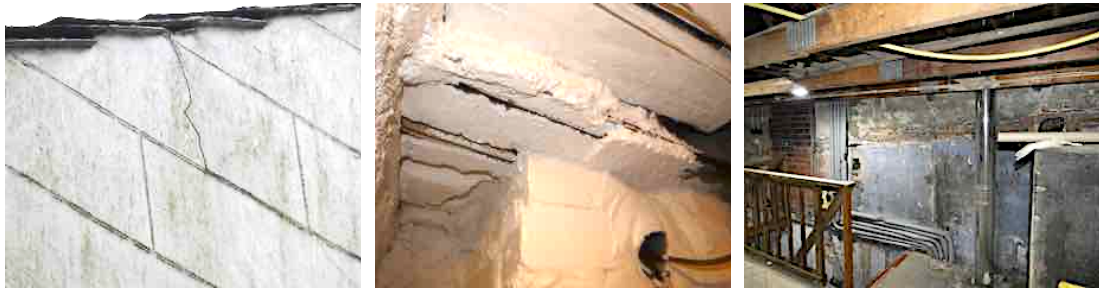
- 2.1.1 There are some structural defects which require more attention. The garden walls have shifted and partial rebuilding or stabilisation will be needed.

- 2.1.2 There is settlement and cracking visible in the structure which could not be diagnosed during the inspection. It may arise from differential settlement (because the main building only has a part basement and therefore is not evenly loaded). The upper roof is certainly unevenly loaded, with stone to one pitch and slate to the other. The base of the corner stack in the north gable of the house may have been removed, and part of the south wing has been demolished, with the gable made up in brickwork. Much of the north wing (including the entire roof frame) has been rebuilt and has had a tie pin inserted. Openings between the spaces have been altered and the first floor opening in the south east quoin of the main building creates a weakness in that area. There is a large tree close to the building, whose roots may be affecting the ground the building stands on.

*Develop proposals using a CARE-Accredited Structural Engineer.<sup>5</sup>*

- *Map the movement and anomalies on the 3D scans and compare with any documentary evidence.*
- *Consult with the Engineer to understand whether the load paths are uneven or have been disrupted.*

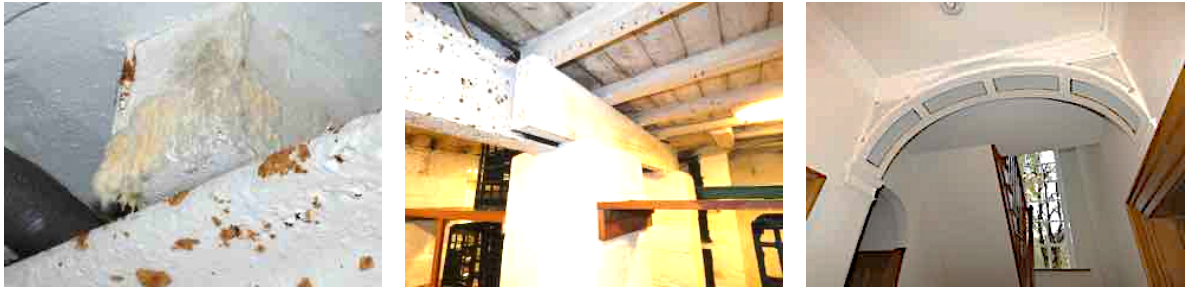
2.1.3 There will be embedded 'bonding timbers' in the structure, embedded timber joists and beam ends and the inner lintels may well have been timber. The pattern of cracking in the render suggests lintels and bonding timbers may have failed and been partially repaired. The steel beams in the basement suggest there was failure of the timber elements, possibly due to rot or beetle infestation, and the rot may be active in the bonding timbers and lintels where they are concealed in the plaster and render. There was evidence of live beetle and dry-rot infestation, and some of the walls have been lined – the reason is not clear but these voids can host rot, too. The floors deflected in heel drop tests.

- *A programme of investigation including opening up vulnerable locations for inspection is recommended before the main refurbishment begins, as any structural issues will need to be addressed early on.*
- *Address dampness as the root cause of timber decay.*

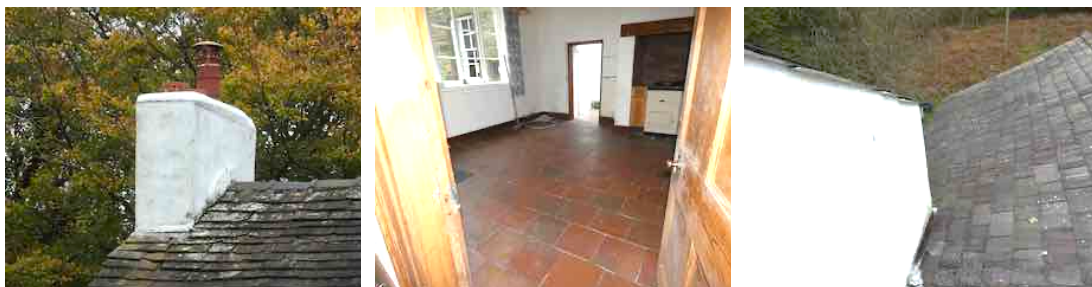
2.2.1 The building suffers from damp – both penetrating damp (from defects in the chimneys, the back gutter where the two building components join, the rainwater goods and rendering) but also from condensation because dampness in the structure is being re-deposited.

2.2.2 The main roof, including the structure, appears fair and can be repaired, but the repairs to alleviate dampness will include rebuilding both upper gable stacks, redoing the back gutter, repairing all the gutters and downpipes, repairs to the render and overhauling the insulation and ventilation of the structure.

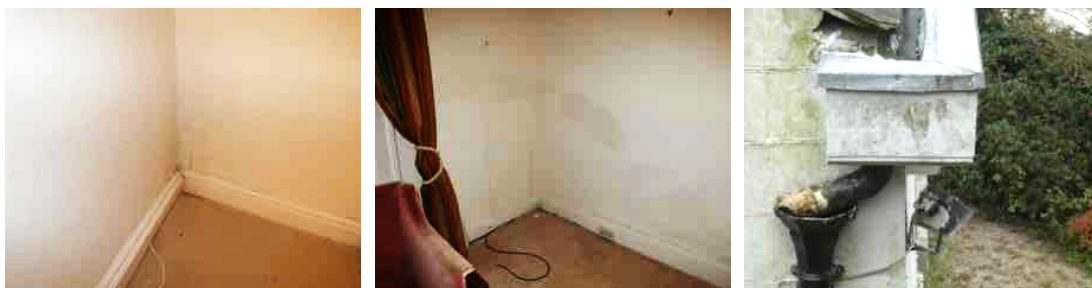
2.2.3 The detailing of the lead front gutter and cornice appears historically inaccurate. UPVC has been used elsewhere. It is not a durable material for gutters and downpipes and not usually allowed on listed buildings. For authenticity and improved performance, the gutters and downpipes should be replaced in suitably-sized cast iron, and the front gutter detail carefully reworked with new joinery and lead linings to give a more authentic appearance.

2.2.4 There is dampness around ground level; this is not so much rising damp as penetrating dampness where the wall / ground detail is weak. Reducing the built-up levels and

introducing good drainage will alleviate this problem. The old osmotic damp proof course is unlikely to be effective (or ever have been) and should not be renewed.

- *The various causes dampness should be attended to promptly as there is evidence of live fungus in structural timbers and corrosion on structural steelwork.*

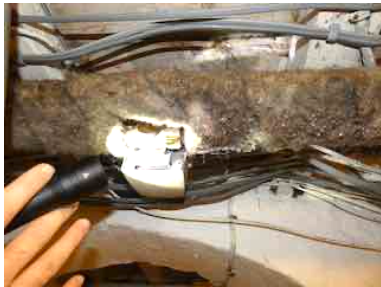
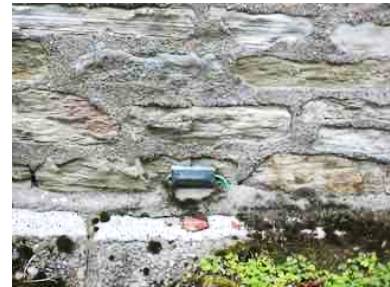
2.2.5 Dry rot cannot be fully eradicated from a previously-affected building as the spores are very fine but the spores become dormant and harmless if the moisture content of the building is low and stable. Sadly, the fungus is very resilient and it can re-establish quite quickly in the presence of moisture.

2.2.6 Managing down the building's moisture content, after the penetrating dampness has been eradicated will require sensitive heating control and good passive ventilation. There has also been a small plumbing leak in the basement, but this issue is likely to be addressed when the systems are renewed.

- *The existing propane heaters are not appropriate and can make condensation worse.*
- *New bathrooms and kitchen should be fitted with heat recovery humidistat controlled mechanical ventilation.*
- *The flues should be capped and ventilated; for redundant flues, this could incorporate further heat recovery extraction from the bedrooms, or the reinstatement of fireplaces in the principal reception rooms.*
- *Proper insulation of the ceilings and floors where the unheated voids of the roof and cellars abut heated rooms is necessary, with appropriate vapour permeable structures or vapour barriers to prevent interstitial condensation.*

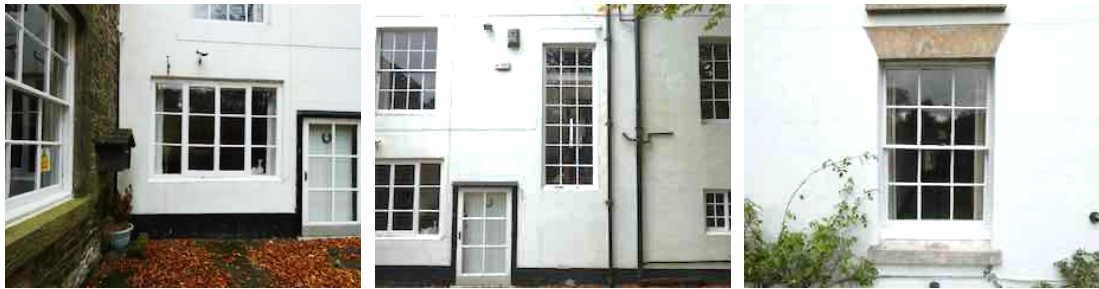
2.3.1 The windows appear to be original with surviving historic glass. Many are rotten in many places. They are mostly capable of repair by a craft joiner with only the two south-facing windows, and possibly the Westmorland of the main house justifying full replacement.

- *Discuss repair options with a craft joiner.*

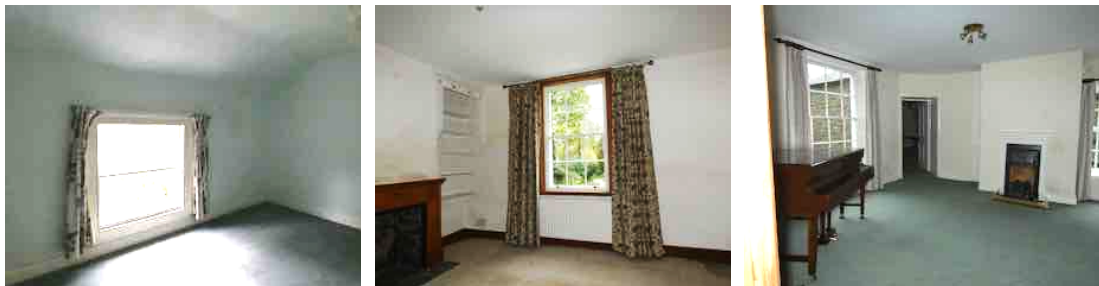
2.3.2 To improve thermal performance all the modern glass could be upgraded to insulated single glazing, or secondary glazing may be introduced. If the shutters survive in the pockets, these can add greatly to the building's thermal performance, security and authenticity.

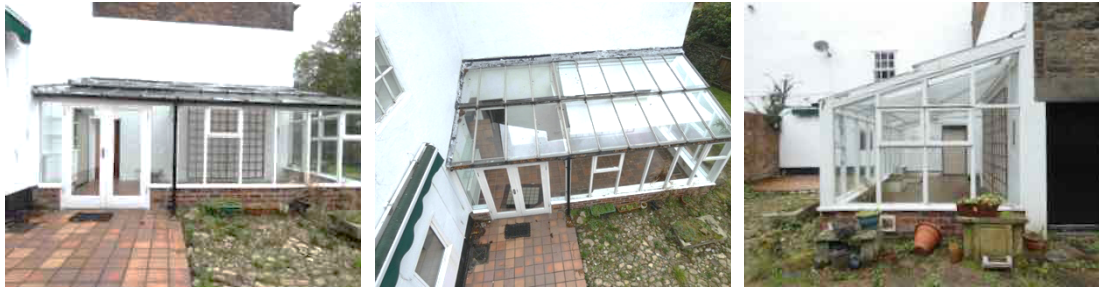
2.3.3 The existing windows are unlikely to accept reglazing in small pane double-glazed units; repairing the existing frames and introducing new double-glazed sashes may be possible but replacing all the windows entirely would not be justified, because double-glazing often detracts from the building's authenticity.

2.3.4 The conservatory (sun room) is modern and in poor condition. It occupies only part of the building's former footprint.

- *A thumbnail window-by-window specification is provided for inclusion in pre-application discussions about what might be granted listed building consent.*

- *It would make sense to demolish this element to make way for a new extension if the client is seeking more ground floor space.*
