2021 8866

Fisher house

Structural Investigation Report

Date of Report: 08/02/2022

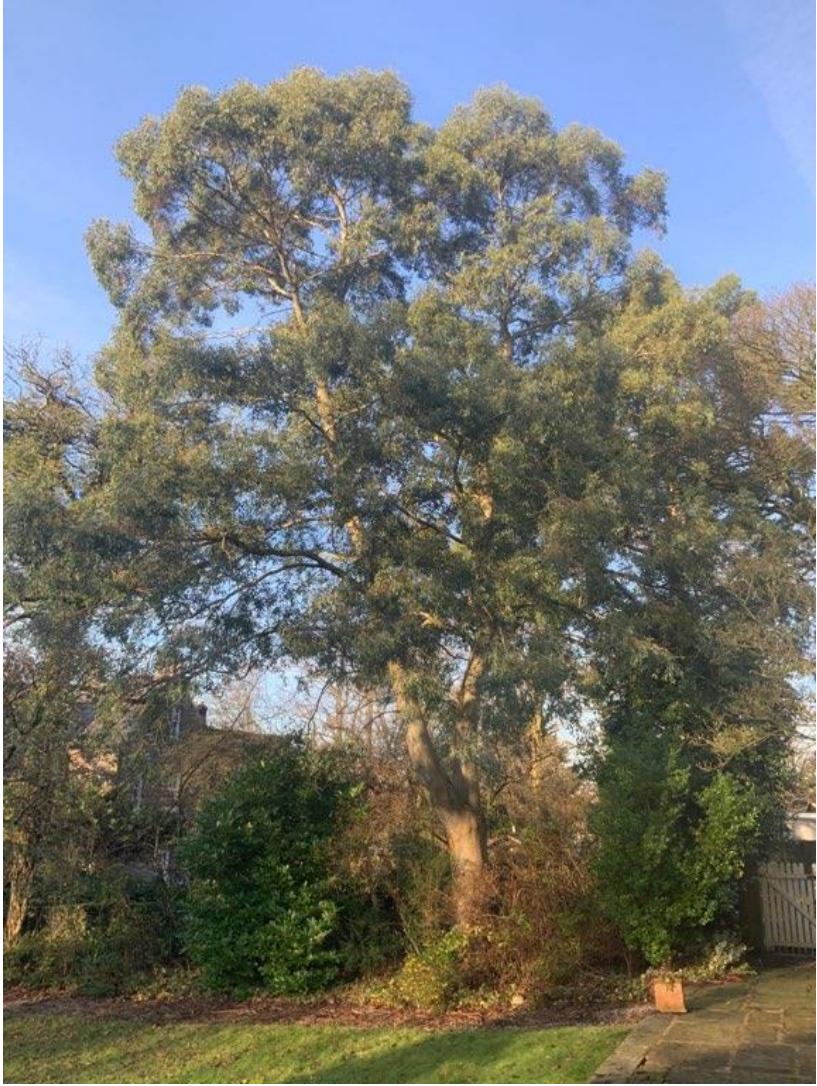
Vegetation	Tree
Distance From	Front Left corner of building
Distance metre	8.0metre (approx)
Approx Height of Vegetation	20.0Metre
Photograph of Vegetation

There are a number of trees around the property that would be considered within influencing distance of the building, and it would be prudent to engage an arboriculturist to undertake a tree survey such that the influence of the trees and risk of building foundation movement can be fully established.

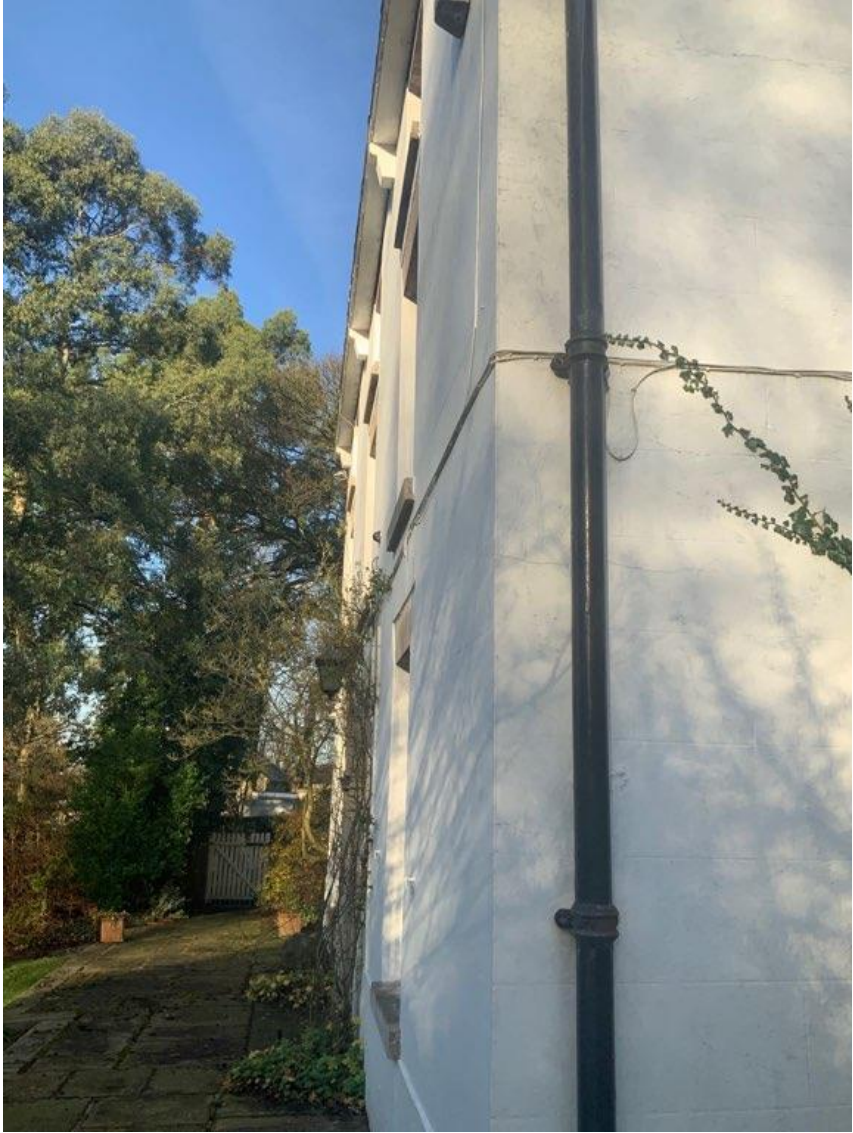
No	6.1.2
Location	Front Elevation
Description	<p>At low level the front elevation leans outwards slightly within a minor bow.</p> <p>At higher level it appears visually the wall leans outwards further, possibly due to some evidence of roof spread.</p>
Photograph

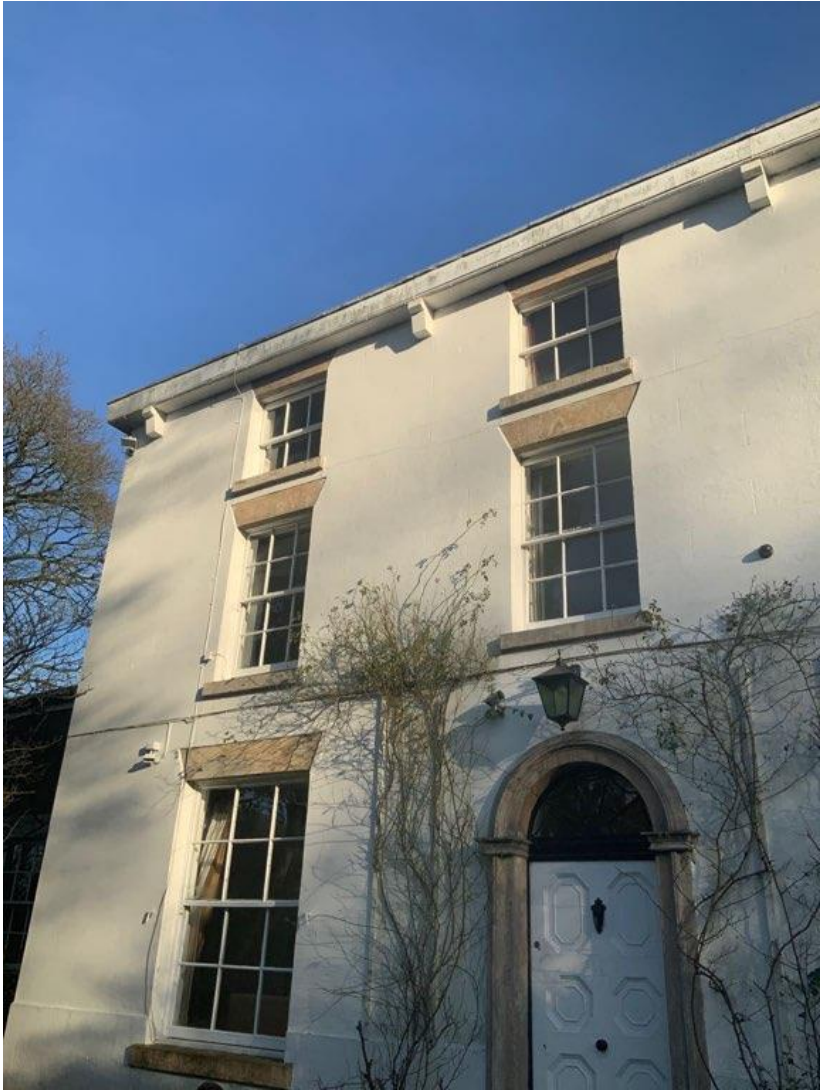
No	6.1.3
Location	Front Elevation
Description	<p>There is cracking evident at second floor level.</p> <p>The cracking is hairline in width within the render finishes and extends generally horizontally across the front of the property between the windowsills.</p>
Photograph

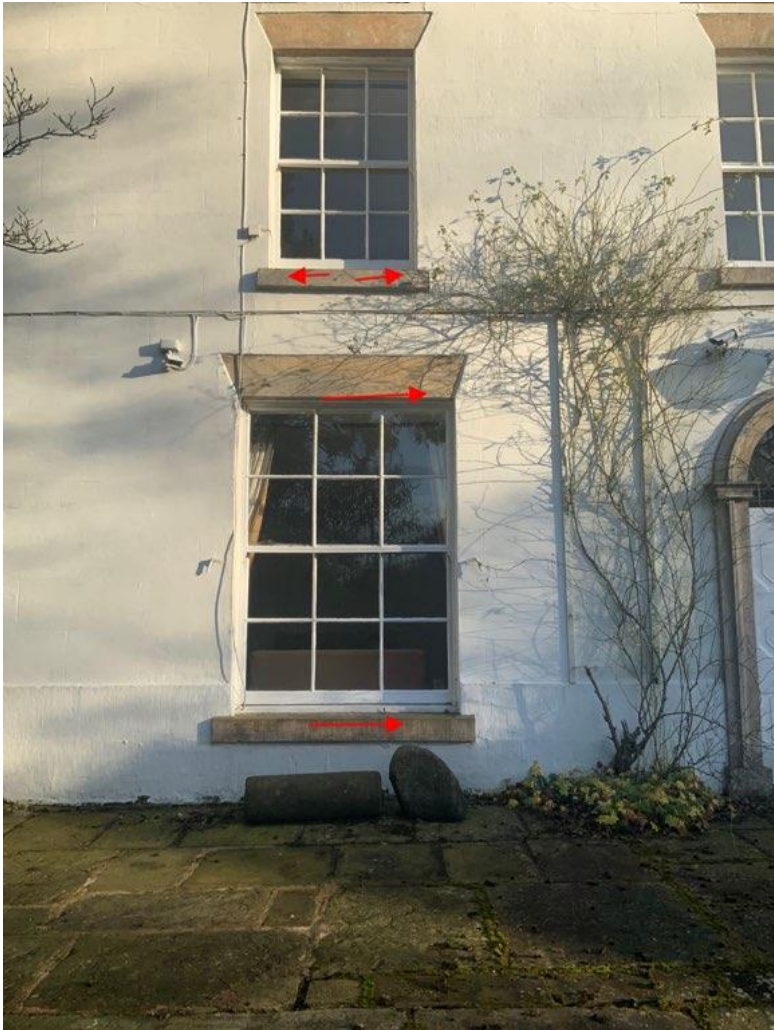
No	6.1.4
Location	Front Elevation
Description	<p>Left ground floor still slopes towards the right slightly around 10 mm/ metre appears to be historic movement with the window frame appearing to be relatively level within the out of square opening.</p> <p>The lintel over the ground floor window has a similar slope to the right.</p> <p>The sill to the window over at first floor appears however to be more level</p>
Photograph

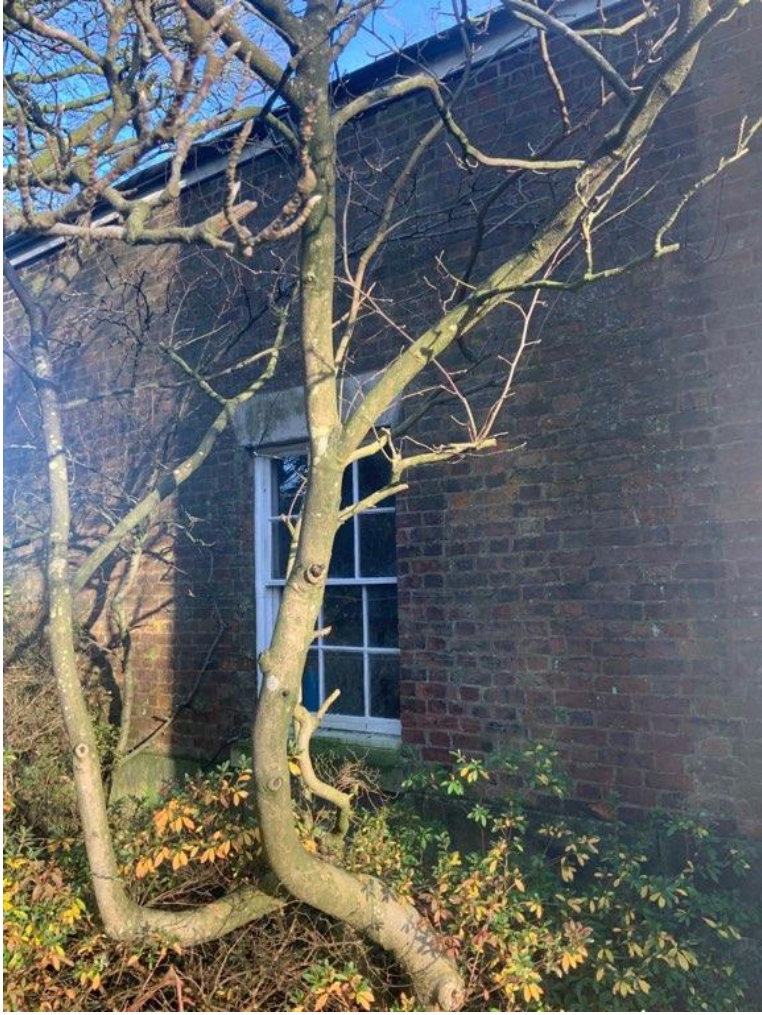
No	6.1.5
Location	Front elevation of the attached garage/workshop
Description	<p>Lower section of wall is formed with a stone plinth over random stone walling.</p> <p>We noted no evidence cracking of structural significance.</p>
Photograph

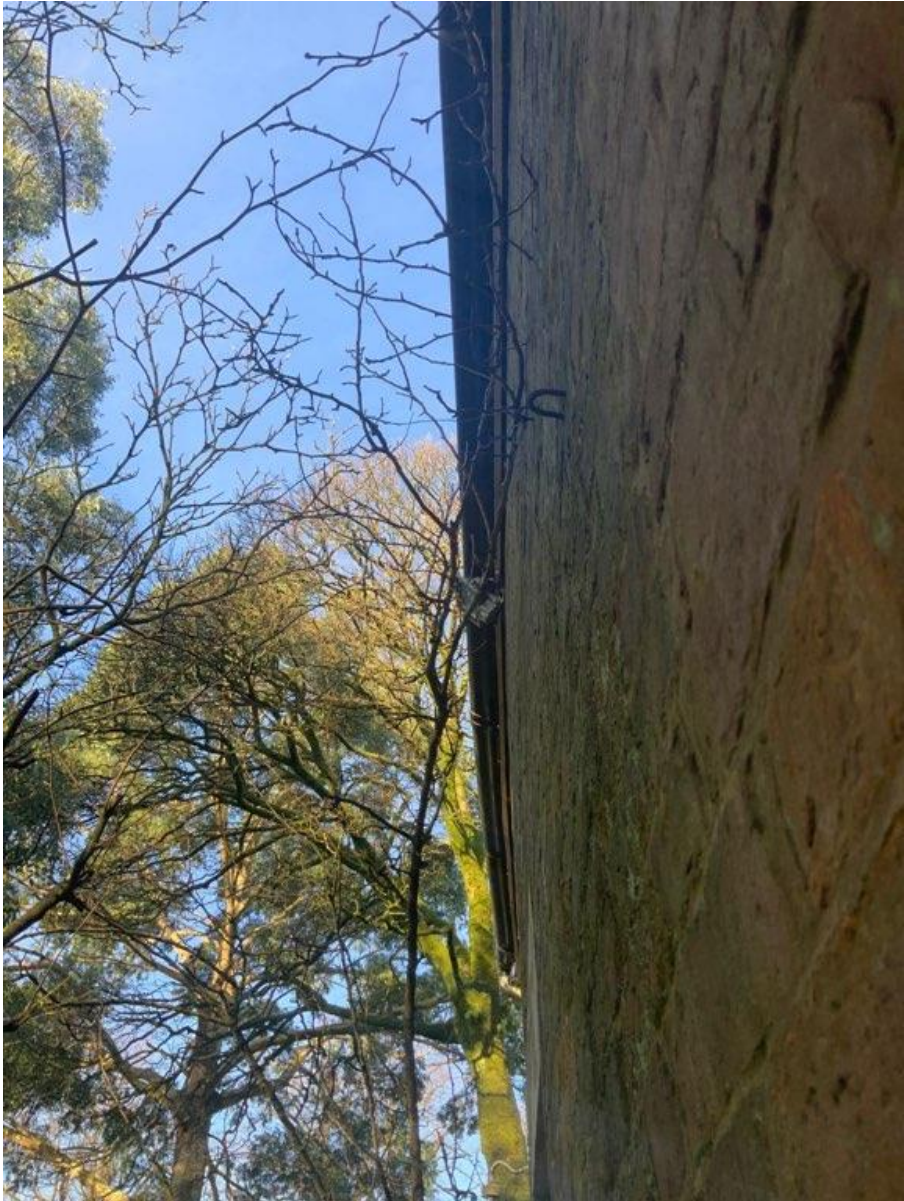
No	6.1.6
Location	Front elevation of the attached garage/workshop
Description	<p>There is outwards bowing of the fascia board and gutter and similar bowing to the front wall at high-level.</p> <p>This is consistent with roof spread</p>
Photograph

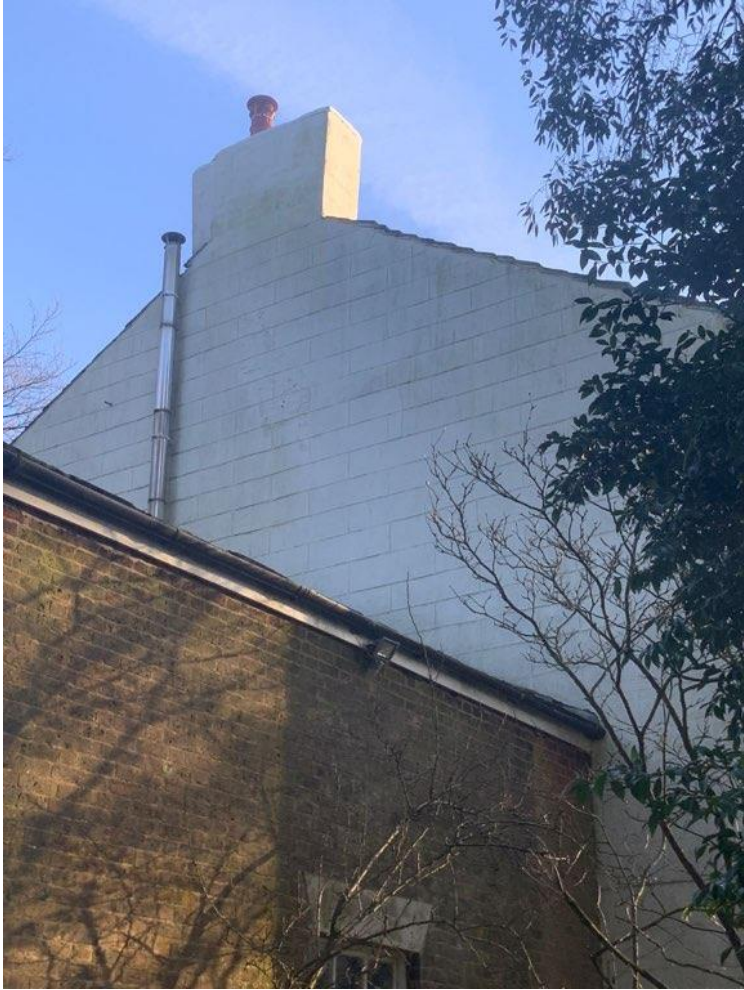
No	6.1.7
Location	Left Elevation
Description	<p>There is cracking evident in render to left elevation. The cracking extends from the roof verge down to the roof over the garage/workshop</p> <p>The cracking it appears to be slightly tapered probably hairline to 2mm</p> <p>The cracking appears that it may follow line of chimney flues.</p>
Photograph

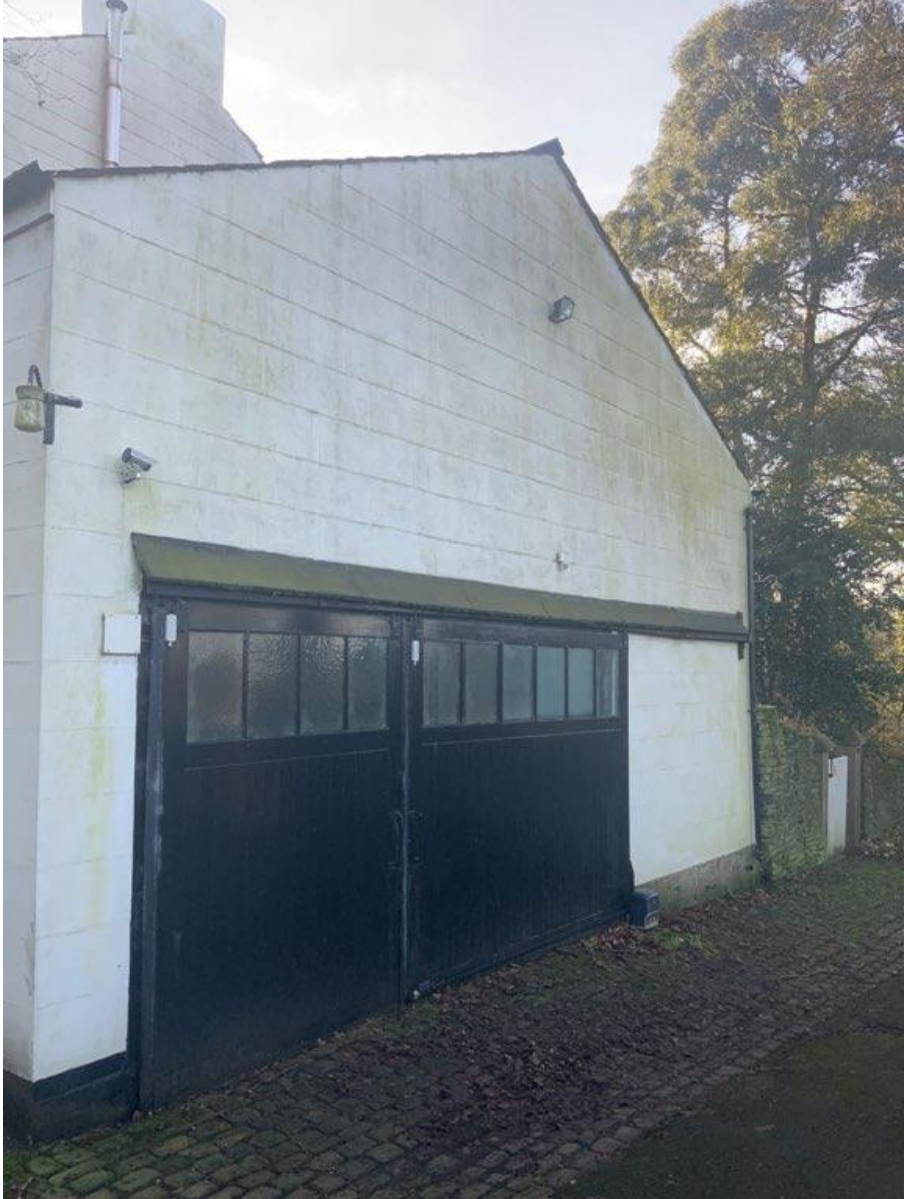
No	6.1.8
Location	Left elevation of the attached garage/workshop
Description	We noted no evidence of structurally significant cracking within the render finishes.
Photograph

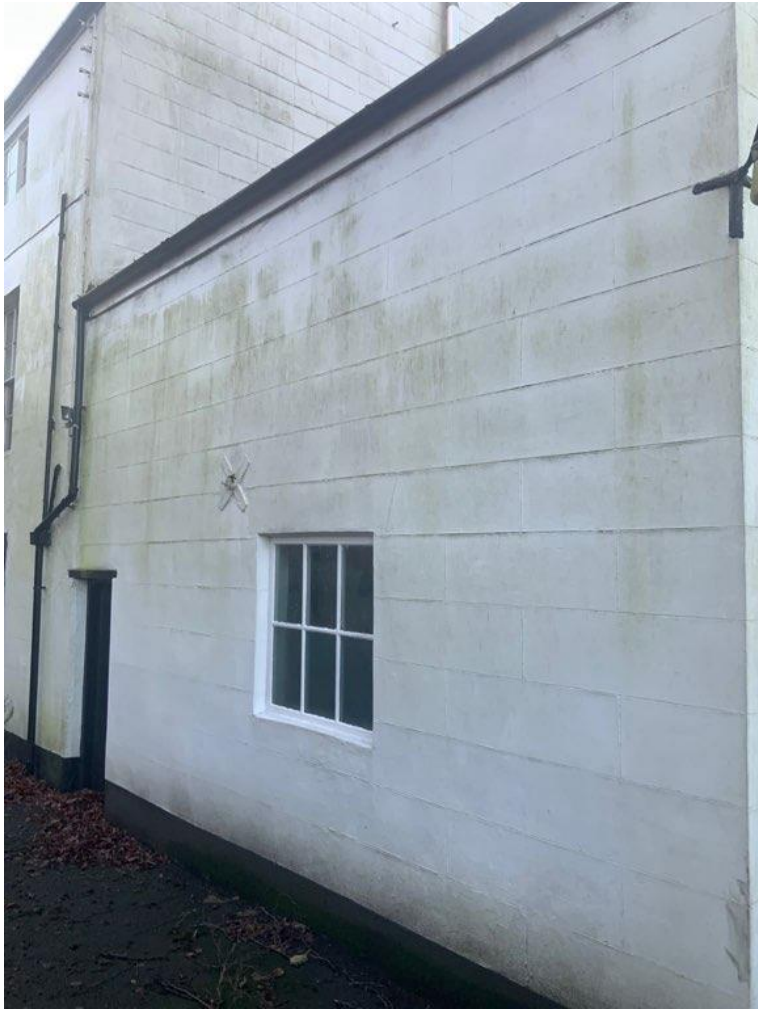
No	6.1.9
Location	Rear Elevation of the attached garage/workshop
Description	<p>The rear elevation of the garage/workshop has significant outward bowing at mid height. There is an historic restraint tie/spreader plate that appears to be situated at the maximum magnitude of the bowing.</p> <p>There is no evidence to suggest the movement is progressive and externally we noted no structural cracking to the render.</p>
Photograph

This wall has a significant bow/lean and whilst ideally, we would recommend rebuilding is required, we could look at developing a scheme of repairs and then restrain the wall back to the next extension.

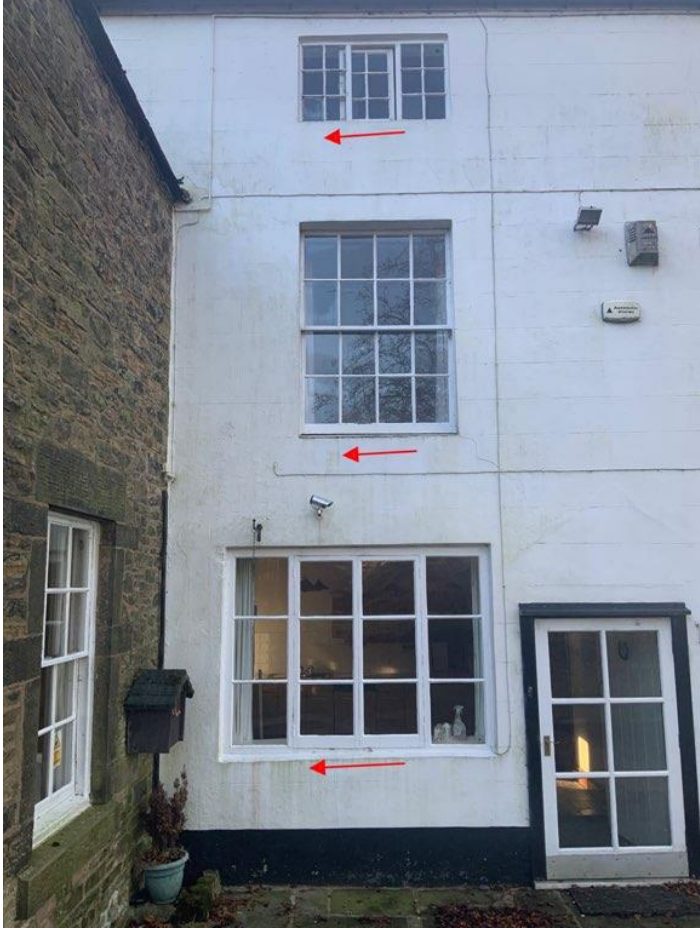
No	6.1.11
Location	Rear Elevation
Description	<p>Historic deformation evident to the kitchen window opening. The window frame appears to have been installed within the distorted opening.</p> <p>There is a similar slope evident within the structural opening of the first floor and second floor windows over.</p>
Photograph

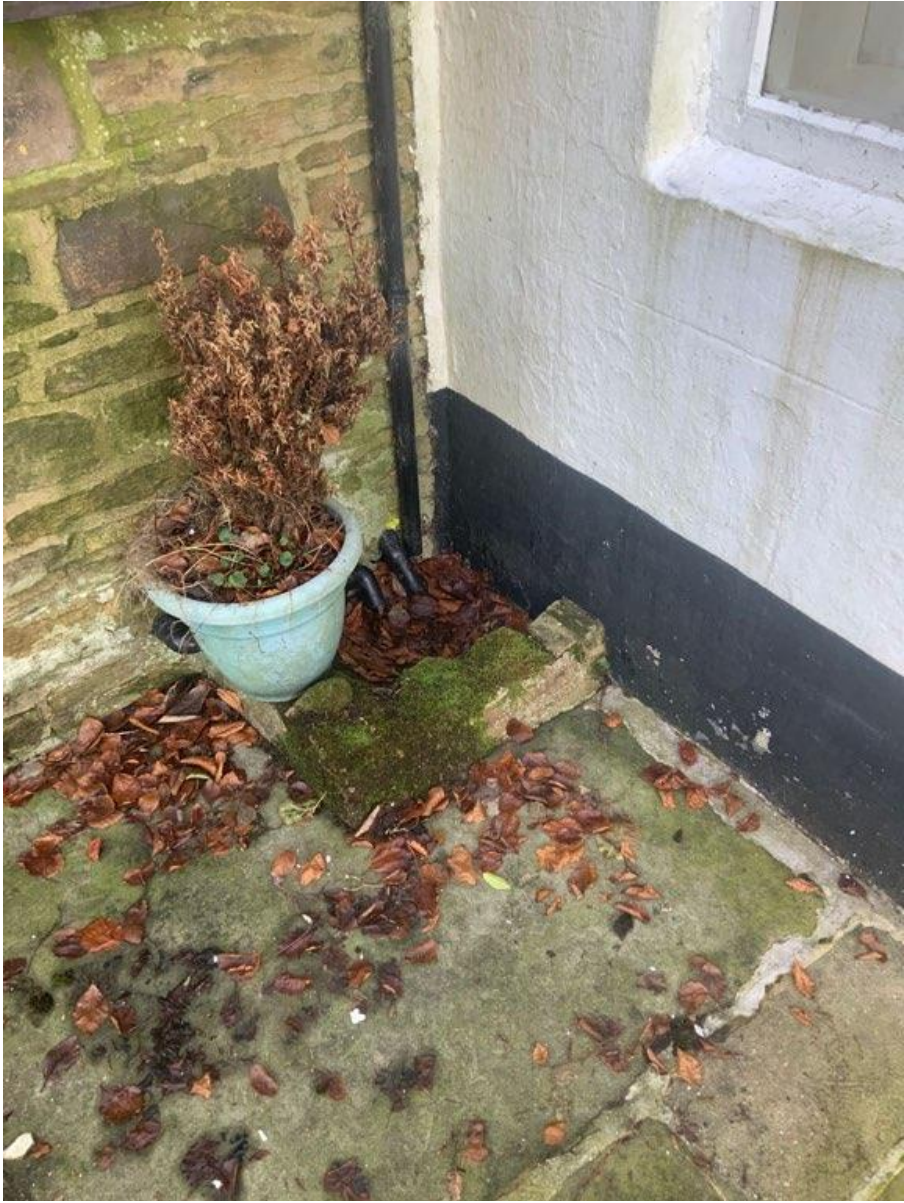
No	6.1.12
Location	Rear Elevation
Description	There is below ground drainage to the rear elevation adjacent the kitchen window.
Photograph

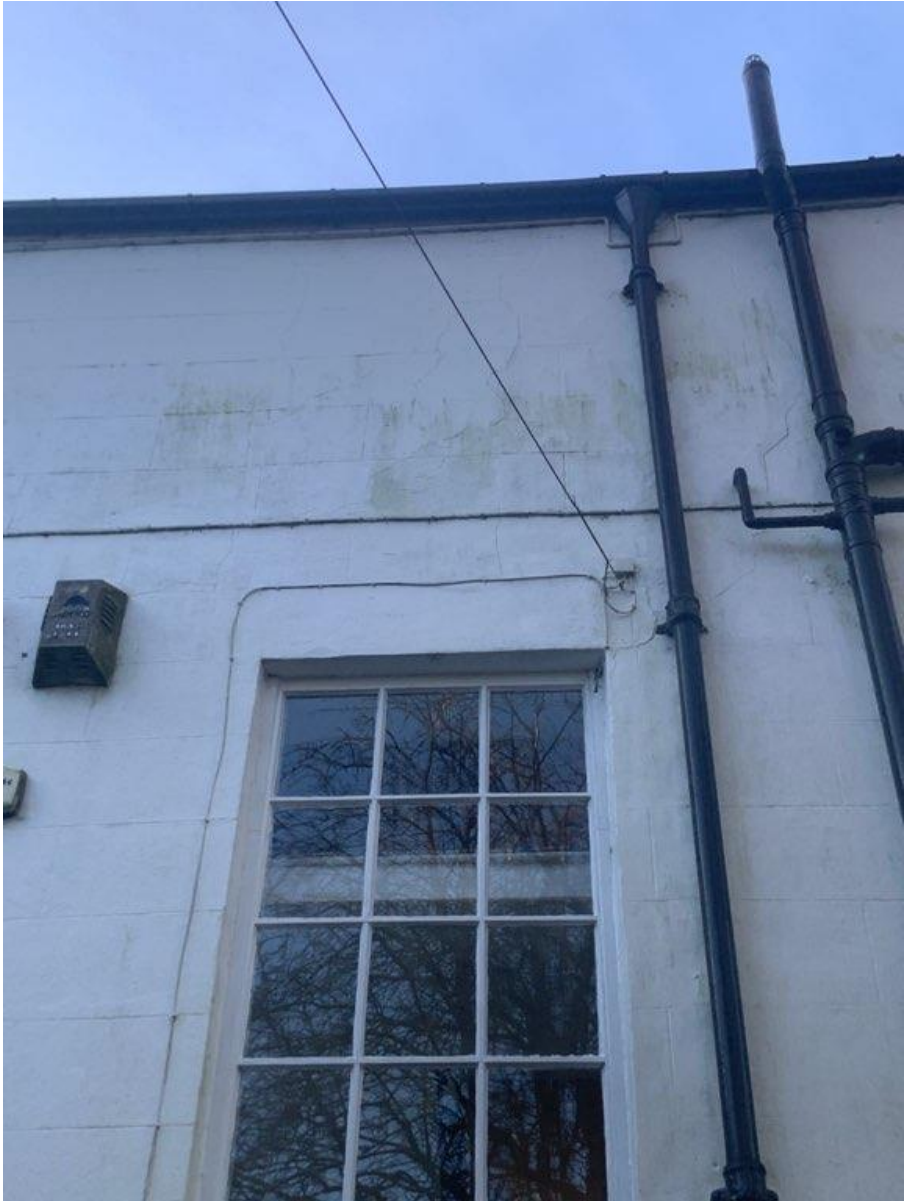
No	6.1.13
Location	Rear Elevation
Description	Random cracking to render above landing window consistent with failure of the render finishes.
Photograph

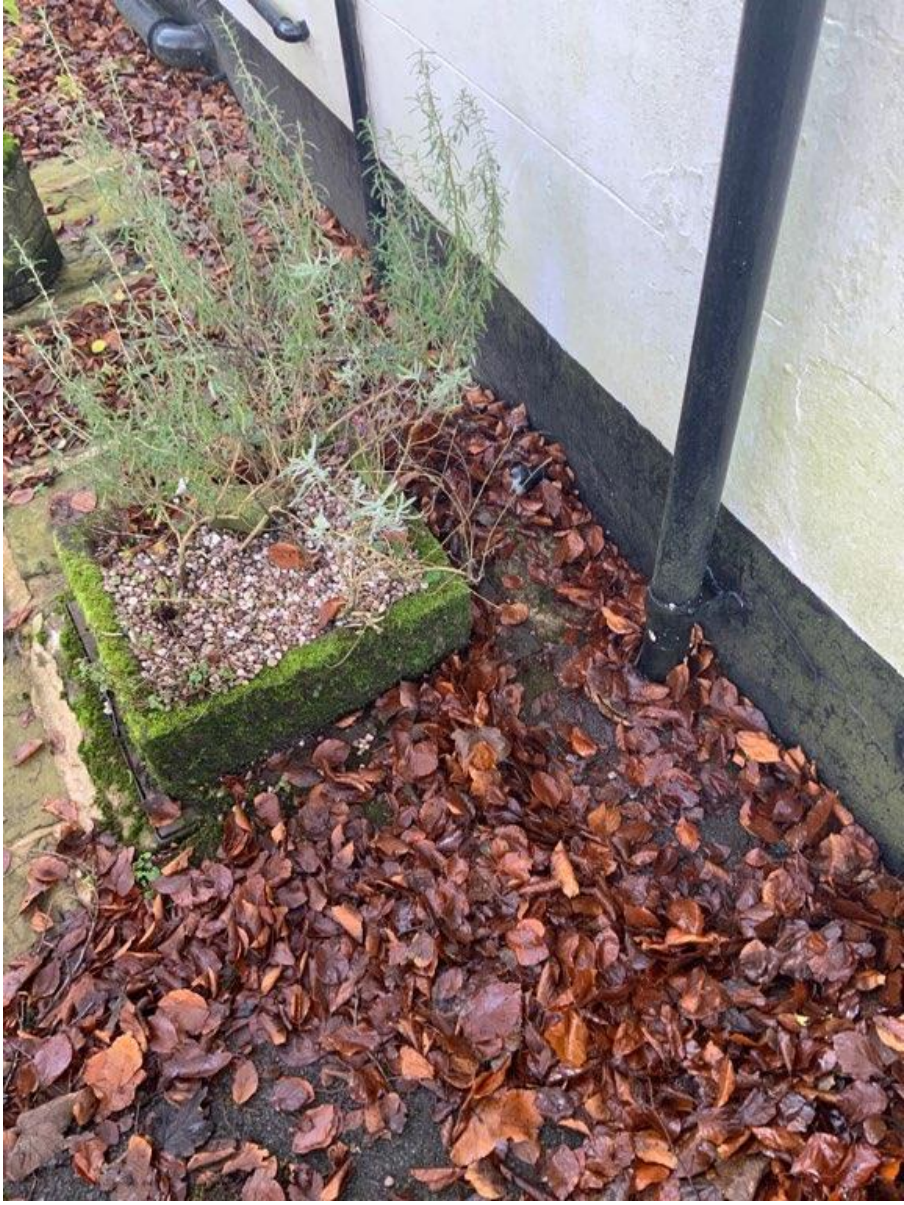
No	6.1.14
Location	Rear Elevation
Description	There is a drainage manhole and below ground drainage local to the rear left corner of the main house adjacent the area of the WC internally.
Photograph

There is also a concentration of below ground drainage local to this area. The drainage survey suggests that drains are not defective in this area, but the CCTV Survey generally suggests the below ground drainage is generally in poor condition and likely to be leaking.

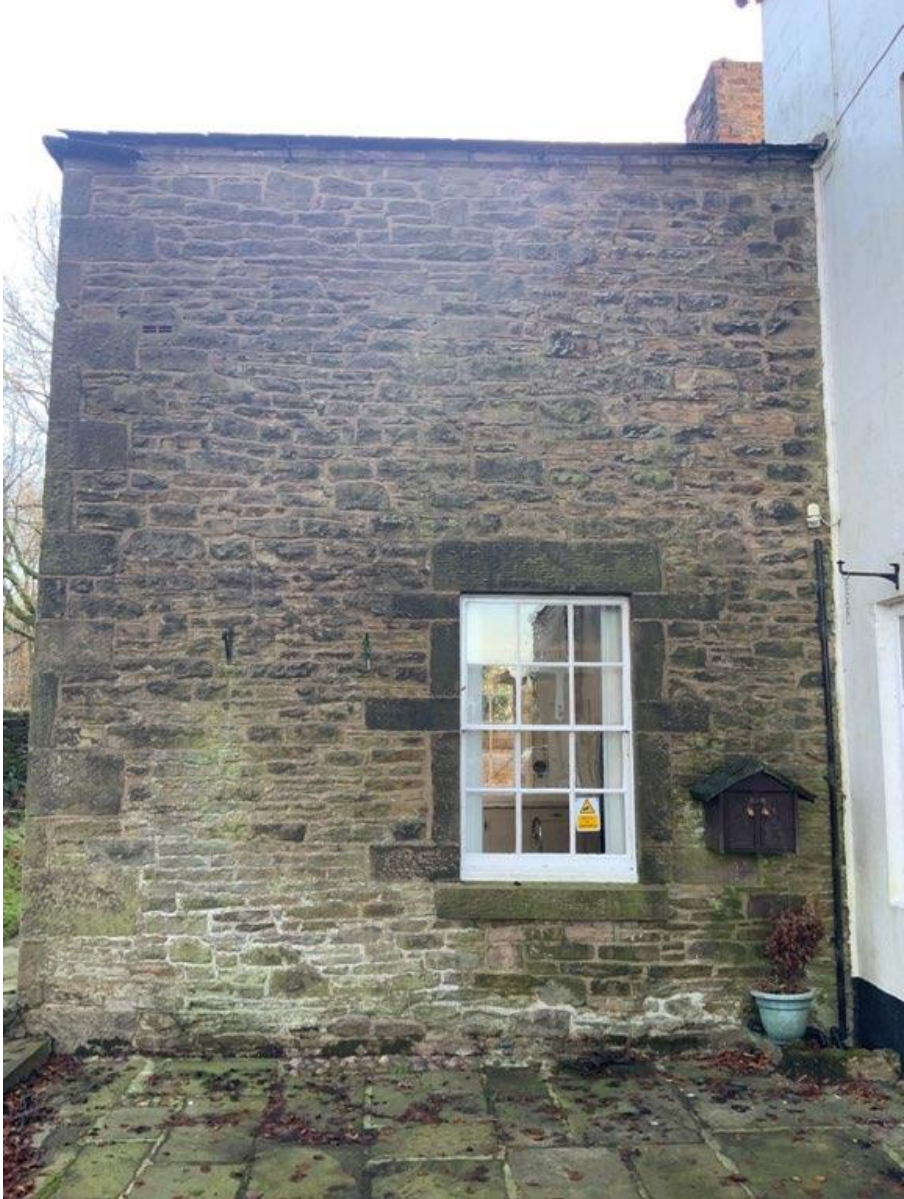
No	6.1.15
Location	Left Elevation right two storey annex
Description	We noted no evidence of significant structural cracking.
Photograph

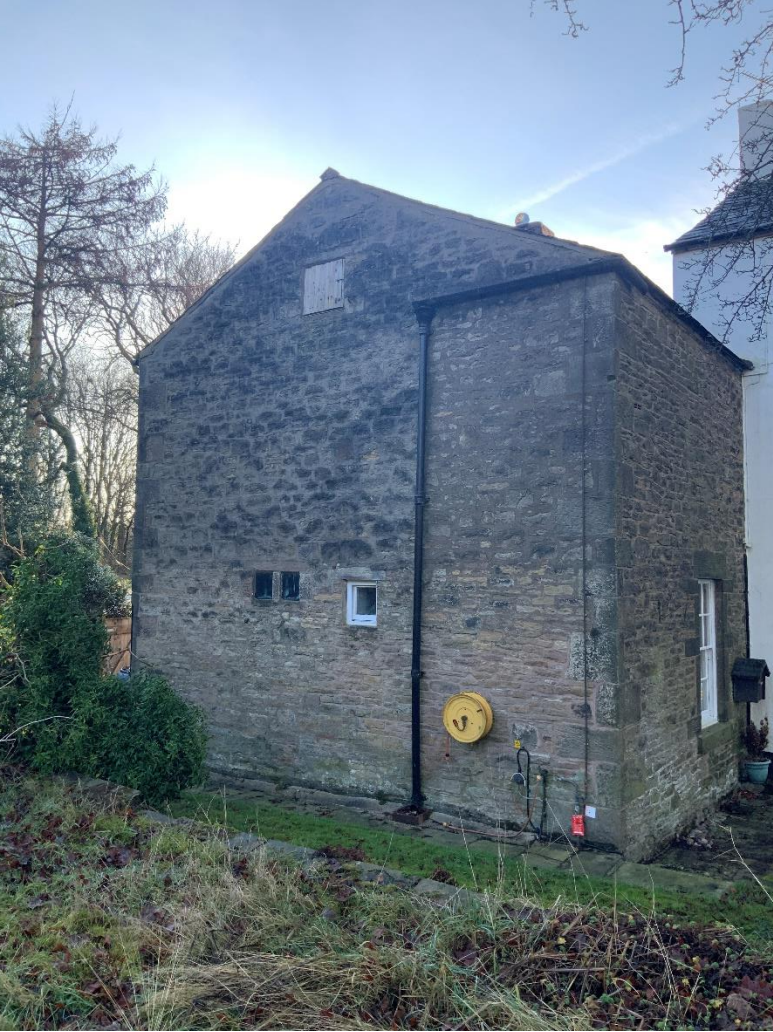
No	6.1.16
Location	Rear elevation right two storey annex
Description	We noted no evidence of significant structural cracking.
Photograph

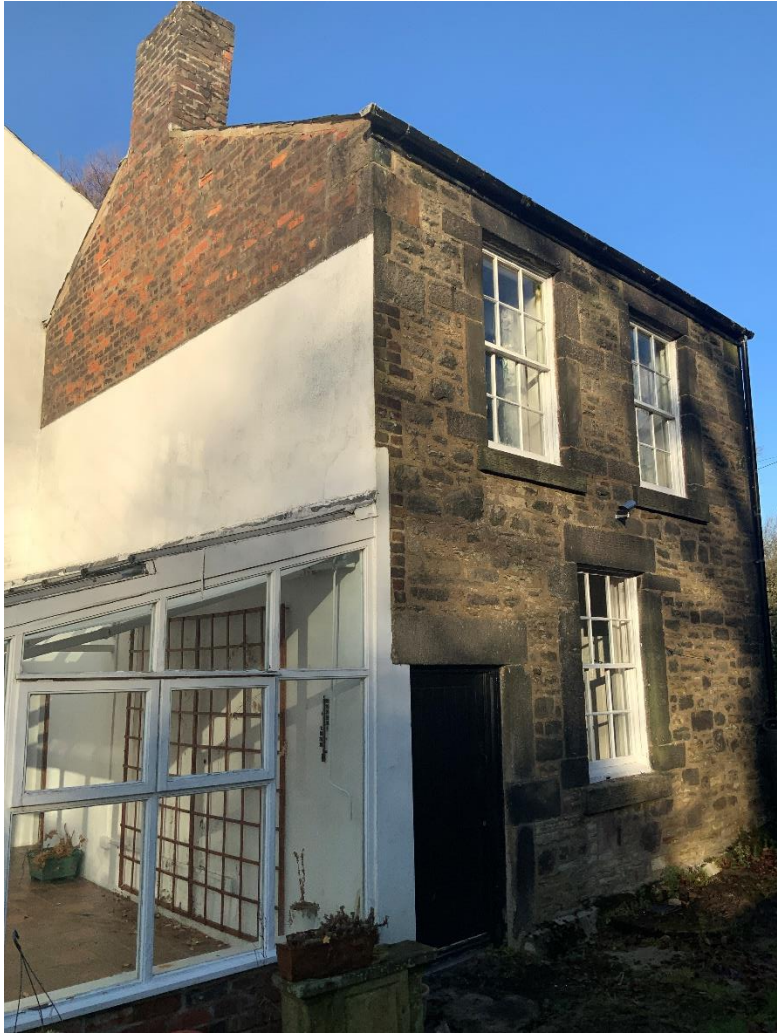
No	6.1.17
Location	Right elevation right two storey annex
Description	We noted no evidence of significant structural cracking.
Photograph

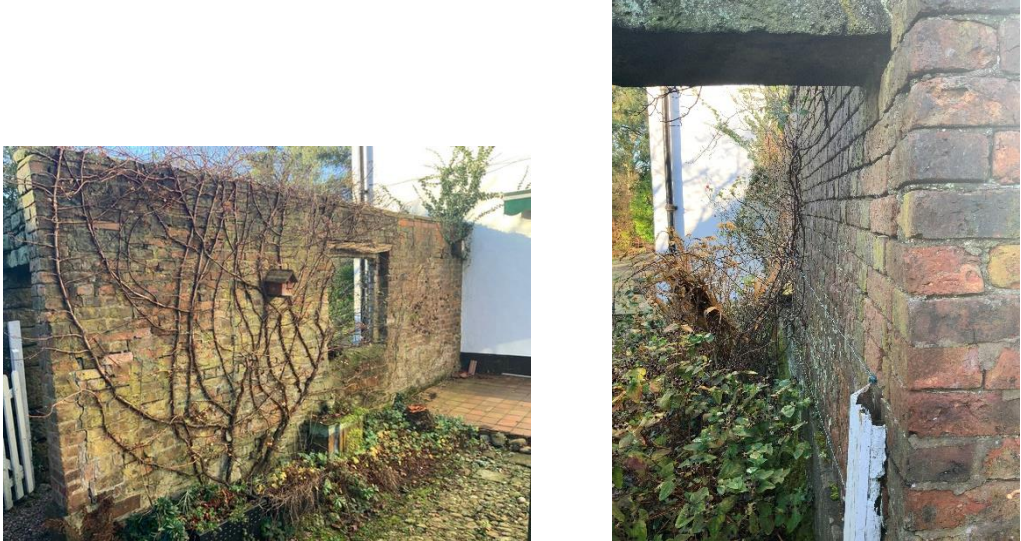
No	6.1.18
Location	Right Elevation
Description	<p>The garden wall abutting the right gable is in poor condition.</p> <p>The mortar jointing is badly eroded and is no lintel present to the front leaf of the wall and a rotten failed timber lintel to the rear leaf over the old window opening.</p> <p>The wall has a significant lean/rearwards bow.</p> <p>We understand that this wall may form part of a demolished section of an older building.</p>
Photograph

There are a number of garden walls to the right side of the property that are in very poor condition and localised repairs, or rebuilding would be recommended

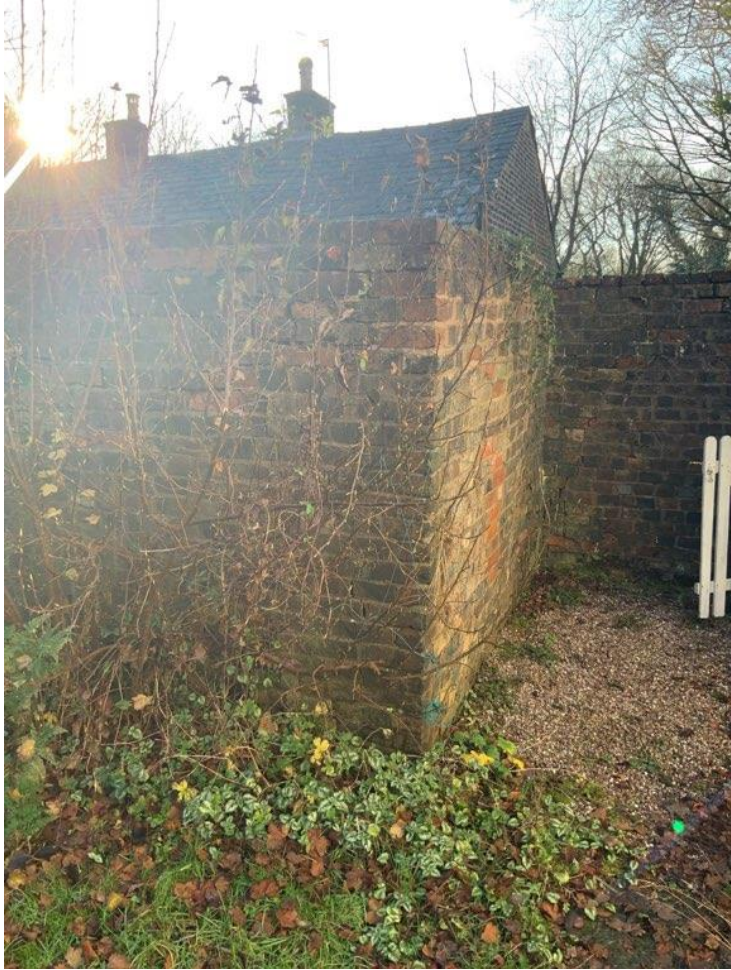
No	6.1.19
Location	Right Elevation
Description	<p>There is movement evident boundary garden wall to the adjacent property.</p> <p>There is evidence of the foundation movement and lateral rotation of the wall.</p> <p>The wall will need to be locally rebuilt. The ownership of the wall and responsibility for these repairs should be established.</p>
Photograph

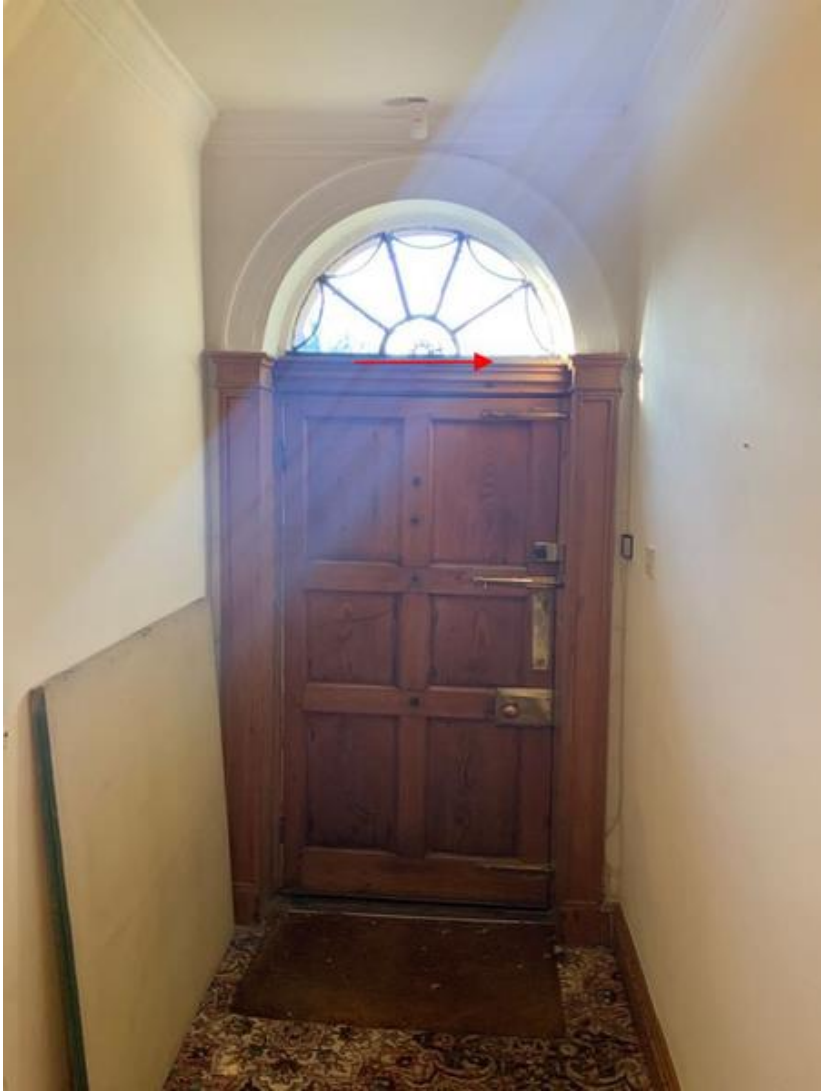
No	6.2.1
Location	Ground Floor, Hall
Description	The head of the door slopes to the left.
Photograph

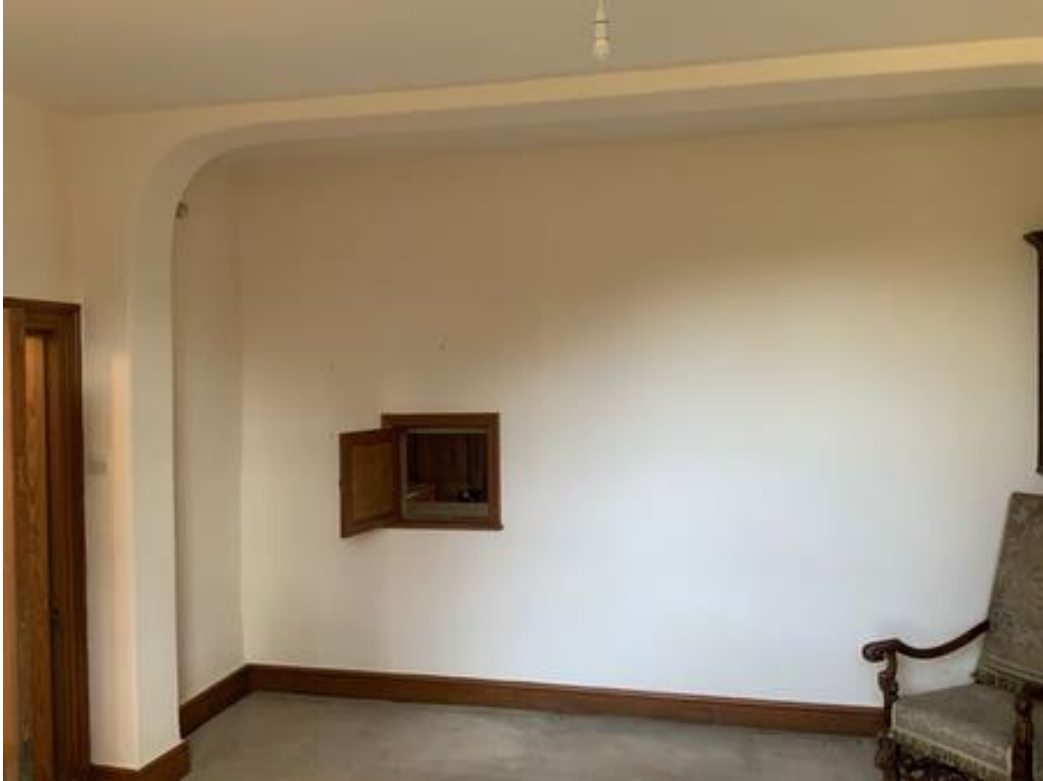
No	6.2.2
Location	Ground Floor, Dining Room
Description	There appears to be in existing beam spanning left to right across the dining room supported on masonry piers either side.
Photograph

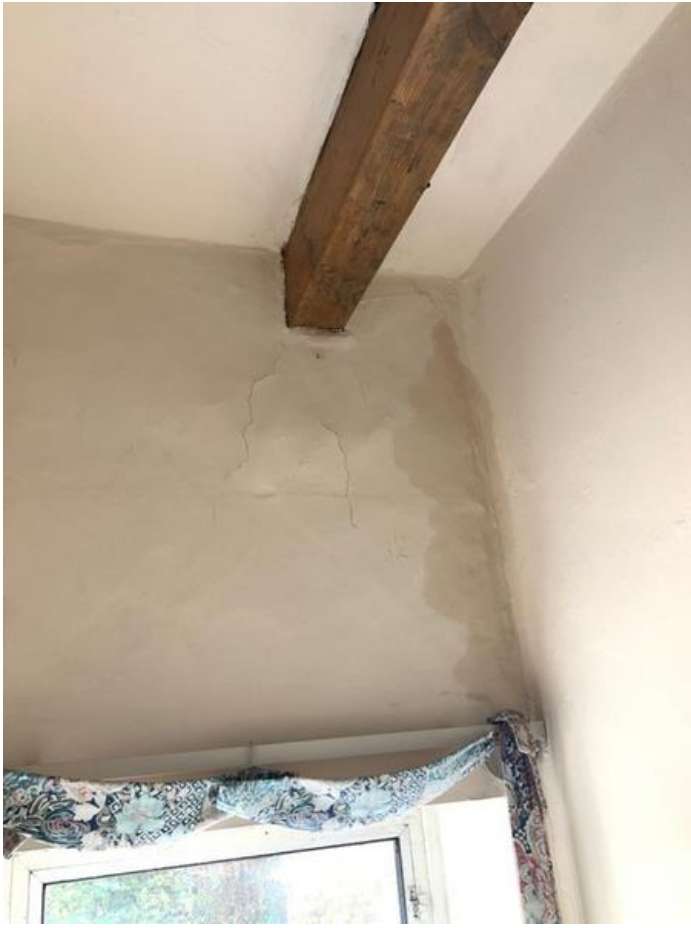
No	6.2.3
Location	Ground Floor, Kitchen
Description	<p>The timber first floor over the kitchen appears to be supported on a series of timber primary beams spanning left to right with presumably timber joists spanning front to rear.</p> <p>There is significant damp evident to the right external wall adjacent one of the timber beam bearings. There is cracking and distress within the finishes below the beam.</p>
Photograph

It appears likely that some strengthening of the floors may be required.

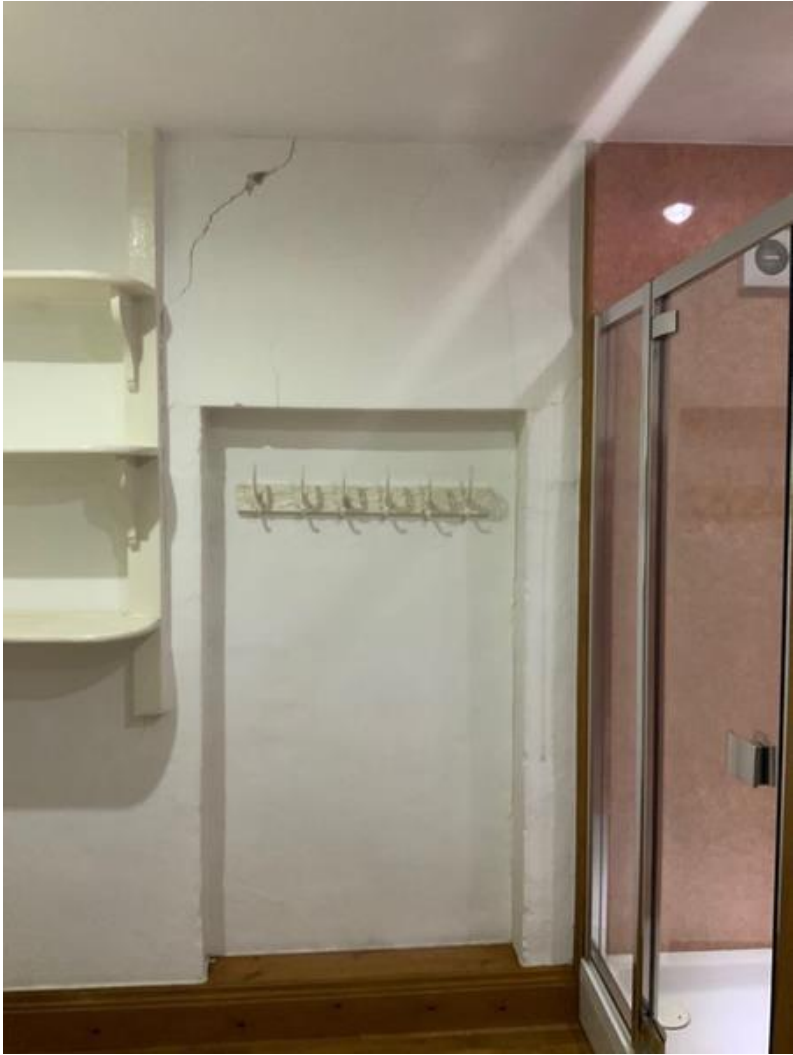
No	6.2.4
Location	Ground Floor, WC/Ground Floor bathroom
Description	<p>Significant structural cracking over existing the infilled old door opening in the original left gable wall between house and the garage.</p> <p>The cracking is tapered and is positioned at the rear extent of the cellar below.</p>
Photograph

There is significant recent damage to the ground floor WC/Bathroom, first floor bathroom and second floor bathroom which are all located in the rear left corner of the main house.

This area is directly adjacent the cellar and the trial hole investigations suggest the walls are founded shallowly of a sandy Clay that appears to be a made ground.

In this regard and given the extend of renovation proposed it would be prudent to underpin the left and rear walls in this area to eliminate the risk of further foundation movement.

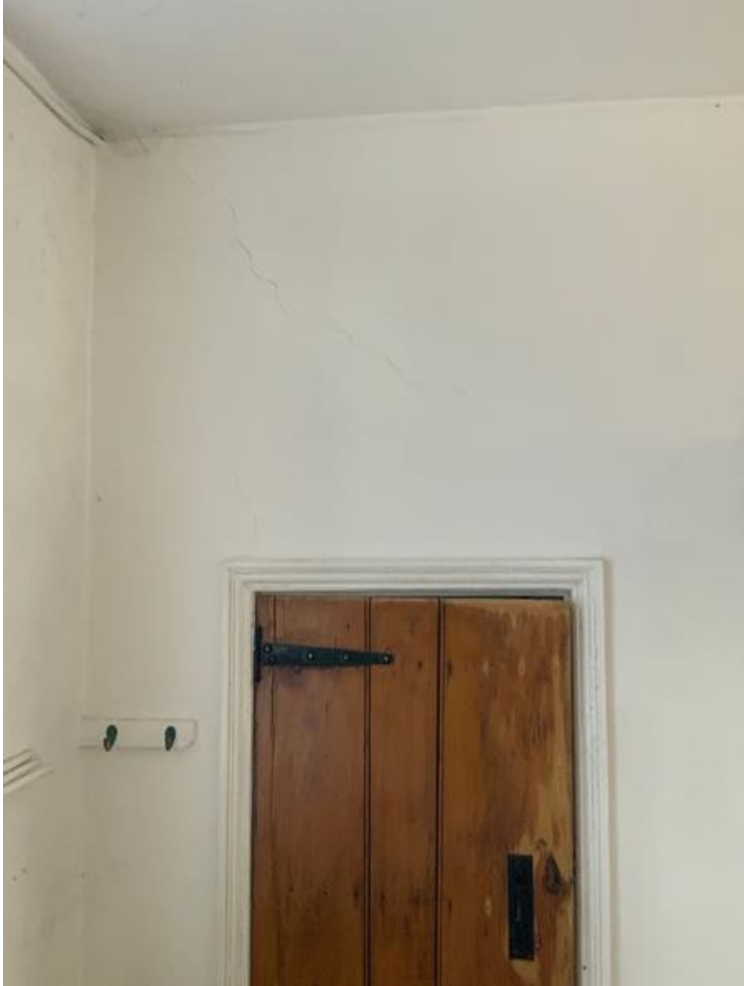
No	6.2.5
Location	Ground Floor, Utility, right two storey annex
Description	<p>Cracking and distortion over internal door within the internal wall within the utility room.</p> <p>The cracking extends towards the left external elevation of the right two storey annex. The crack patterns and movement are consistent with potential foundation movement.</p>
Photograph

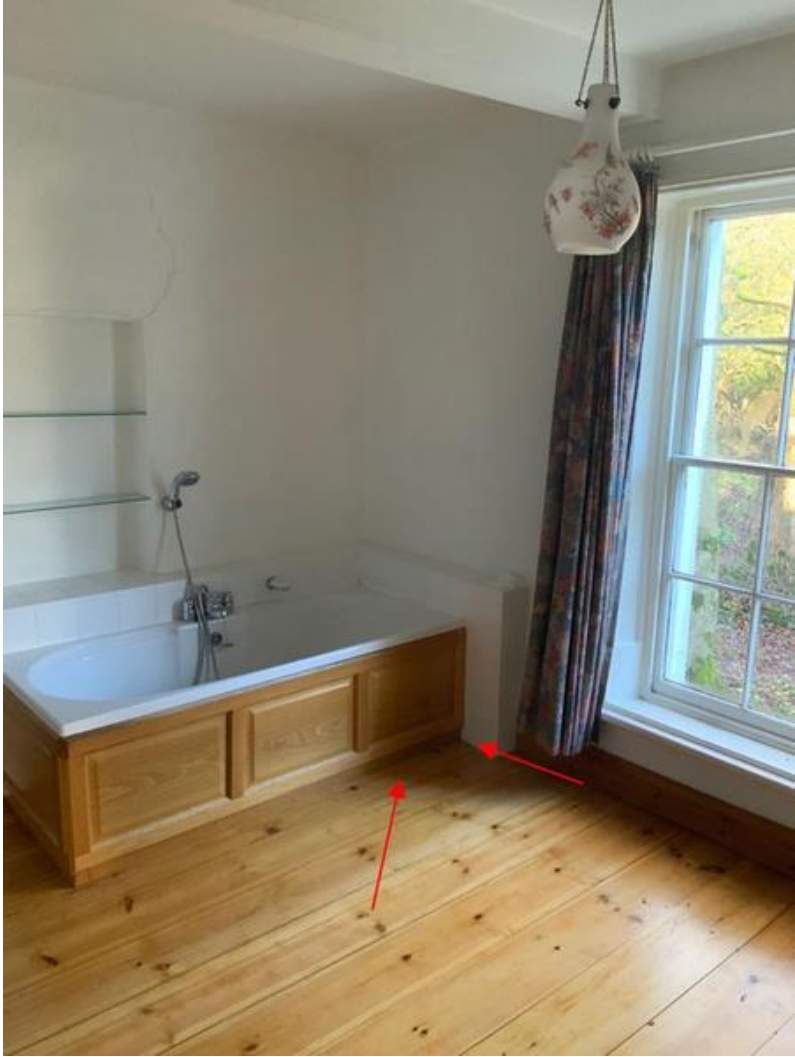
No	6.2.6
Location	First Floor, Bathroom
Description	<p>There is cracking evident to the left external elevation of the bathroom around the infilled window.</p> <p>The cracking is consistent with foundation movement. The floor slopes towards the rear and left and appears to be both historic in nature as well as potentially of more recent origin.</p>
Photograph
