2021 8866

Fisher house

Structural Investigation Report

Date of Report: 08/02/2022

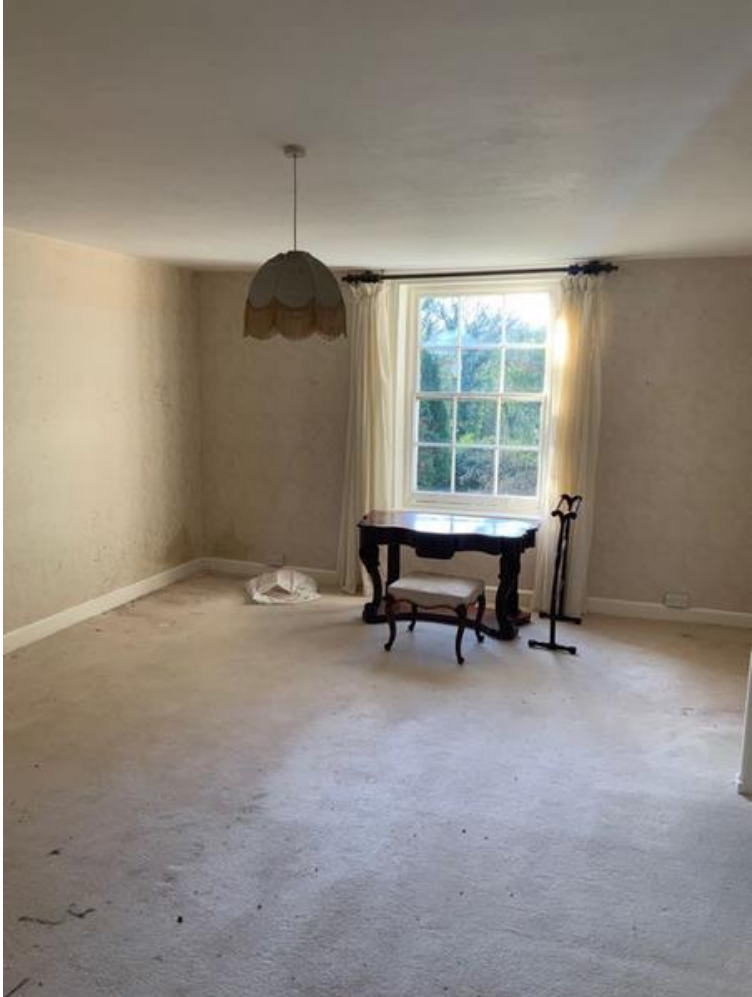
No	6.2.7
Location	First Floor, Front Left Bedroom
Description	<p>The floor within the front left bedroom is it's very bouncy.</p> <p>Loading the floor and inducing deflection and bounce in the floor results in the window sash in the front wall rattling and movement/vibration can be felt in the front elevation.</p>
Photograph

In addition to the deflection and movement of the timber floors we noted that the movement of the floor was transmitted to the external walls, this was particularly noticeable in the first-floor left bedroom where vibration/movement could be felt within the front external wall.

It appears likely that some strengthening of the floors may be required.

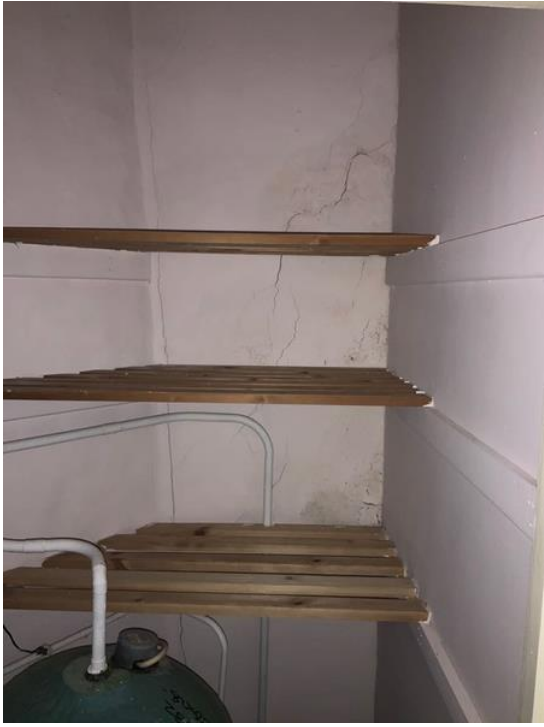
No	6.2.8
Location	Second Floor, Front Left Bedroom
Description	The floor within the front left bedroom is it's very bouncy, similar to the first floor below.
No	6.2.8
Location	Second Floor, bathroom
Description	<p>Within the airing cupboard there is tapered diagonal cracking.</p> <p>The cracking is within the external left wall. The cracking appears to be quite old and is consistent with foundation movement.</p>
Photograph

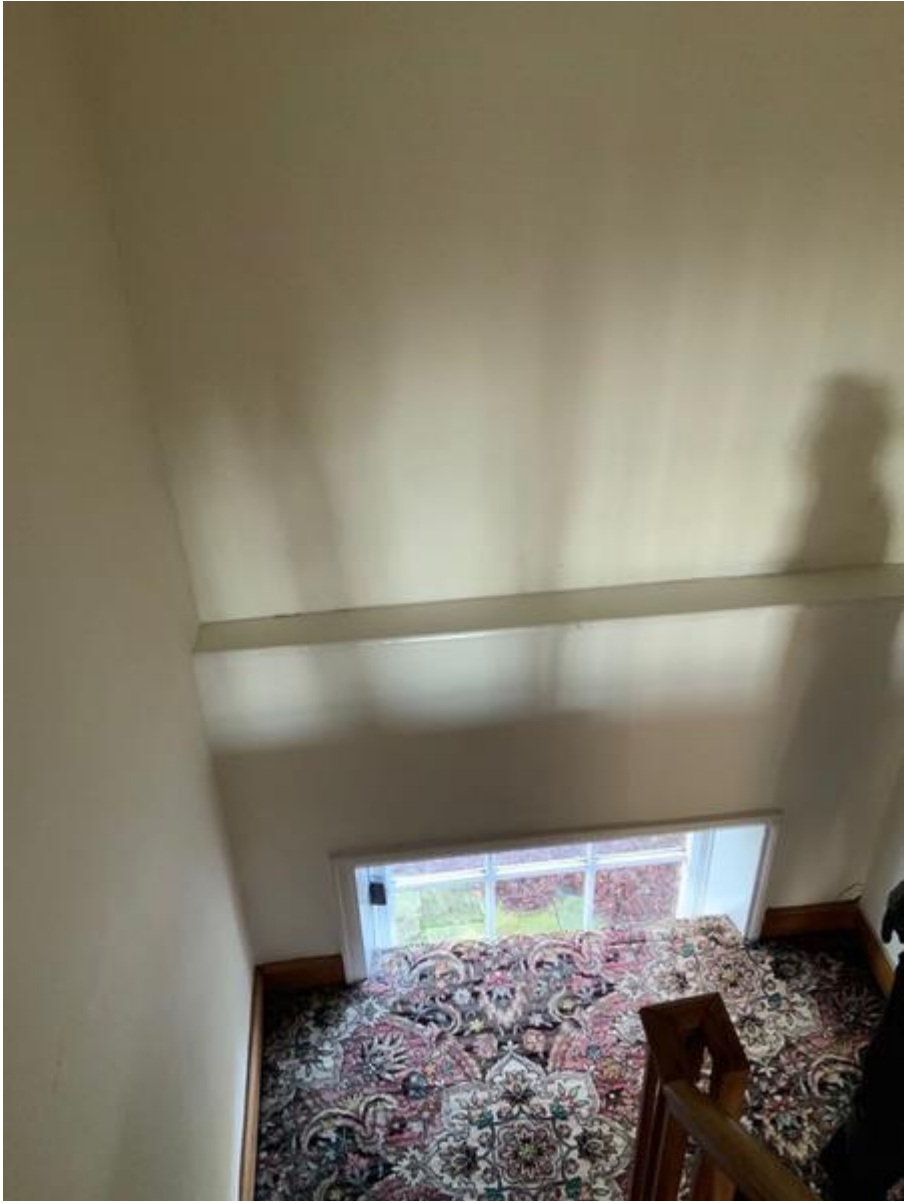
No	6.2.9
Location	Second Floor Landing
Description	The external rear wall changed in thickness from 330mm to 220mm at second floor chamber level.
Photograph

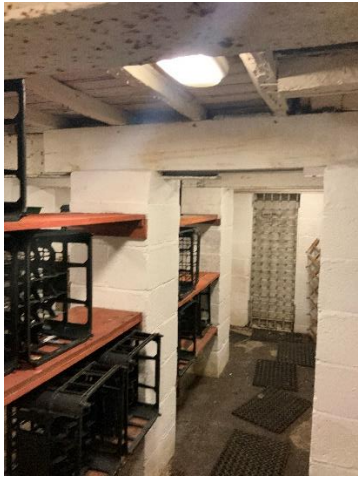
No	6.2.10
Location	Cellar
Description	<p>The cellar is situated below the Parlour to the left of the hall.</p> <p>The cellar does not extend below the hallway or below the rear WC/ground floor bathroom.</p>
Photograph	
No	6.2.11
Location	Cellar
Description	<p>Within the cellar there are a series of later block piers that support timber and steel beams. These are more recent additions to the cellar area.</p> <p>These in turn support the original timber floor joists.</p> <p>It appears that historically the timber ground floor has been strengthened. This is likely due to rot or deterioration of the original supports.</p>
Photograph

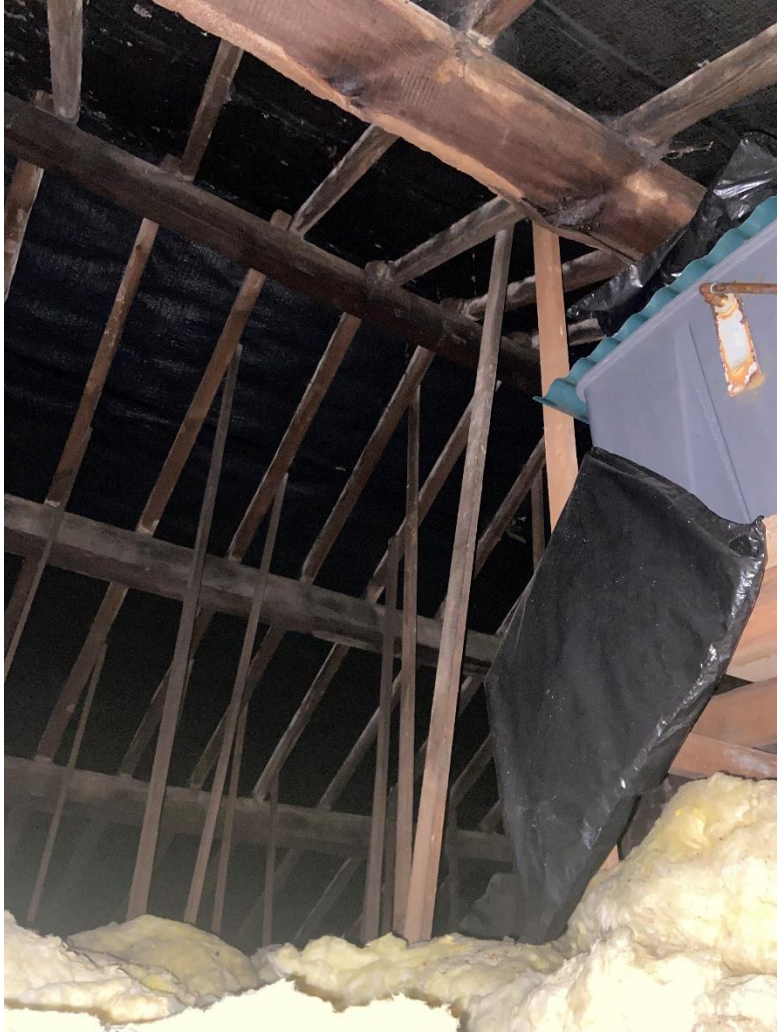
No	6.2.12
Location	Roof Space
Description	<p>An inspection was completed from the loft hatch. The absence of crawl boards and the depth of insulation prevented safe access</p> <p>The roof is of traditional construction with a structural ridge and purlins supporting the timber rafters.</p>
Photograph

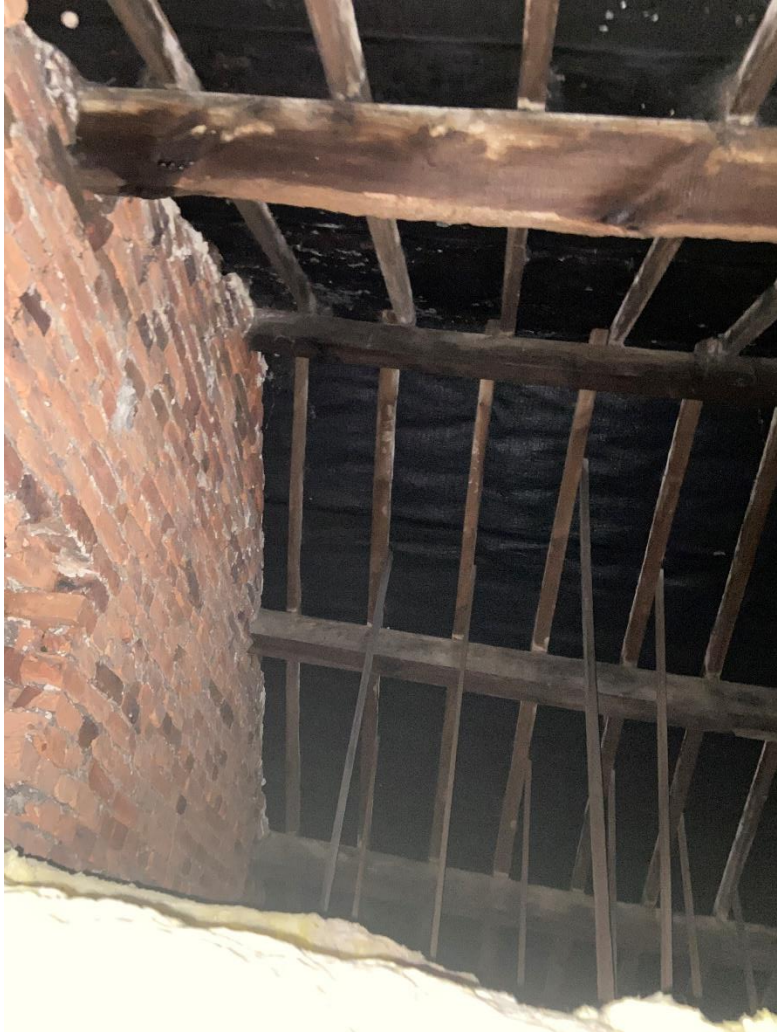
No	6.2.13
Location	Roof Space
Description	There is moisture and damp staining evident to the timber purlins and evidence of some deterioration of the timbers.
Photograph

There is minor to moderate deflections evident with the roof slopes and ridge to the main house. The visual inspection of the roof structure suggests that there may be some deterioration issues due to rot and infestation. Reviewing the Peter Cox timber and damp report we noted that they identified dampness within the timbers.

The roof has however been serviceable structurally for many years and we would suggest that we approach the adequacy of the roof structure based on a combination of the condition, structural calculation and degree of deflection/movement.

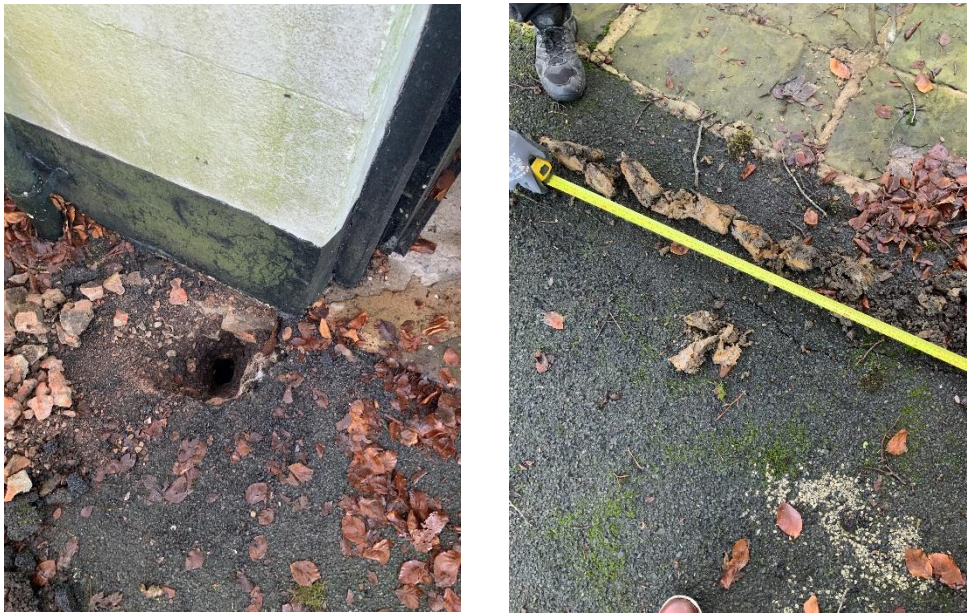
Trial Hole No	1
Location	Rear left corner of main house at intersection with garage/workshop
Observations	<p>600mm below ground: Underside of wall foundation. No foundation spread.</p> <p>Foundation bears upon Soft moist/wet Orange/Grey sandy CLAY probable MADE GROUND</p> <p>600mm to 1600mm: Soft moist/wet Orange/Grey sandy CLAY with black topsoil inclusions, Probable MADE GROUND.</p>
Photograph

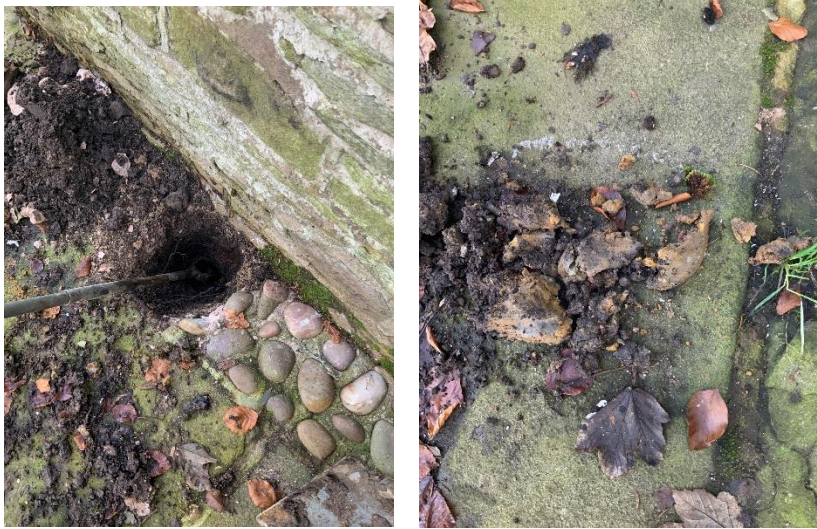
Trial Hole No	2
Location	Midway along left elevation of right two storey annex.
Observations	<p>300mm below ground: Underside of wall foundation.</p> <p>Foundation consists of 90mm thick stone with 30mm projection from wall face.</p> <p>Foundation bears upon Soft moist/wet Orange/Grey sandy CLAY with black inclusions possible MADE GROUND</p> <p>300mm to 1200mm: Soft moist/wet Orange/Grey sandy CLAY with black inclusions possible MADE GROUND</p>
Photograph

Foundation movement is also evident to the left wall of the rear two storey annex, the movement here is relatively minor and could be related to leaking drainage. In this regard repairing/replacing the drains is likely to reduce the risk of further movement.

The foundations in this area are however quite shallow at 300mm and are at risk of movement due to clay shrinkage.

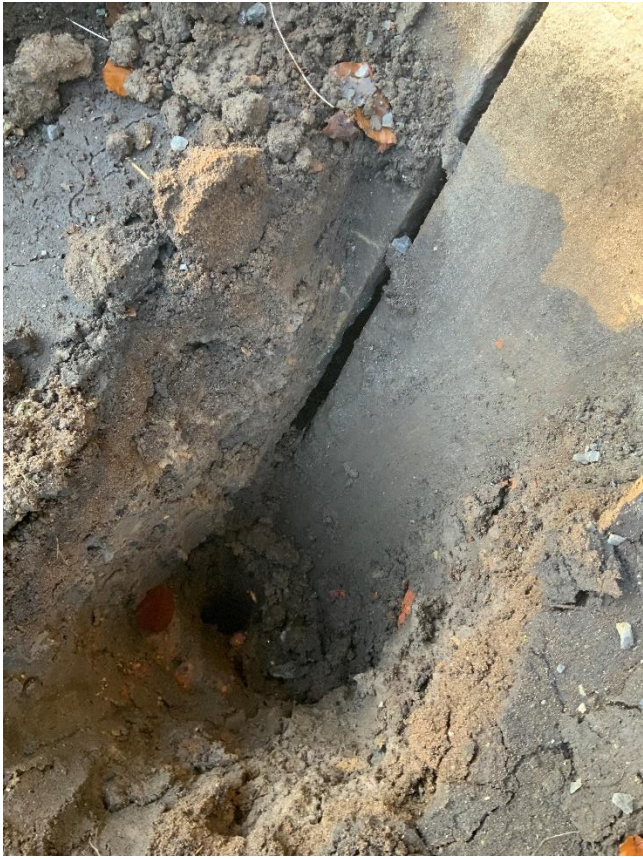
Trial Hole No	3
Location	Midway along right elevation of right two storey annex.
Observations	<p>700mm below ground: Underside of wall foundation not confirmed, wall obscured by large, inclined flag bottom of flag or foundation not established. spread.</p> <p>700mm to 1400mm: Soft to firm moist Orange/Grey sandy Clayey MADE GROUND with some roots.</p>
Photograph

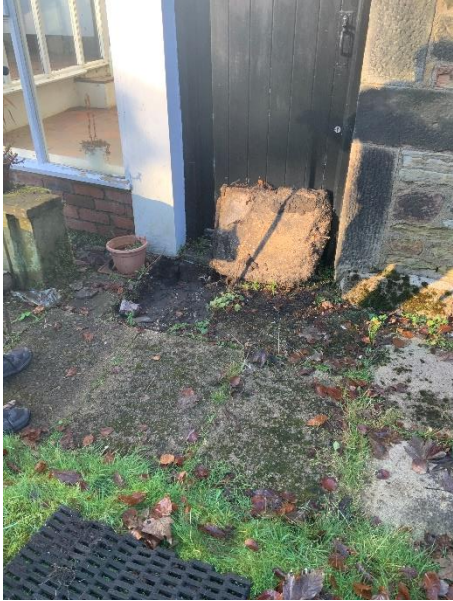
Trial Hole No	4
Location	Front right corner right elevation of right two storey annex adjacent door.
Observations	Excavation inconclusive ground full of rubble and bricks impossible to excavate more than 300mm below ground level.
Photograph

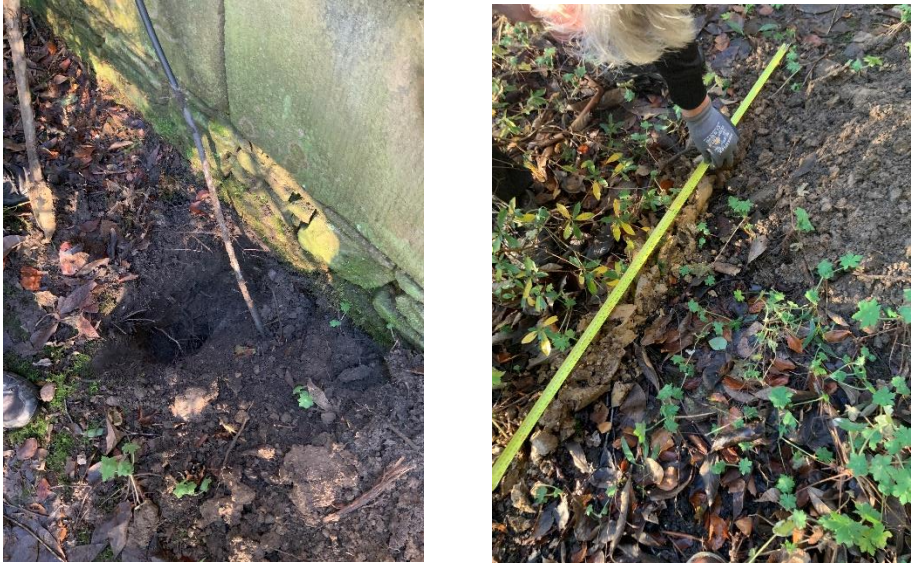
Trial Hole No	5	
Location	Front right corner of house on right elevation	
Observations	<p>0 to 900mm stone plinth to wall over random stone walling.</p> <p>900mm obstruction in ground appears to project from the wall. Possible foundation.</p> <p>900mm moist orange/brown firm Sandy CLAY.</p>	
Photograph
