DAYTIME BAT SURVEY

FISHER HOUSE, RIVINGTON LANE,
RIVINGTON, BOLTON

2021

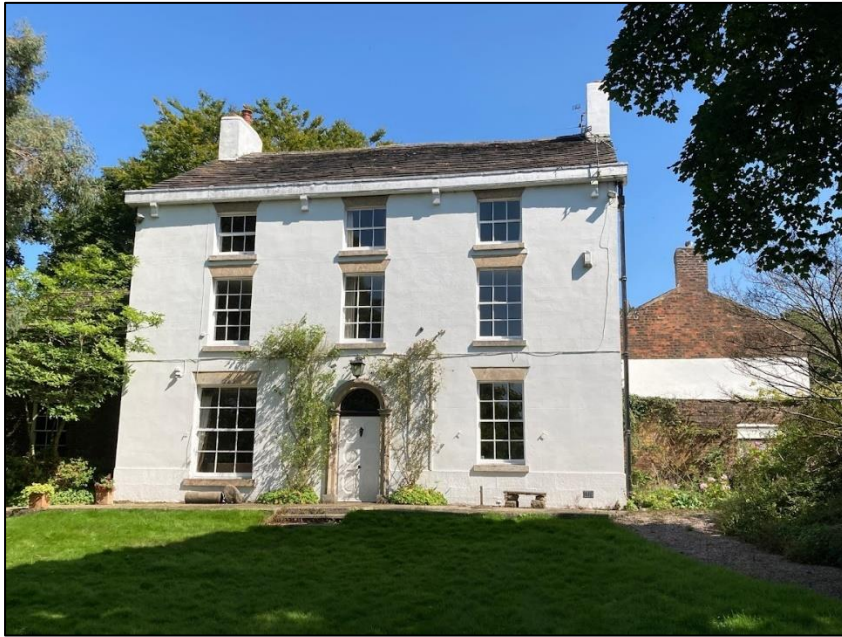
- 3.2 The main part of the dwelling is rendered and painted white, with other sections of the building left un-rendered with exposed stone and brickwork present (see Photograph 1).

Photograph 1 showing the exterior of the building

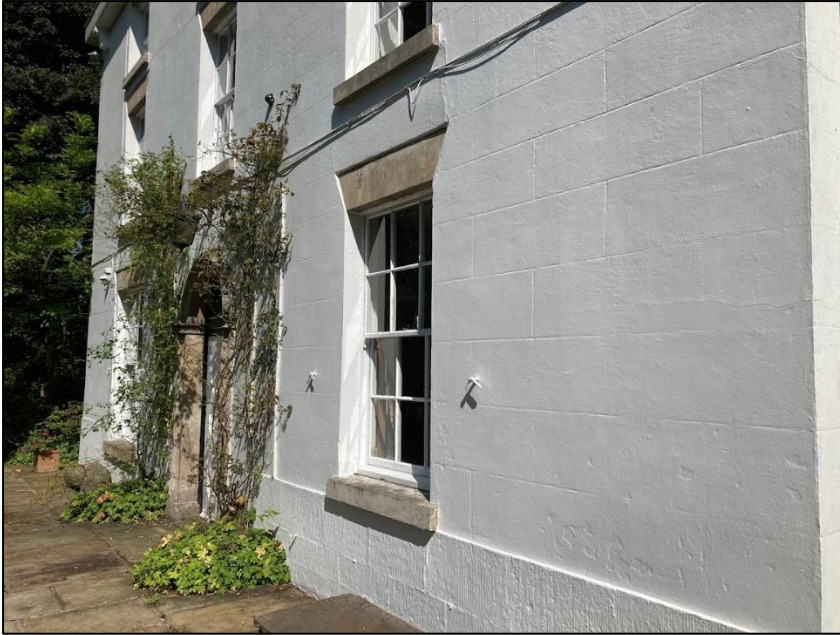
- 3.3 The render, where present, is in excellent condition, free from cracks, crevice's and flaking features bats may exploit (see Photograph 2). The masonry, including the stone sills and lintels, is also in good condition and sealed with mortar with no missing or receded sections offering potential entry points (see Photographs 3 and 4).

Photograph 2 showing a section of the rendered exterior

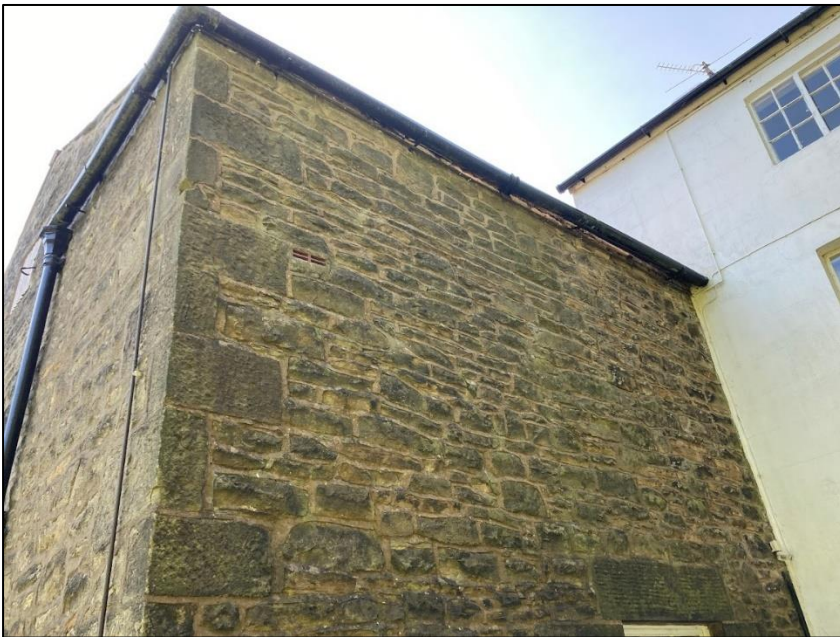
Photograph 3 showing the exterior of the building

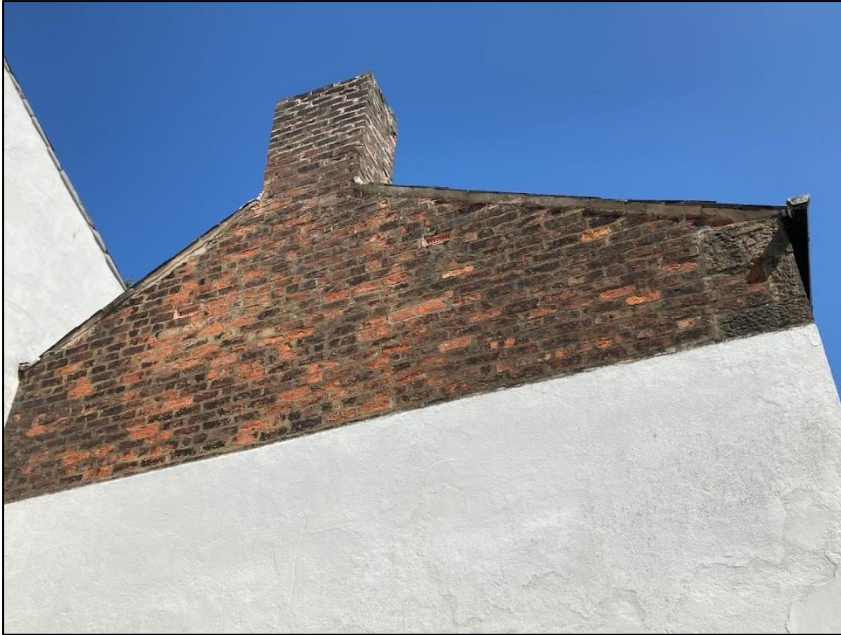
Photograph 4 showing the building's exterior

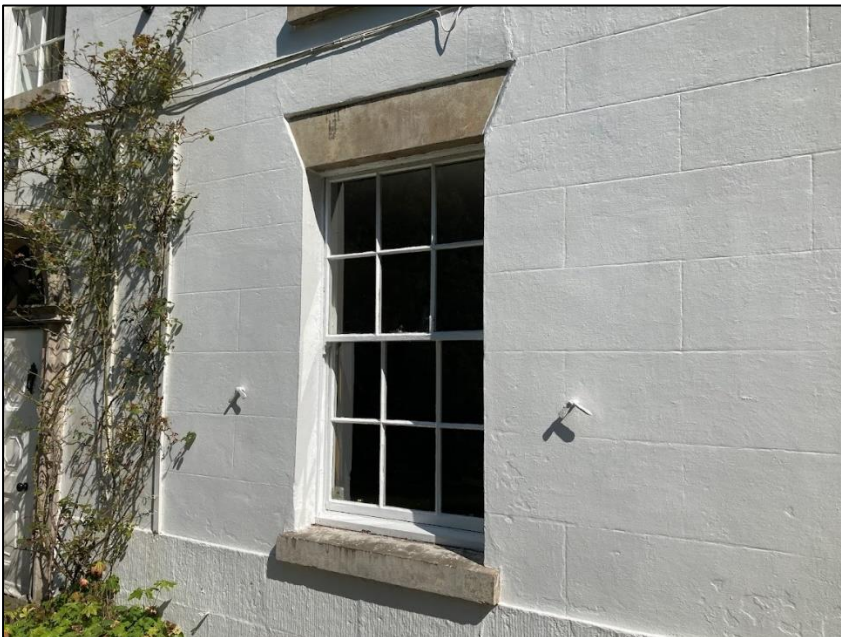
- 3.4 The timber window and door frames across the building are in reasonable condition and sealed to the surrounding masonry with no gaps crevices present (see Photographs 5 and 6).

Photograph 5 showing one of the timber window frames

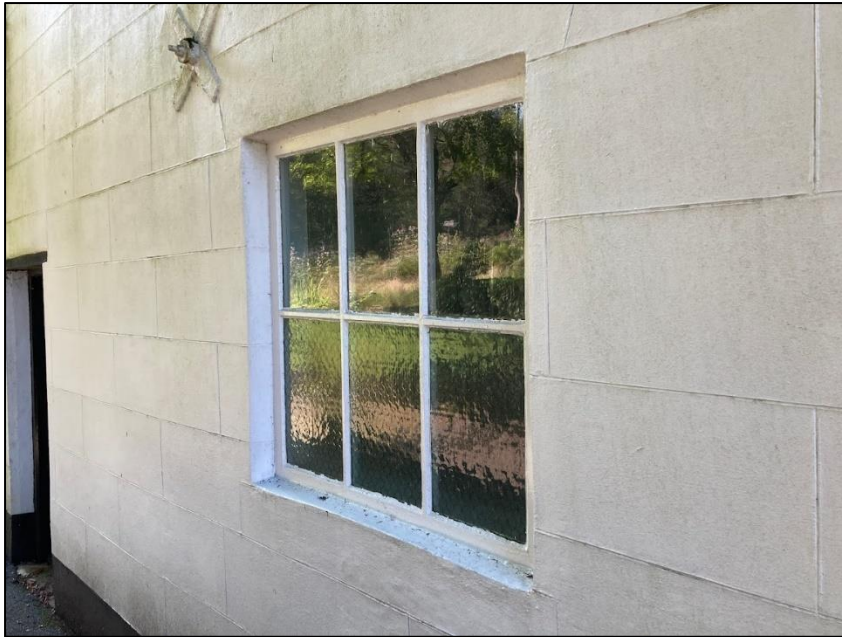
Photograph 6 showing one of the timber window frames

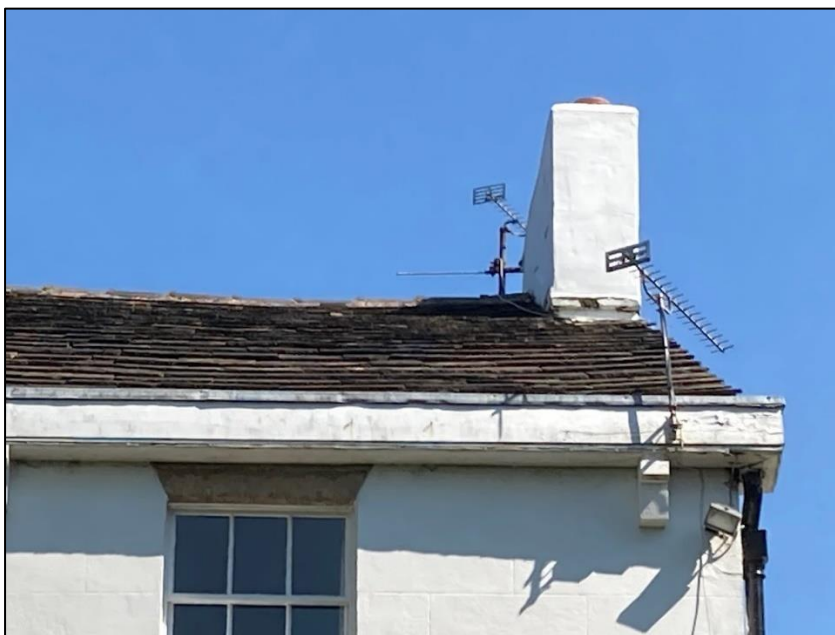
- 3.5 The pitched and hipped roofs are covered with a combination of stone flags and slate roof tiles (see Photographs 7, 8 and 9). The tiles are largely intact and fitted flush to one another. However, many of the stone flags and a few of the slate roof tiles are lifted offering potential entry points for bats.

Photograph 7 showing the stone flag section of the roof

- 4.2 It is considered the dwelling offers high bat roost suitability and the garage offers moderate bat roost suitability. If the proposed extension and refurbishment works are to result in the destruction/disturbance of these potential bat roosts (including works to the buildings roofs, box guttering, roof void spaces and the first-floor of the garage), then further bat survey work is required to determine if an active roost is present in the building, and if so, the species of bat and the type of roost present. It is recommended that two dusk emergence surveys and one dawn re-entry survey are undertaken on the dwelling and a minimum of two dusk emergence surveys/dawn re-entry surveys are carried out on the attached garage at an optimal time of year (between May and September).

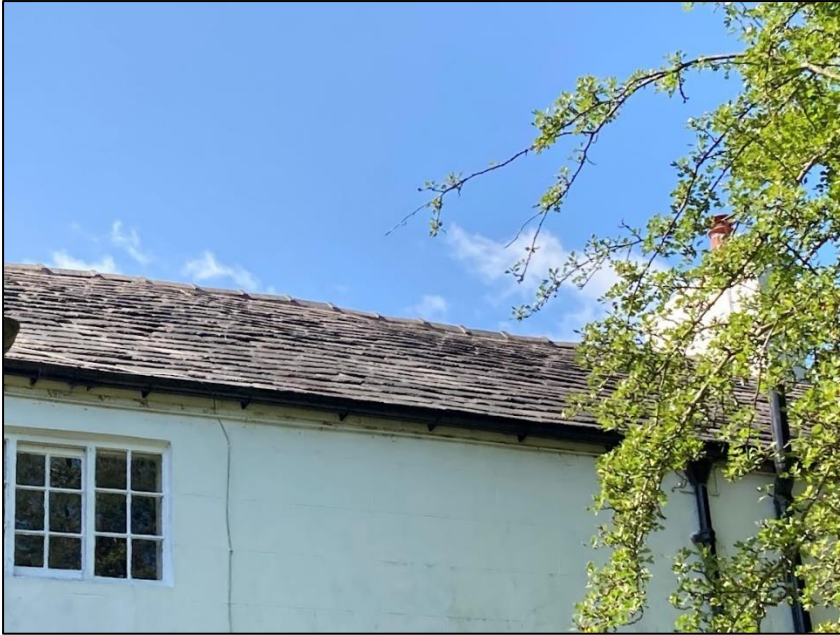
Photograph 8 showing a slate covered section of the roof

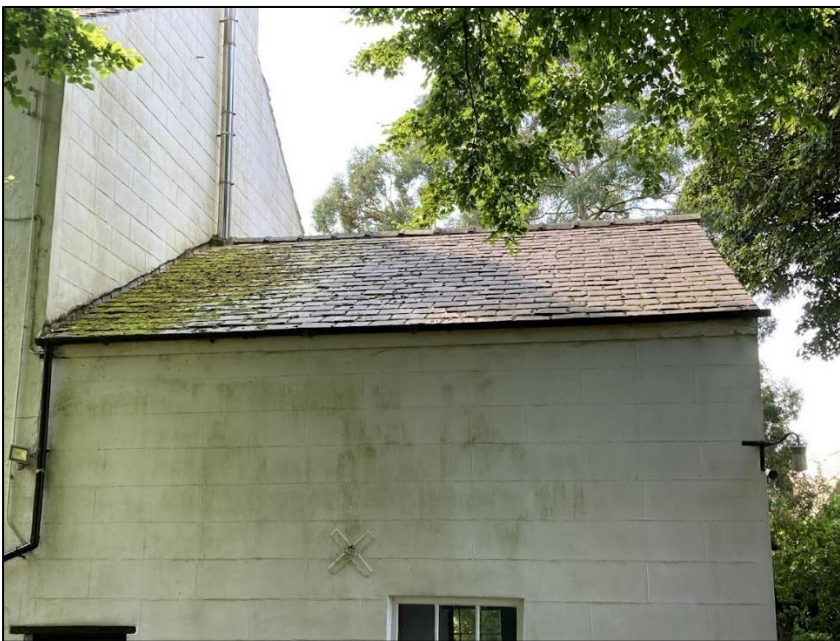
Photograph 9 showing the garage roof

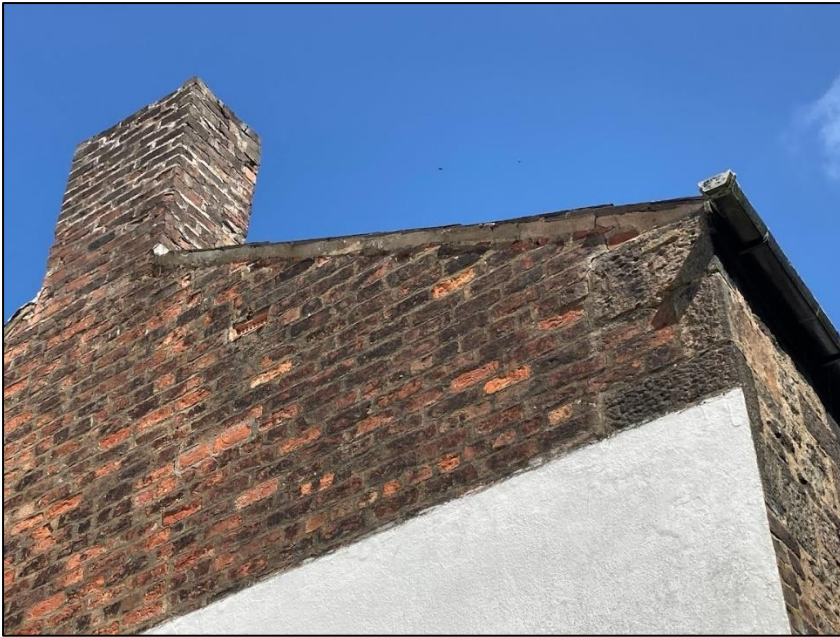
- 3.6 The roof edges are finished with mortar (see Photographs 10, 11 and 12). The mortar is in good condition, effectively sealing the point to roof tiles and flags meet the gable walls.

Photograph 10 showing one of the gable ends of the building

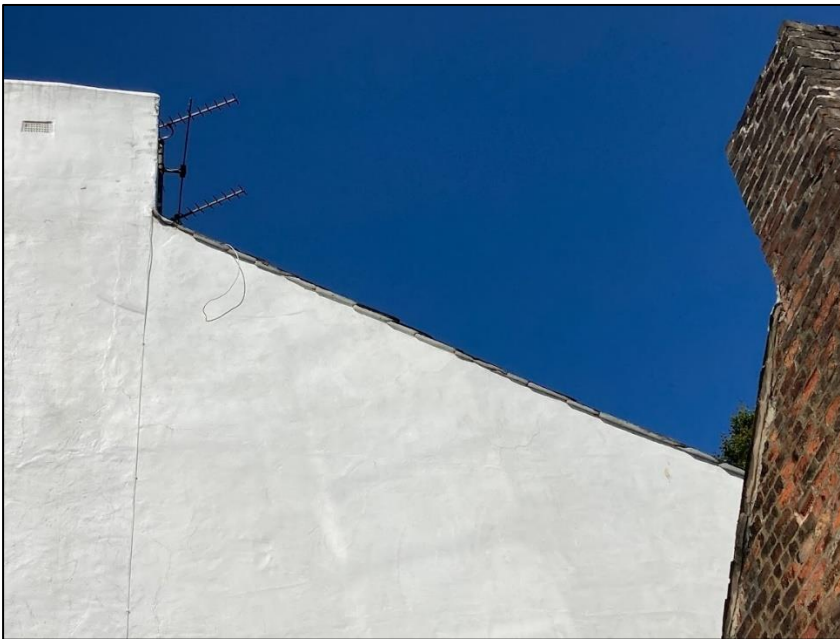
Photograph 11 showing one of the gable ends of the building

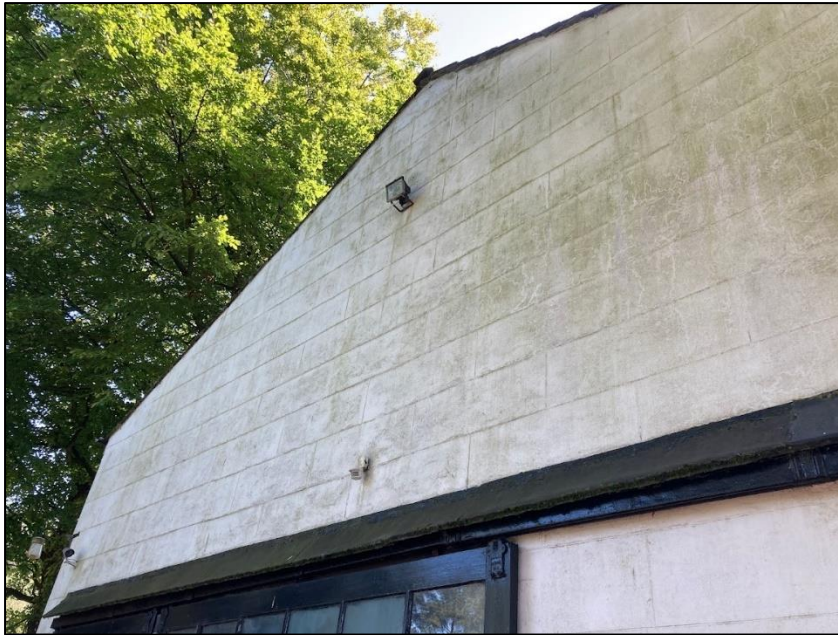
Photograph 12 showing the Garage gable end

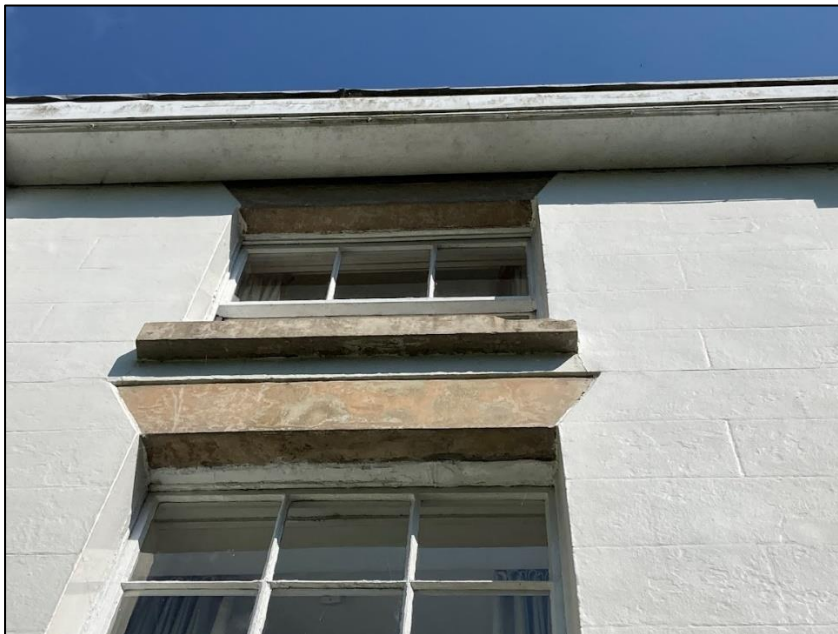
- 3.7 The south-western facing, front elevation of the main dwelling has a relatively large box guttering feature. This is not fitted flush to the rendered wall and offers multiple potential entry points into the roof void space (see Photograph 13).

Photograph 13 showing the box guttering

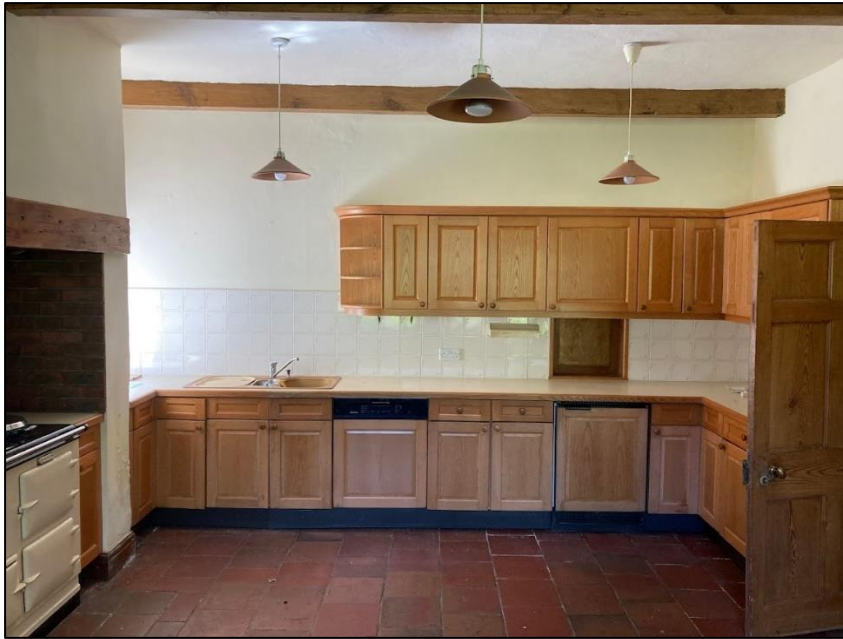
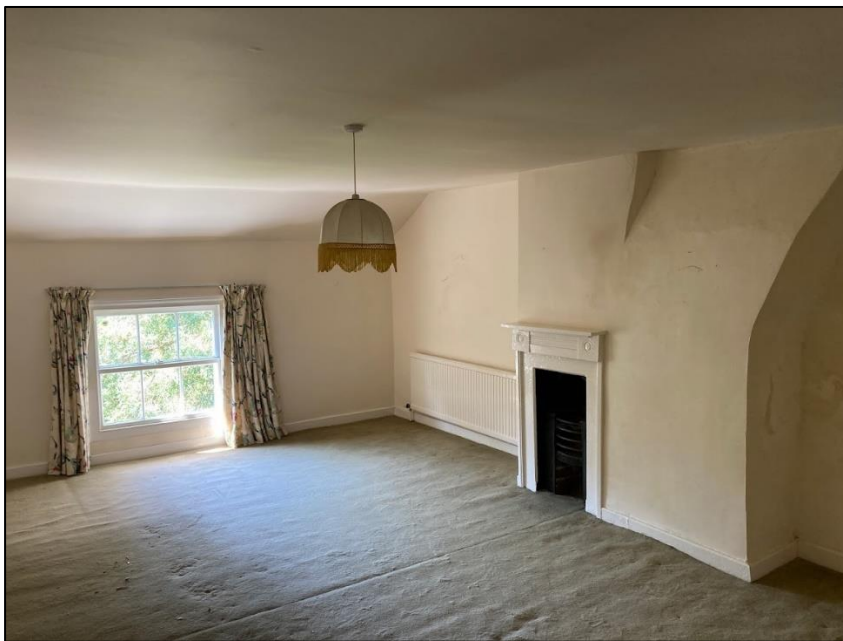
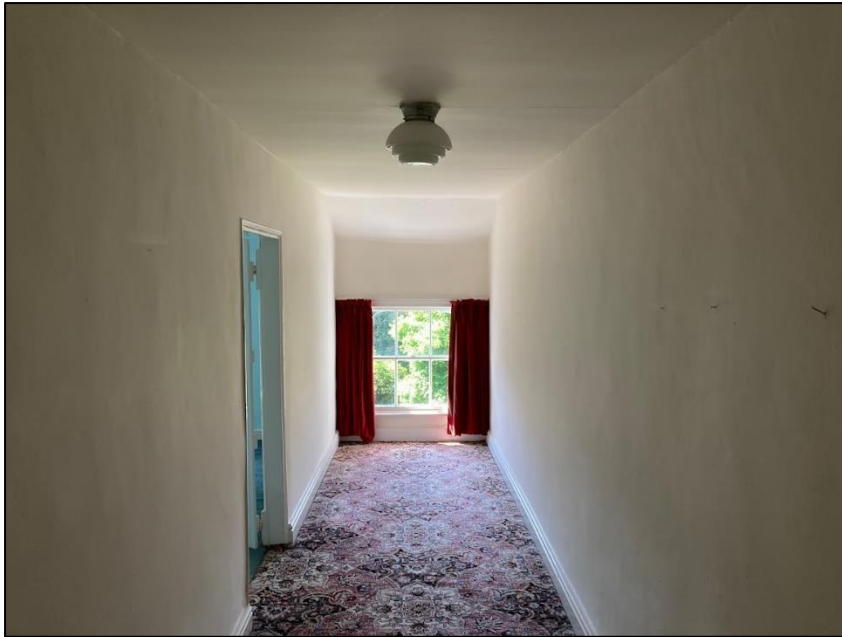
- 3.8 The internal spaces of the building consist of typical rooms found in dwelling, such as bedrooms, living rooms, hallways bathrooms, kitchen, etc. These spaces are all finished to a high standard and do not offer any habitats associated with roosting bats (see Photographs 14, 15 and 16).

Photograph 14 showing the interior of the building

Photograph 15 showing the interior of the building

Photograph 16 showing the interior of the building

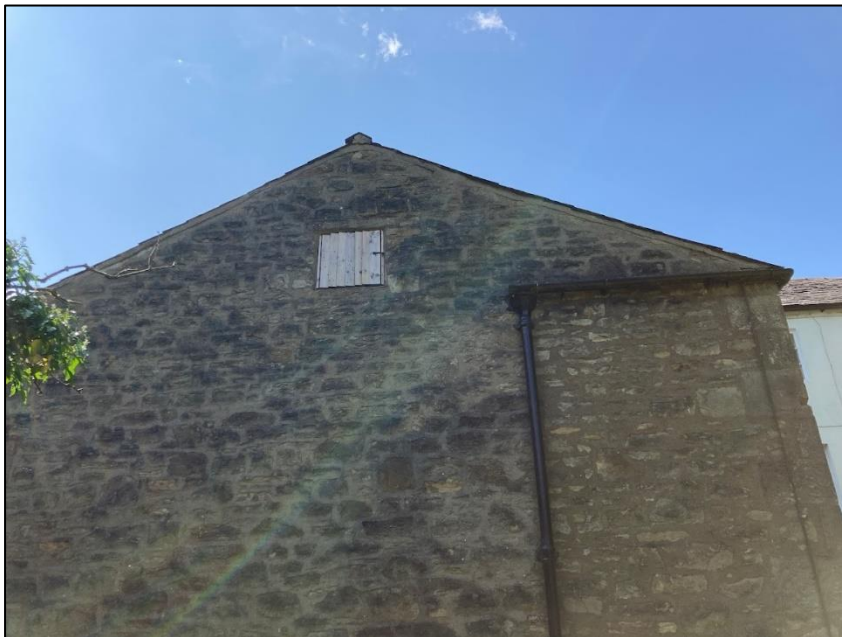
- 3.9 Two roof void spaces are located above the dwelling. One, above the extension of the main dwelling, could not be accessed due the height of the external access hatch (see Photograph 17).

Photograph 17 showing the external access hatch to the roof void space

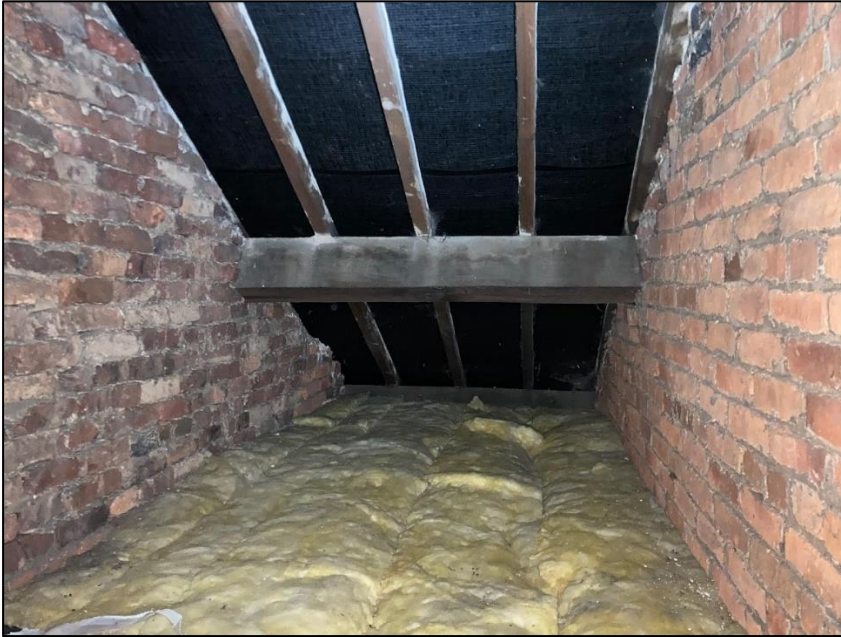
- 3.10 The second roof void space could easily be accessed via an internal hatch and ladder. The roof void space is spilt with brick partition walls. The partition and gable walls are in reasonable condition and sealed with mortar (see Photograph 18). The floor is covered with fibreglass insulation and the underside of the roof is lined with roofing felt. The felt is in good condition, however, a small number of rips are present offering

Photograph 18 showing the roof void space

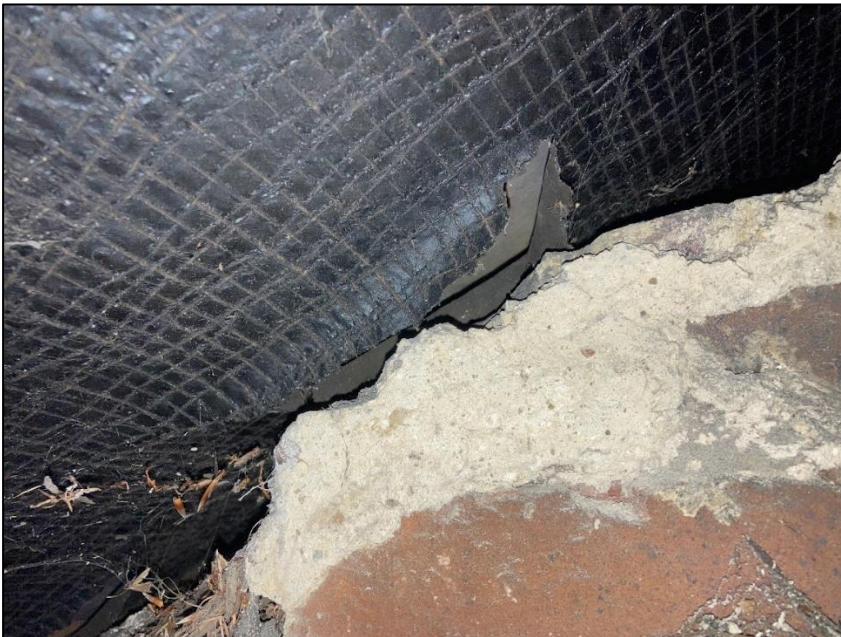
potential entry points (see Photograph 19). The roof timbers are free from cracks and crevices.

Photograph 19 showing one of the rips in the roofing felt

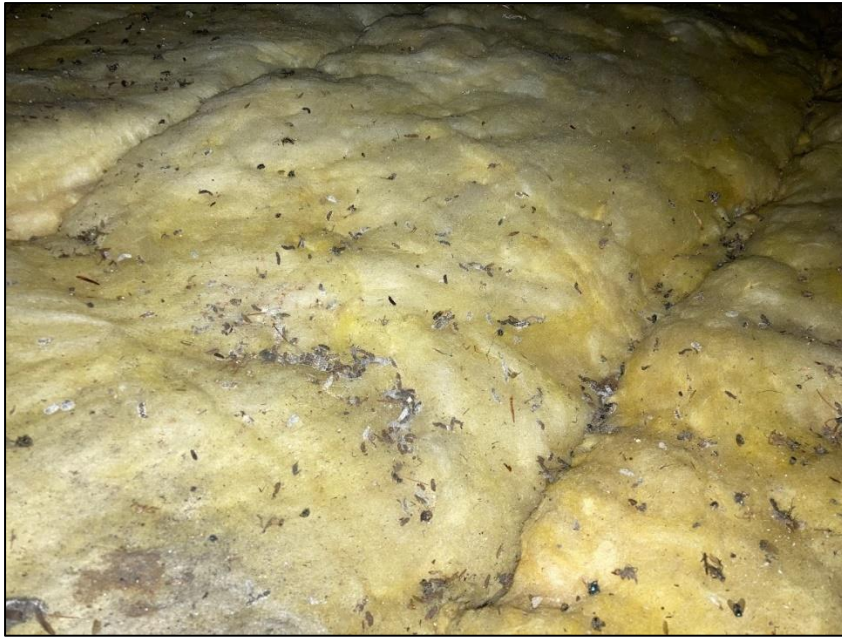
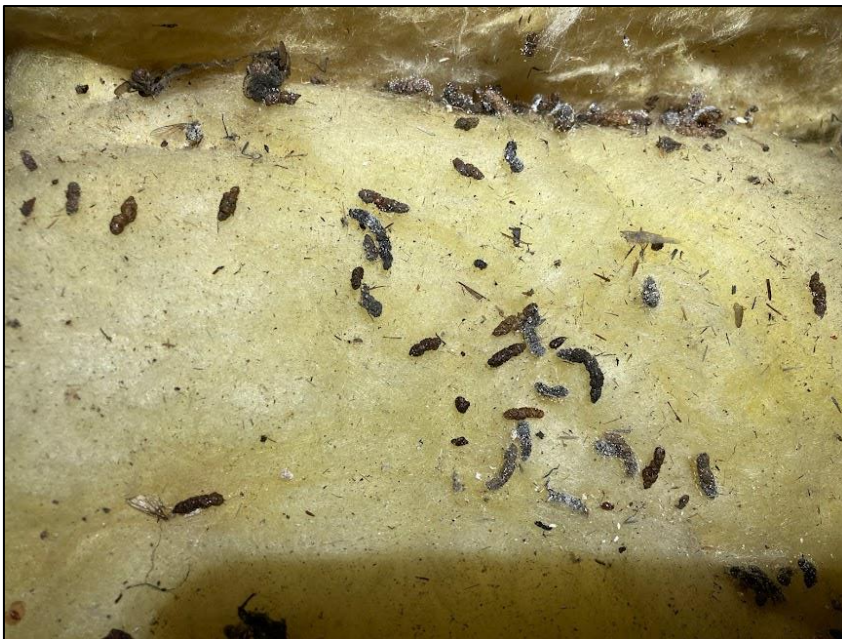
- 3.11 Concentrations and scattered bat droppings were found across the roof void spaces (see Photographs 20 and 21). Samples of the droppings were taken to be sent off for DNA analysis.

Photograph 20 showing bat droppings found in the roof void space

Photograph 21 showing bat droppings found in the roof void space

- 4.1 Evidence of bat activity in the form of bat droppings was found in the roof void space of the main part of the dwelling and in the first-floor space of the garage. Multiple entry points are located across the roofs and underneath the box guttering of the main dwelling. A roof void space could not be accessed in one part of the dwelling.

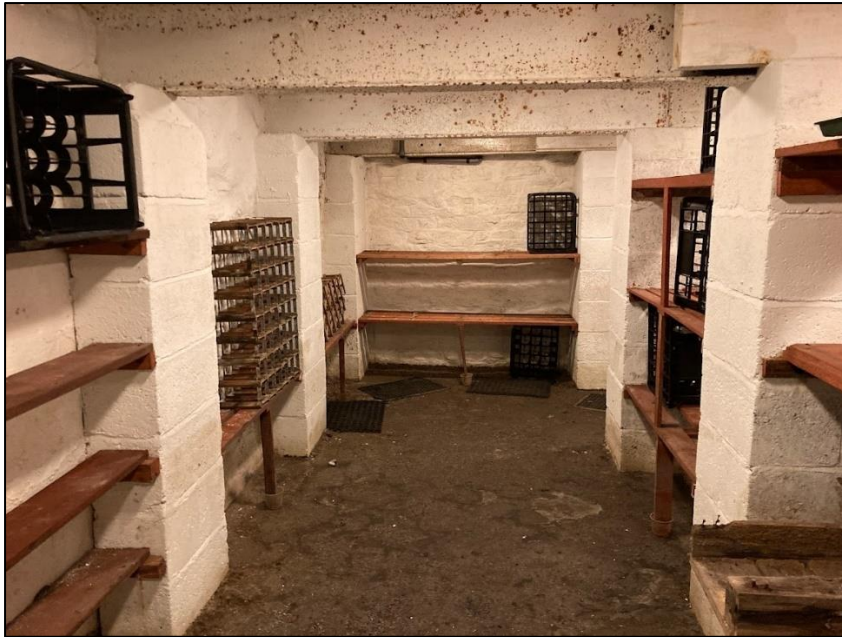
- 3.12 A basement/cellar is accessed via an internal staircase. The room is cool and in good condition (see Photograph 22). The stone and concrete block walls are sealed with mortar and painted white. No potential entry points were located, and no evidence of bat activity or occupancy was found. Therefore, the basement is considered to off negligible bat roost suitability.

Photograph 22 showing the basement

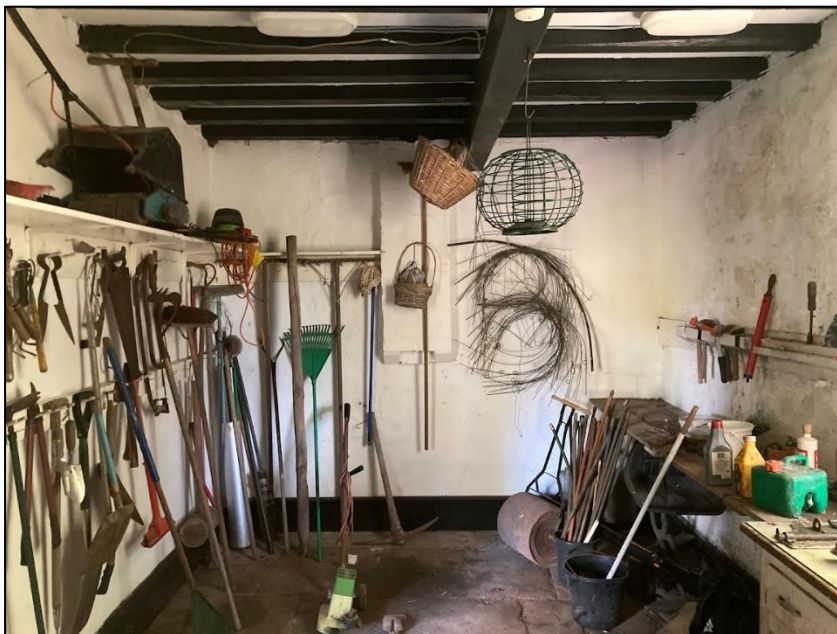
- 3.13 The garage consists of ground floor and first-floor spaces. The ground floor consists of garden maintenance equipment (see Photograph 23). The brick and stone walls are rendered and painted white. The render is in good condition offering no potential roosting habitat. The roof timbers are in good condition, free from gaps and cracks bats may exploit.

Photograph 23 showing part of the ground floor of the garage

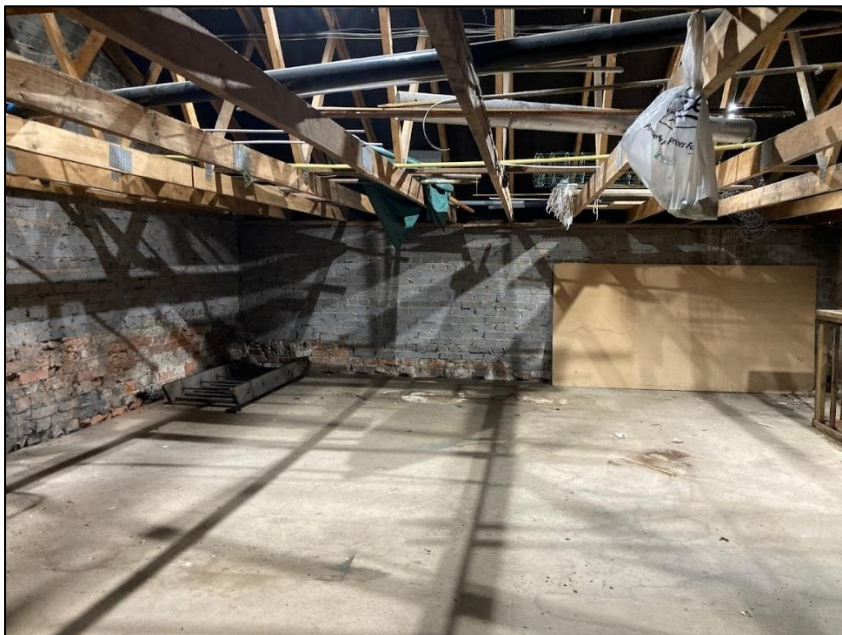
- 3.14 The first-floor space is accessed via an internal staircase. This space is currently empty and open to the underside of the roof (see Photograph 24). The roof is lined with felt. The felt is in reasonable condition and free from tears or folding features. The gable wall is free from gaps or cracks bats may exploit. A small number of scattered bat

Photograph 24 showing the first-floor space of the garage

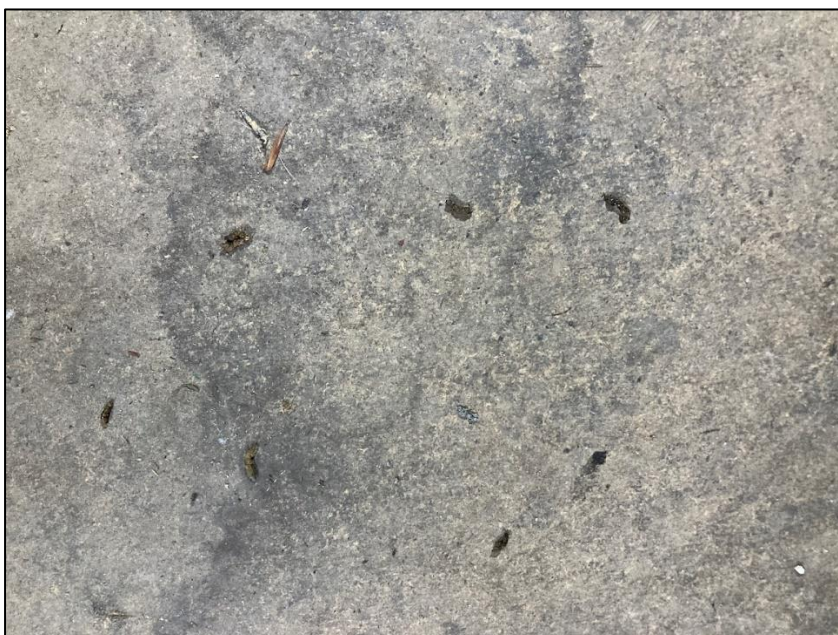
droppings were found on the floor of the first-floor space (see Photograph 25). Samples of the droppings were taken to be sent off for DNA analysis.

Photograph 25 showing the scattered bat droppings found in the garage
