Arboricultural Report

Principle Formal Arboricultural Report/Survey
(in accordance with BS 5837:2012 Trees in Relation to Design,
Demolition and Construction)

Location: Coleby Lodge Farm, Heath Road,
Coleby, Lincoln LN5 0AR

Date: 22nd August 2019

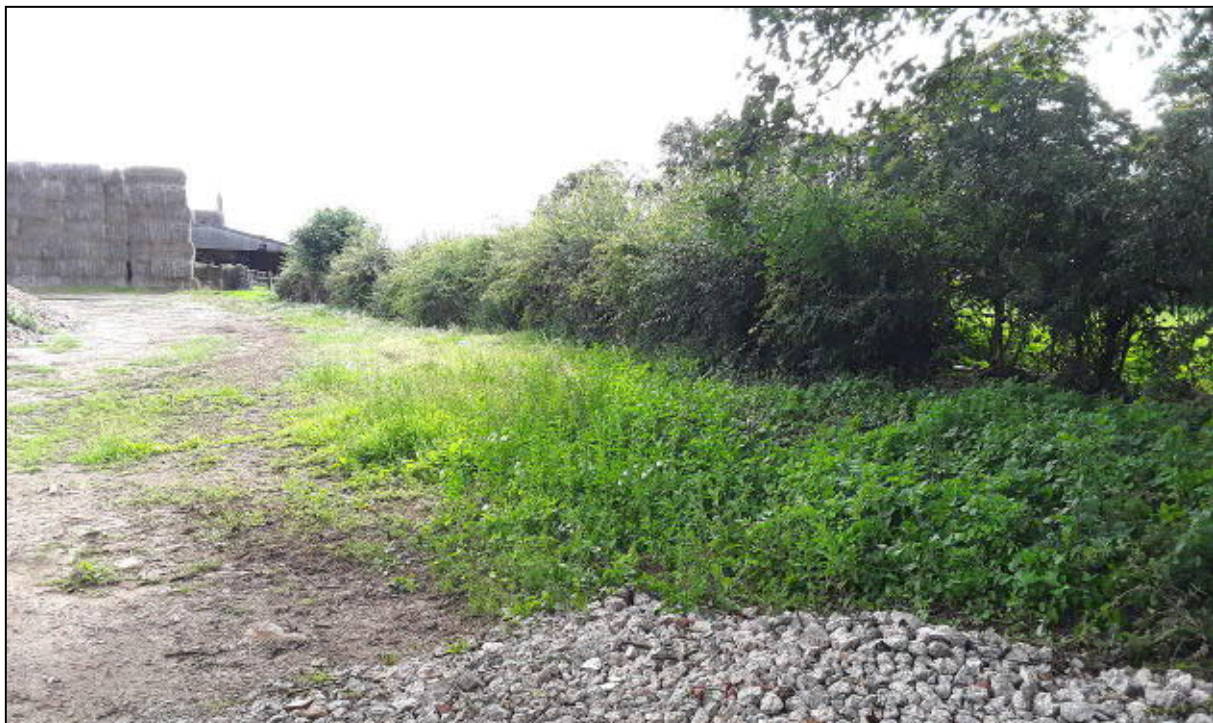
A short section of hedgerow, H1, forms part of the western site boundary; an enclosed grass paddock is situated beyond

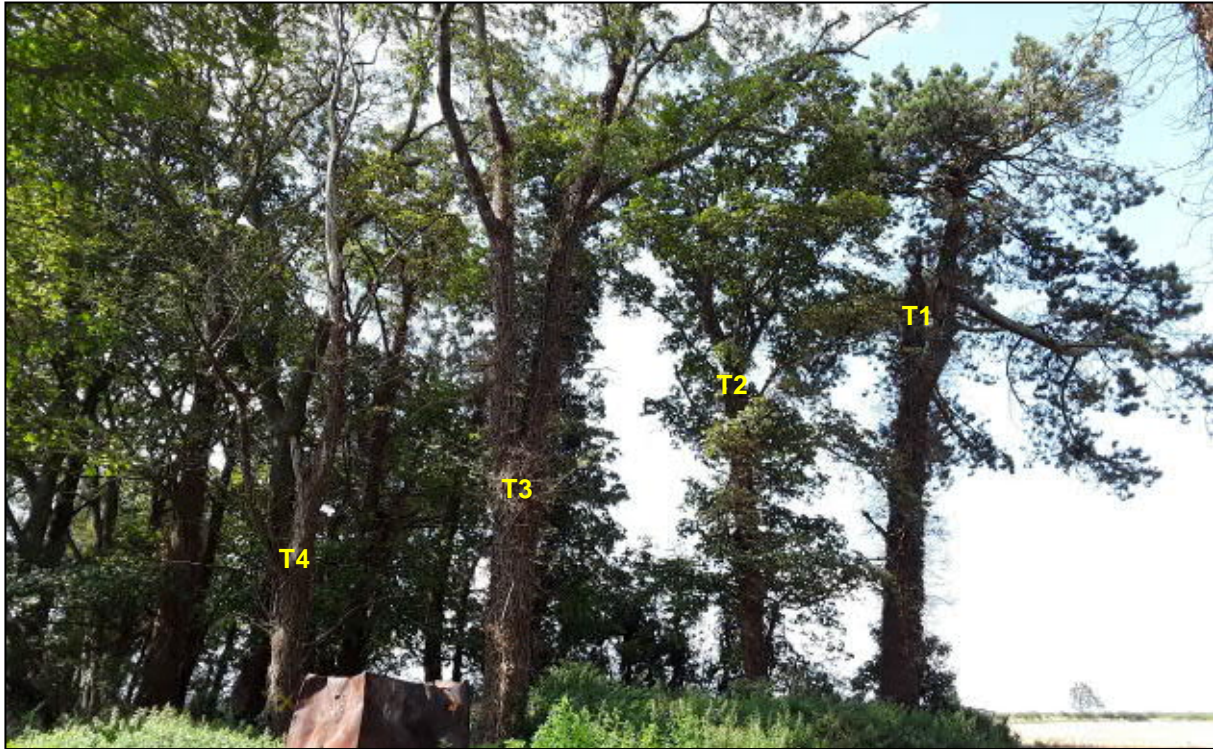
The trees situated directly adjacent to the west side of the access track vary in condition and are categorised accordingly

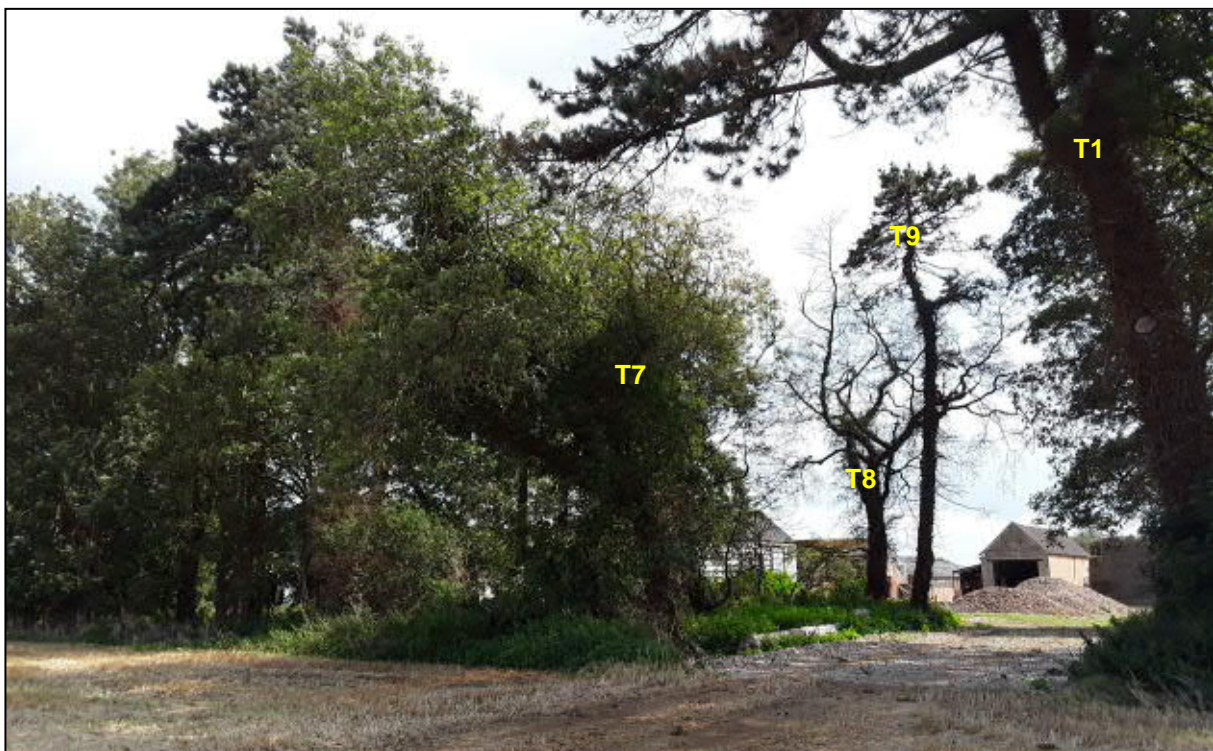
A category "U" tree and two category "C" trees are situated east of and adjacent to the existing access

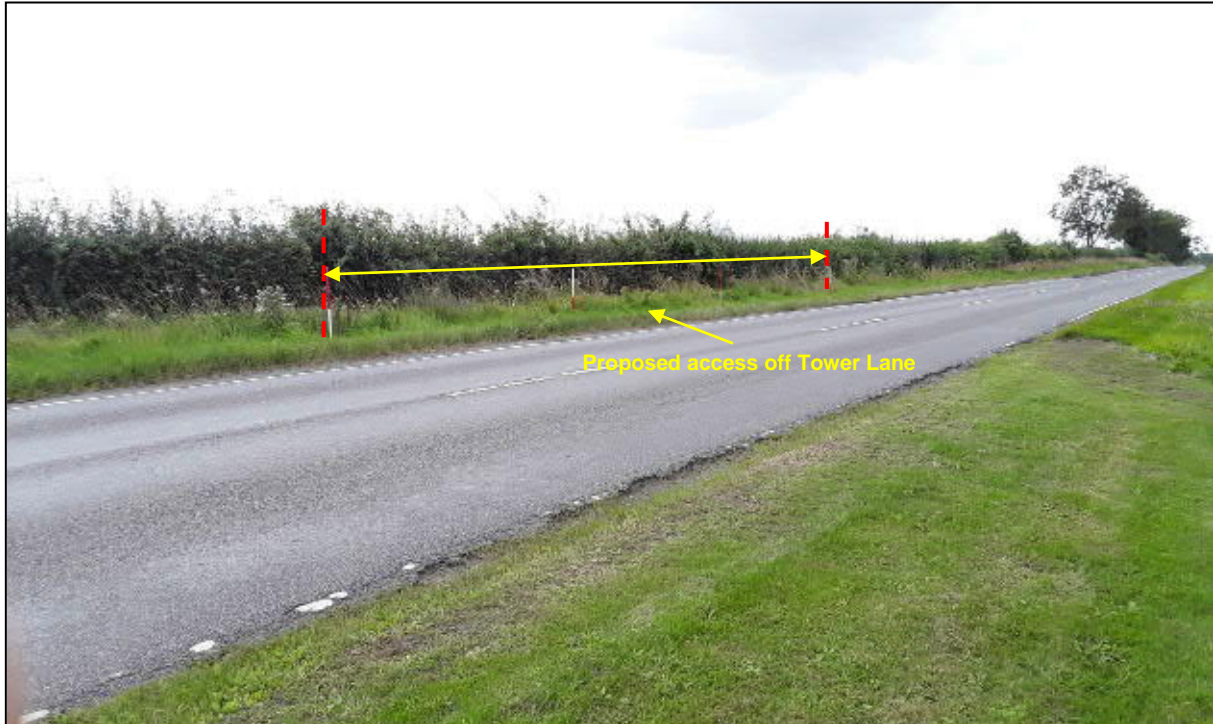
New vehicular access off Tower Lane is proposed through the existing hedge line (H2) growing along the northern field boundary

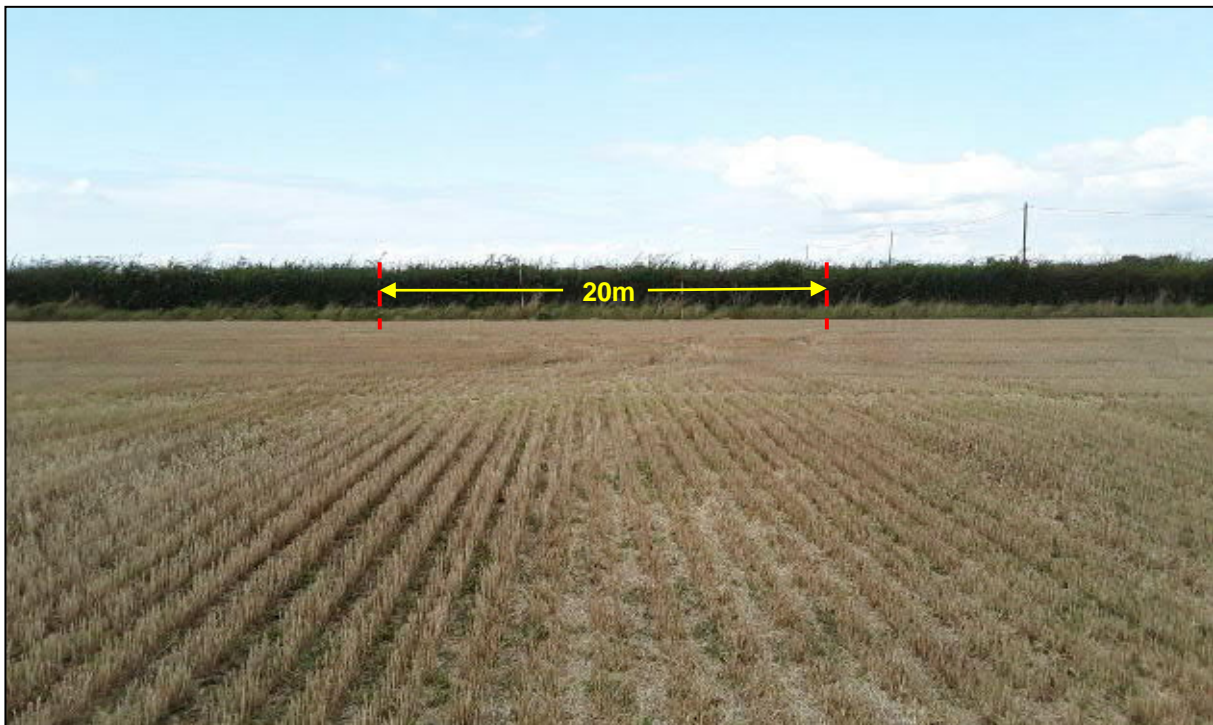
A short section of hedgerow (H2) is proposed for removal to facilitate the proposed new vehicular access

8.7 In accordance with the proposed access arrangement a short section of hedgerow, H2, will require removal. The maximum length proposed for removal to facilitate the access and visibility splays is 20m. Two sections of hedgerow, approx. 60m and 112m respectively, are proposed to be retained along the northern field boundary.

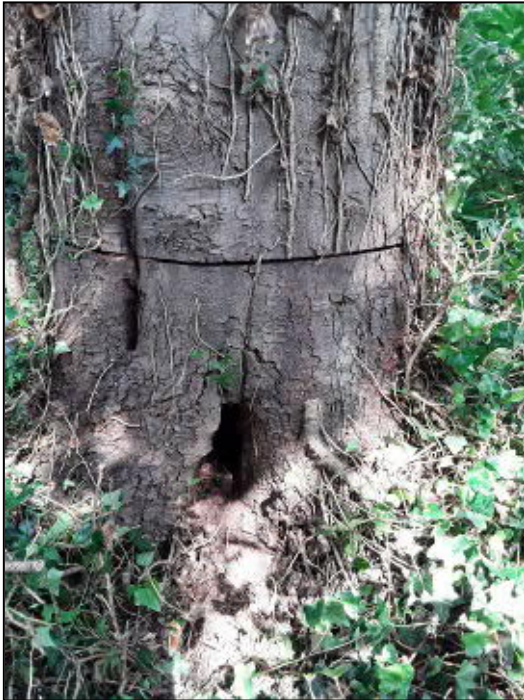
T2, a category "C" tree has a decay cavity in the base of the tree and has been ring-barked in an attempt to manage the ivy coverage

T2	00024	Sycamore	Mature	58 (over ivy)	7	1	18	N4, S5, E4.5, W4.5	Fair	Fair	Tree located west of access track. Ivy growth restricts full visual assessment of the tree. An attempt to manage the ivy is evident however, through doing so the base of the stem is damaged with a clear ring around the bark. Basal cavity and decay is apparent at the base of tree on the west side. Probe extends up to approx. 25cm into the cavity. First branch at 2m extends north, relatively low canopy. Canopy dieback and leaf necrosis evident. Minor cavities remain from historic wounding to lower branch east. Deadwood, crossing, duplicating branches.	In context with the current land use, sever ivy at base and remove first 6m. Should development occur remove tree.	10+	C1
T3	00025	Ash	Mature	69 (over ivy)	8.3	1	24	N6, S7, E6, W4	Fair	Fair	Tree located west of access track. Single stem up to 6m, from here co-dominant stems develop. Ivy growth restricts full visual inspection of the tree. Attempt to manage ivy has resulted in damage to the bark, although ring incomplete. High canopy with some dieback evident. Leaf wilting in places may indicate infection of ash dieback which is clearly evident in mature ash trees within wooded area adjacent to site edge. Deadwood throughout canopy.	In context with the current land use, sever ivy at base and remove first 6m. Should development occur remove tree.	10	C1

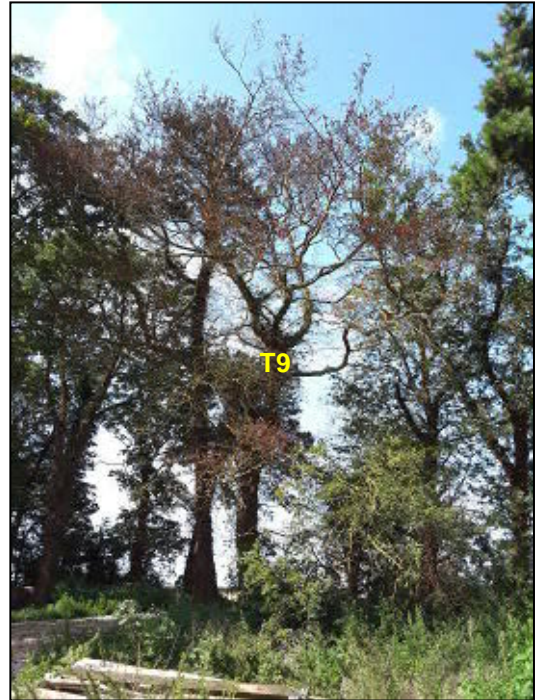
T9 appears to have no live canopy and the main stem has been ring-barked in an attempt to manage ivy, on this basis the tree is category "U"

Tree No.	Tag No.	Species	Age Class	Stem Diameter (cm)	RPA Radius (M)	Stem No.	Height (M)	Crown Spread (M)	Physiological Condition	Structural Condition	Comments	Management Recommendations	Remaining Contribution (yrs)	Category Grading
T9	00030	Beech	Mature	71 (over ivy)	8.5	1	19	N3, S9, E6, W6	Poor/Dead	Poor	Tree approx. 2m east of access track. Ivy coverage restricts full visual inspection. Significant damage to the bark, i.e. ring barking, from attempt to manage ivy. Tree has poor vitality and appears dead. Leaves brown and dead, no live growth apparent. Lower canopy 3m agl south.	In context with the current land use remove tree.	0-5	U

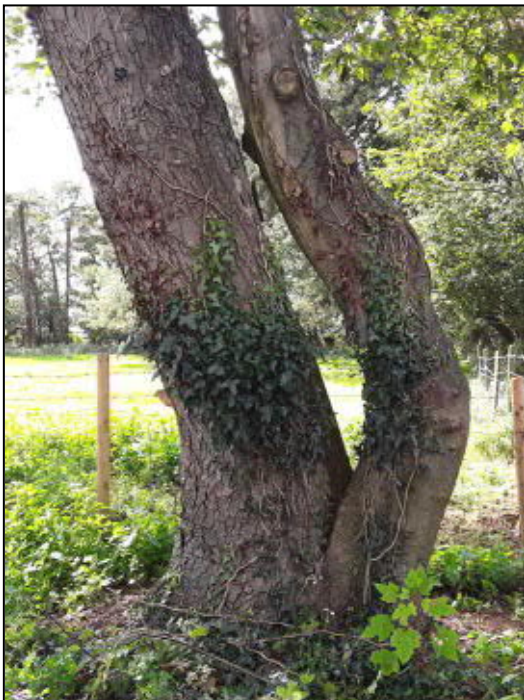
T5 is twin-stemmed with included bark at the stem union; *Kreftschmaria deusta* colonises the base of the tree and bark inclusion

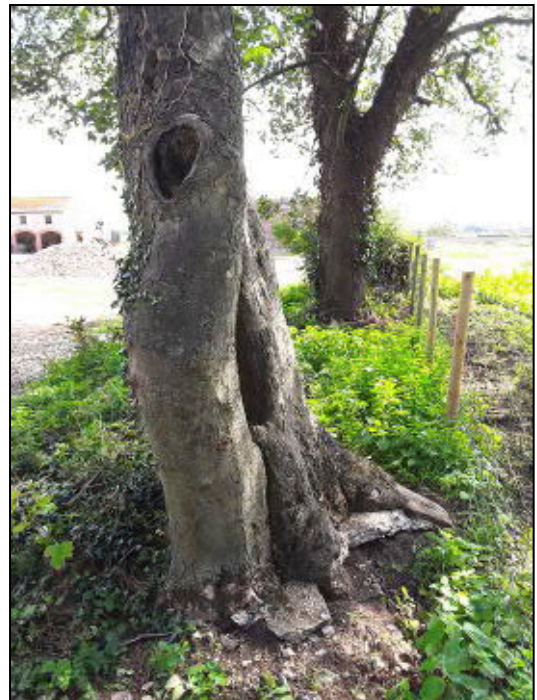
Large sections of concrete are embedded in the base of T5; basal decay is evident, particularly on the north and west sides of the tree
