## PHASE I GEO-ENVIRONMENTAL SITE ASSESSMENT

Land North West of Tollgate House,  
Barrington Road,  
Bedlington,  
NE22 7AP

Report Ref: 21-1085-r01  
Date Issued: April 2022

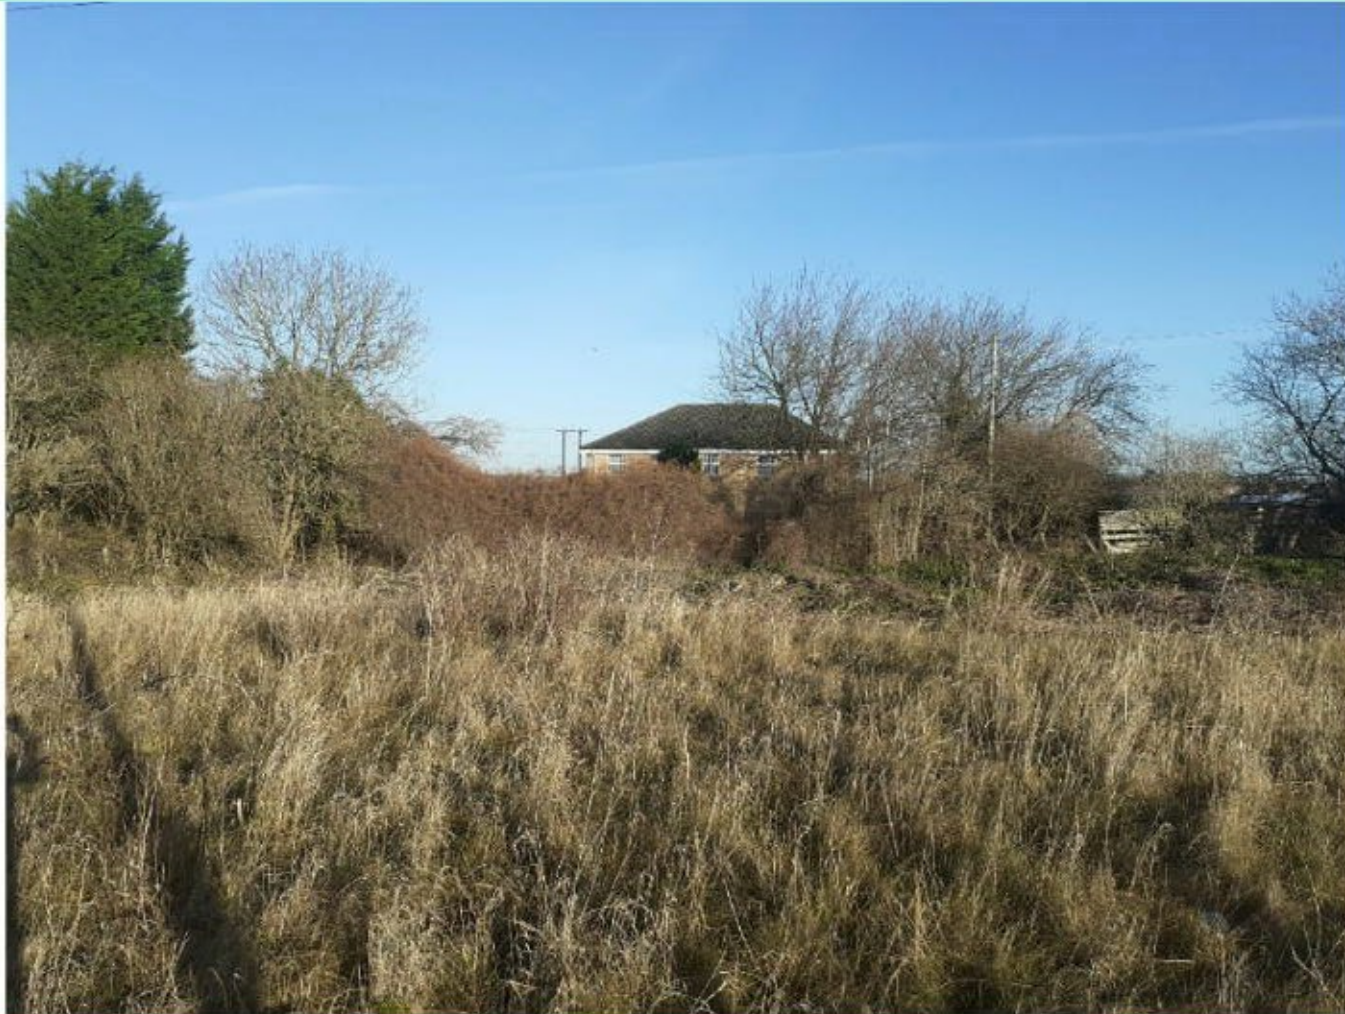
**PLATE 1 – OVERVIEW OF THE SITE LOOKING WEST**

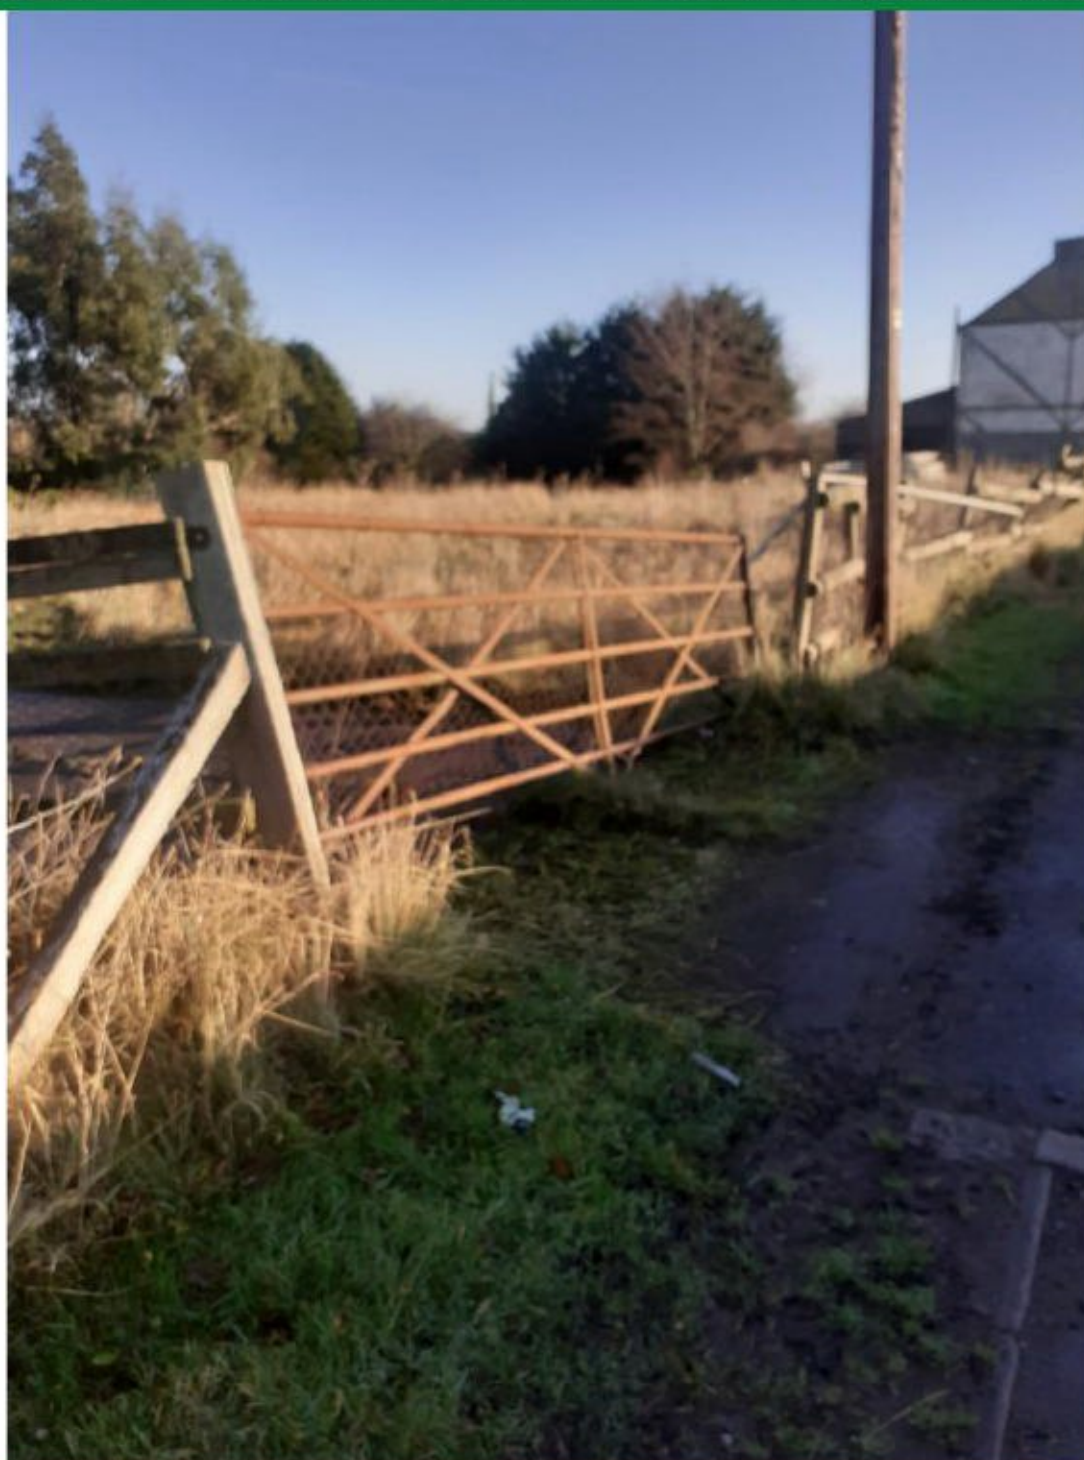
**PLATE 2 – ACCESS GATE AT THE CENTRE OF THE SOUTHERN BOUNDARY**

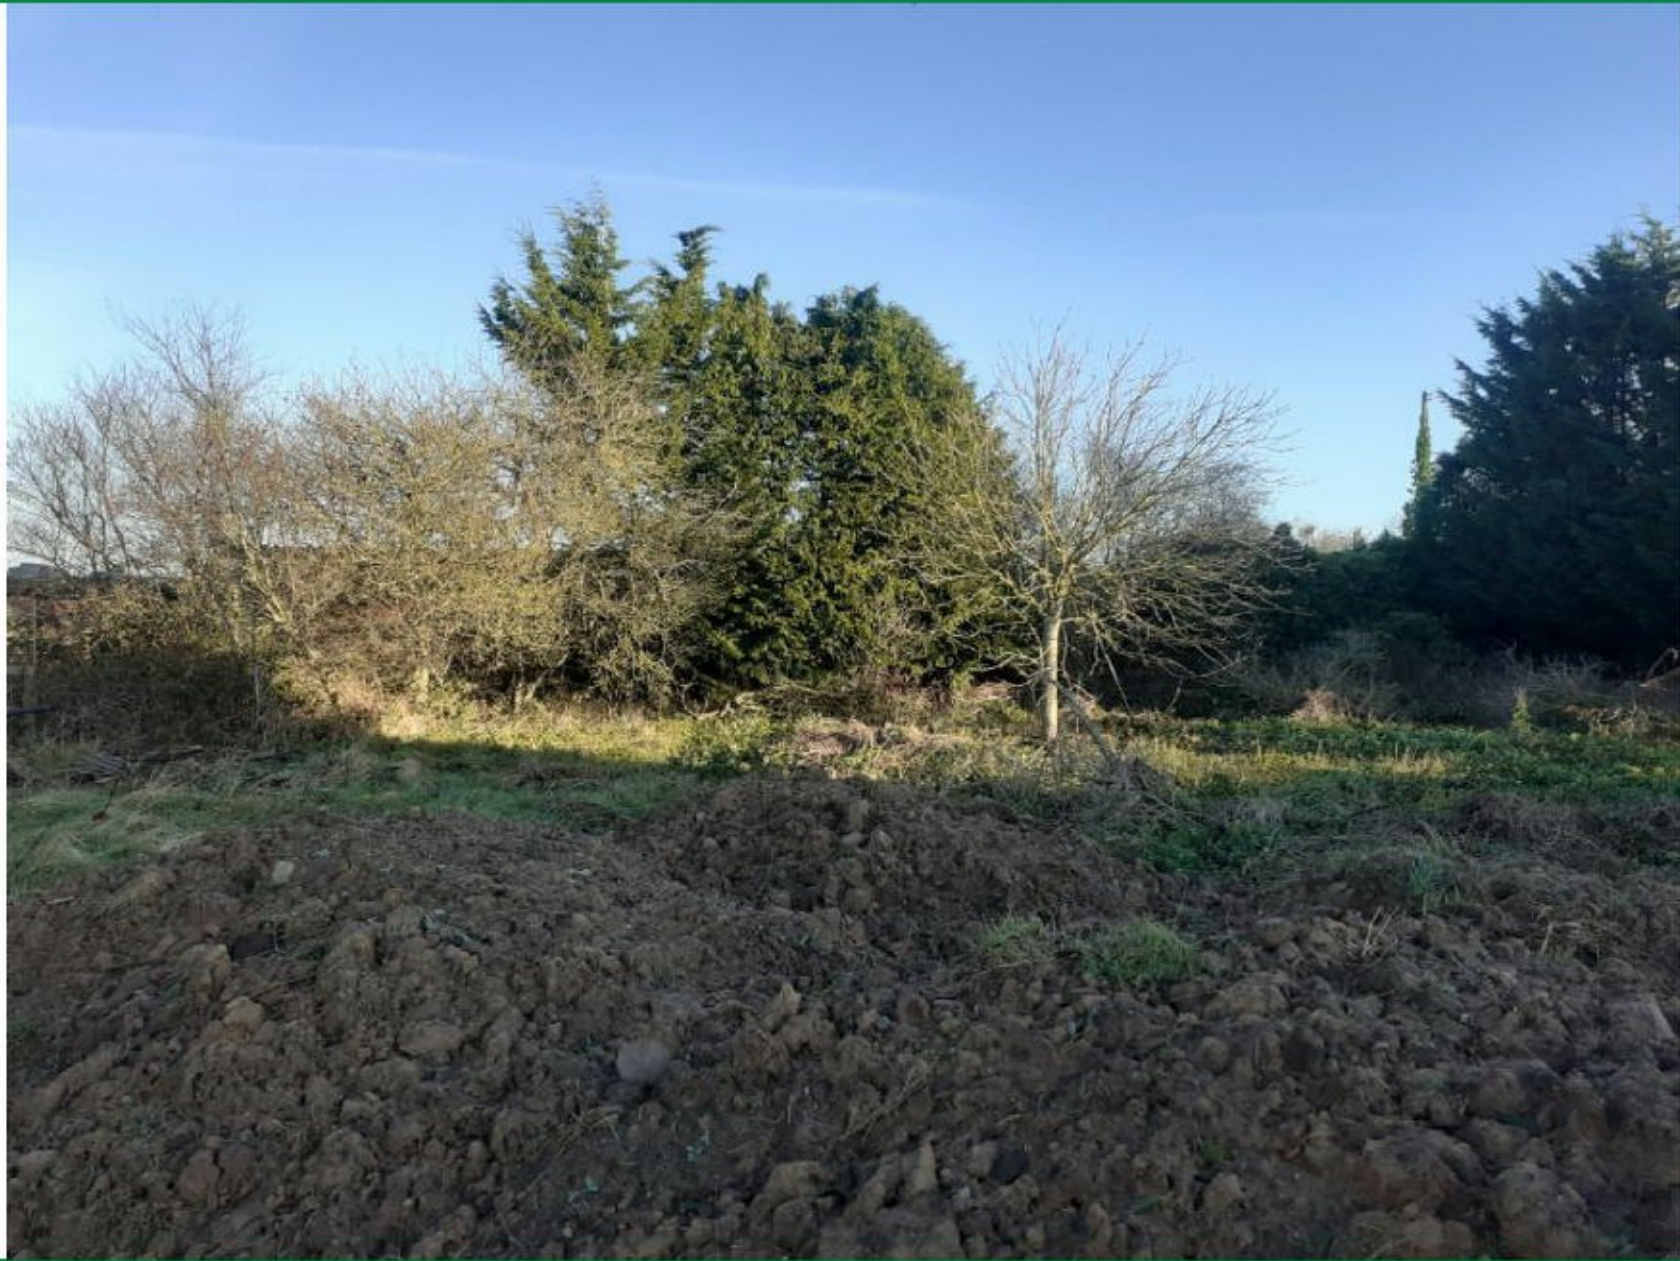
**PLATE 3 – EVIDENCE OF EARTHWORKS AND THE EASTERN BOUNDARY**

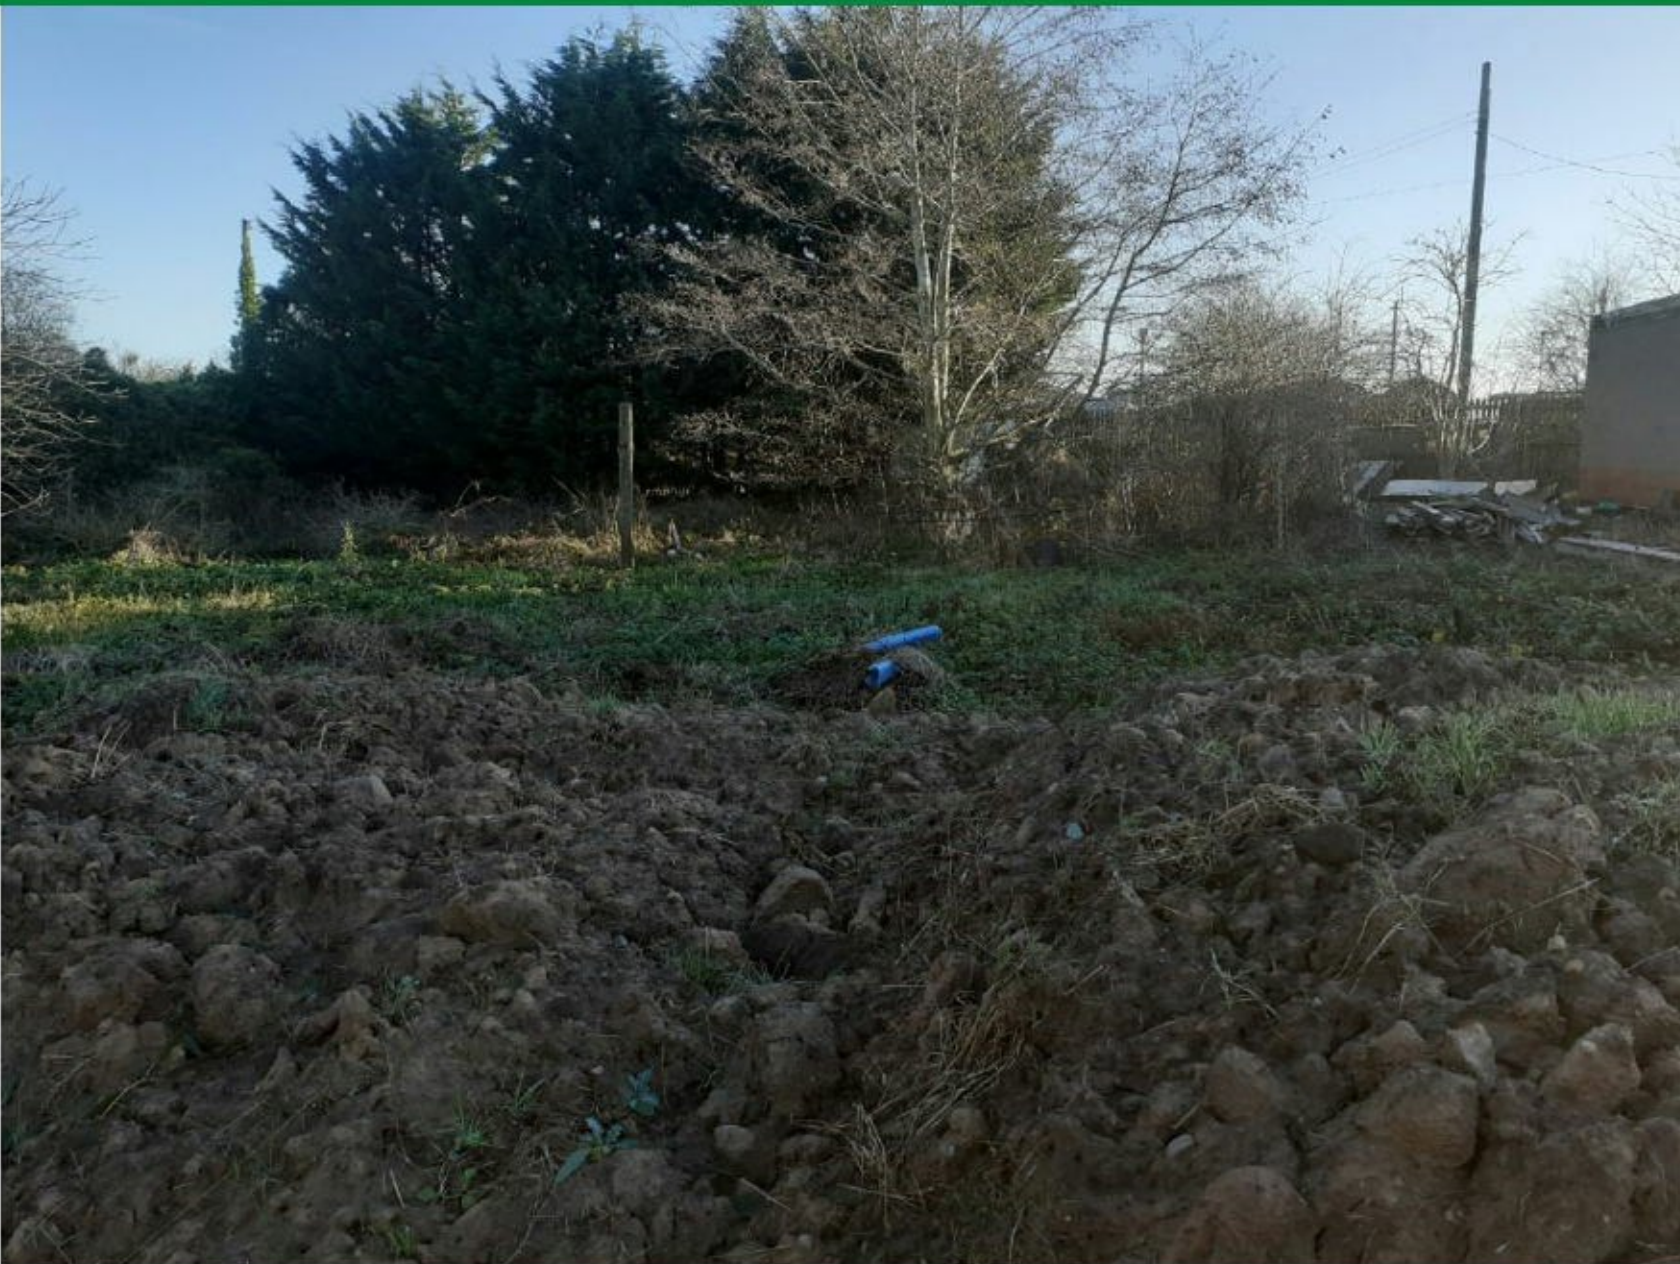
**PLATE 4 – EASTERN SITE BOUNDARY**

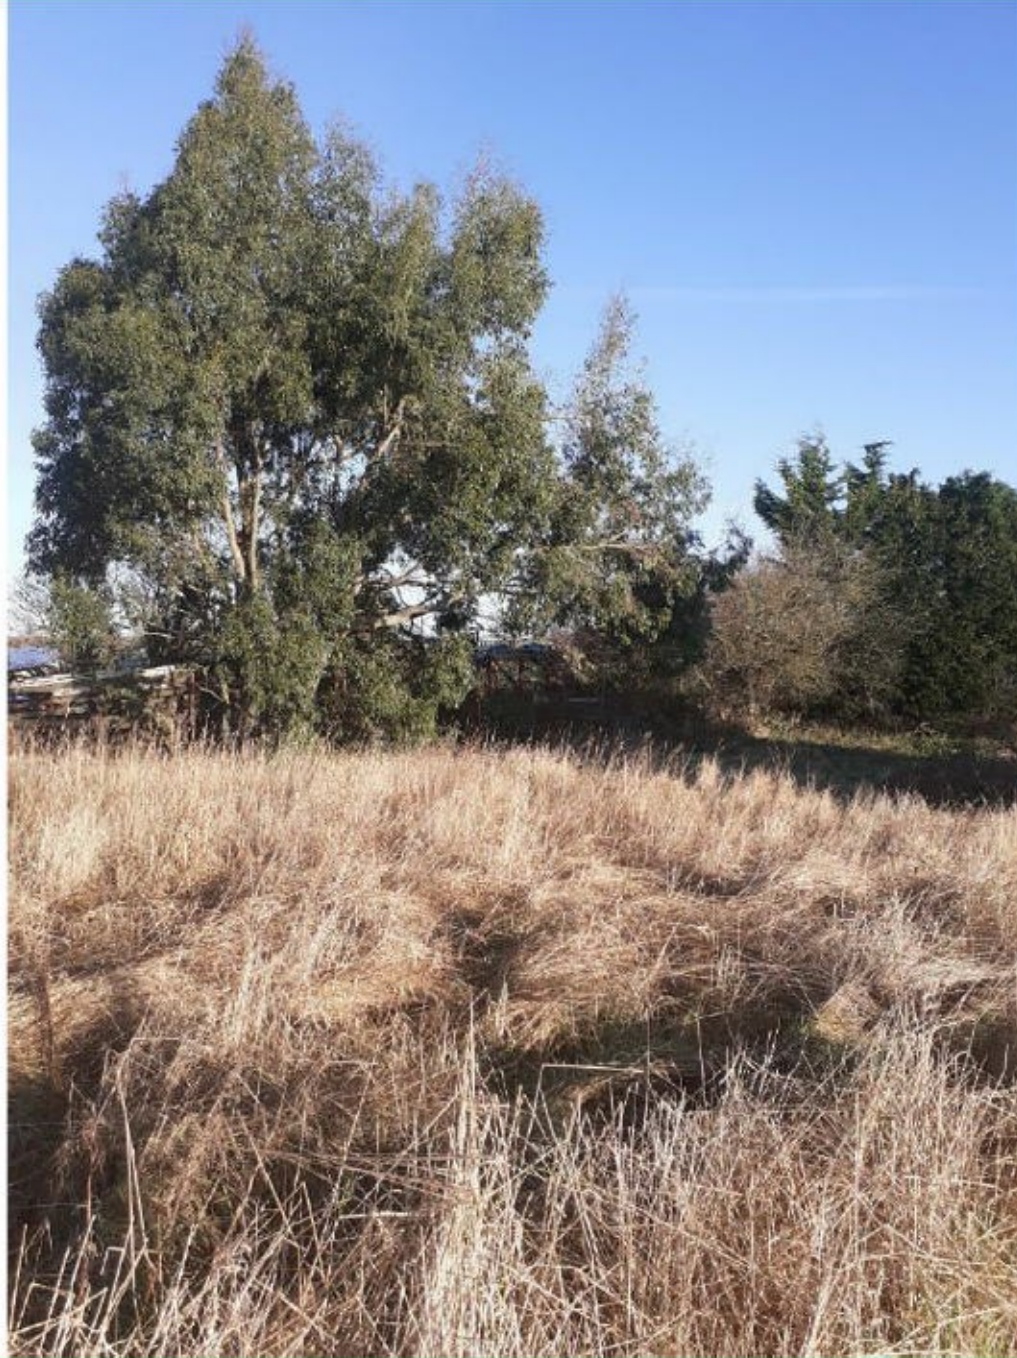
**PLATE 5 – NORTHERN SITE BOUNDARY**

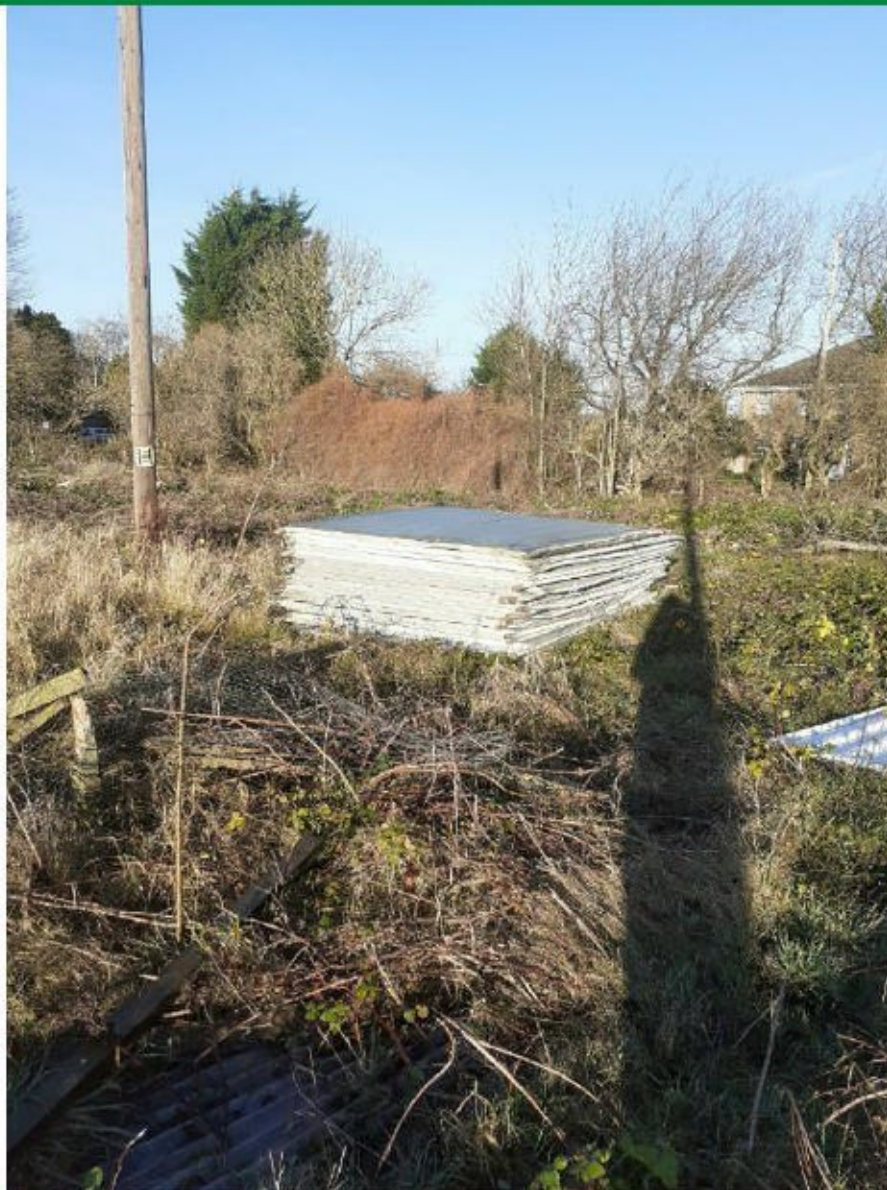
| <b>Waste Storage</b> | Potentially hazardous waste streams are likely to be generated at the site and were observed during the site walkover in the form of numerous metal sheets, brick rubble from previous wall and stockpiled subsoil of unknown origins. |

**PLATE 6 – STORED METAL SHEETING IN THE CENTRE OF THE SITE**

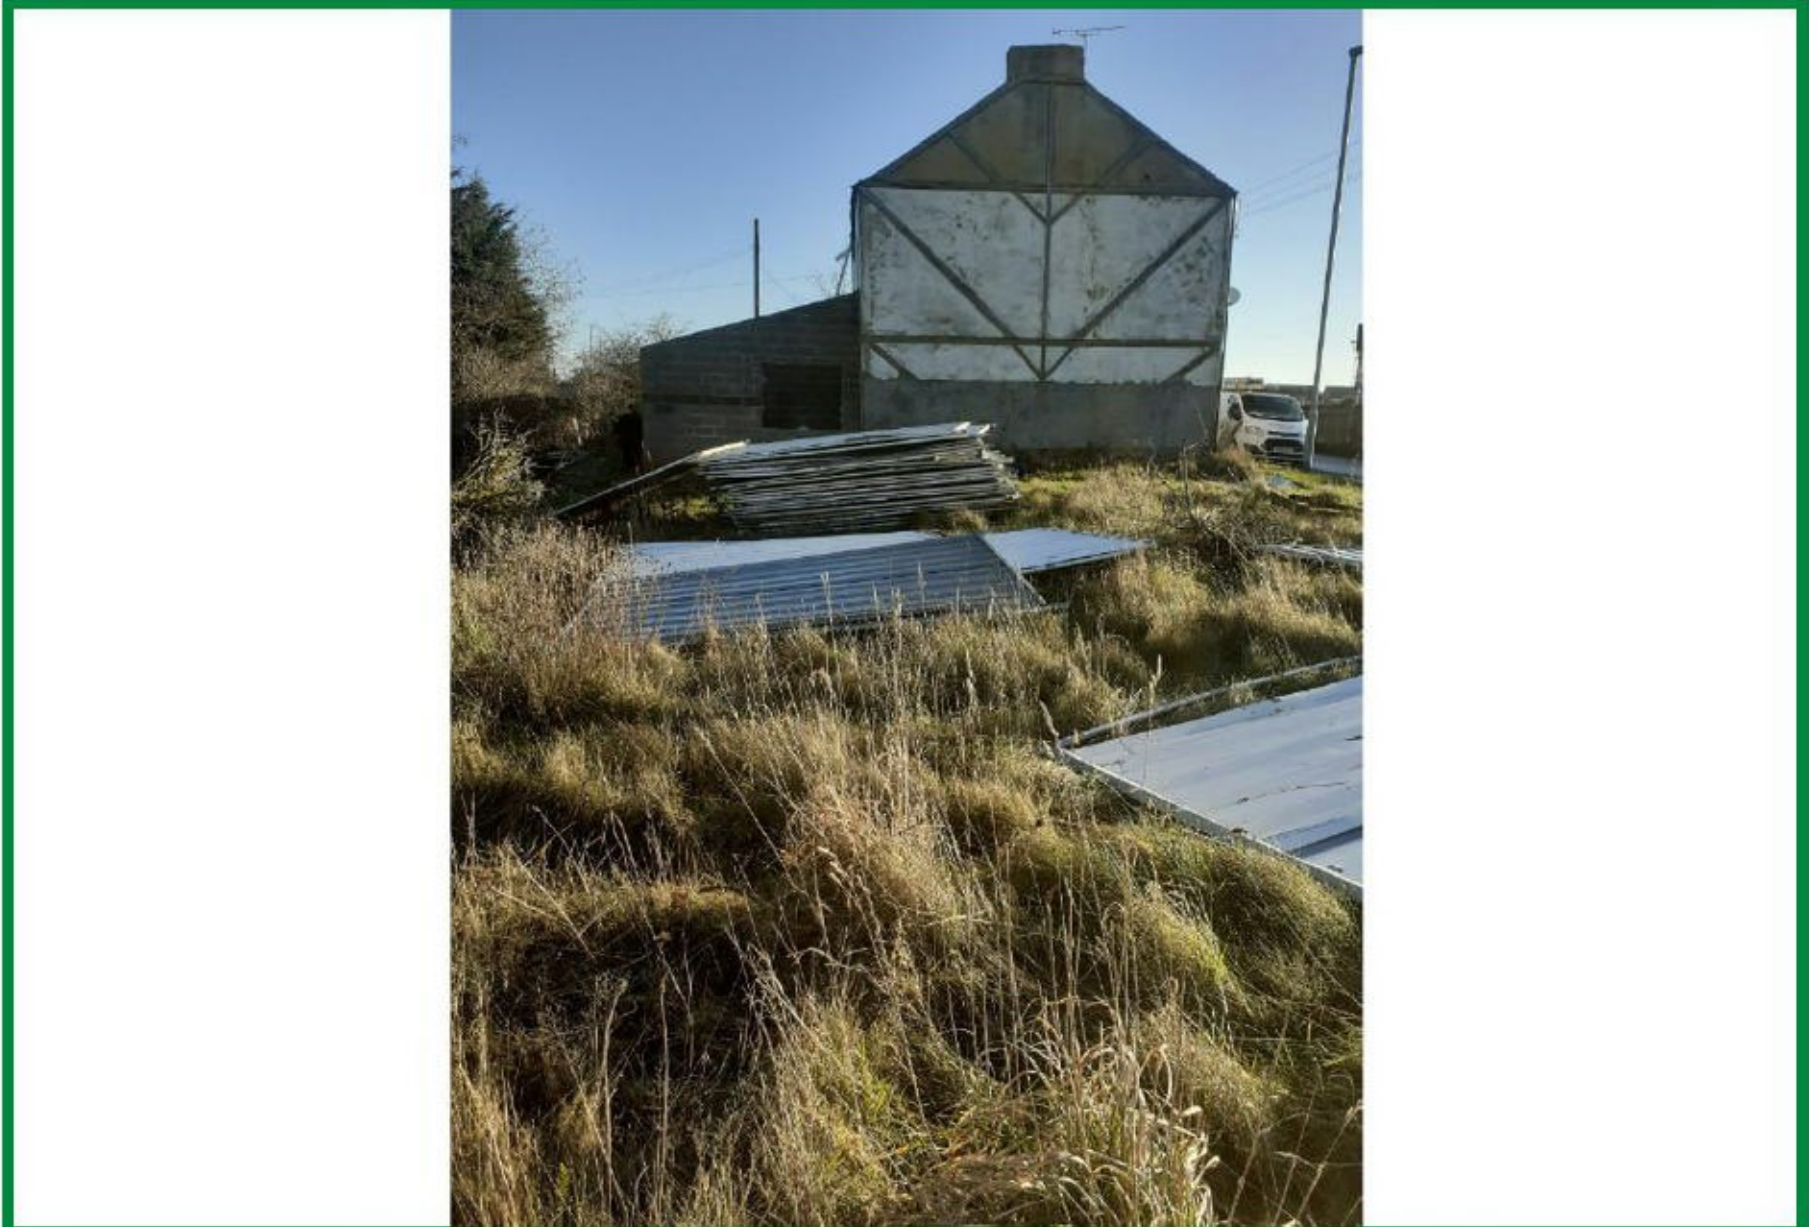
**PLATE 7 – STORED METAL SHEETING TO THE EAST OF THE SITE**
