Our ref: GS/yh 2021.125

Conversion of Hollands House Farm Barn, Lees Lane, Dalton.

Following an enquiry from Peter Dickinson Architects and subsequent instructions we carried out a structural appraisal of the above building on 2 March 2022. The purpose of the appraisal was to assess the structural condition of the barn and to advise its potential for conversion to provide a habitable residential dwelling.

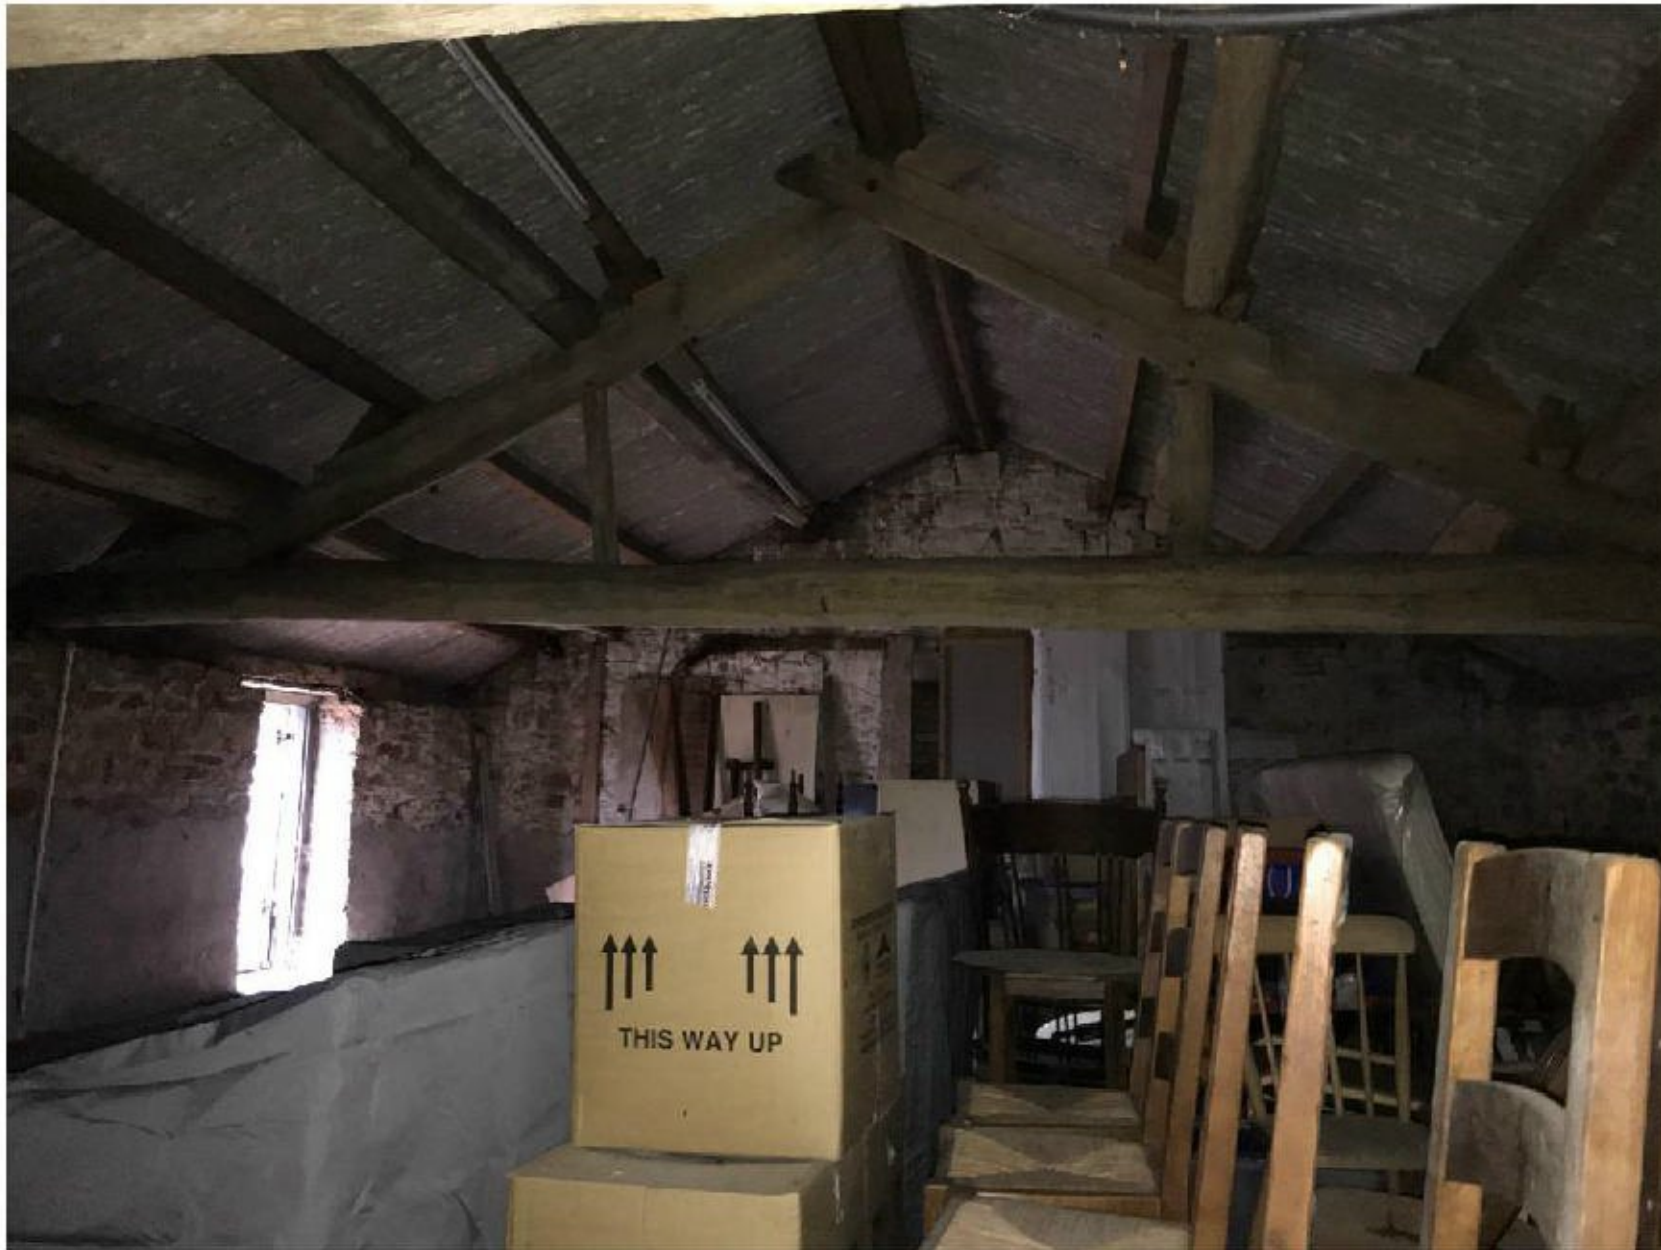
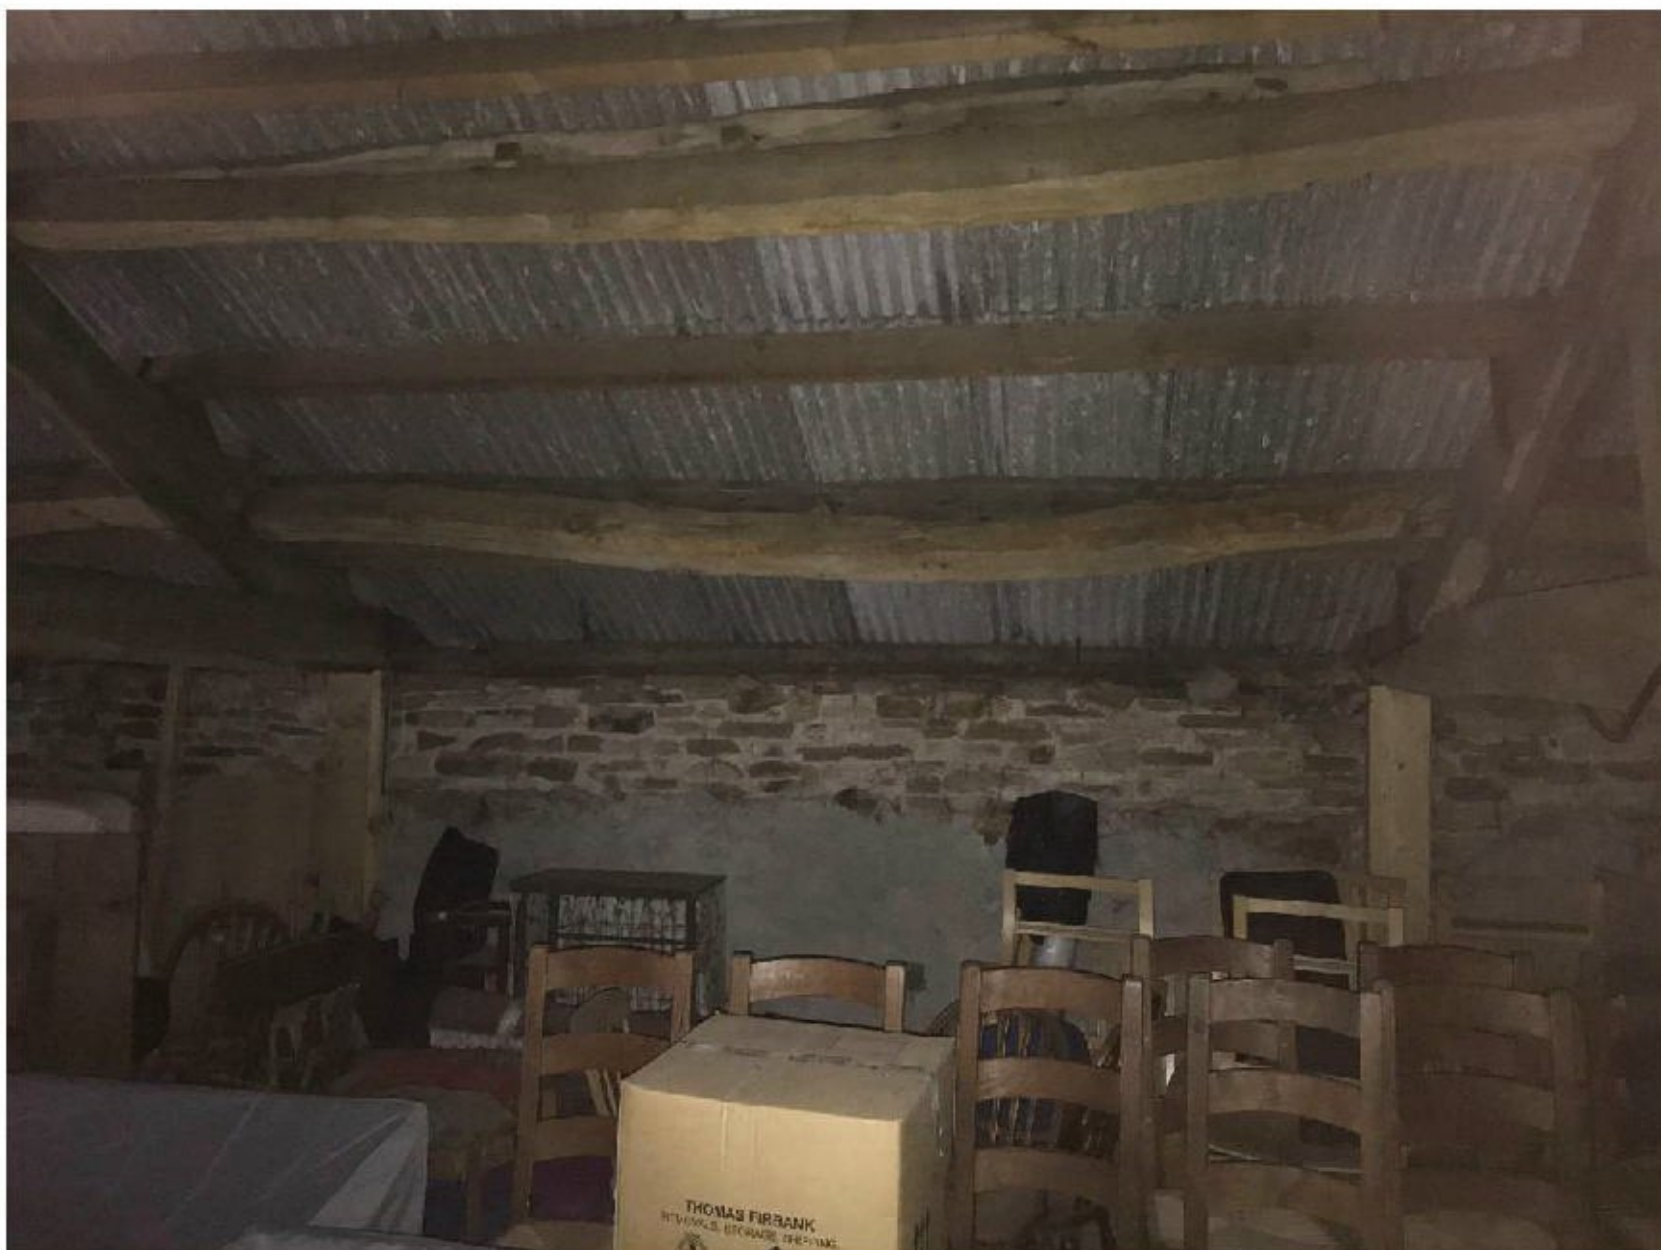
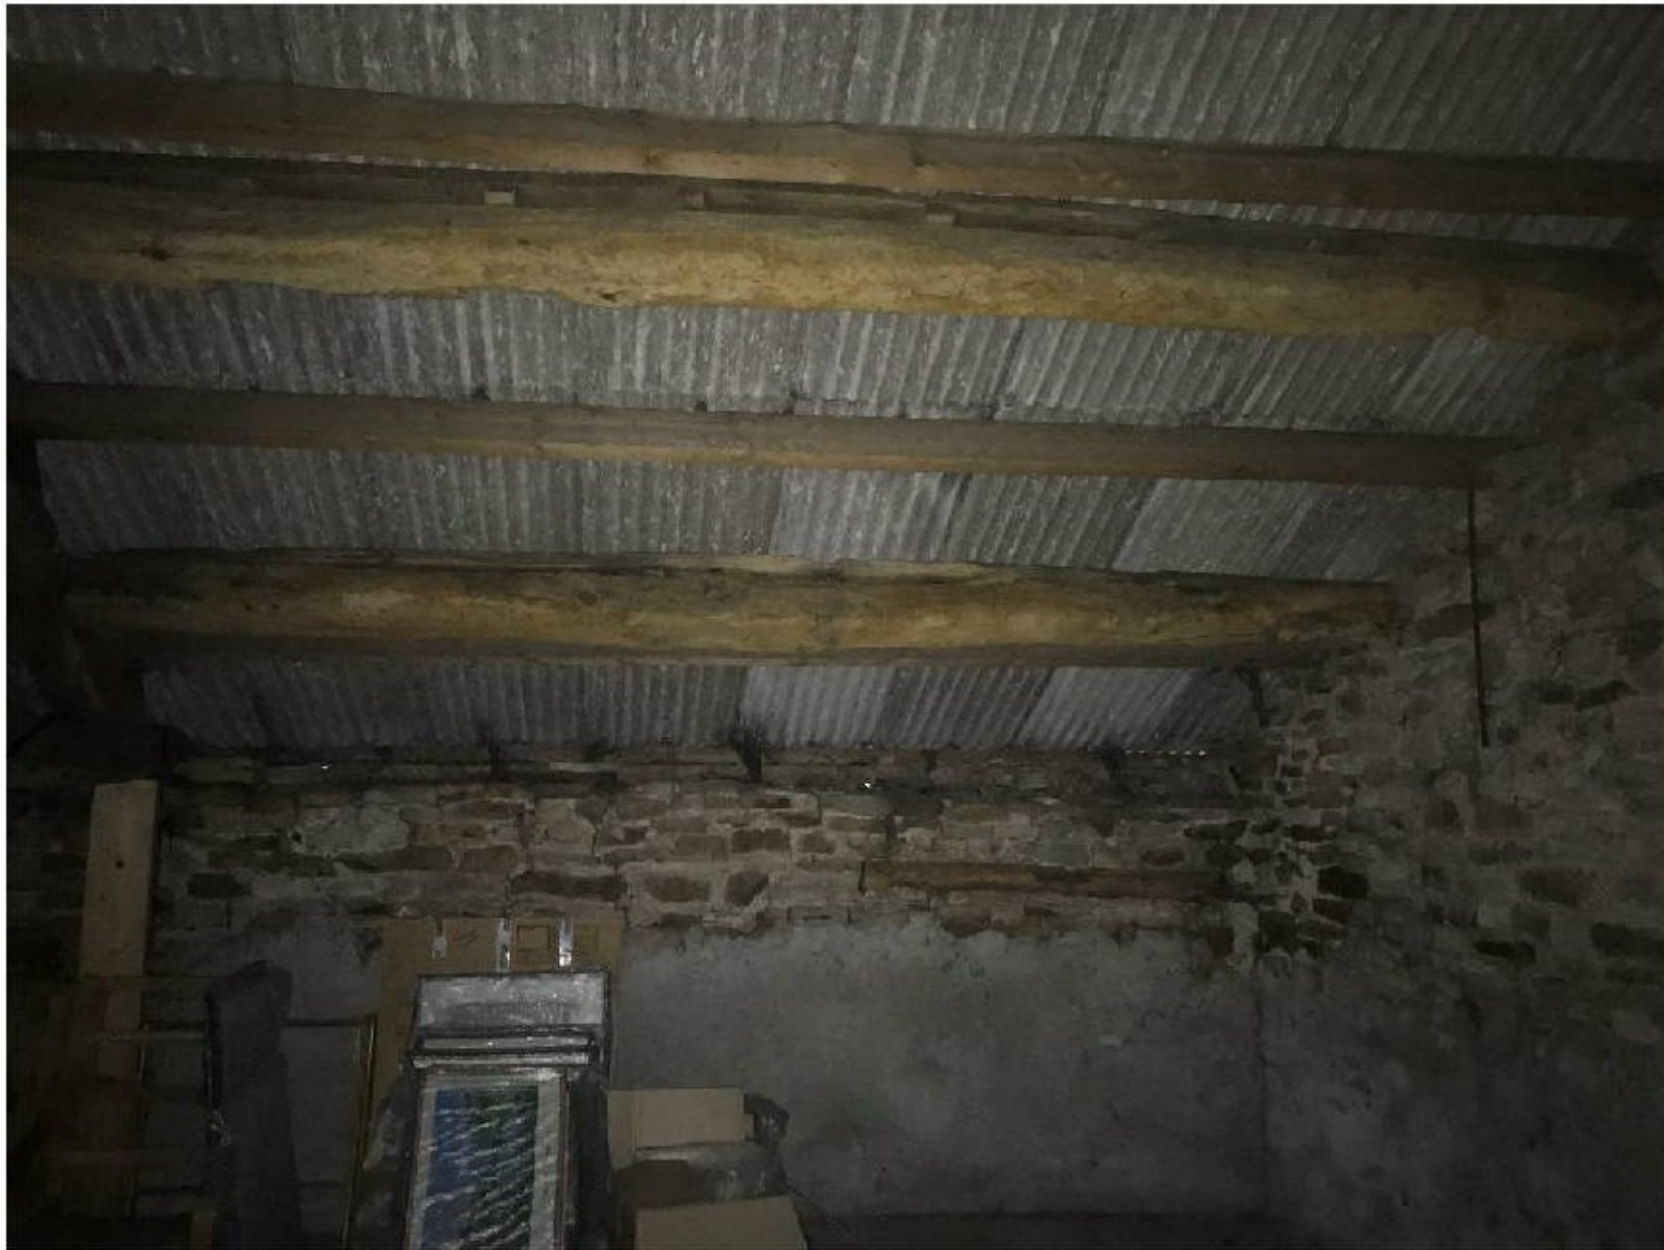
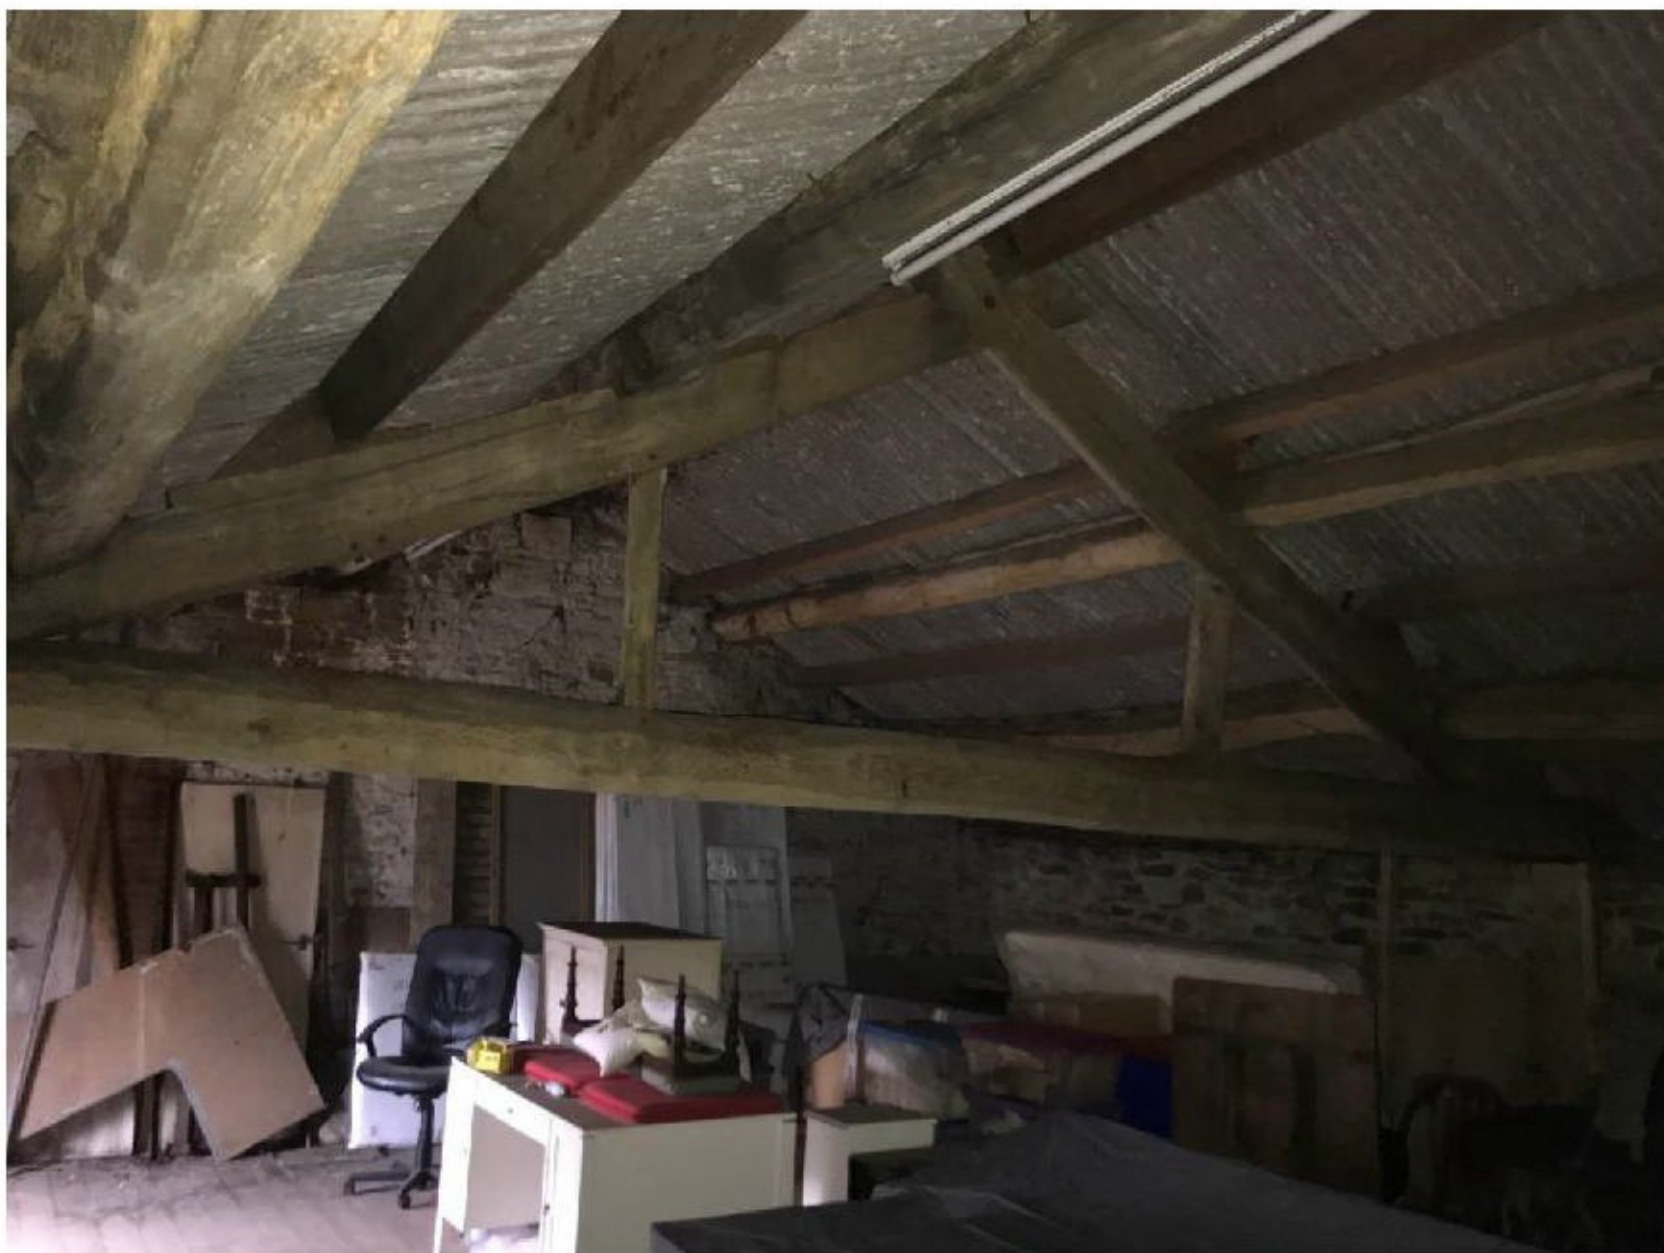
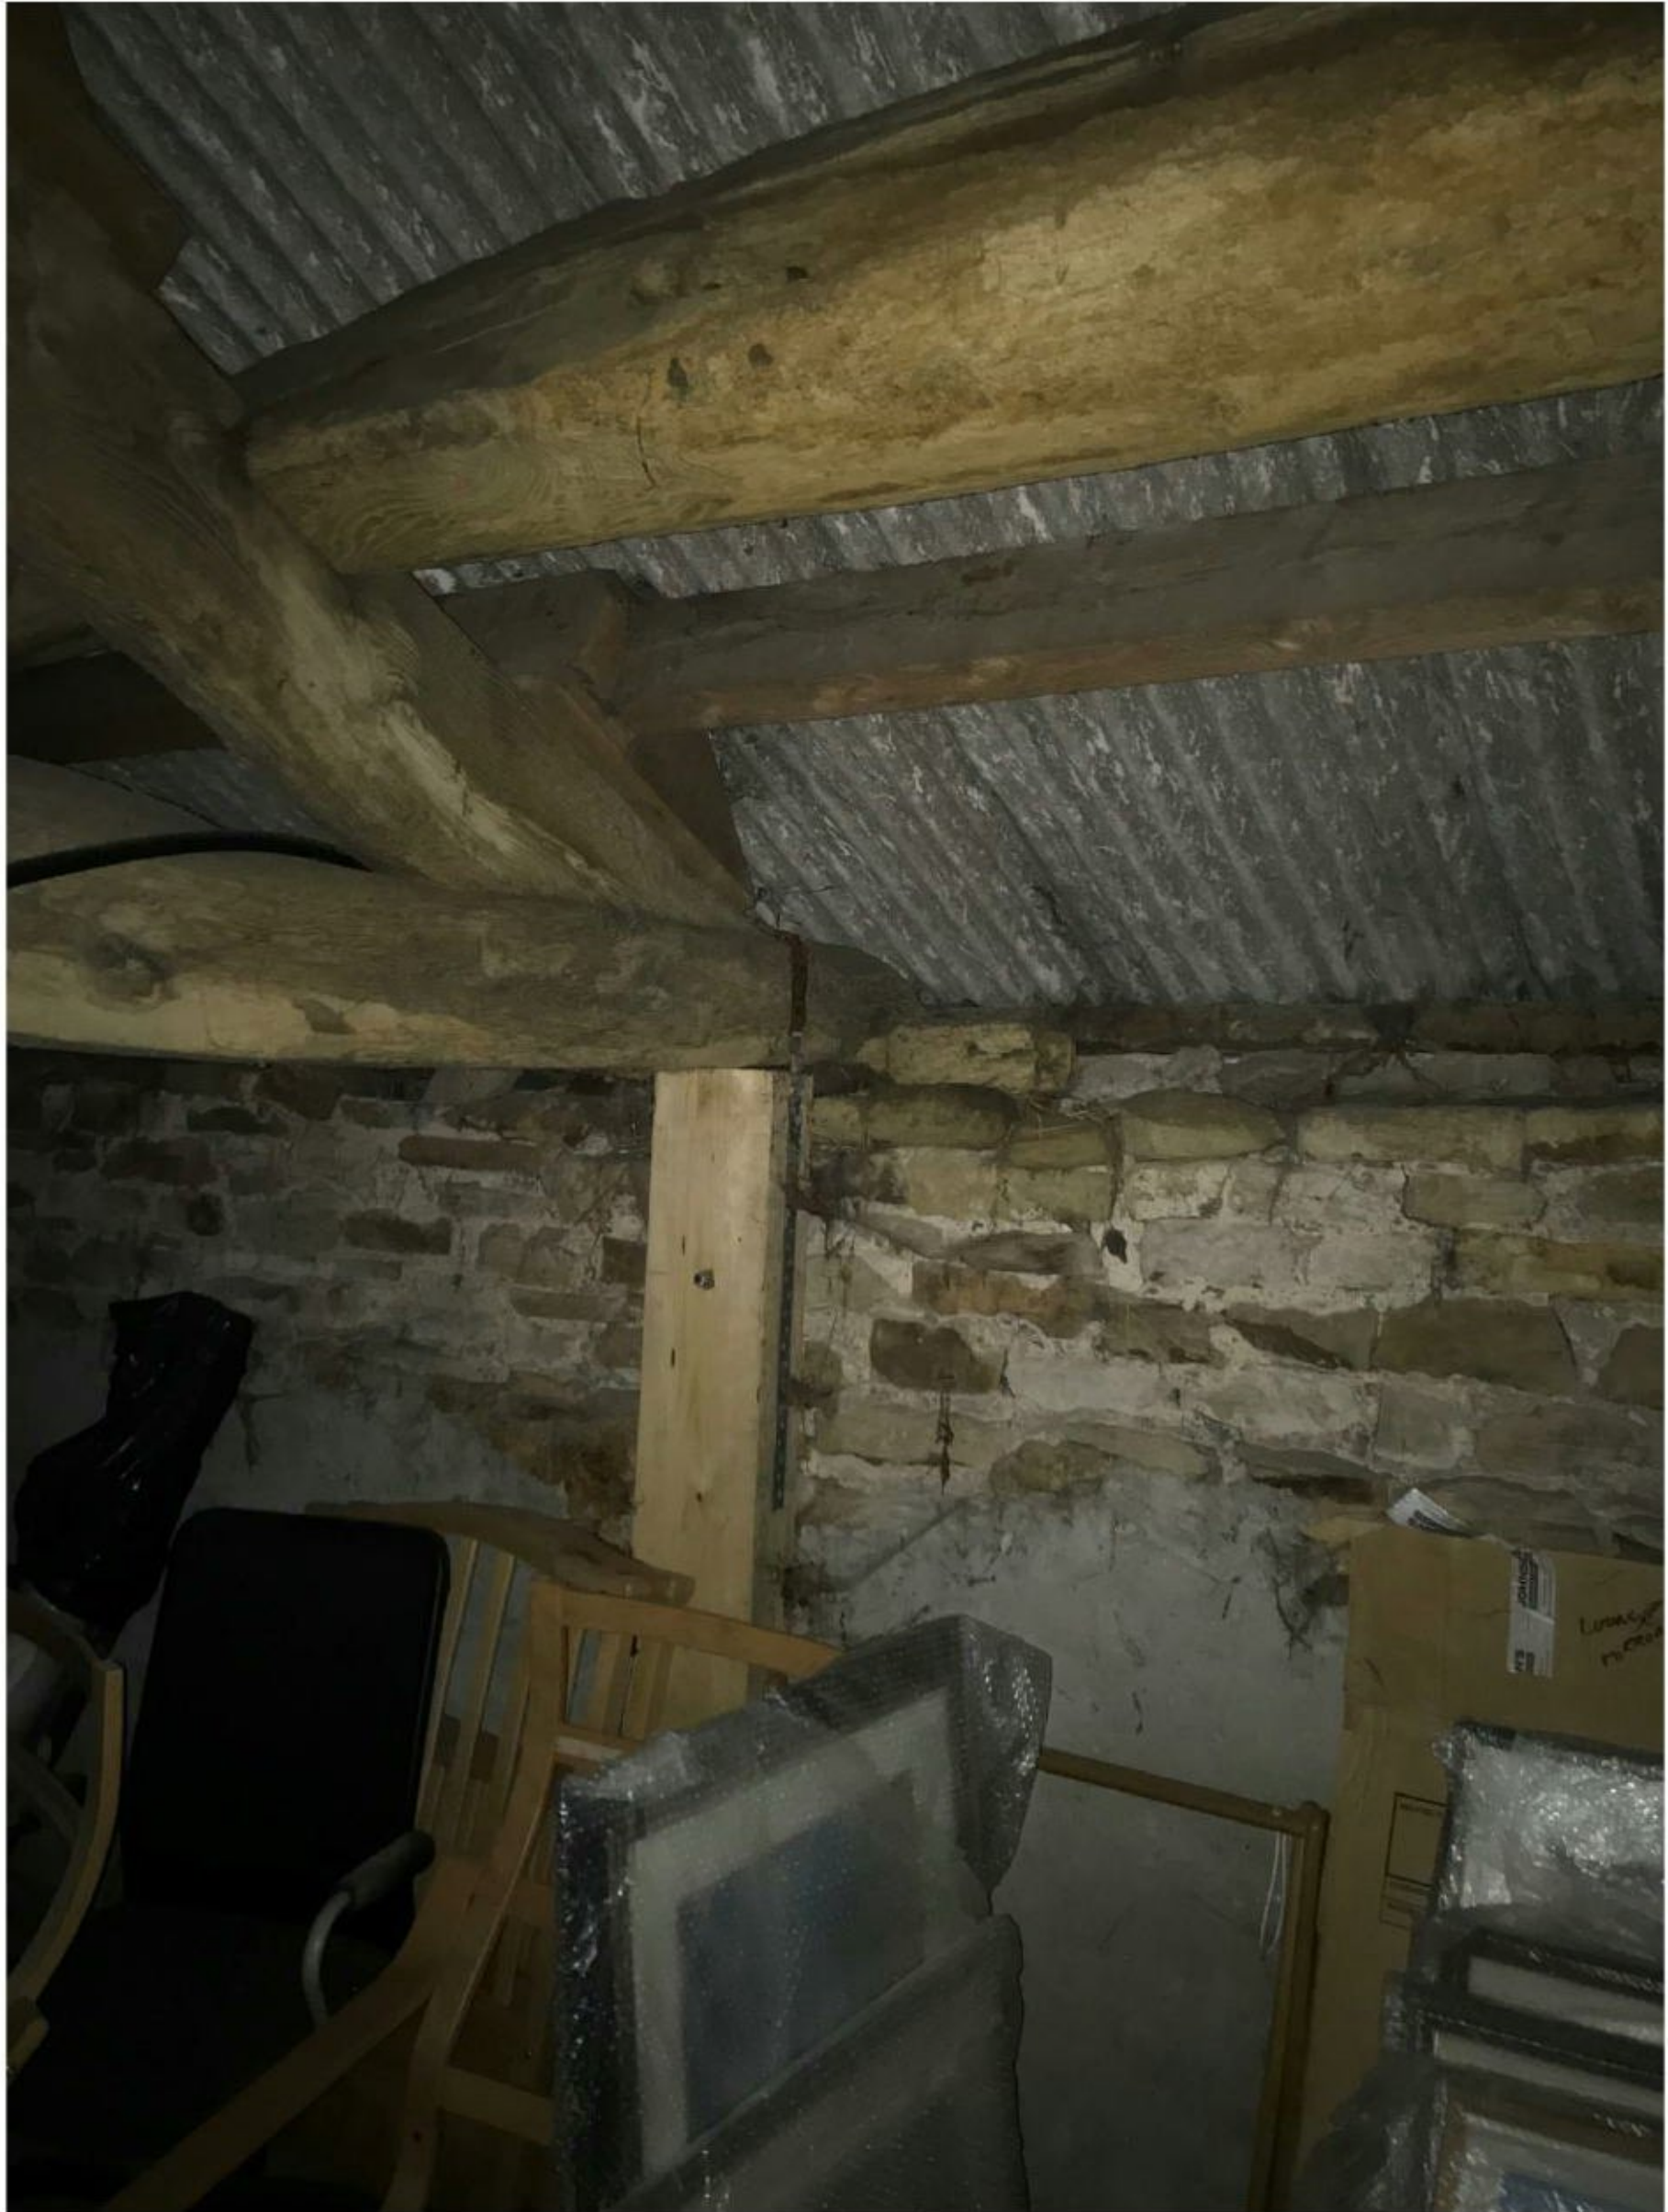
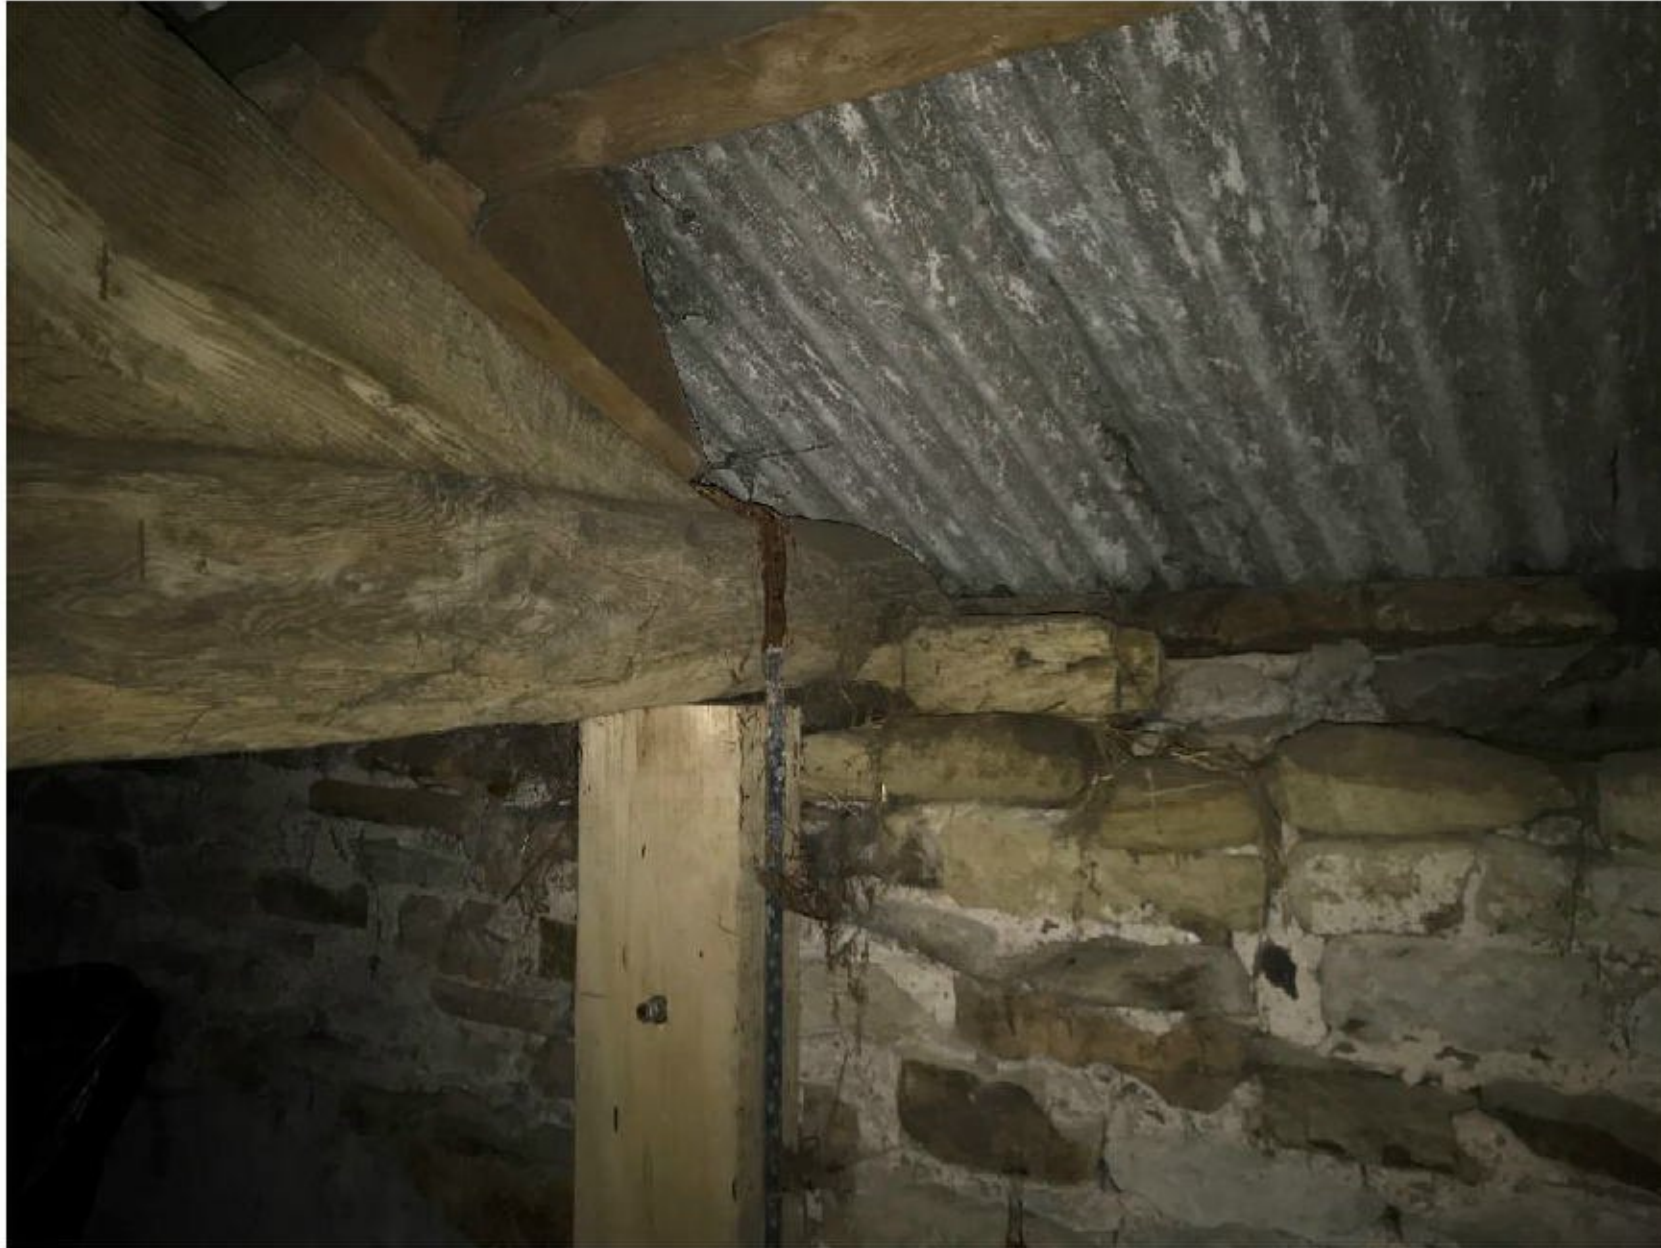
Roof Asbestos cement roofing sheets spanning the original rough timber purlins which have been augmented and strengthened with the introduction of regular timbers. Purlins span gable to gable with two intermediate timber trusses which span the full width of the building. The original “jack” rafters have been removed.

Whilst we observed no evidence of excessive deflection or distress we did notice extensive woodworm to many of the timbers and in particular the purlins and wall plate.

Photograph 1 Roof Construction

Photograph 2 Roof Construction

Photograph 3 Roof Construction

Photograph 4 Roof Construction

Photograph 5 Roof Construction

Photograph 6 Roof Construction

- Remove the asbestos cement roofing sheets, introduce rafters and provide an insulated watertight roof with slates commensurate with the adjacent buildings.
- Either overlay or break out the existing floor slab and replace with an insulated slab with a damp proof membrane.
- Treat **all** timbers to eradicate woodworm and/or any other.
