Our ref: GS/yh 2021.125

Conversion of Hollands House Farm Barn, Lees Lane, Dalton.

Following an enquiry from Peter Dickinson Architects and subsequent instructions we carried out a structural appraisal of the above building on 2 March 2022. The purpose of the appraisal was to assess the structural condition of the barn and to advise its potential for conversion to provide a habitable residential dwelling.

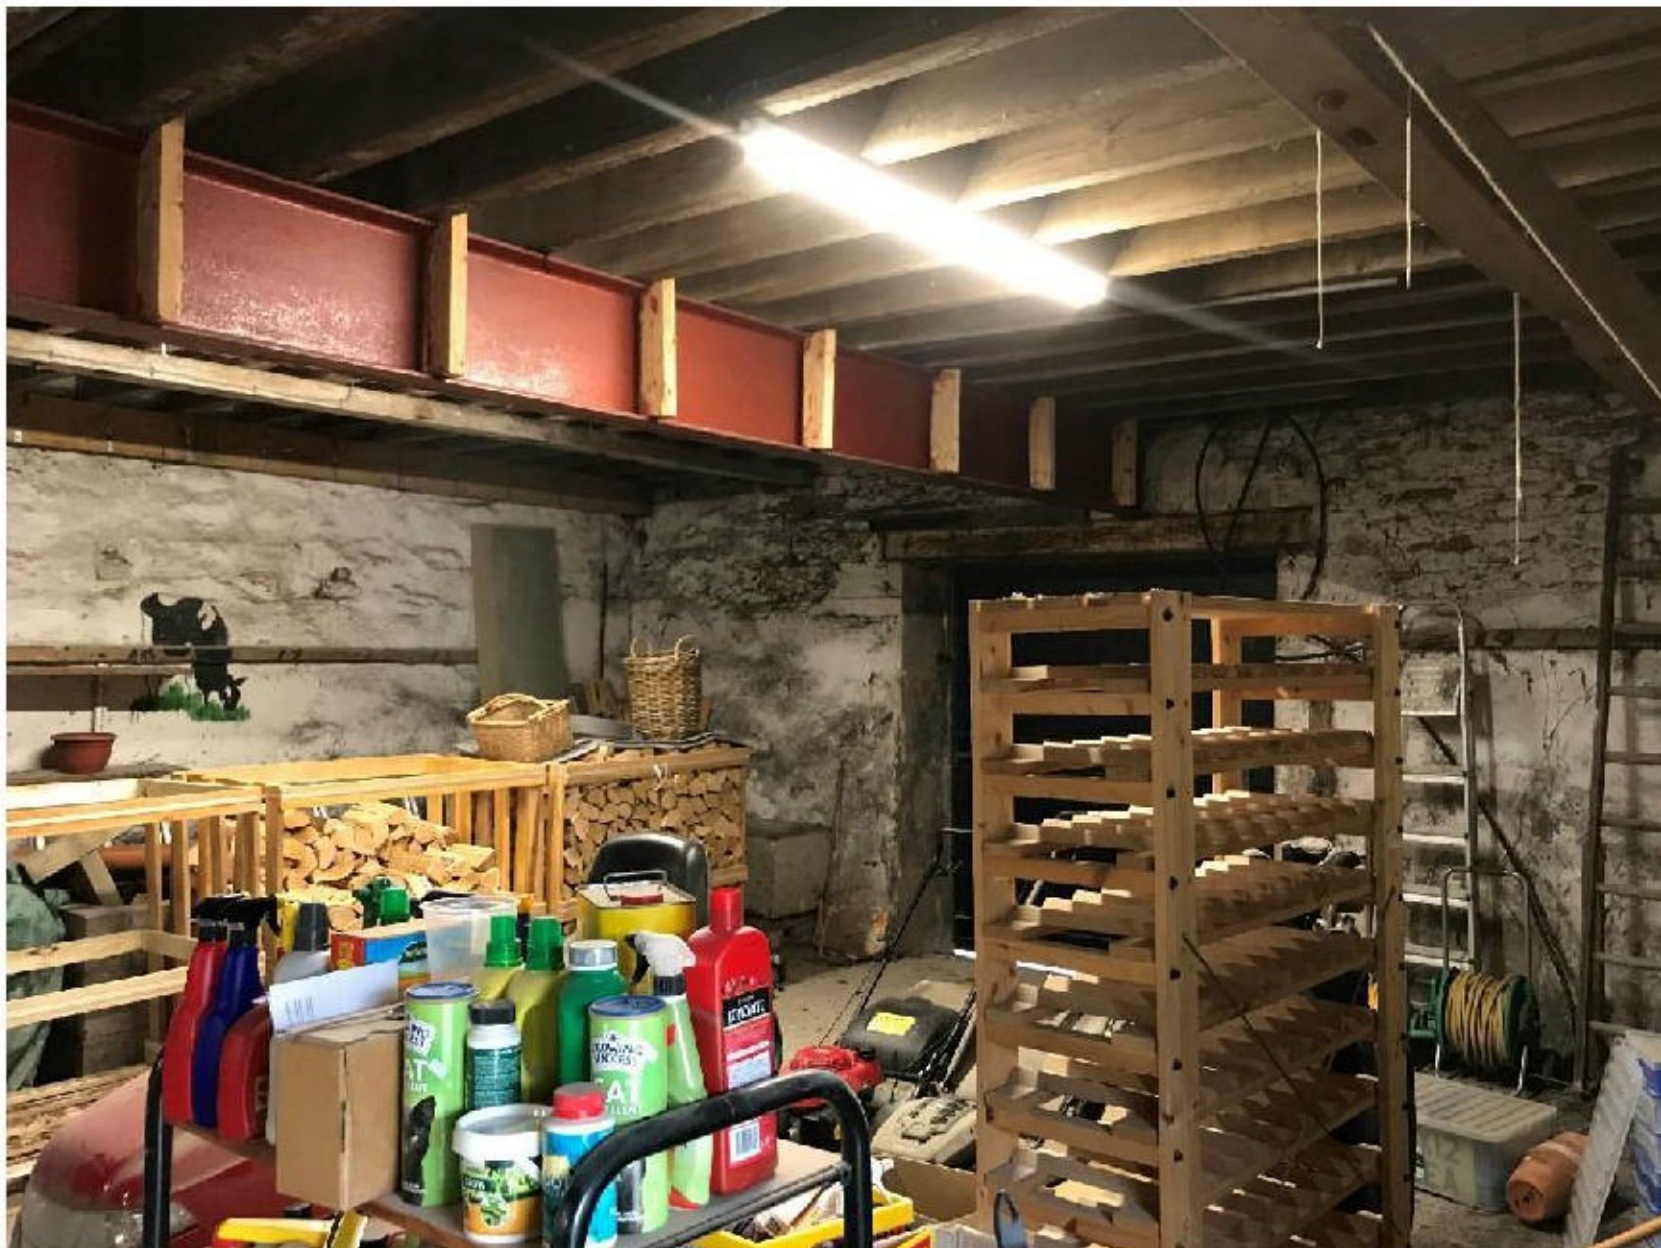
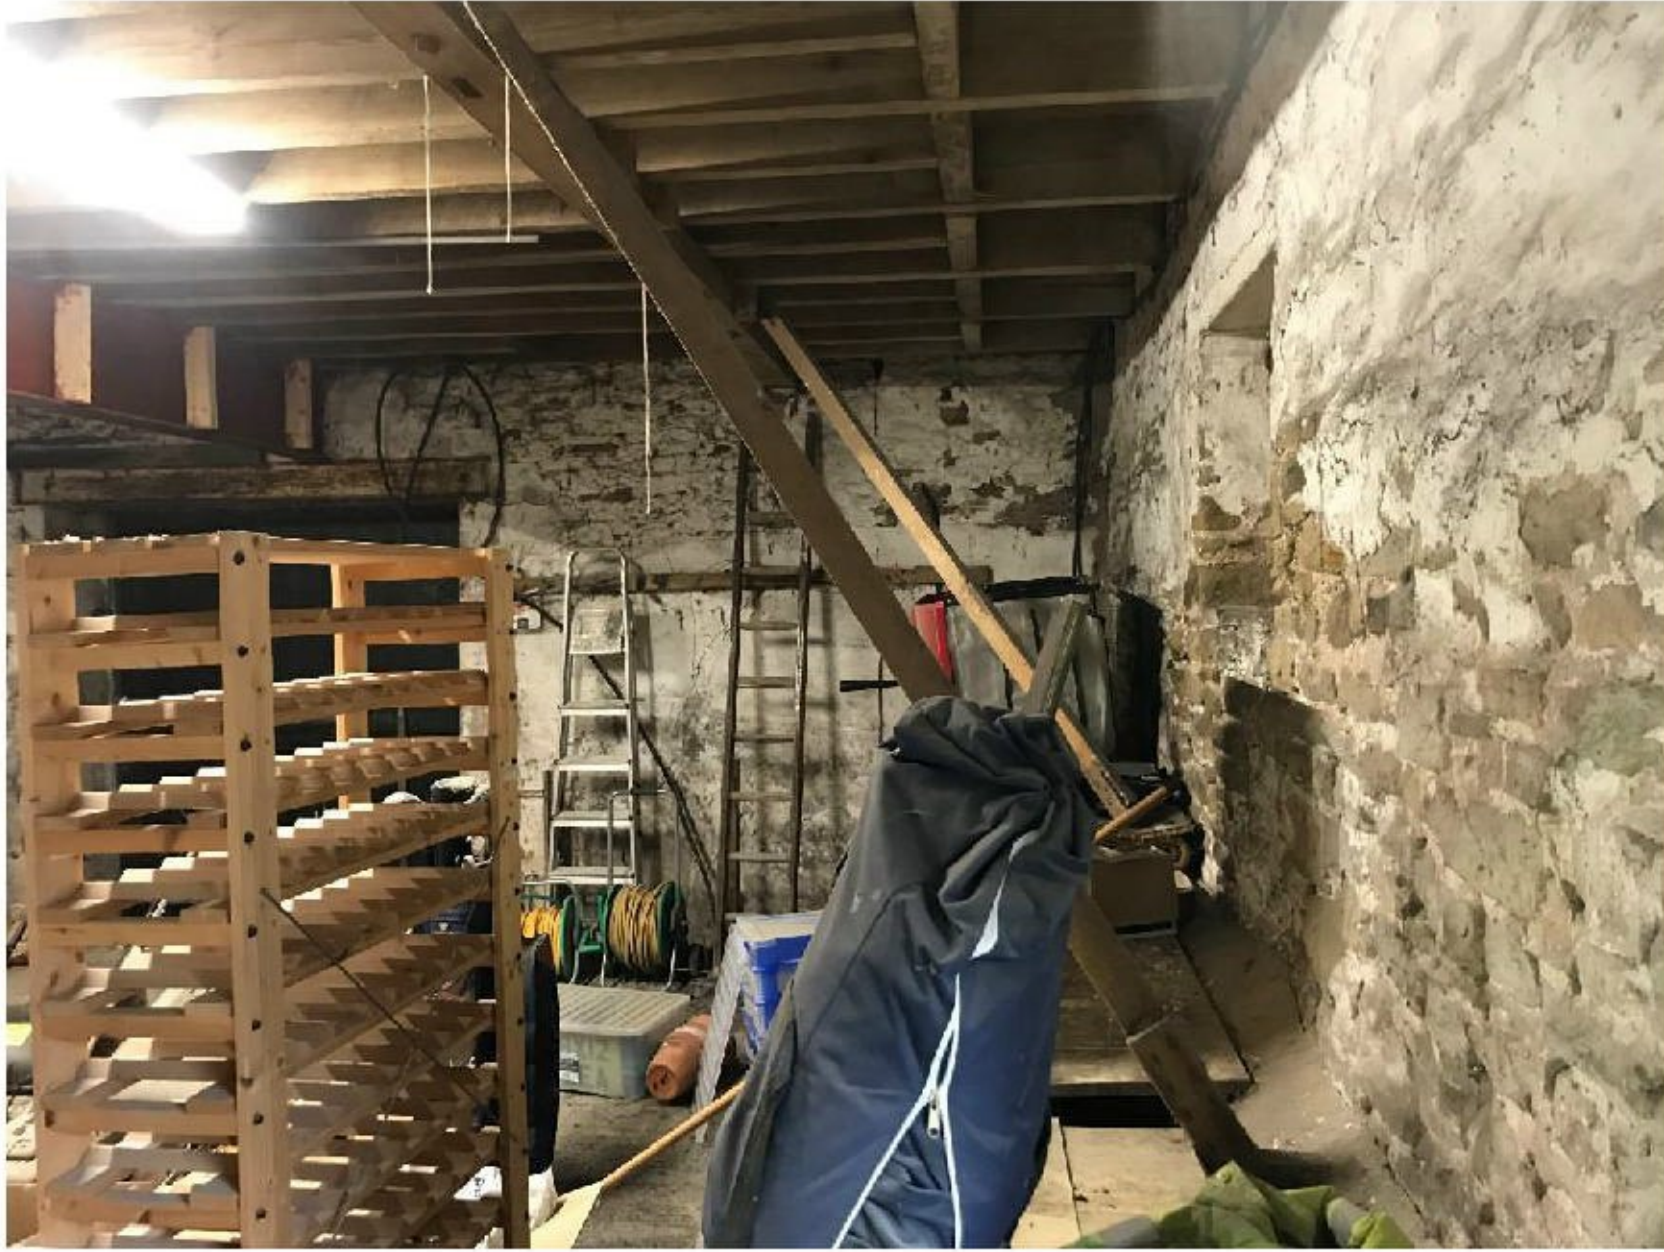
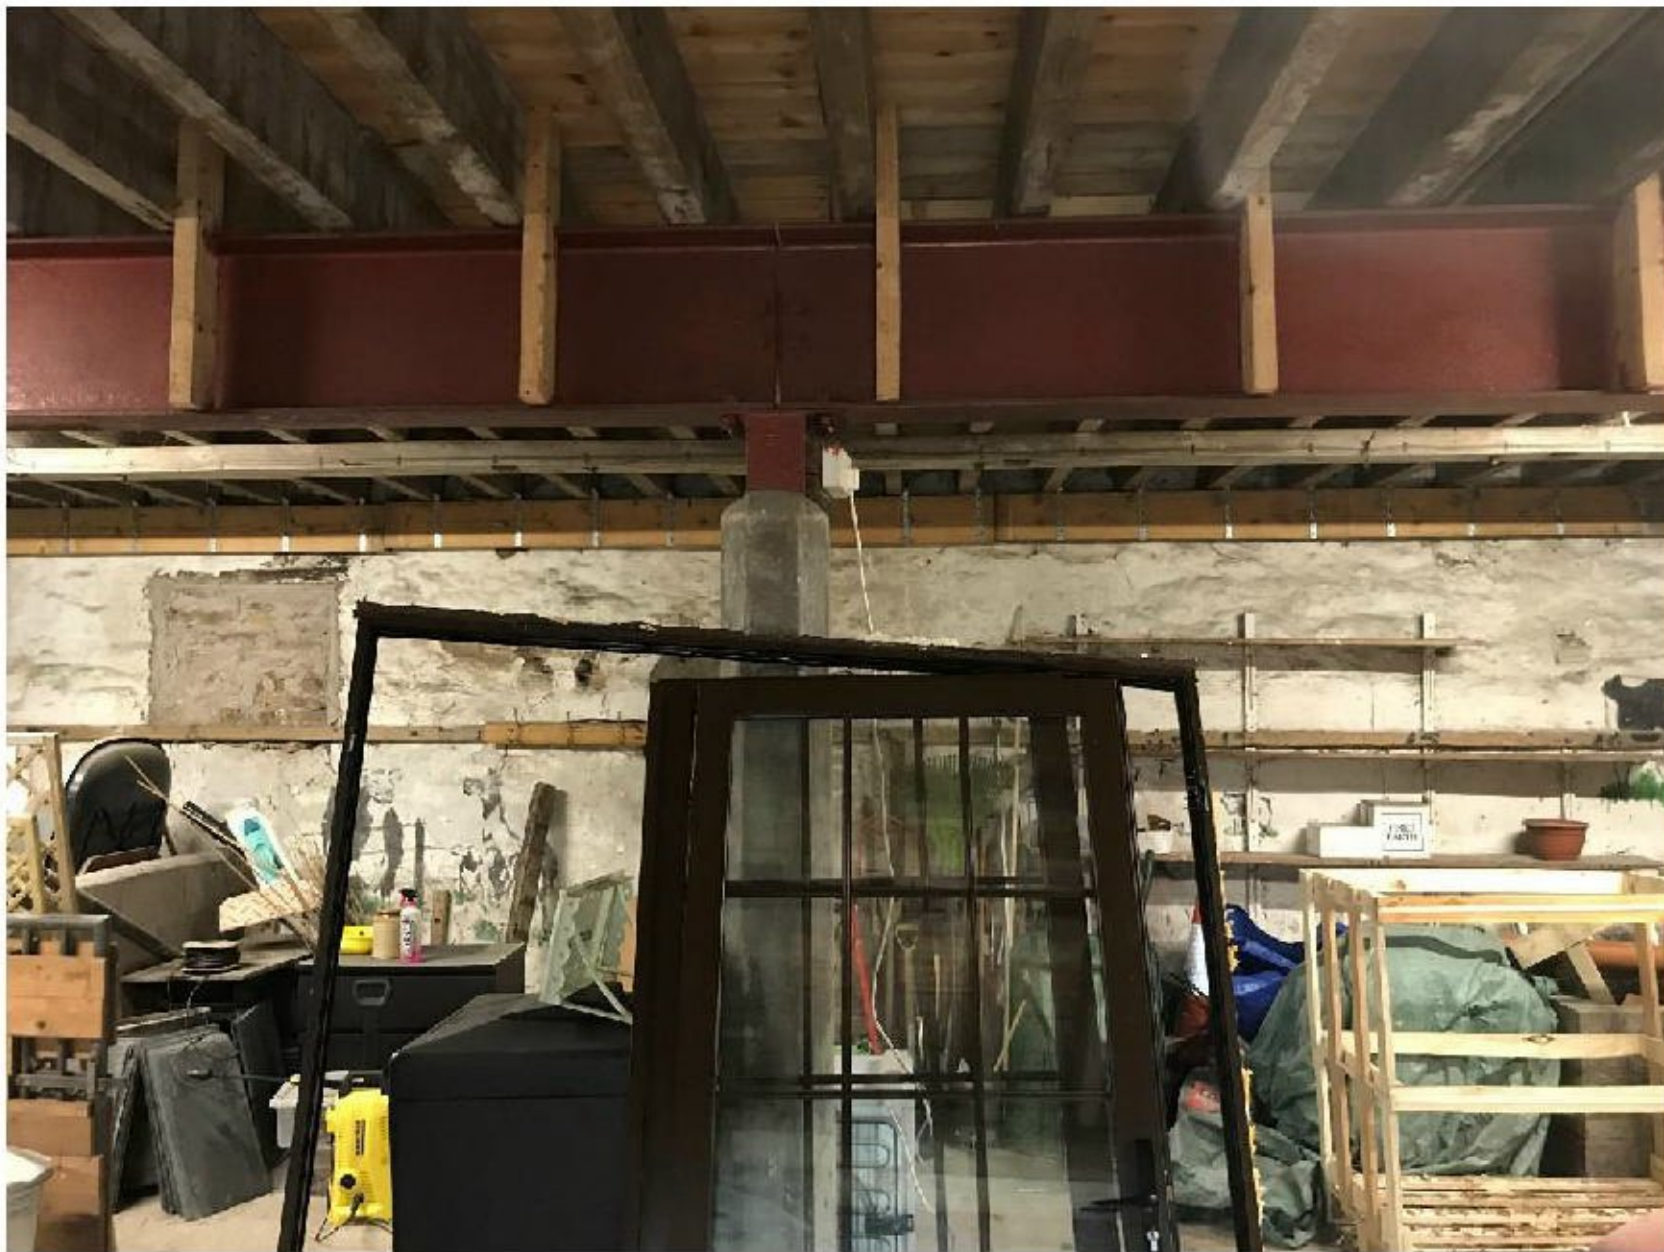
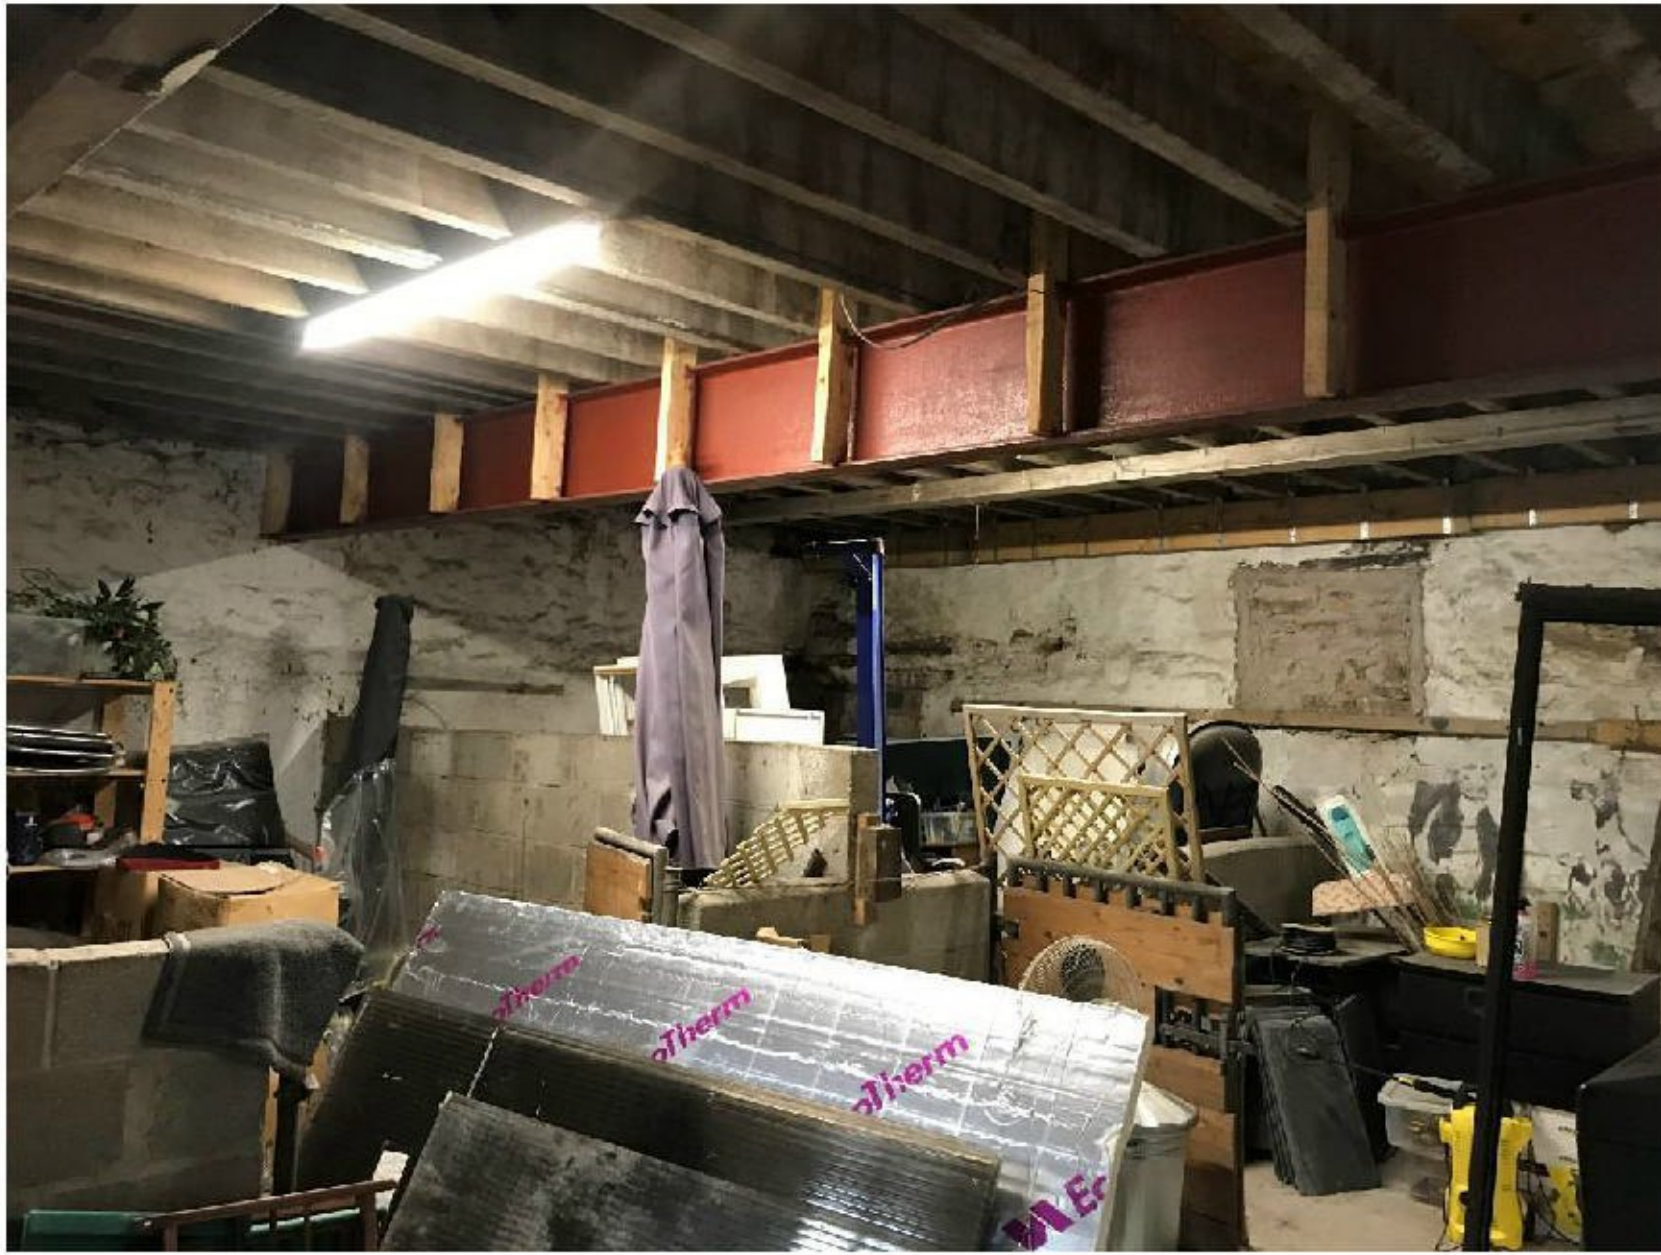
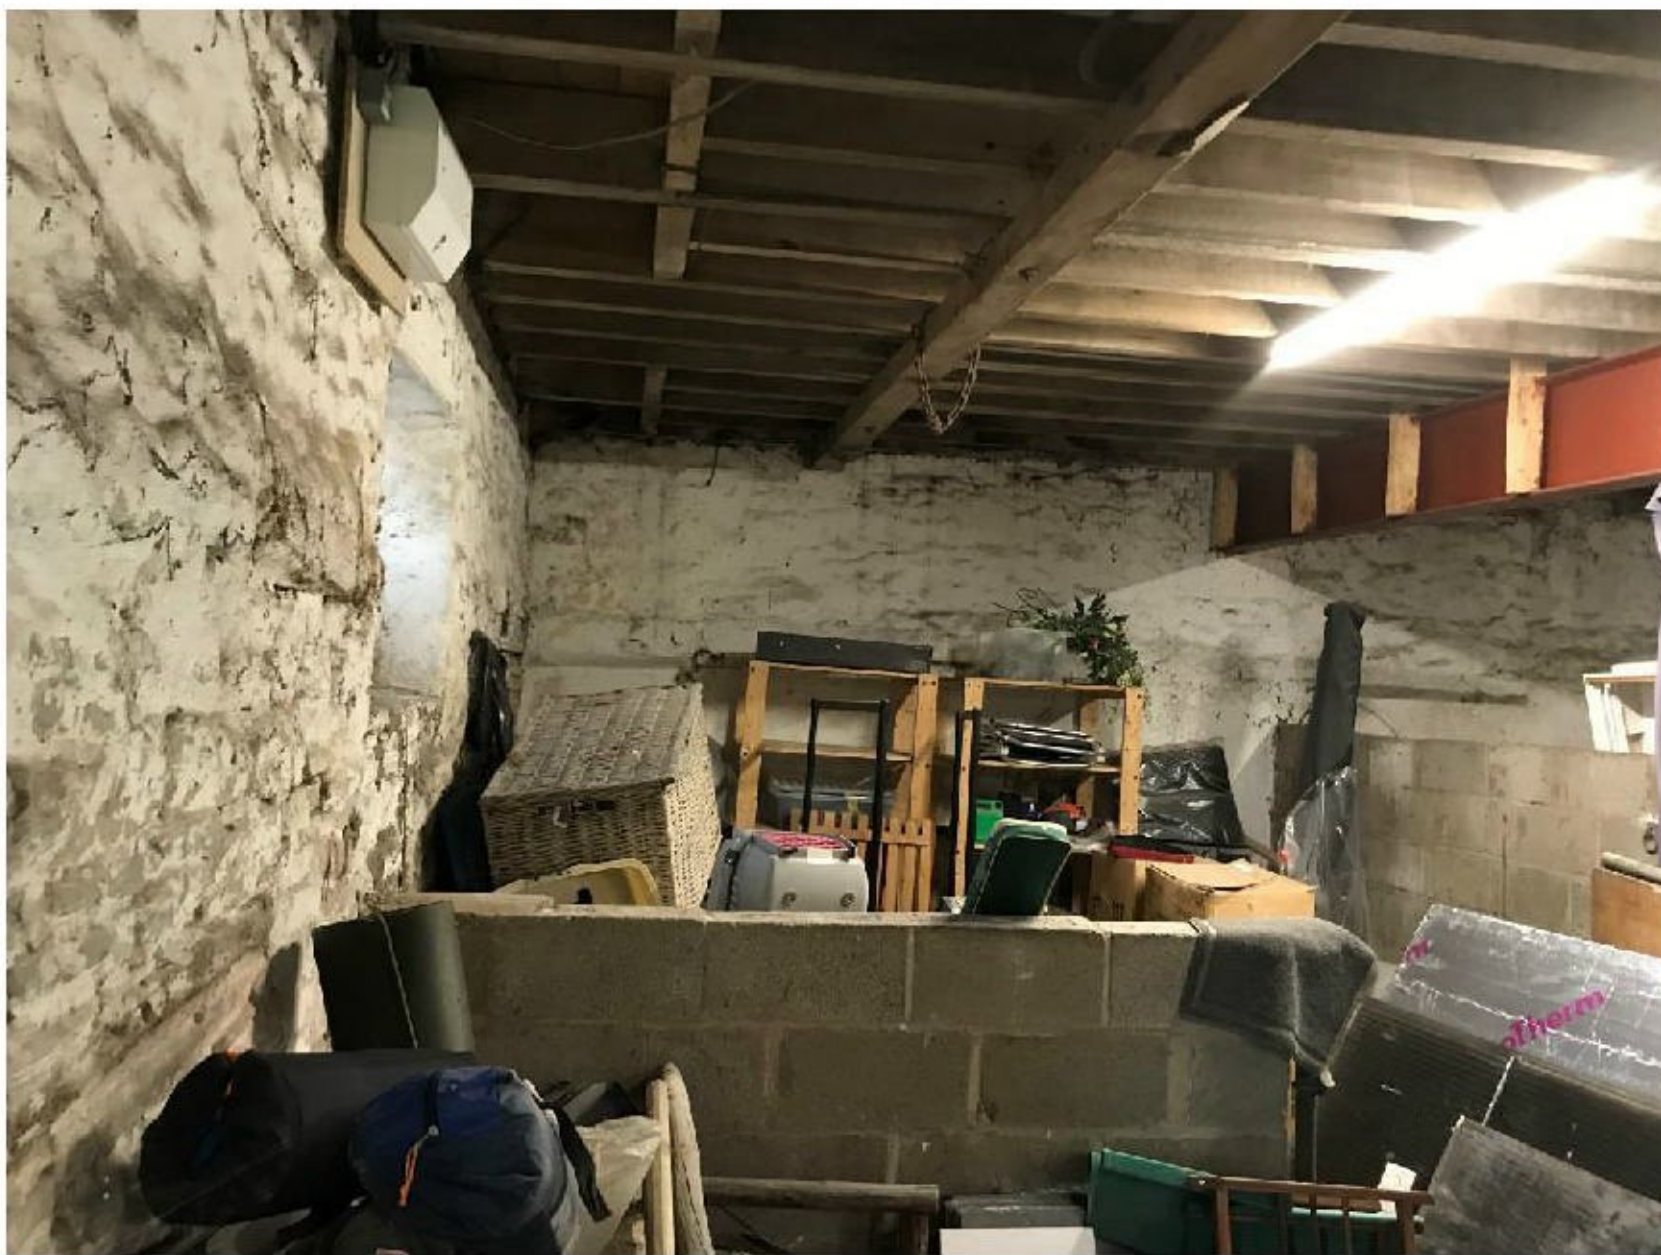
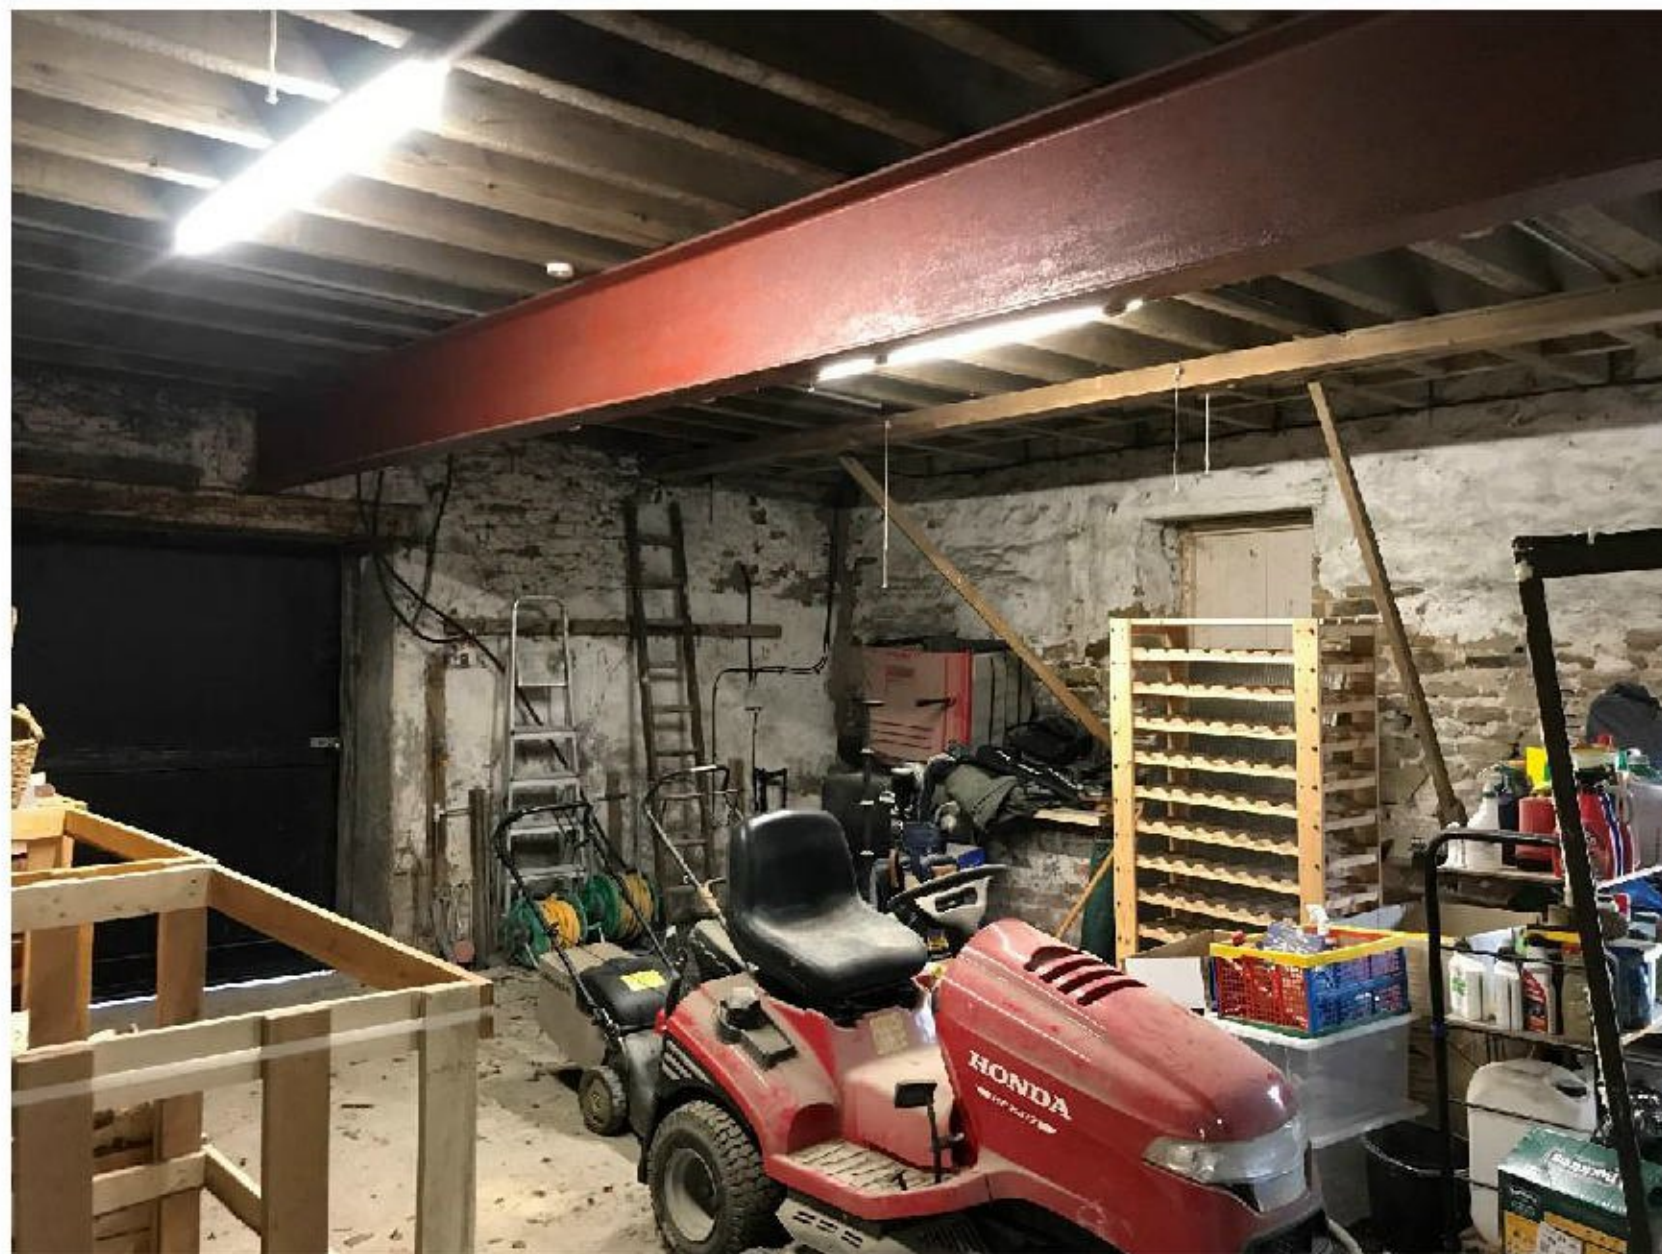
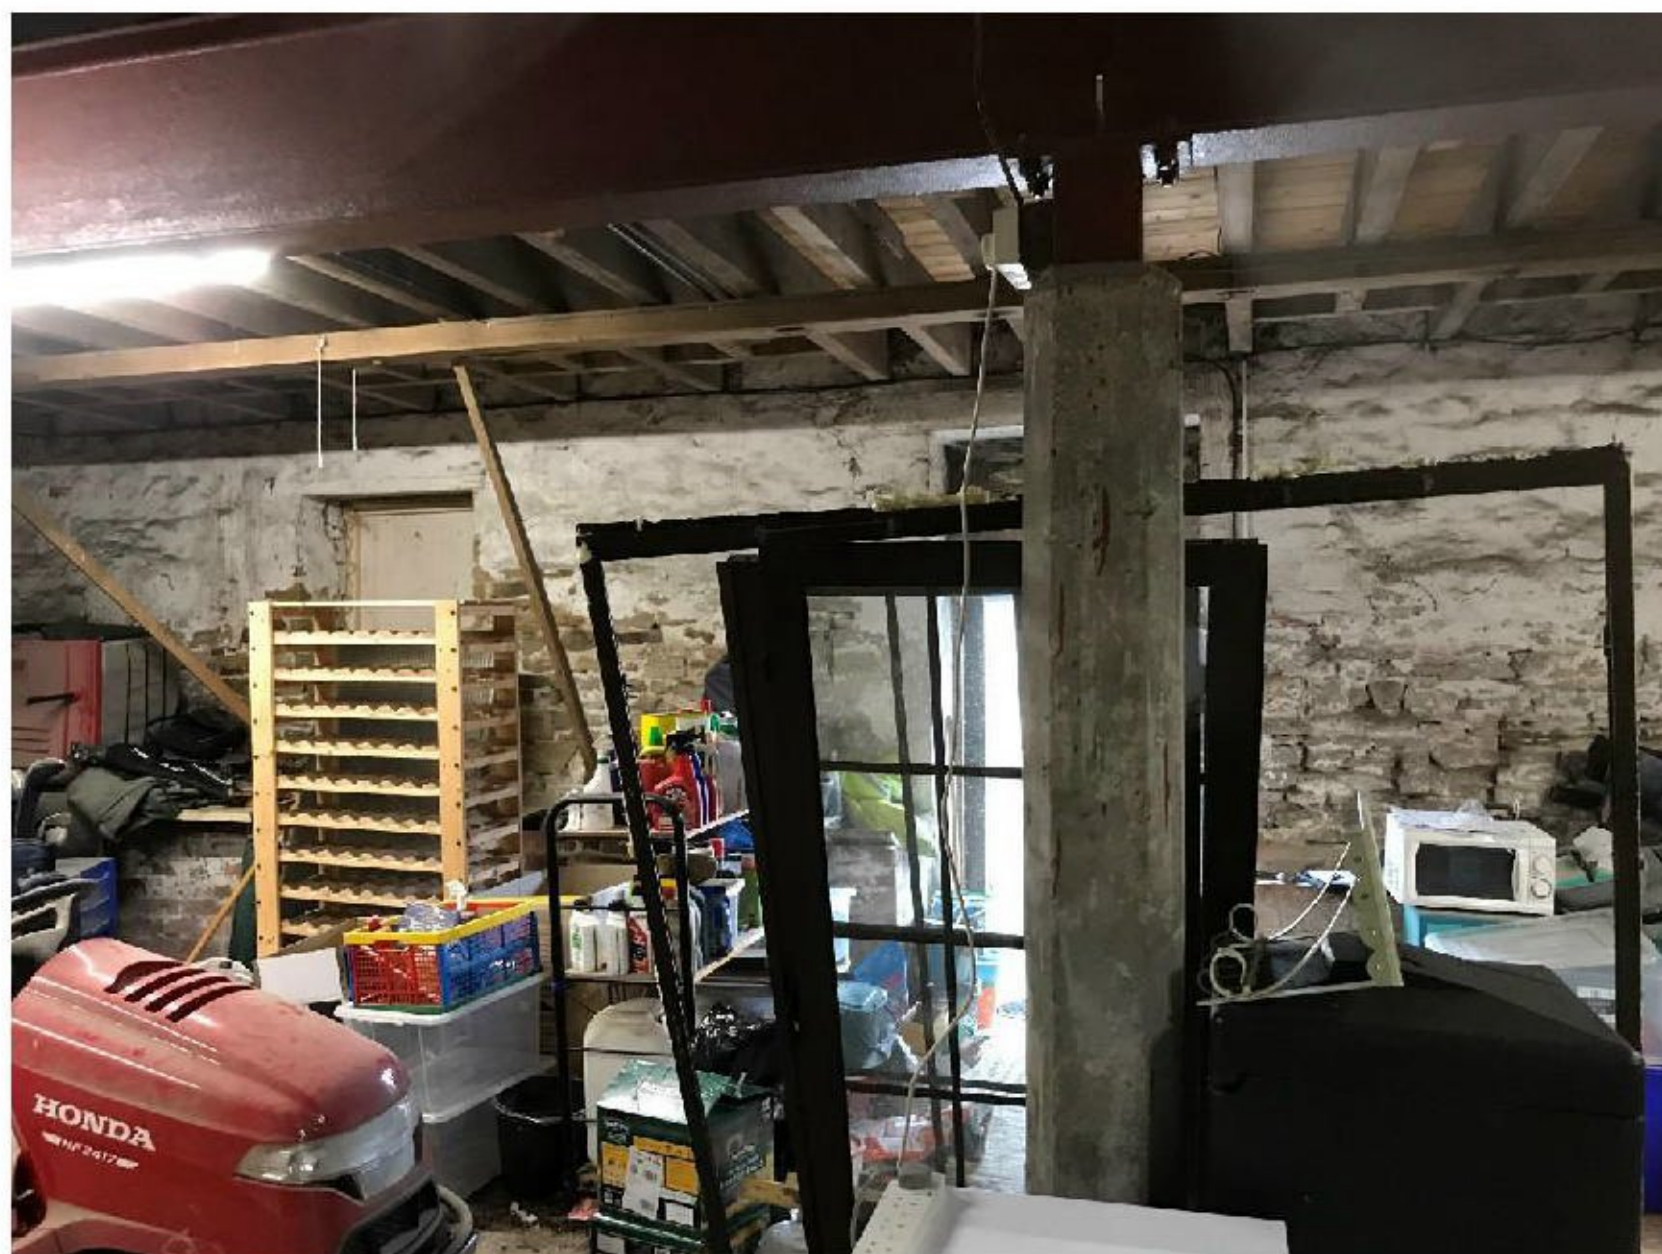
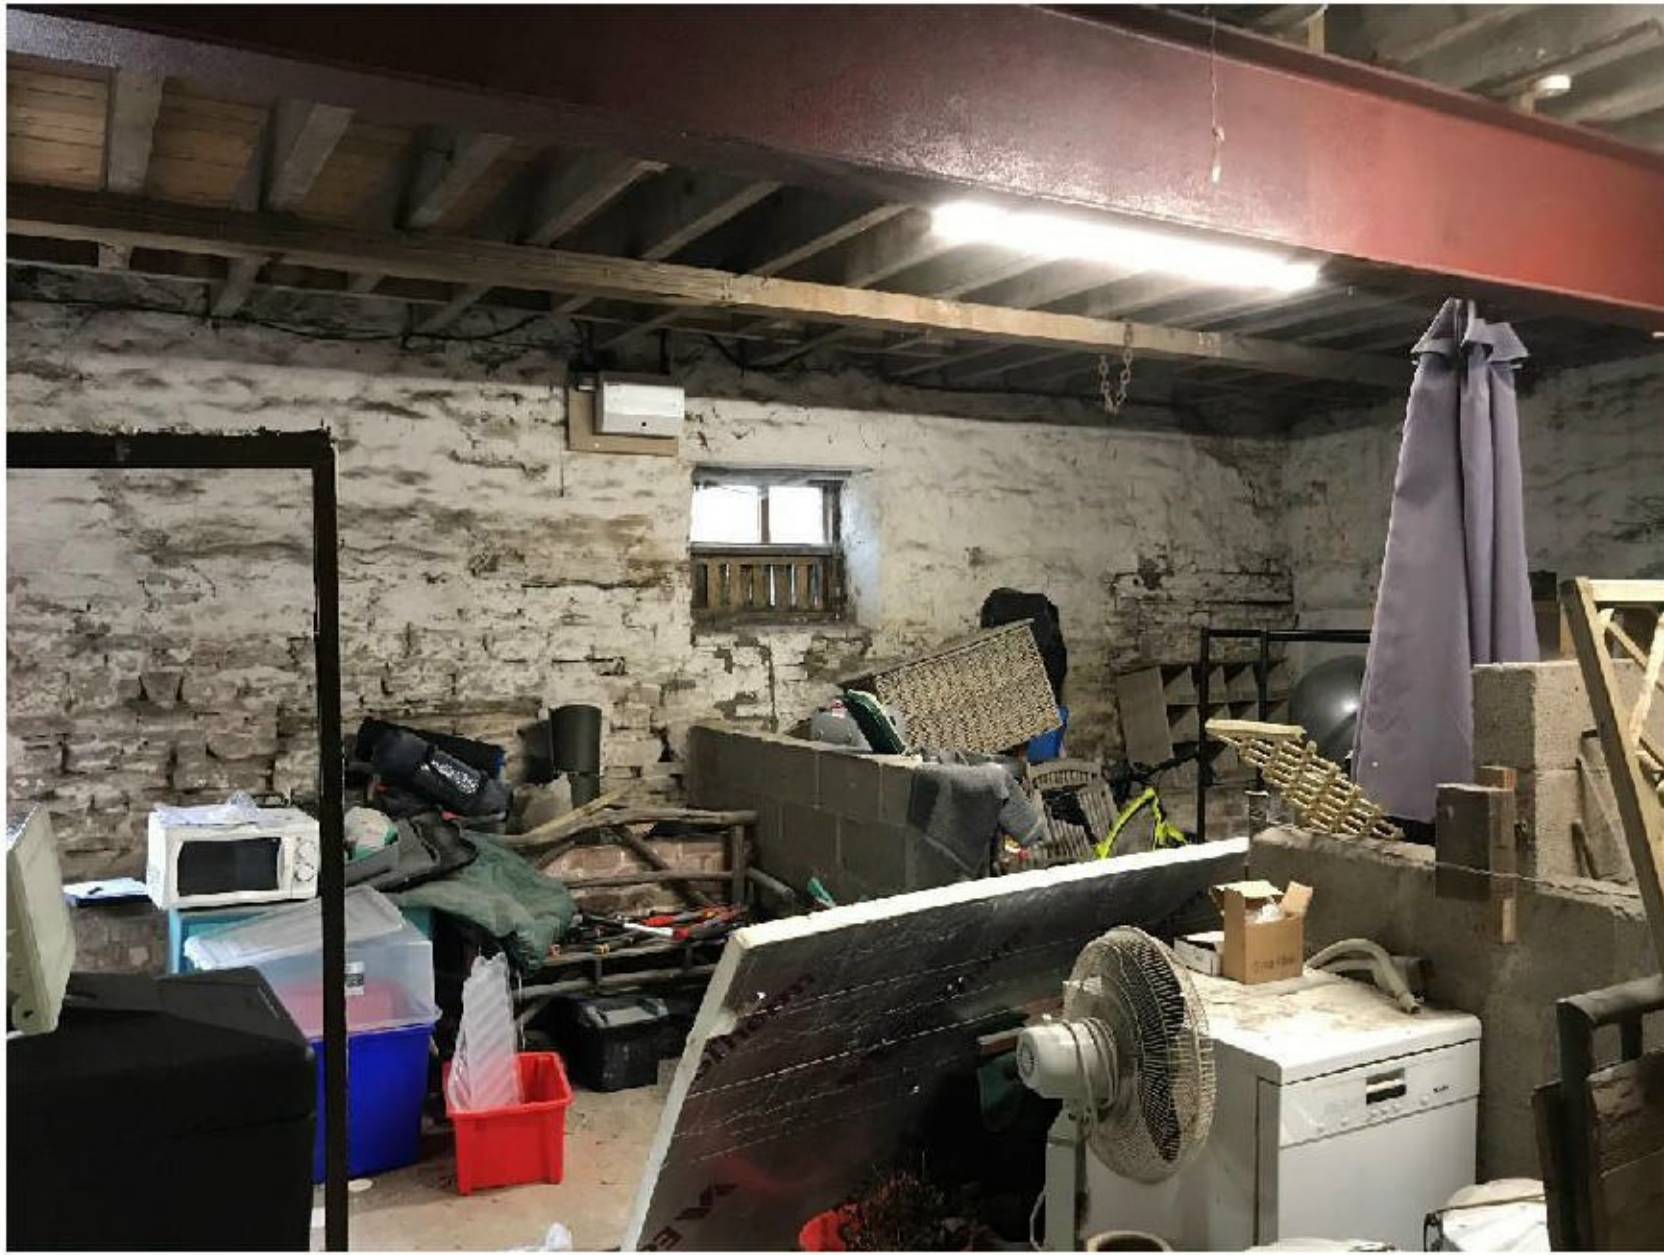
First Floor This comprises 9” x 3” timber joists at 16” centres spanning side to side with a 457 UB spine beam at mid width and running the full length of the building with a 6” x 6” steel support column at mid length. The floor has clearly been added more recently and may have replaced an original mezzanine floor to the “Hay Loft”.

The floor structure was in sound condition and could be incorporated into the plans for the conversion.

Photograph 7 First Floor Construction

Photograph 8 First Floor Construction

Photograph 9 First Floor Construction

Photograph 10 First Floor Construction

Photograph 11 First Floor Construction

Photograph 12 First Floor Construction

Photograph 13 First Floor Construction

Photograph 14 First Floor Construction

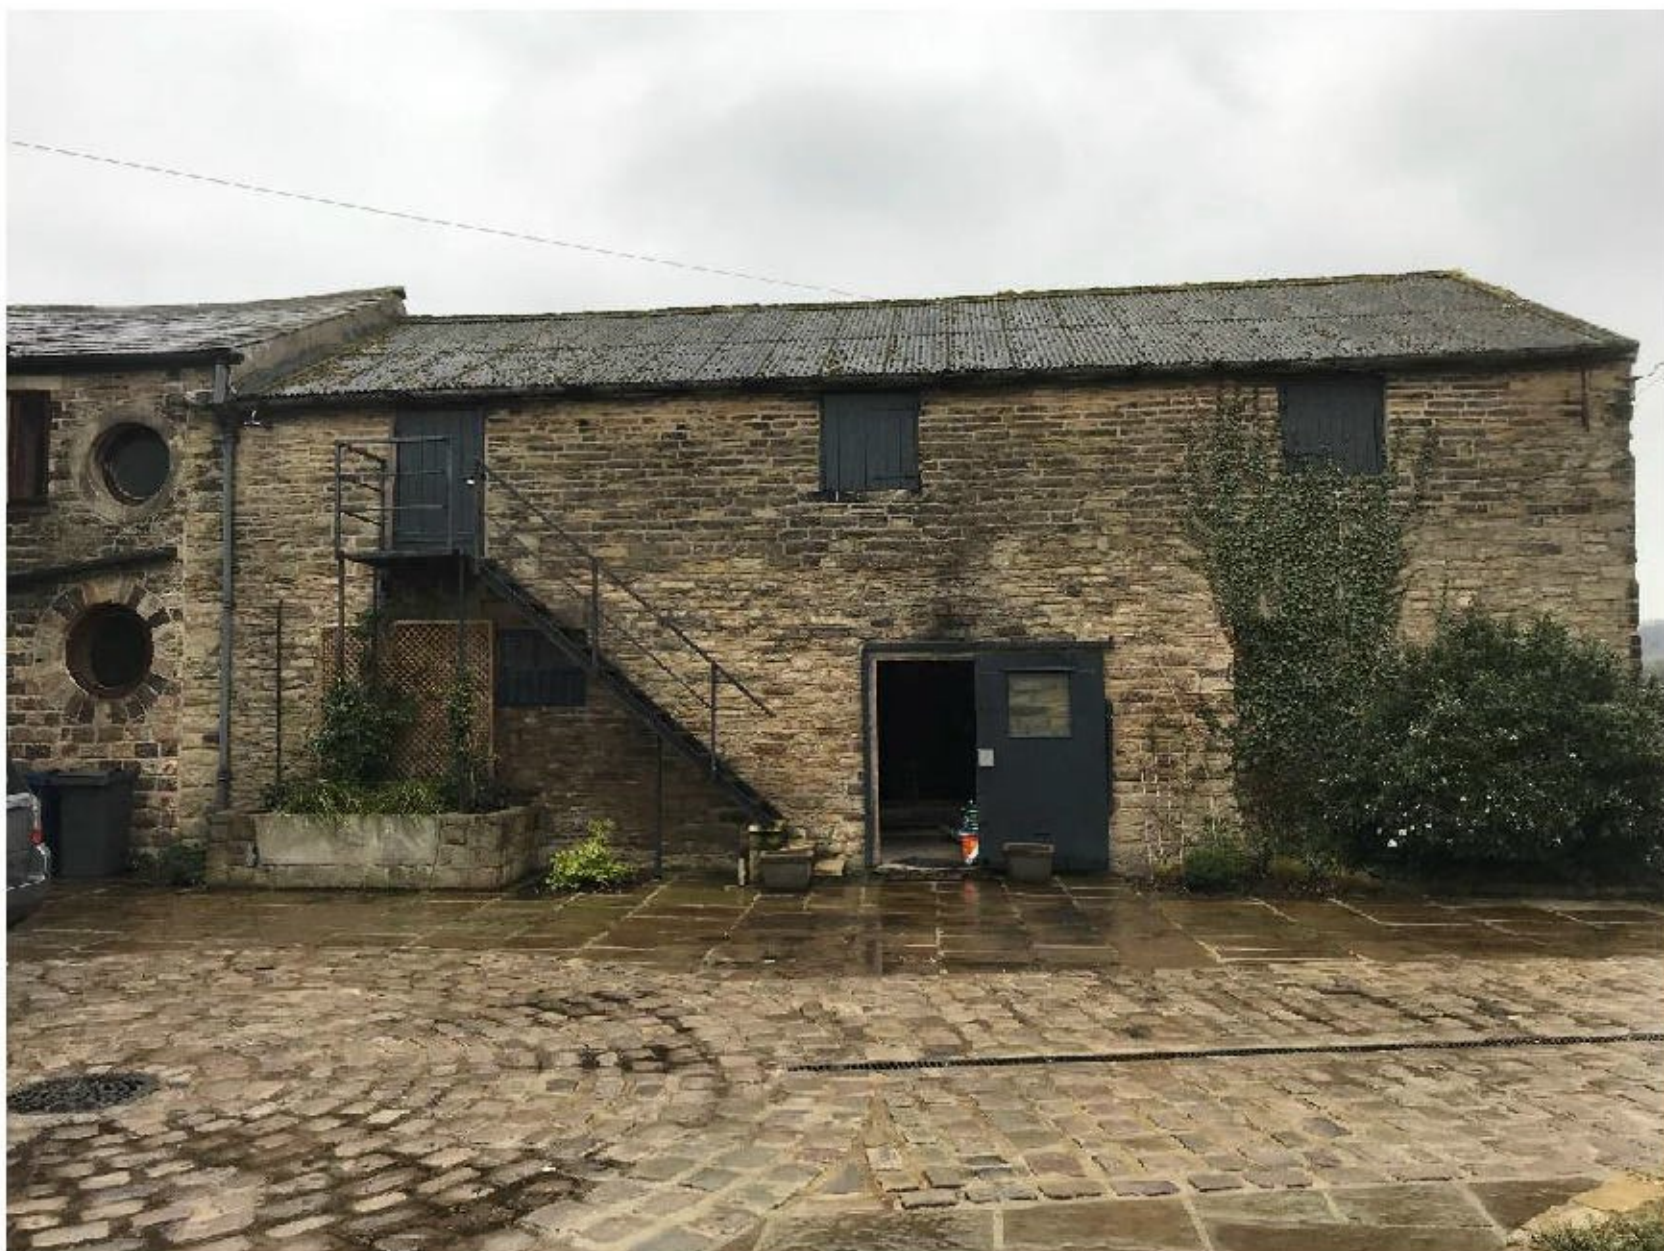
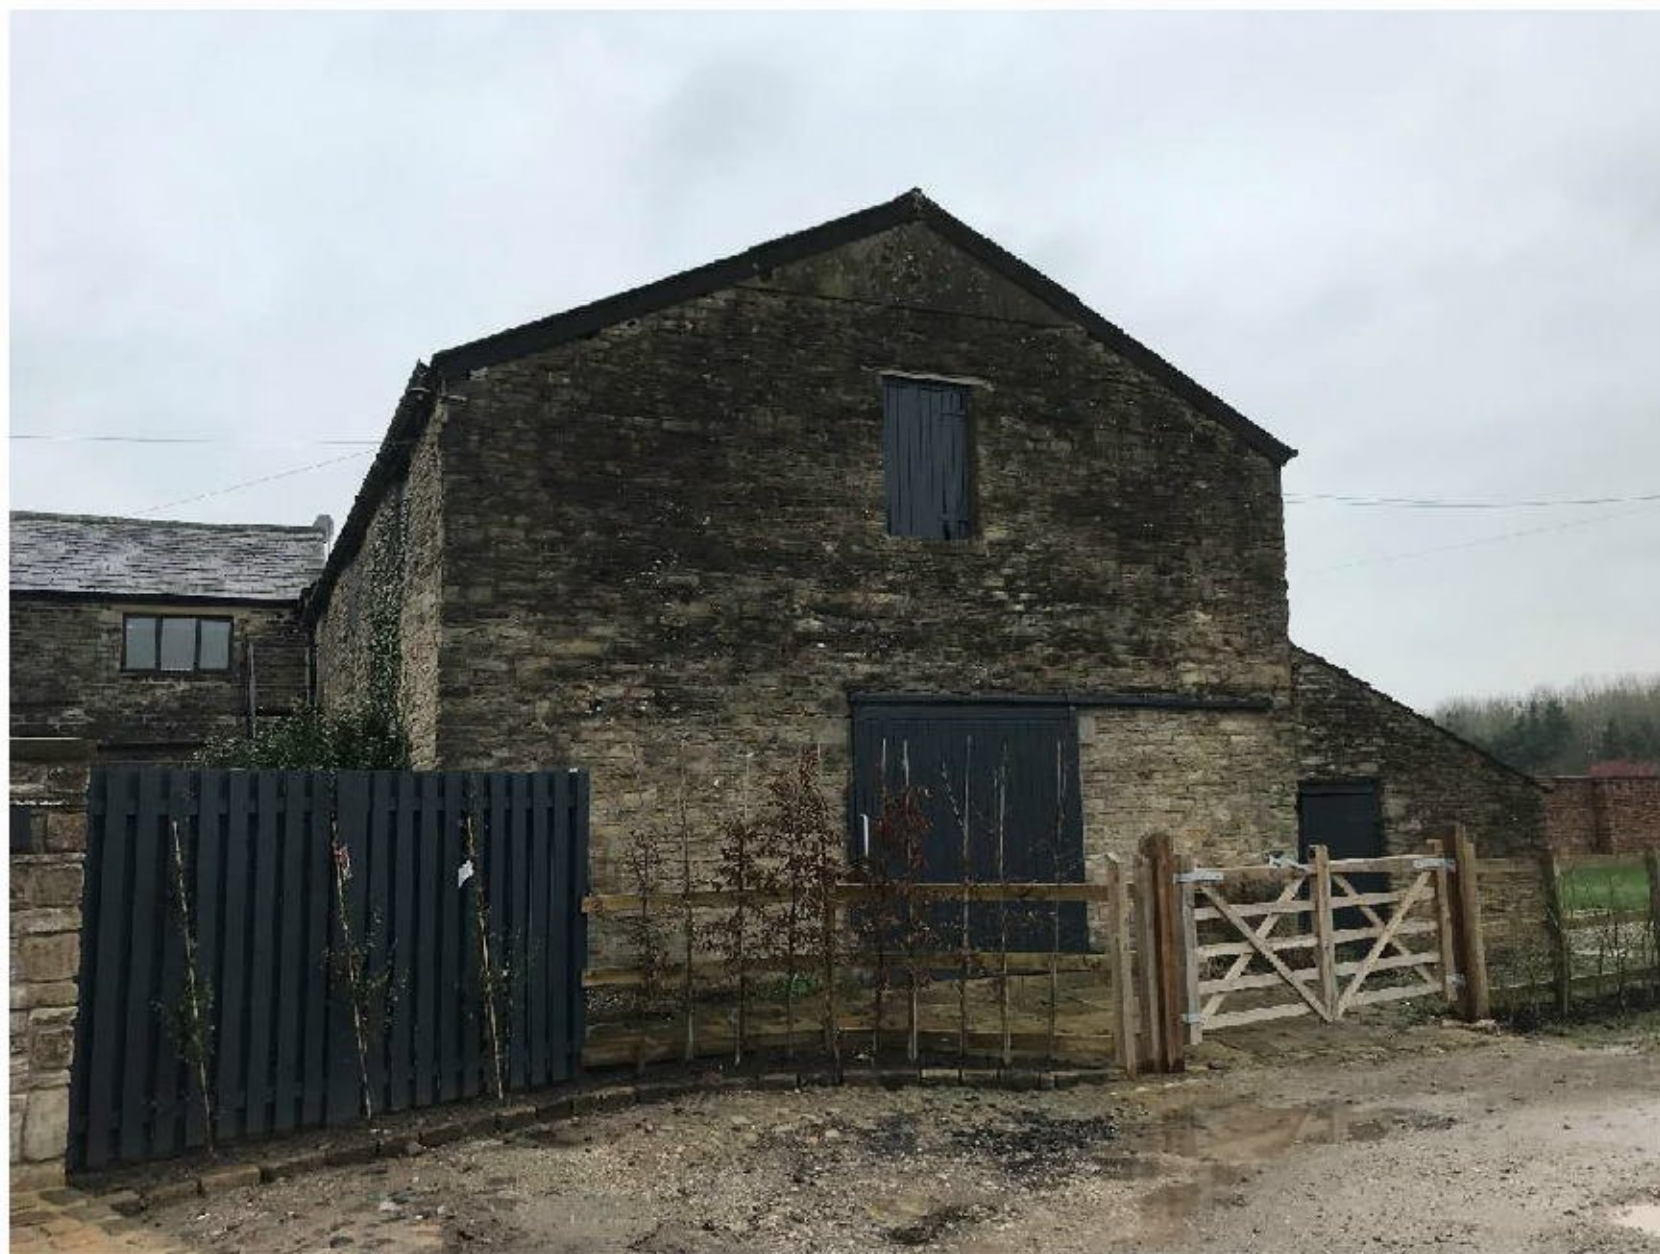
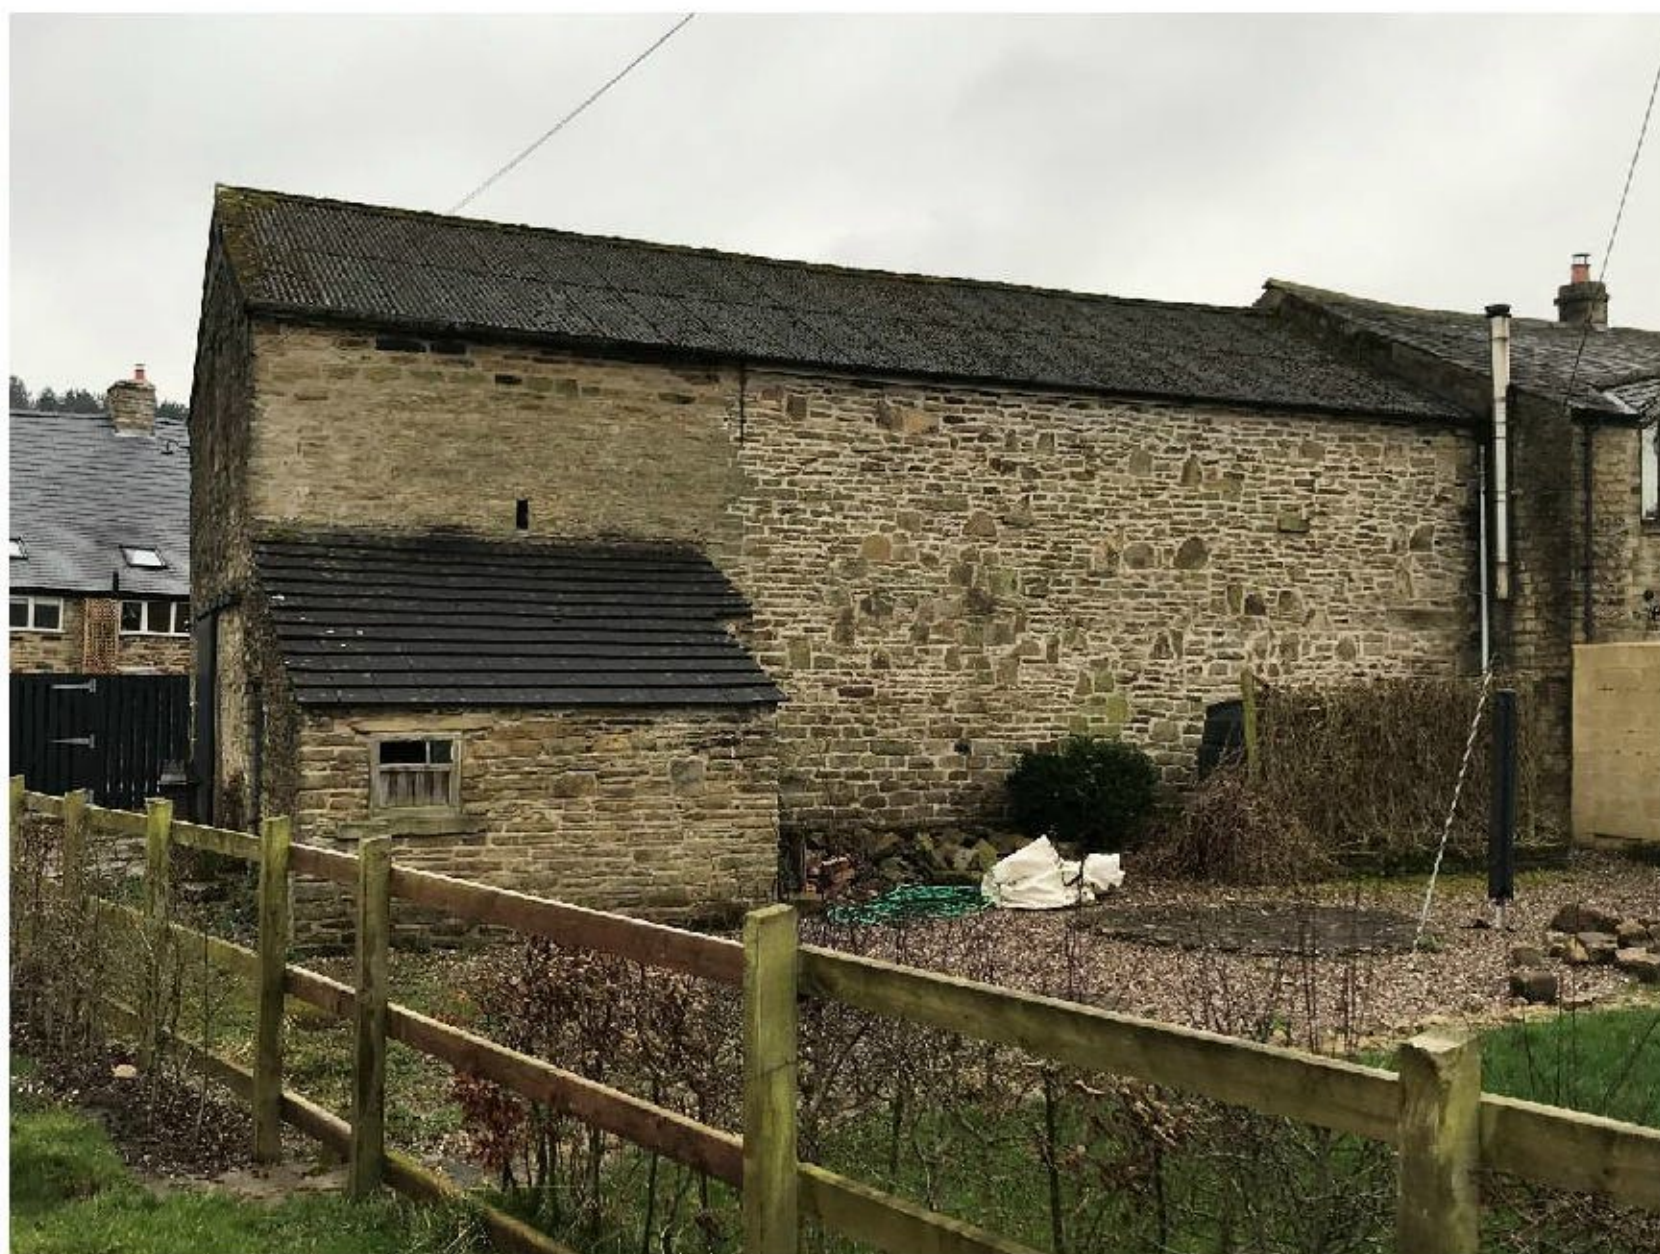
Walls Solid 600 mm thick stonework comprising an outer leaf of roughly dressed coursed stone, inner leaf of random stone and rubble infill with “through” stones.

All walls were level and plumb and displayed no evidence of movement or distress.

Photograph 15 Elevations

Photograph 16 Elevations

Photograph 17 Elevations
