Date of issue: June 2022

Ref: 2022D007/R01

> Ecological Appraisal - Bats & Buildings 13 West Street Norham

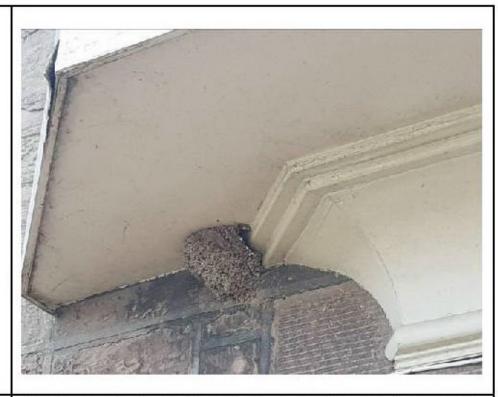
House martin have an active nest beneath the bay window of the property. Adults were observed to regularly return to feed chicks.

Photograph 2. Active house martin nest beneath bay window

- Works must not be undertaken to the bay window until the house martin chicks have fledged and the nest is no longer in use.
- Two house martin nesting cups will be installed. One at eaves height and one below the bay window after it has been replaced. These can be sourced from www.nhbs.com or RSPB.org.uk.
- The ornamental hedgerow will only be cut back over the winter months (September to February).

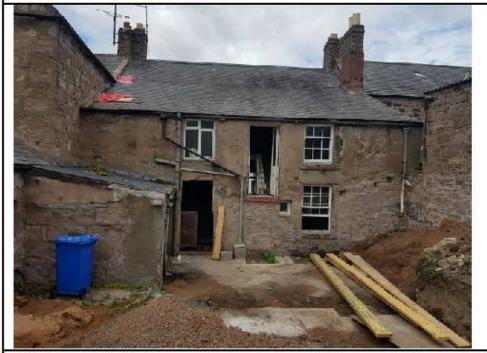
- The building is two-storey height.
- It is of stone construction with corner quoins and stone lintels/sills. The front elevation appears sound with regard to potential bat roosting locations. The rear elevation has areas of failing mortar and where rendered, some areas are lifted/flaking. There is a single area of missing mortar at eaves height.

Photograph 3. Rear of property. Staircase below central window and built structure to right of image have been removed. Shallow mortar gaps can be seen

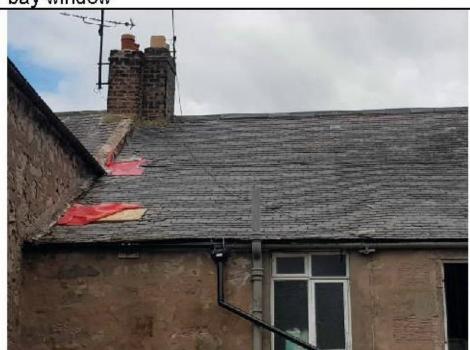
Photograph 4. Roof tile damage at rear

- Works to strip the lower roof coverings over the rear of the building will ensure that all stripping of lifted, missing, slipped or broke tiles is undertaken by hand. Each tile must be lifted and turned to ensure no bats are present beneath these features. Following inspection, the tiles can be discarded.
- Should bats be discovered, all works must stop and the project ecologist must be contacted immediately on 07737719536.

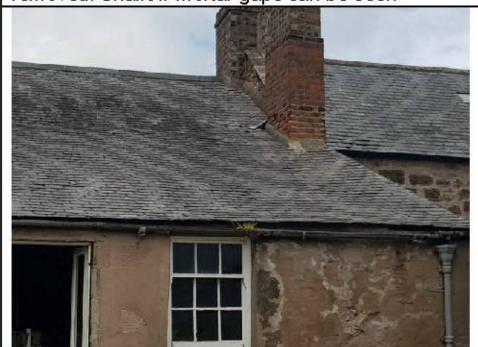
- There are three chimneys remaining. These are of brick construction. Some mortaring has worn away but does not appear to create gaps or holes suited to roost use. Where the chimneys connect to the roof, mortar appears sound. There is a single area of lifted lead flashing.

Photograph 5. Examples of slipped and lifted tiles as well as lifted lead flashing at rear

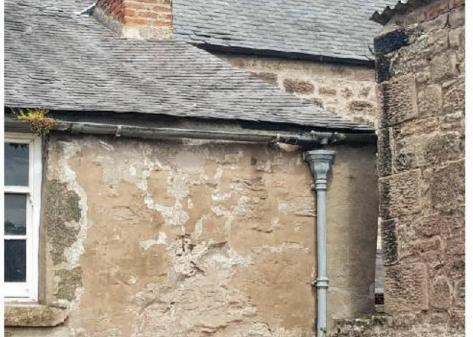
Photograph 6. Section of missing mortar at eaves height behind drainage stack.

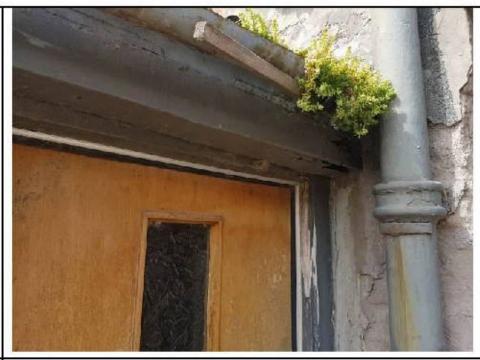
- The single-storey rear section has a corrugated metal mono-pitched roof and the stone elevations are rendered. Above the rear entry door there is a small soffit box. This is constructed of wood and has deteriorated significantly, leaving an access gap into this feature. There was no evidence of bat use associated with this soffit.

Photograph 8. Hole into soffit box above rear door

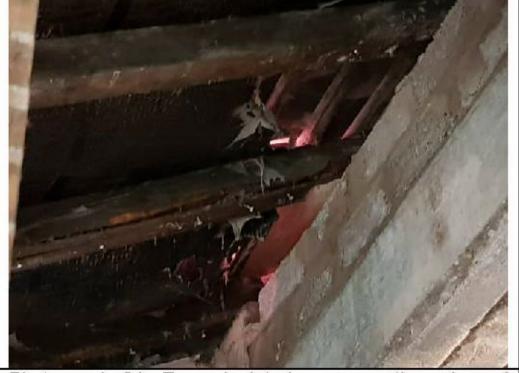
Photograph 21. Example interior access through roof coverings to exterior
