# TECHNICAL NOTE

**Job Name:** Little Stour

**Job No:** 331101000.100.00061

**Subject:** Summary of Little Stour tree survey results.

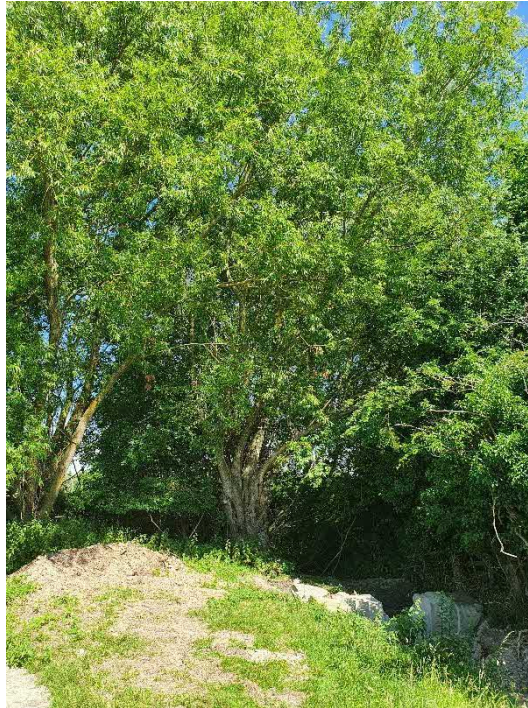
Figure 3: Tree T1 photographed from the south looking north.

Willow T1 is located in the rear garden of Littlebourne Water Mill approximately 86m west of the main house and 11m south of Nargate Street to the north. The tree is mature and in poor structural condition. Several large cavities were identified on the north and south sides of the stem and resonated hollow when struck. Decay appeared to be progressive with wood discolouration and low levels of reaction growth. The decayed stem supports a heavy canopy with long limbs and healthy leaf growth which increases the likelihood of failure.

The tree (T1) should be removed for reasons of sound arboricultural management. There is a history of failed willows within the same line of trees south of Nargate Street. The tree is in poor condition with several large cavities on all sides of the stem which increases the likelihood of collapse.

The tree should be removed within six months from the date of survey.

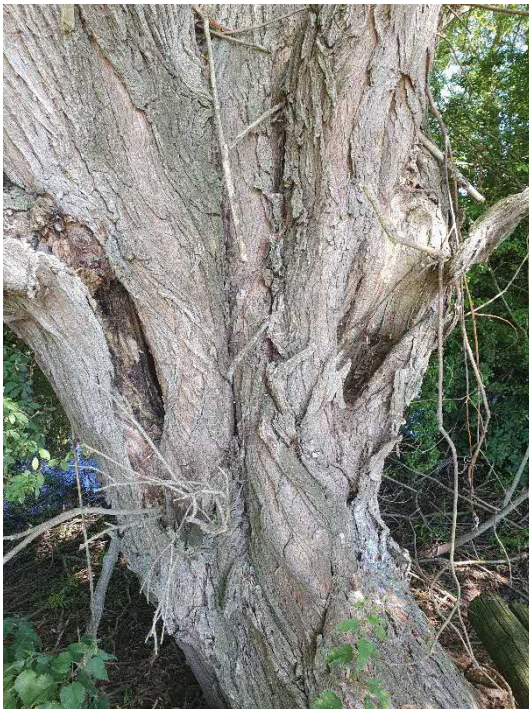
Figure 4: Cavities at limb removal/failure points on south side of stem

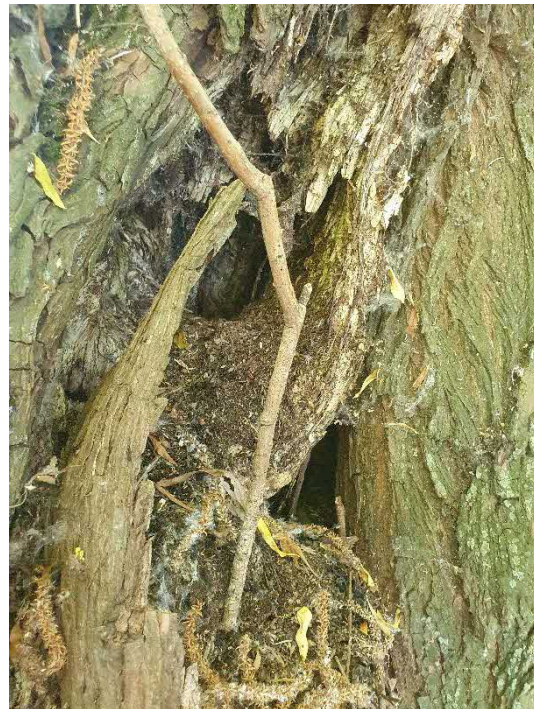
Figure 5: Cavities and decay at base on north side of stem
