REPORT ON TWO BARNS,
 SHORNHILL FARM,
 SHORNHILL,
 WITHINGTON
 GL54 4BJ

JOB NUMBER 22 / 159
CLIENT Mr P O'Sullivan
DATE 8th June, 2022

Section	Title
1.00	Preamble
2.00	Structural Form and Condition
3.00	Stability Considerations
4.00	Conclusions
Appendix A	Photographs A - J

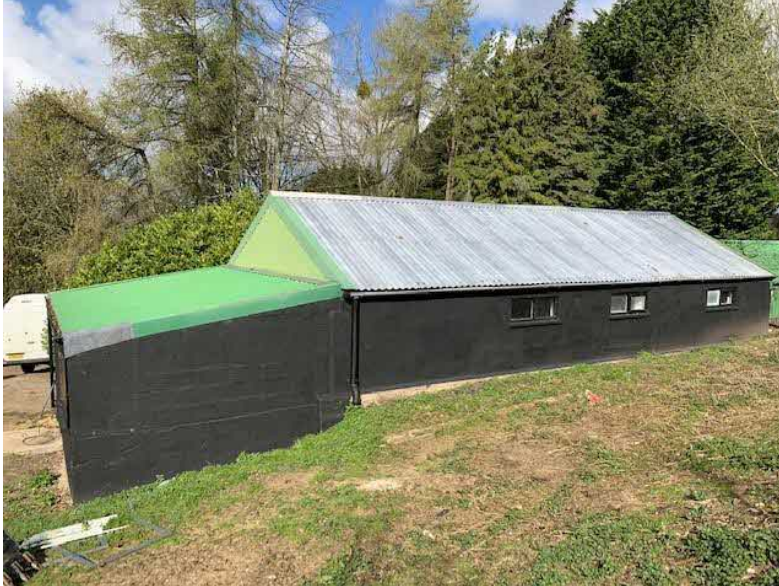
Building 1 -- larger structure to the south [Plate A]

PLATE A – GENERAL VIEW FROM EAST

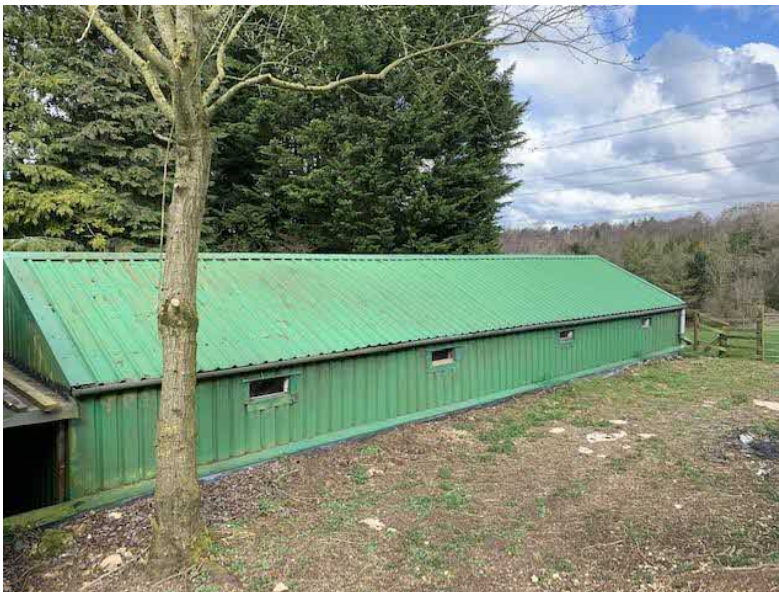
Building 2 -- smaller structure to the north [Plate B]

PLATE B -- GENERAL VIEW FROM EAST

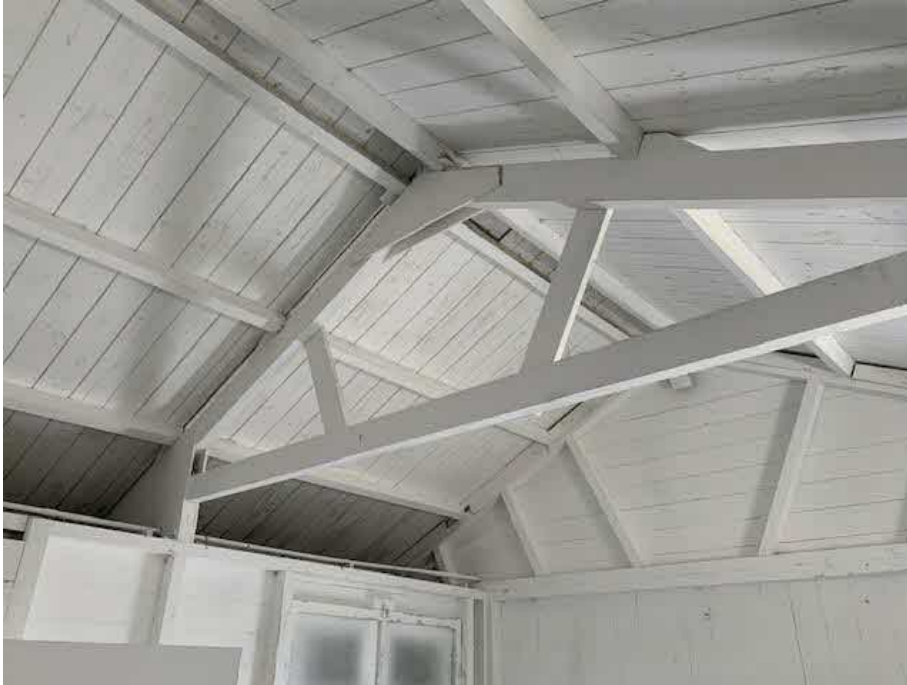
The roof structure comprises a series of fabricated timber trusses spanning the narrow width of the building. [Plate C]. The truss members are sawn timbers connected to each other with truss plates and bolted joints to create the roof shape with a slightly raised bottom tie to increase the internal ceiling height. [Plate D]. The roof is covered with corrugated sheeting supported on timber purlins spanning between the trusses. The purlins are securely fixed to the trusses and the roof soffit is timber boarded.

The roof structure will comply with current Codes of Practice due to the purlin and truss member sizes.

PLATE C -- ROOF STRUCTURE OF FABRICATED TIMBER TRUSSES

The roof can be retained and will probably benefit from enhanced fixings to the two side walls in the form of simple metal straps secured internally.

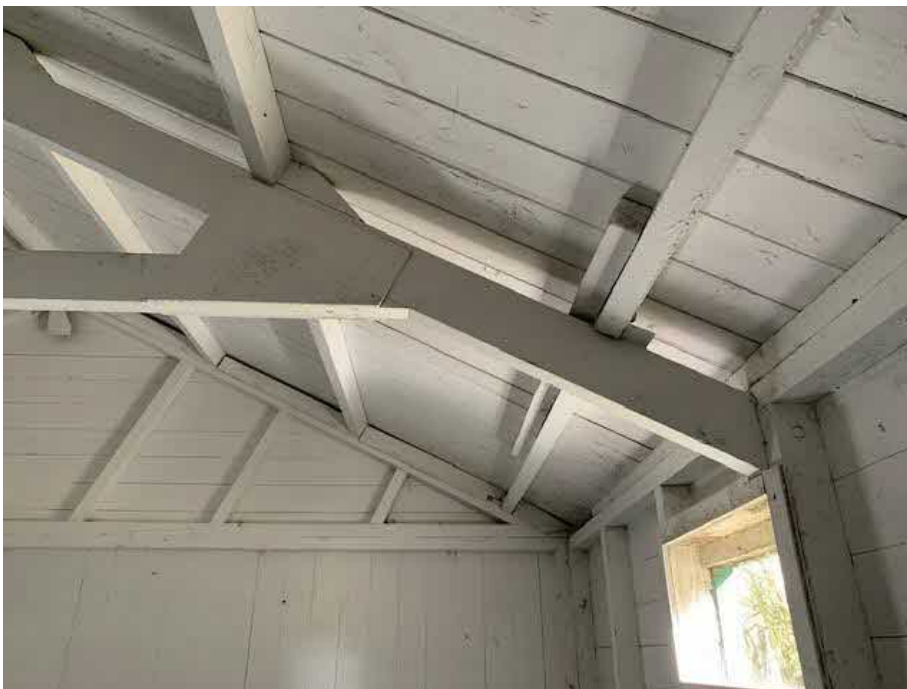
The trusses are secured to the tops of the front and rear walls with metal fixings into a timber plate which appears to be screwed or bolted to the top of the masonry.

PLATE D -- RAISED TRUSS TIE AND WALL CONNECTION

Consideration might be given to locally enhance the fixings of the trusses to the external walls and this can be simply completed internally without removing any of the existing roof cladding which will remain.

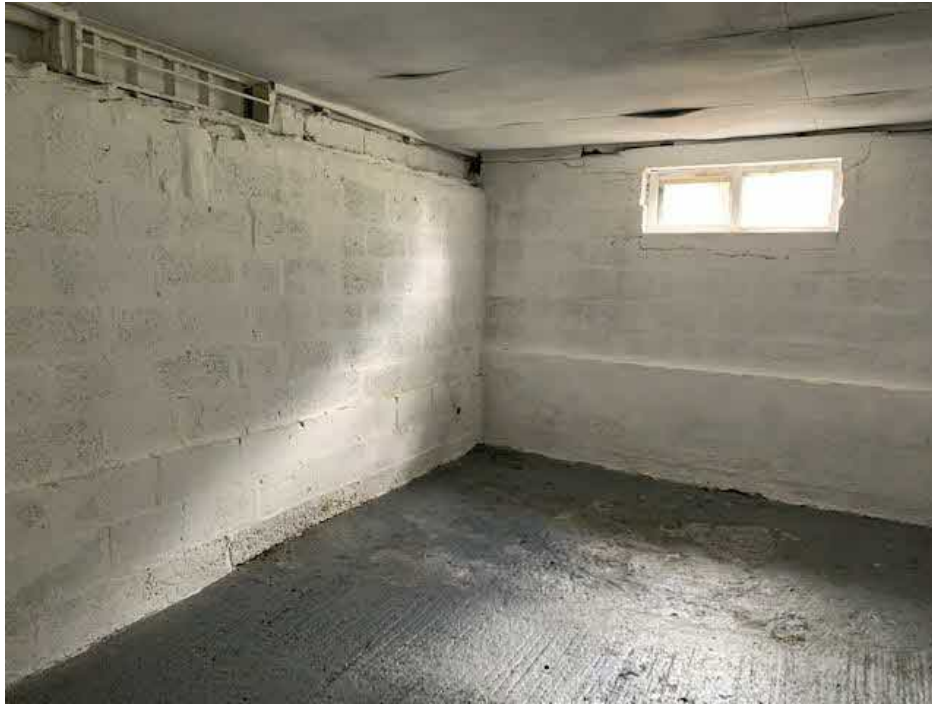
The perimeter walls comprise at least 215mm thick solid blockwork masonry at the eastern elevation [Plates E and F] and 100mm thick solid blockwork masonry with externally projecting masonry piers spaced at fairly equidistance intervals along the other walls – the purpose of the piers is to ‘stiffen’ the general 100mm blockwork. [Plates G and H]. The walls are rendered externally.

PLATE E -- EXTERNAL AND INTERNAL WALLS

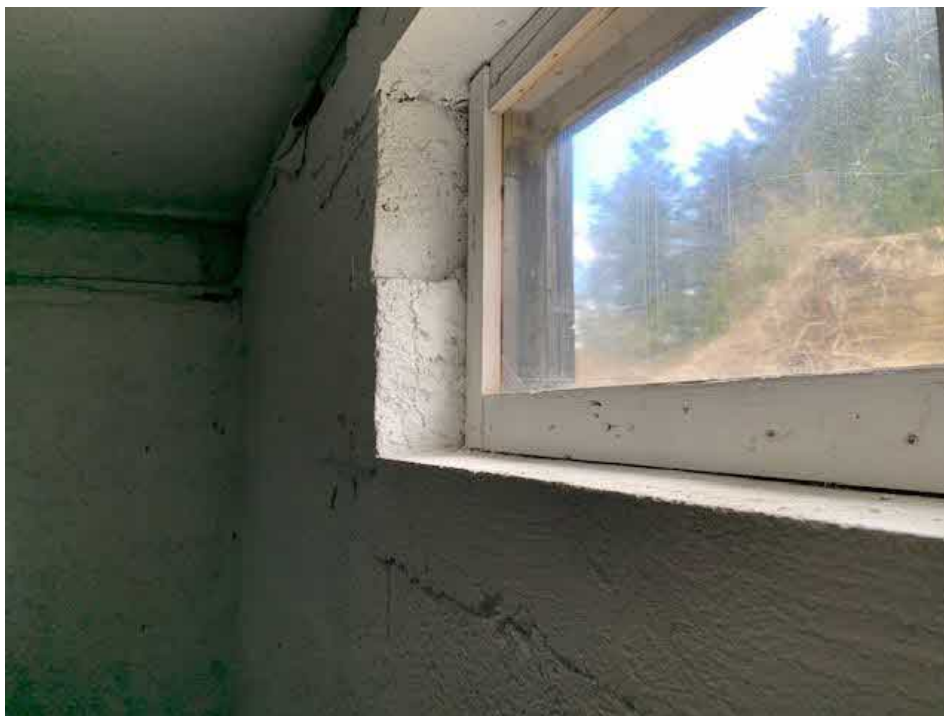
The eastern side wall is clearly acting as an adequate retaining structure due to the total absence of damage in it.

PLATE F -- EXTERNAL WALL THICKNESS AT EASTERN ELEVATION

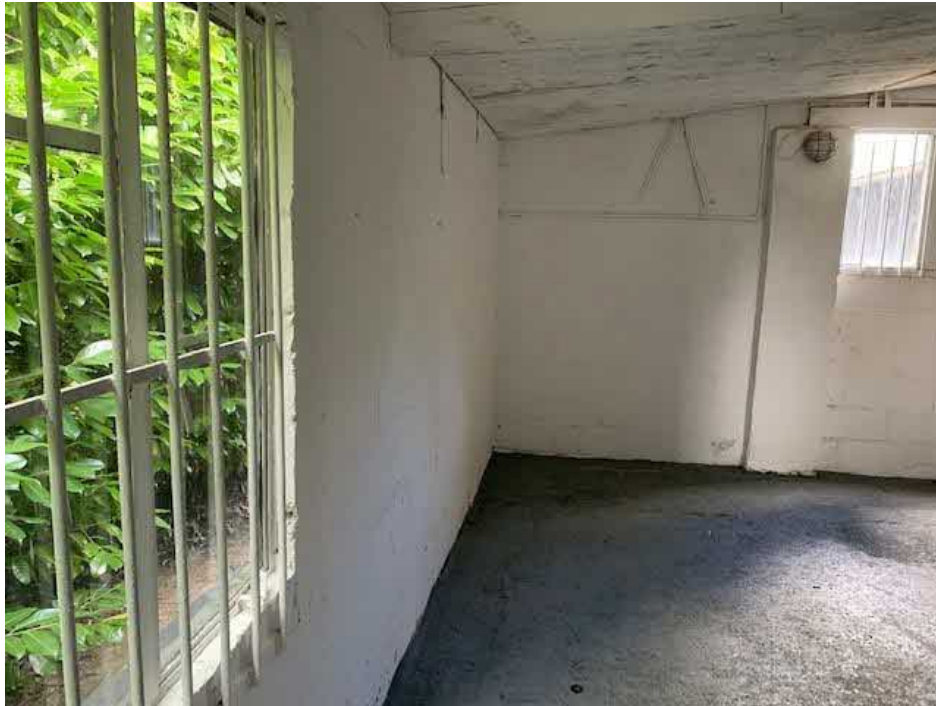
The slenderness [height / thickness ratio] of all walls [including those stiffened with external piers] is within the limitation set out in the British Standard Code of Practice for Unreinforced Masonry [BS5628 – Part 1].

PLATE G -- EXTERNAL WALLS

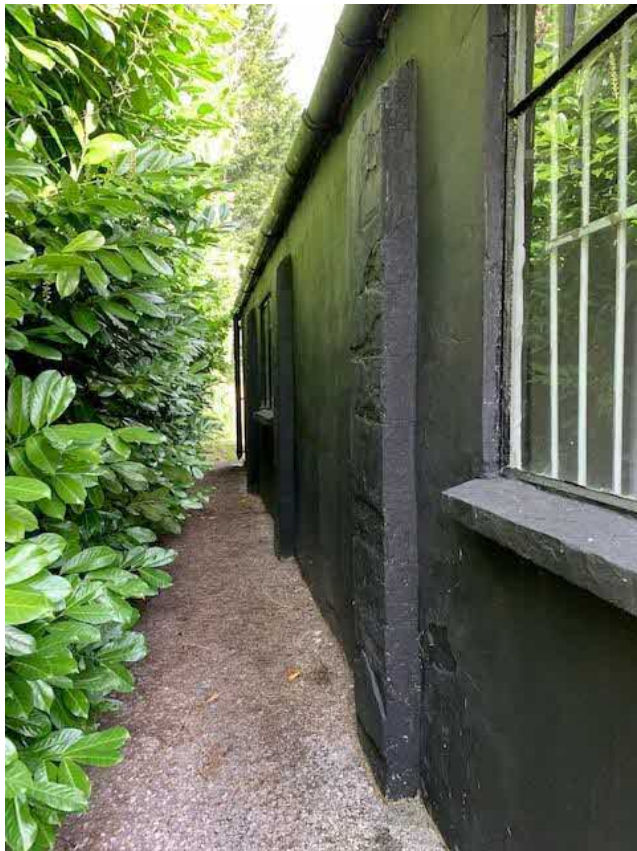
PLATE H -- EXTERNAL STIFFENING PIERS

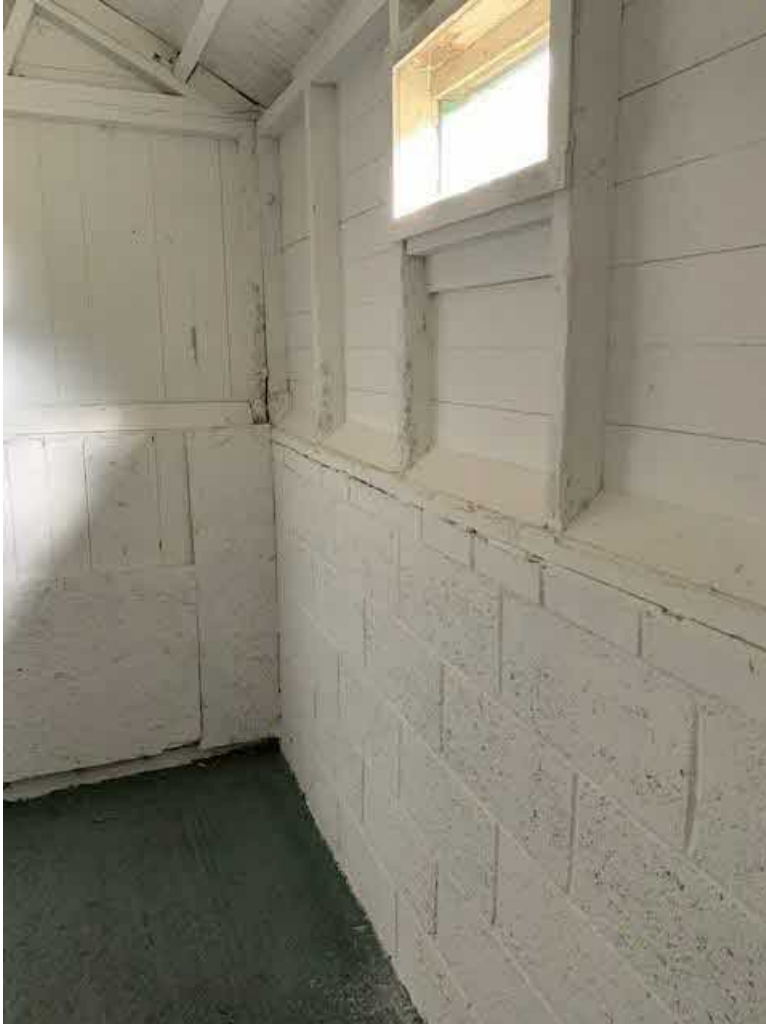
The walls comprise solid blockwork masonry varying in thickness between 100mm and 215mm but without stiffening piers. The masonry extends to about half height with timber studding above. [Plate J]. The walls are clad with profiled metal sheeting.

PLATE J -- EASTERN WALL
