Tree Works Assessment
Cloister Park, Frithelstock, Torrington, EX38 8JH

Instructed by:	Steve Hart Cloister Park Frithelstock Torrington EX38 8JH
Compiled by;	Bruce Macfarlane, MArbor A, P Dip Arb (RFS)
Date:	9 th June 2022
Report ref:	CTC09062022TPO

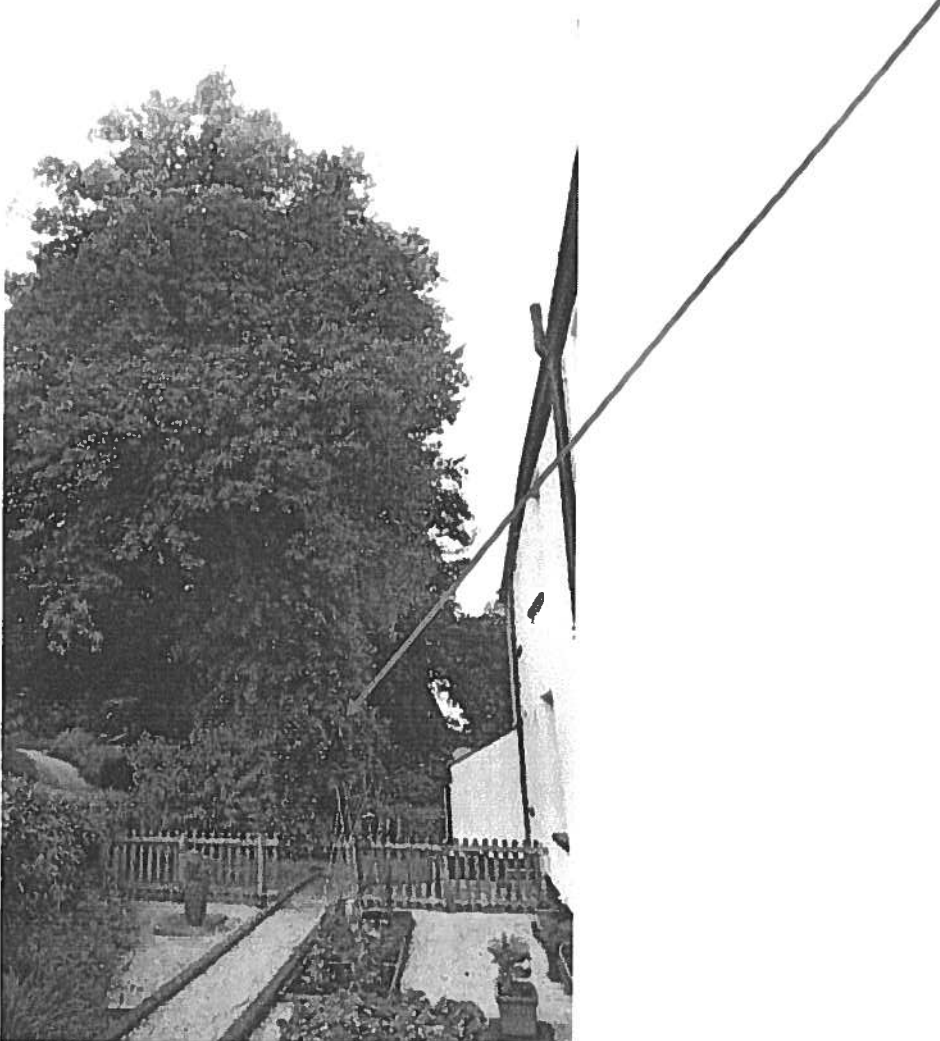
4.3 As is typical of the species the tree has epicormic growth around its main trunk and up into the canopy of the tree with new twiggy growth on all main branches. The lower epicormic has been cut back on a regular basis to keep it under control. This excessive new growth means the canopy of the tree is very dense with little light or wind reaching the centre of the tree.

4.4 Due to its position of the tree towards the corner of the house it is exposed to the prevailing winds that come across from the coast. These high winds are a concern to the occupants of the property and the tree regularly drops small branches in high winds. The restricted rooting zone means there are concerns the tree could fail at the root plate in these winds.

Photo 1: Lime tree to the south of the main house at Cloister Park with dense epicormics growth.

5.1 This is a large healthy lime tree close to the main house at Cloister Park, the rooting zone of the tree is not a large area due to the road and the closeness of the property. Due to the very thick foliage and height of the tree the tree has a very dense 'sail area' and is susceptible to high coastal winds. This is a concern of the owners of the tree and they now wish to prune the tree to reduce the impact of the prevailing winds.

5.2 To reduce the impact of the winds the following pruning should be carried out;

1. Remove all epicormics on the main trunk and on the main branches in the lower middle and upper canopy.
2. Reduce height of crown by maximum of 2m to reduce influence of the wind.
3. Prune epicormics to a height of 6m on main trunk on an annual basis to control excessive regrowth
