JP Chick & Partners Ltd
Consulting Civil & Structural Engineers

Red House Farm
Otley Road
Framsden
IP14 6HU

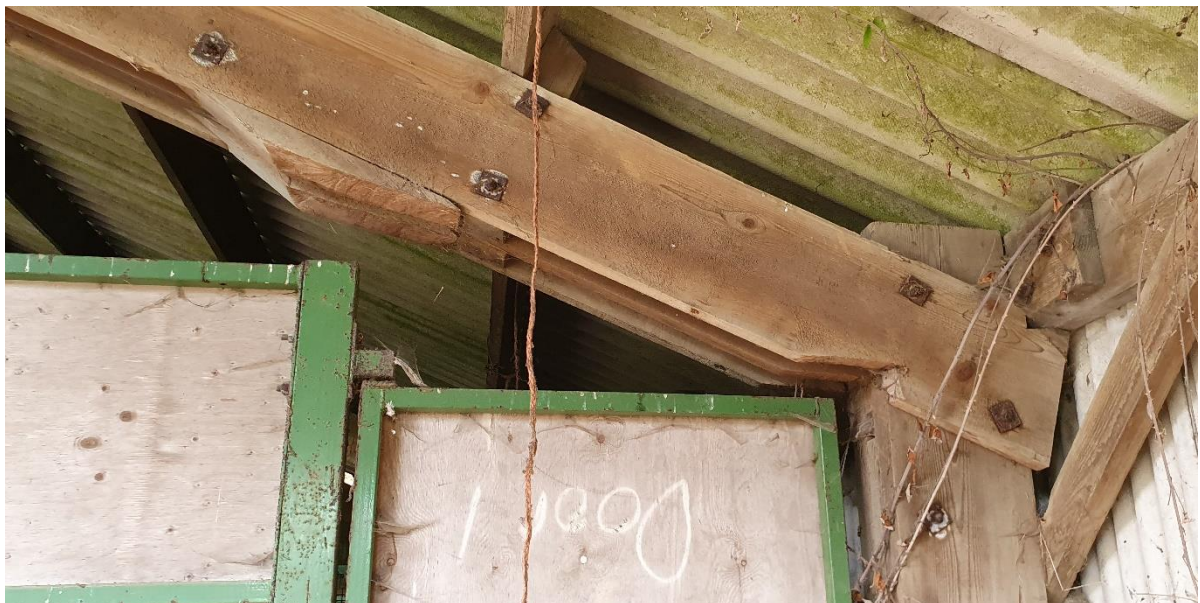
Figure 6 – Modifications to timber portal frame

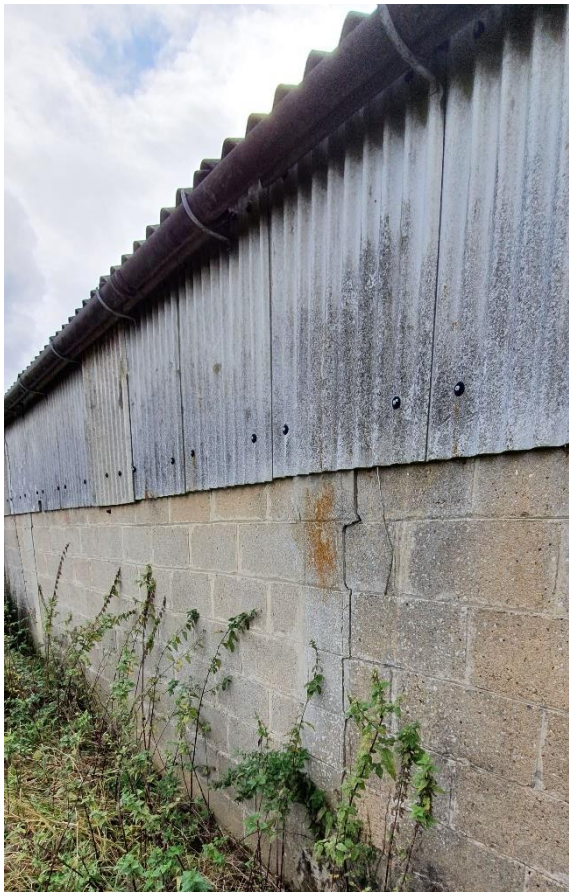
Figure 7 – Vertical cracks at portal frame locations

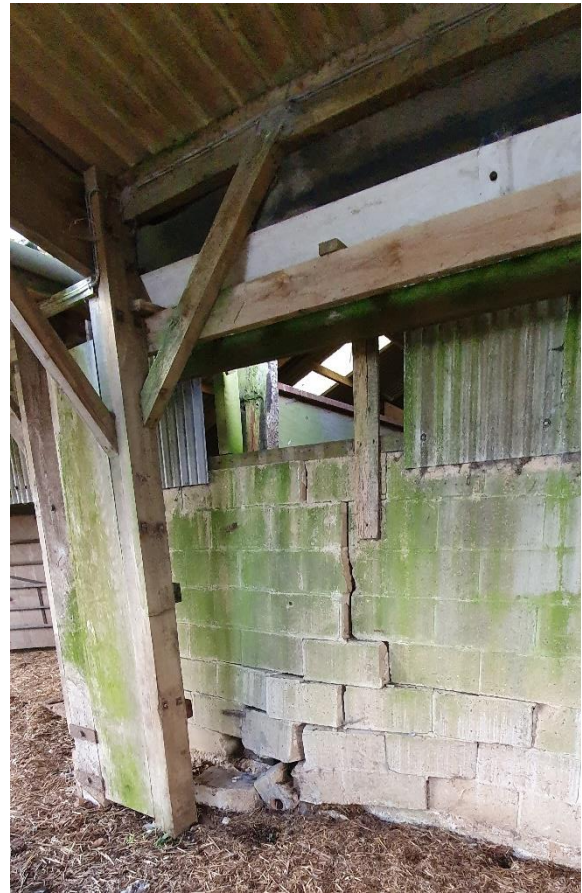
Figure 8 – Damage to external wall to rear of barn

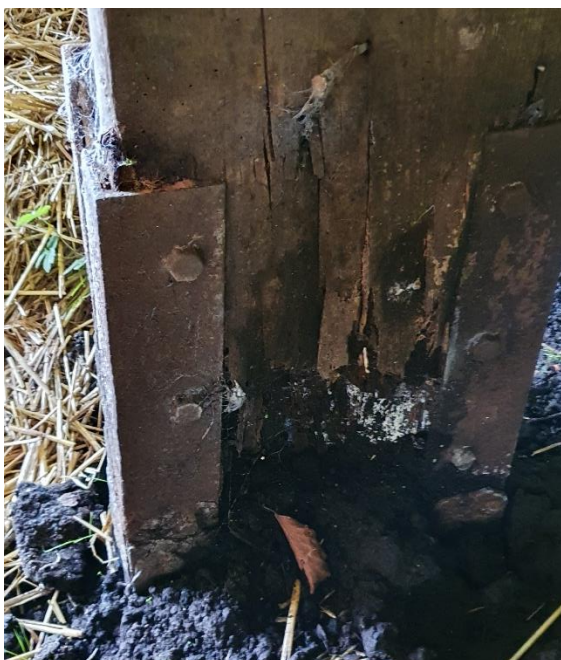
Figure 9 – Significant rotting of timber columns

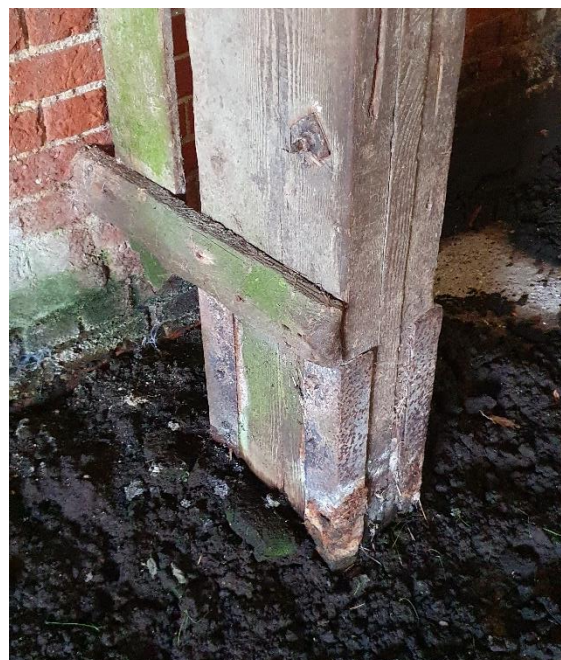
Figure 10 – Corrosion of both timber and steel

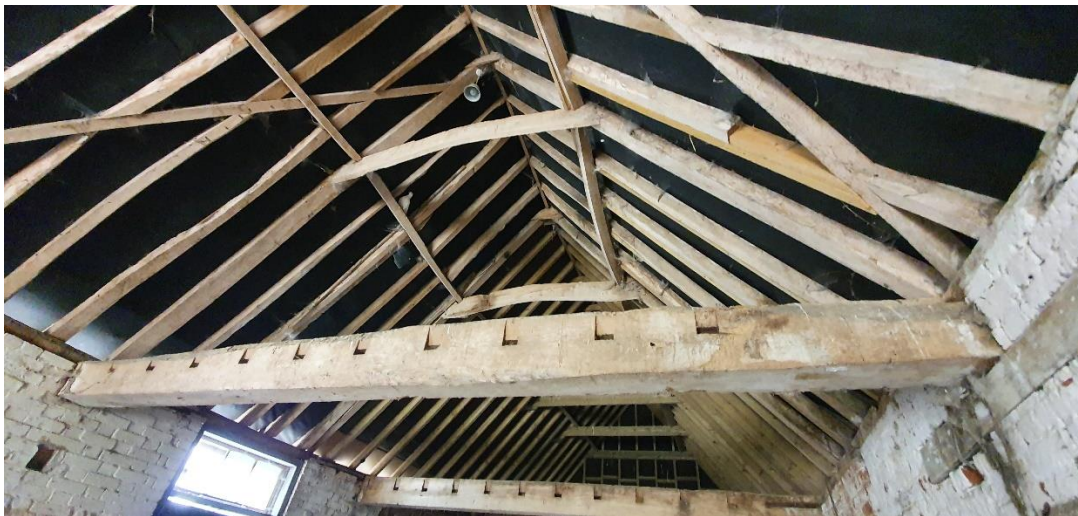
Figure 16 – Barn 2 Roof

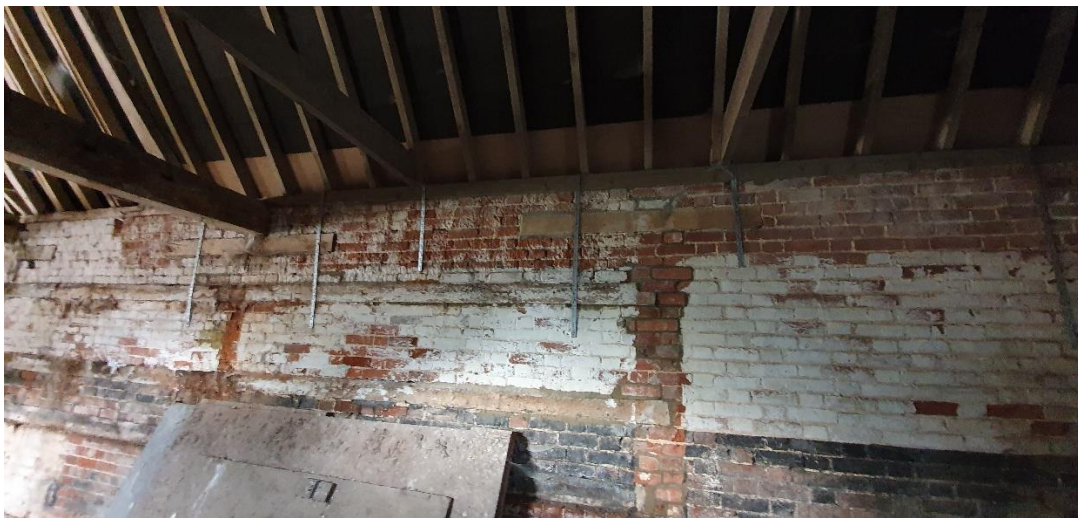
Figure 17 - Replaced roof structure

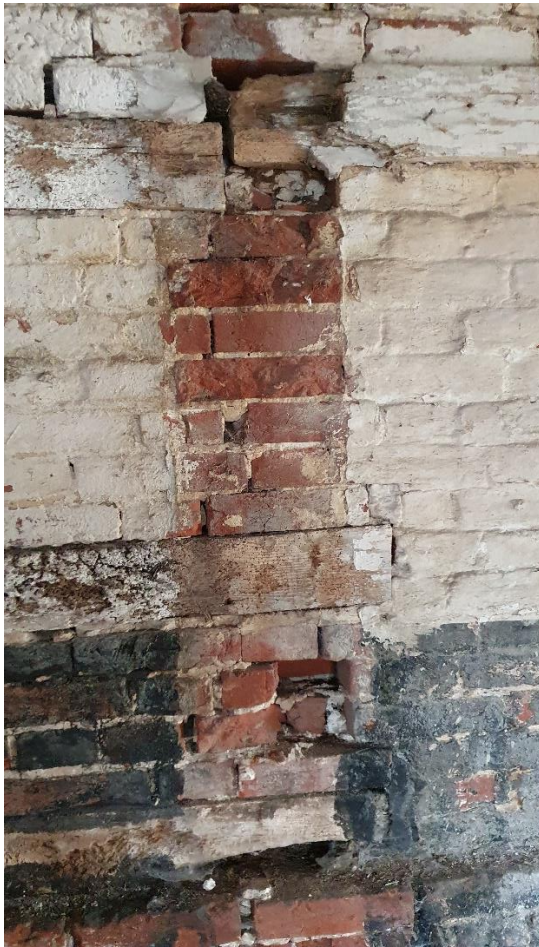
Figure 18 – Bond timber and pier removal

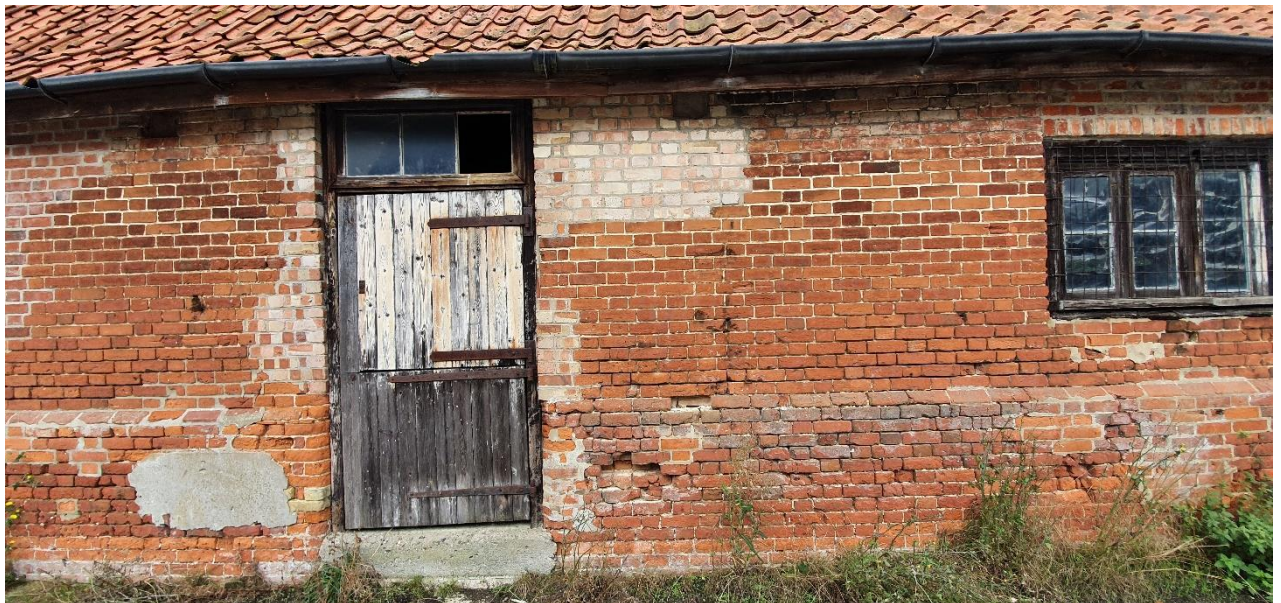
Figure 23 – Barn side view

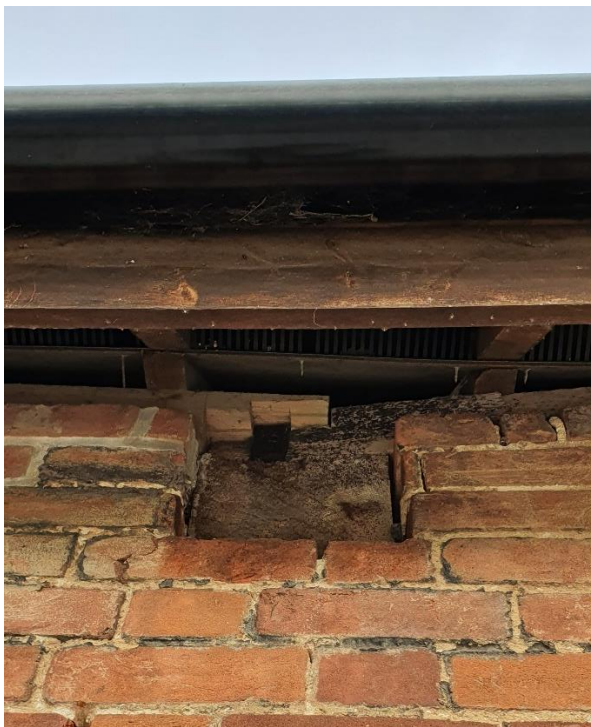
Figure 24 – Eaves & exposed timber beam end

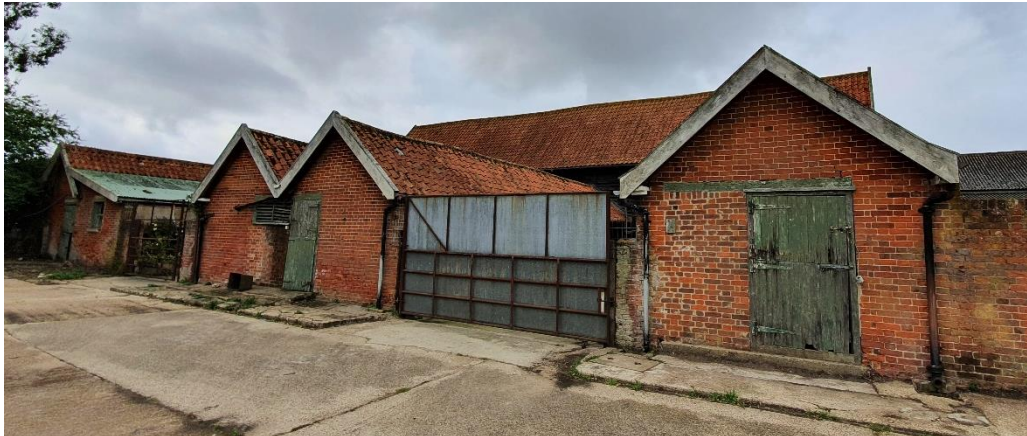
Figure 26 – Barn 3 outbuildings along front elevation

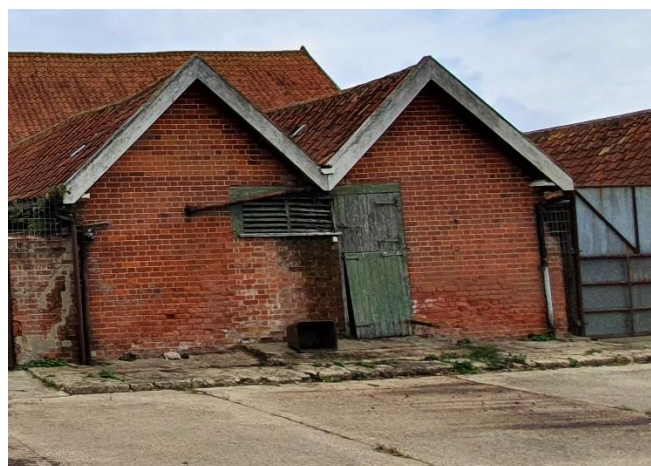
Figure 29 – Outbuilding front elevation

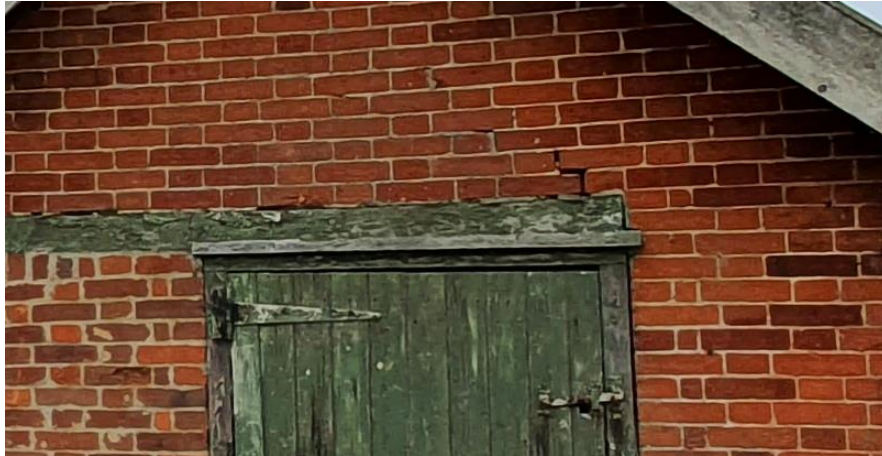
Figure 30 – Cracking above weathered timber lintel

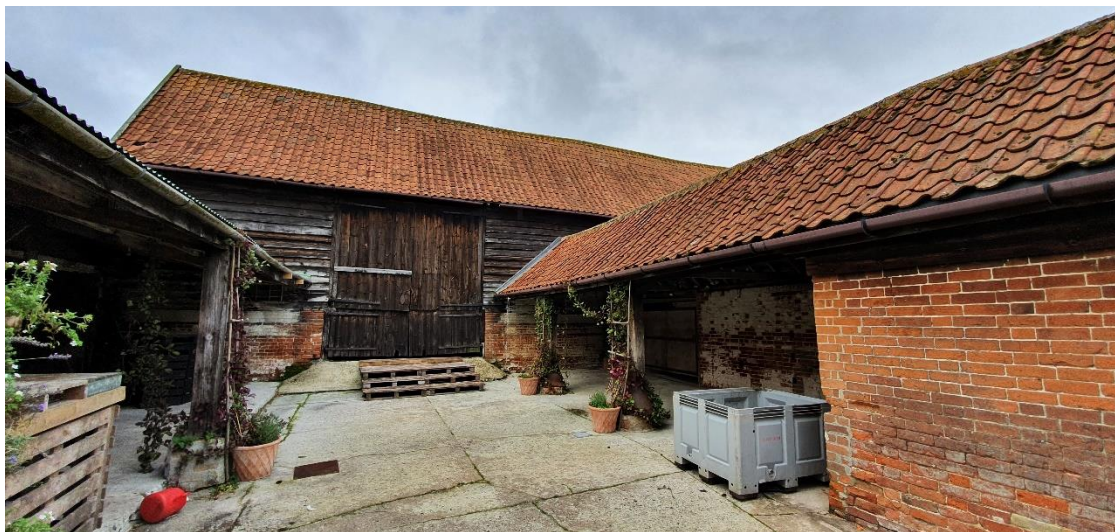
Figure 31 – Outbuildings in courtyard area

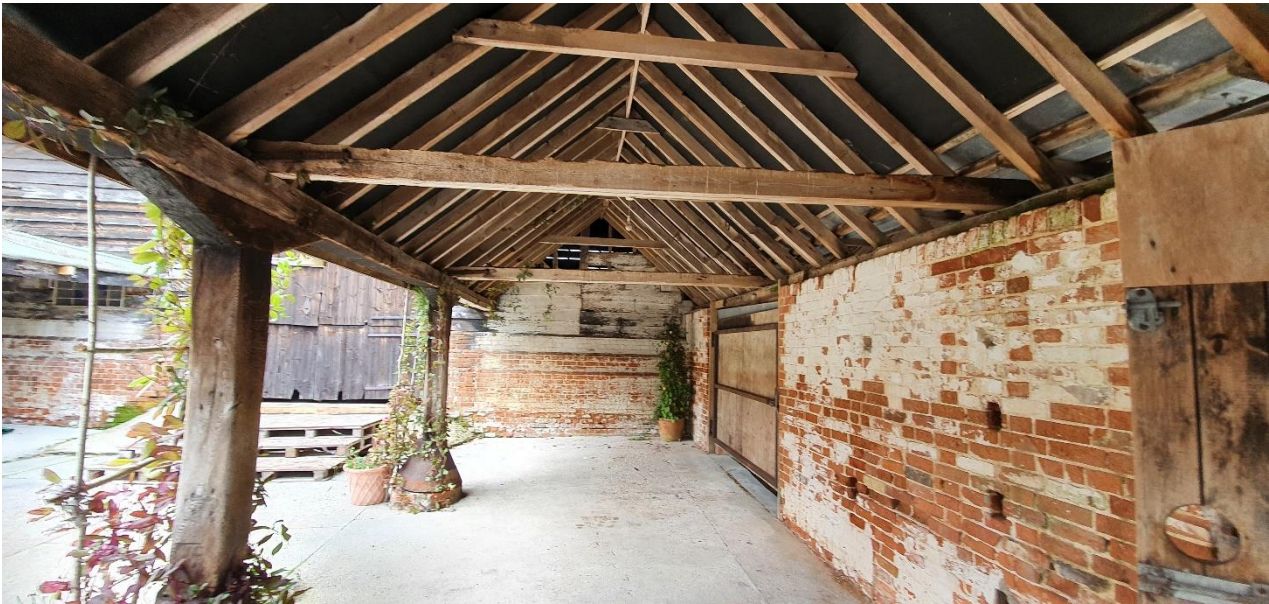
Figure 32 – Outbuildings in courtyard area

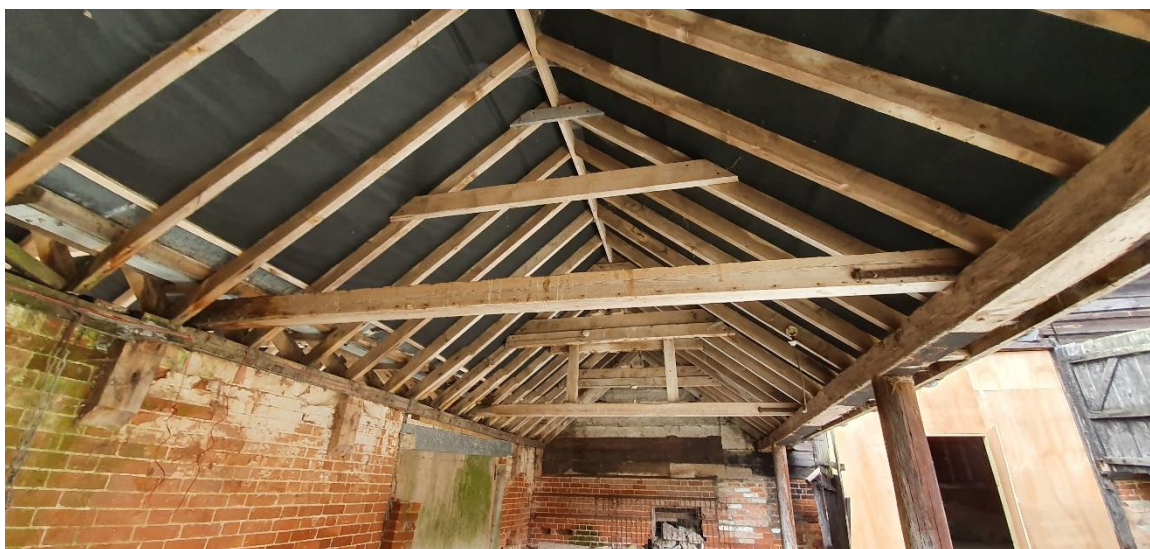
Figure 33 – Outbuildings in courtyard area. Note damp timbers to tie members

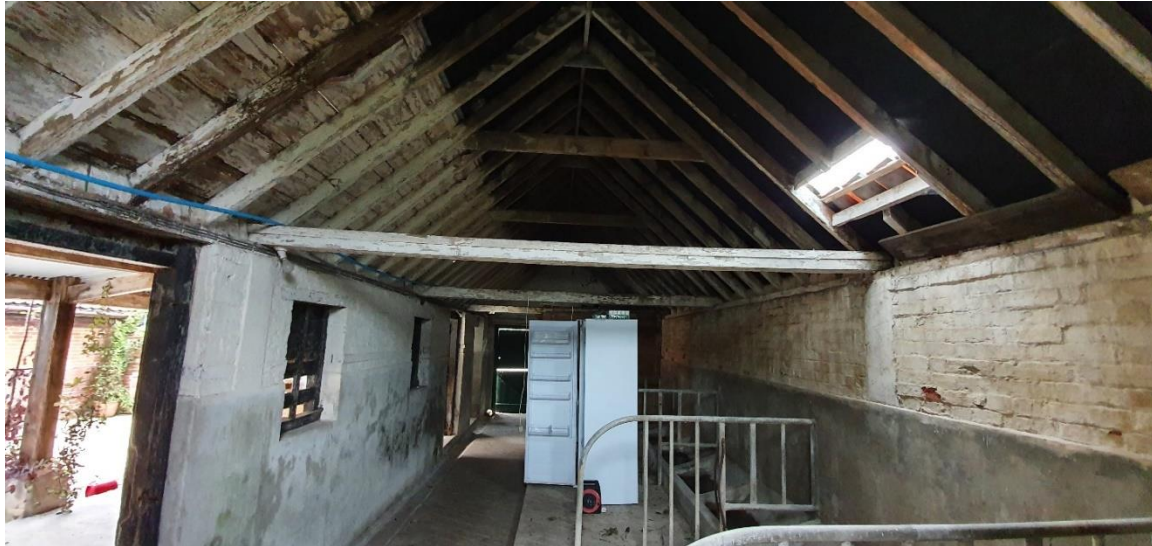
Figure 34 – Outbuilding with lean-to roof

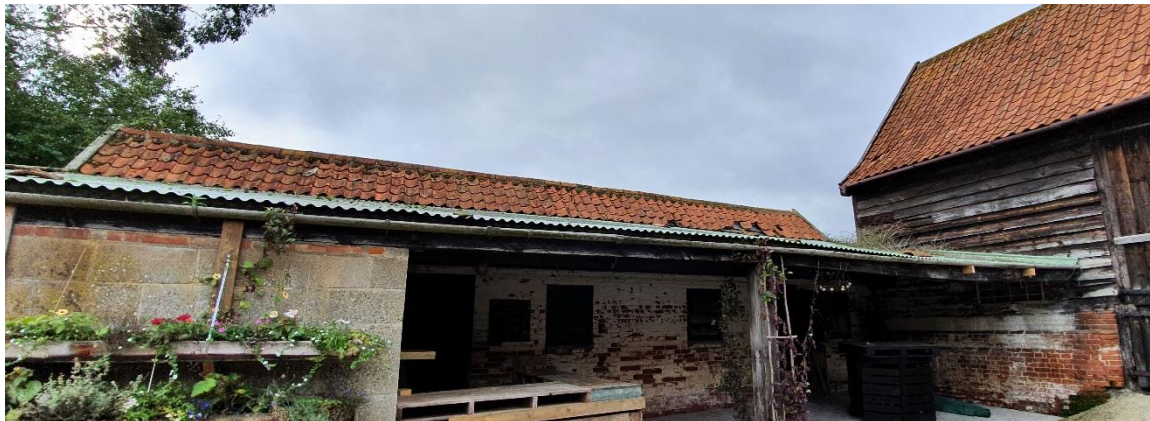
Figure 34 – Outbuilding with lean-to roof. Note lack of flashing between both roofs

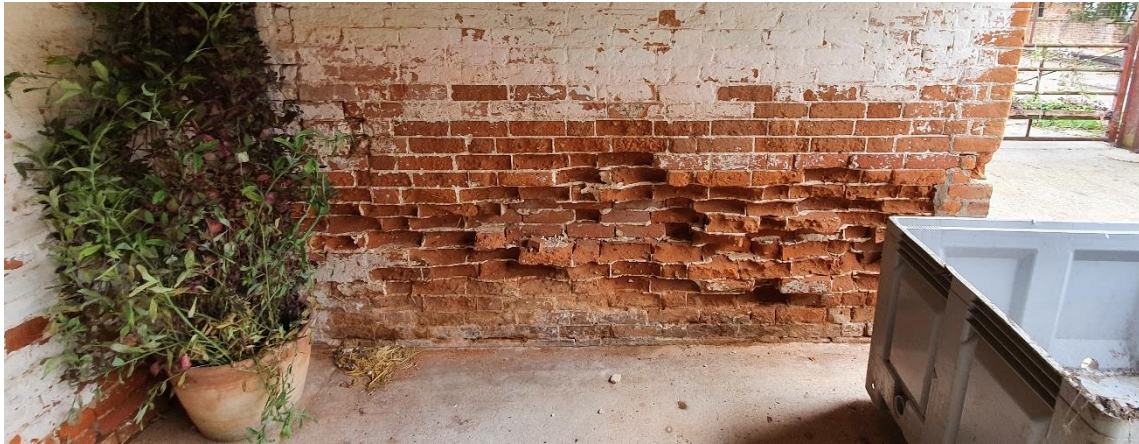
Figure 35 – Significant damage to masonry wall

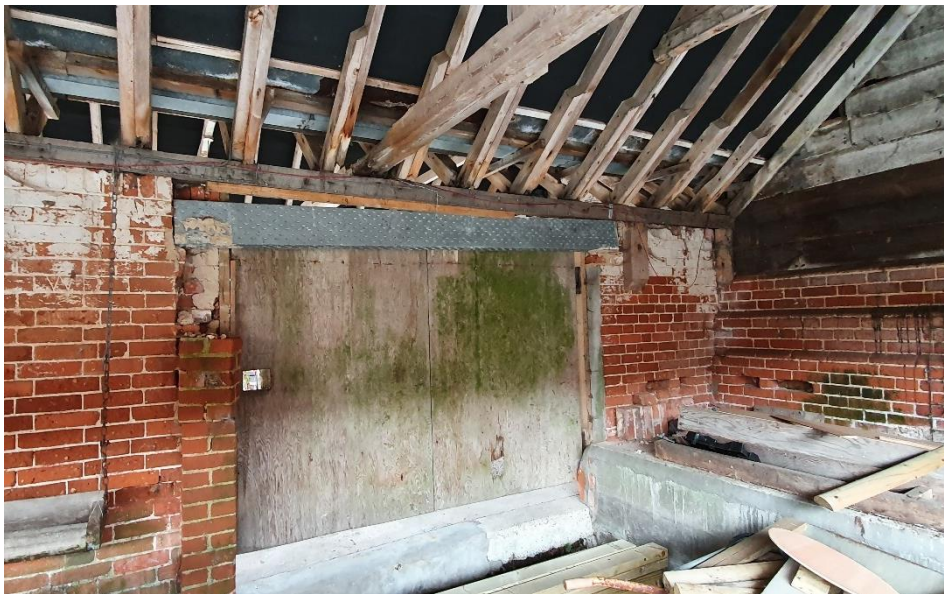
Figure 36 – Removal of masonry directly below lintel bearing. Note drop in lintel at support.

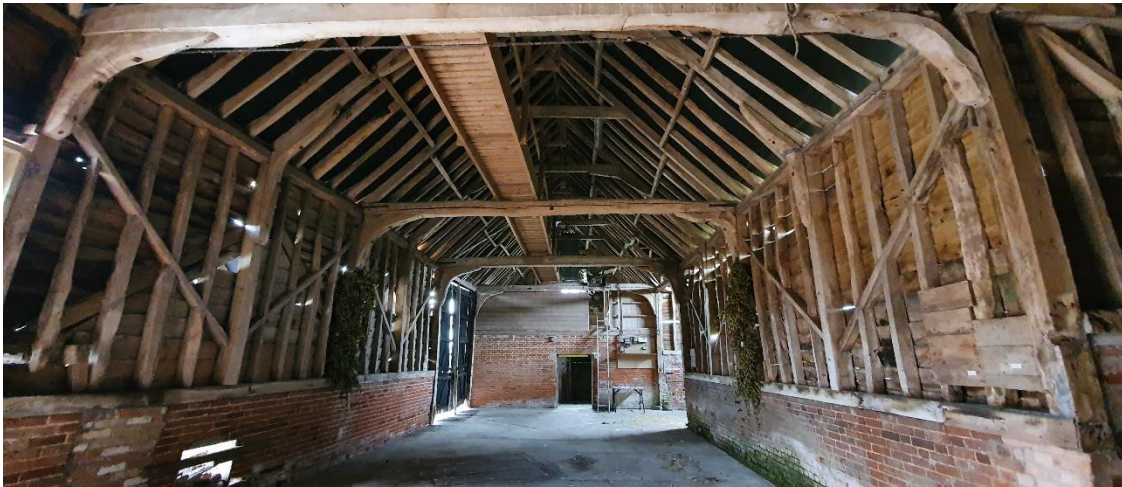
Figure 37 - Internal view of existing barn

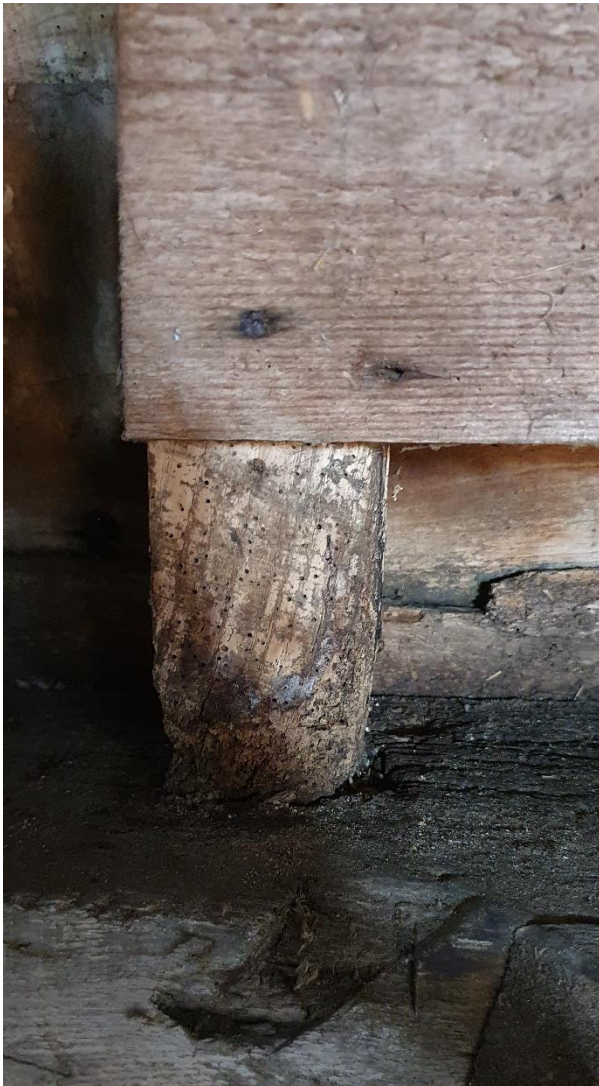
Figure 38 – Typical timber defects to barn 3

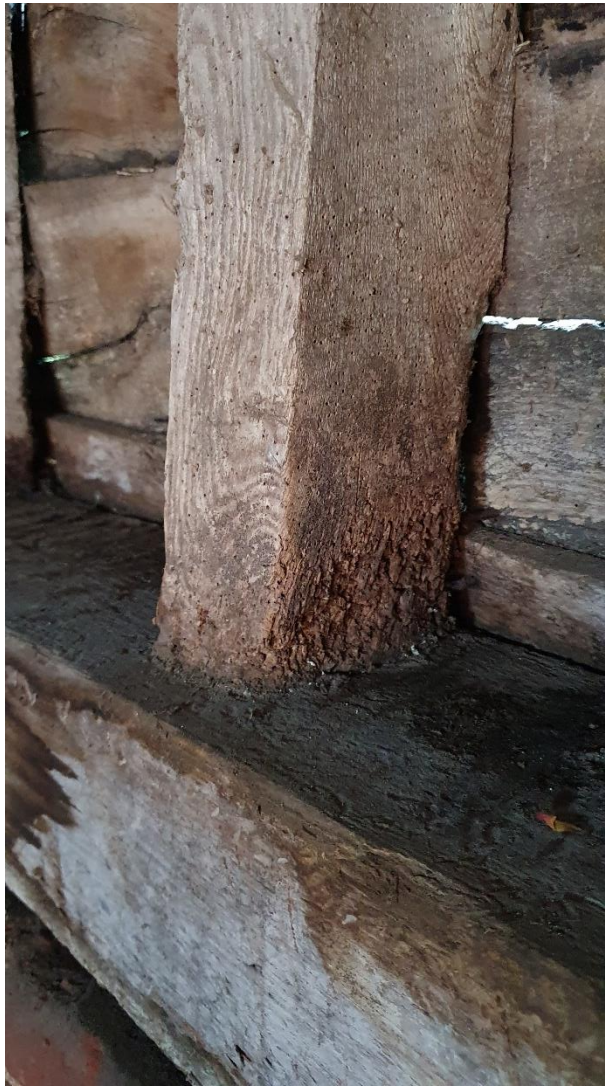
Figure 39 – Further typical defects to barn 3

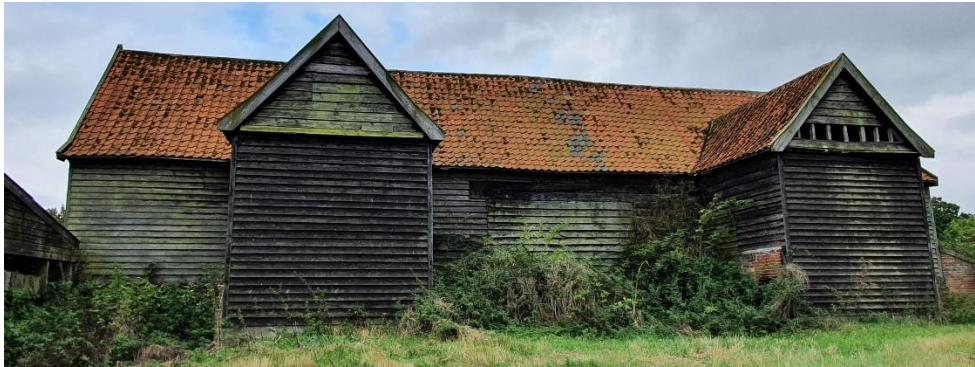
Figure 40 – rear elevation of Barn 3
