29 Southlands Way, Congresbury

Preliminary roost assessment

June 2022

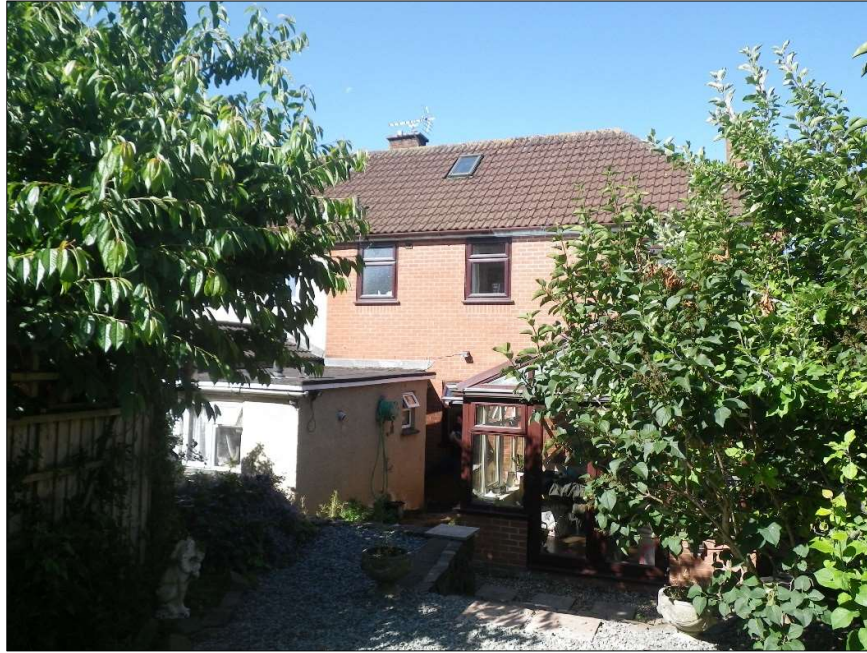
The survey site (eastern elevation)

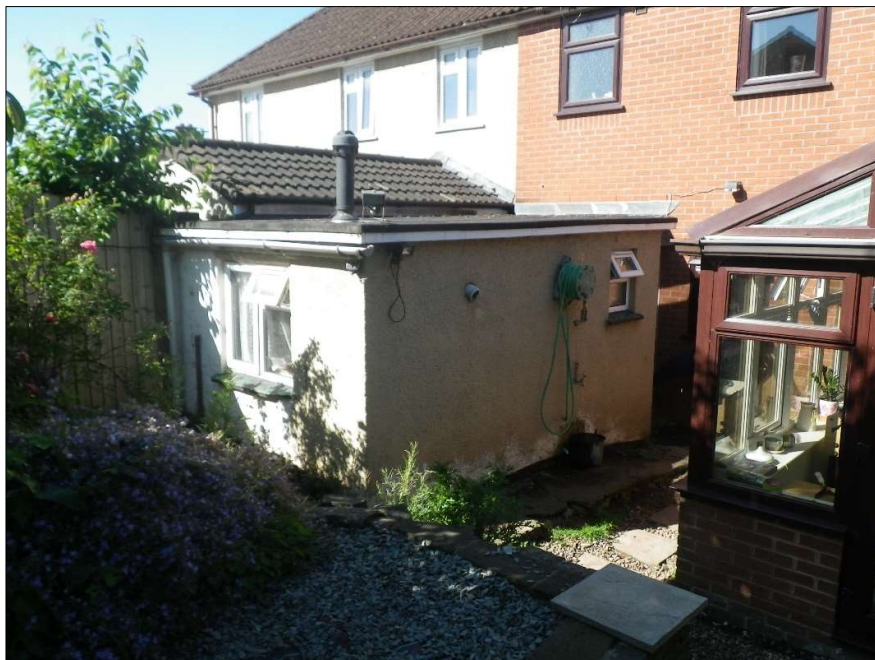
The outhouse: northern and eastern elevations

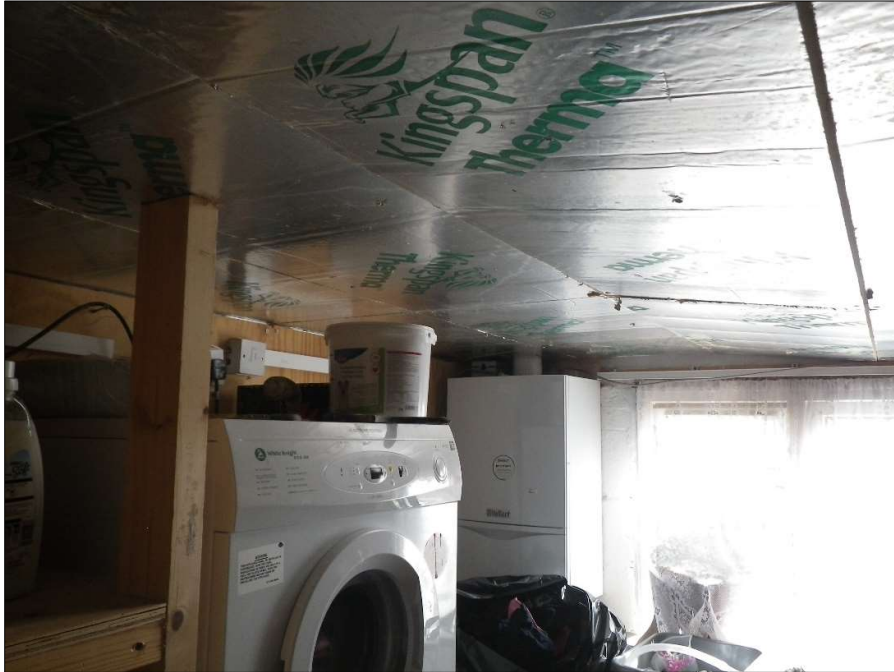
Interior view of the outhouse

The sagging ceiling in the outbuilding and the side compartments in the roof void did not demonstrate any evidence of roosting bats.

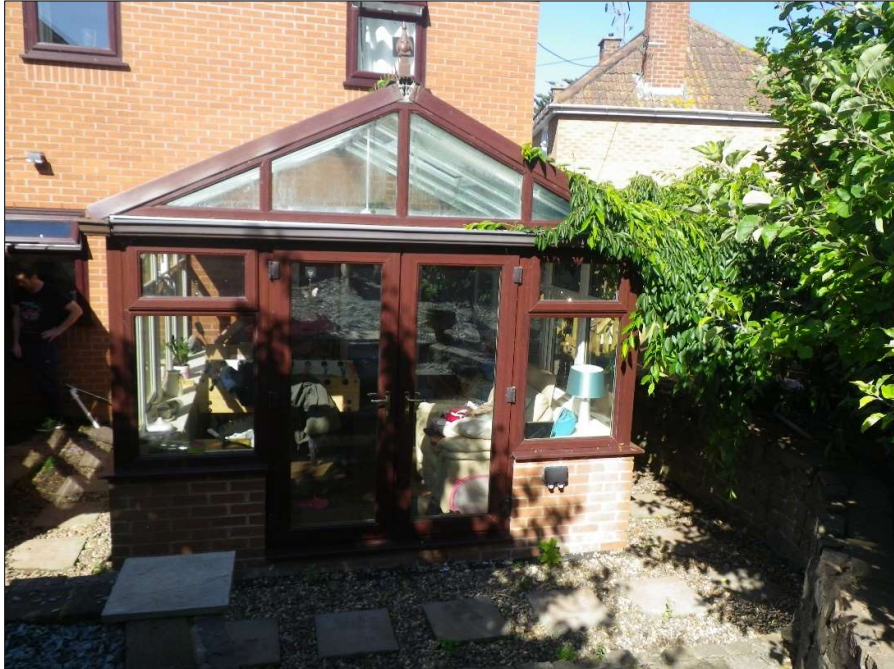
The conservatory: eastern elevation

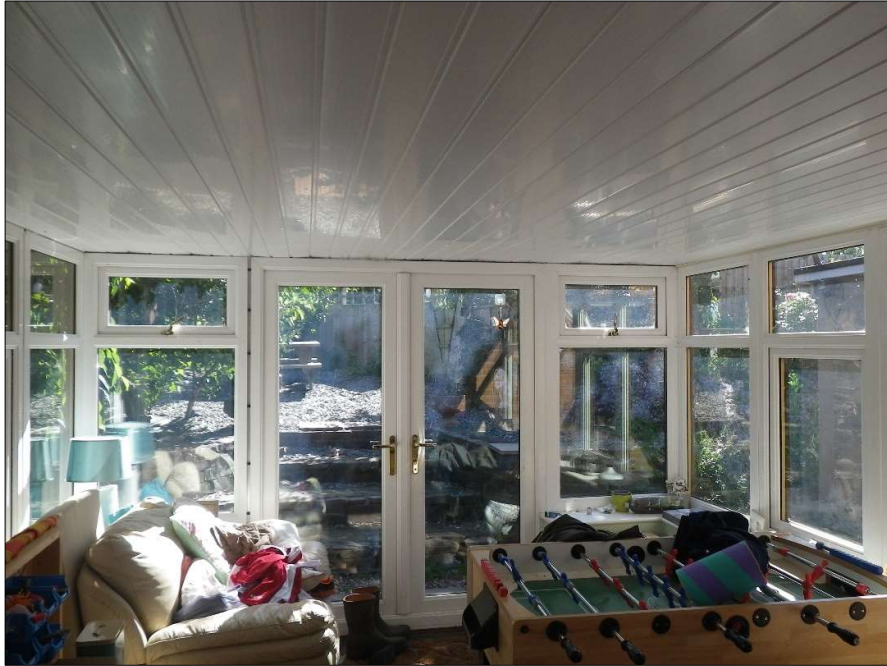
The conservatory: interior view looking east

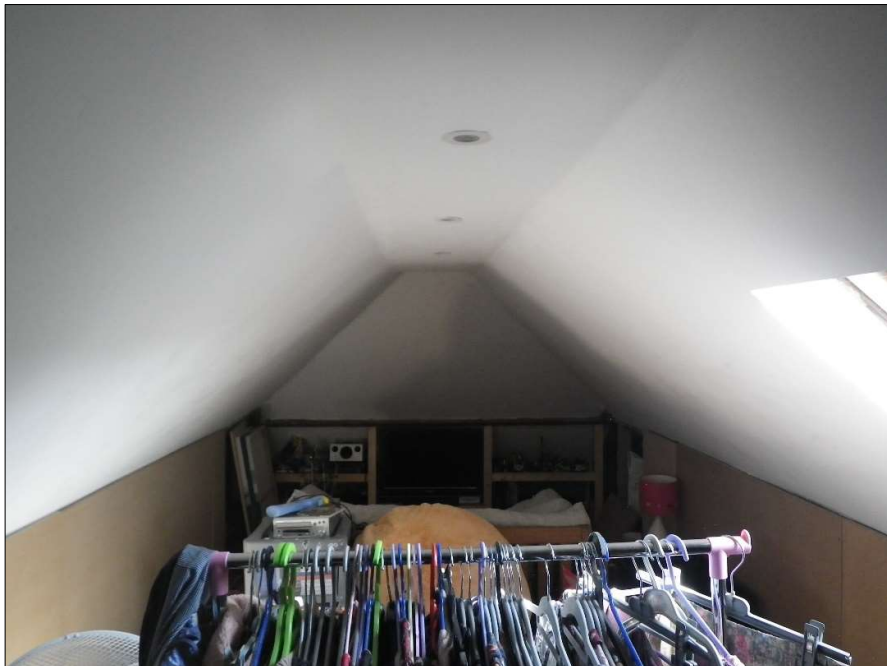
The roof void -looking north
