Tree Hazard Evaluation Survey Report

5 Studley Drive,
Swarland,
Morpeth
NE65 9JT

| Report Date | : | 30/06/2022 |

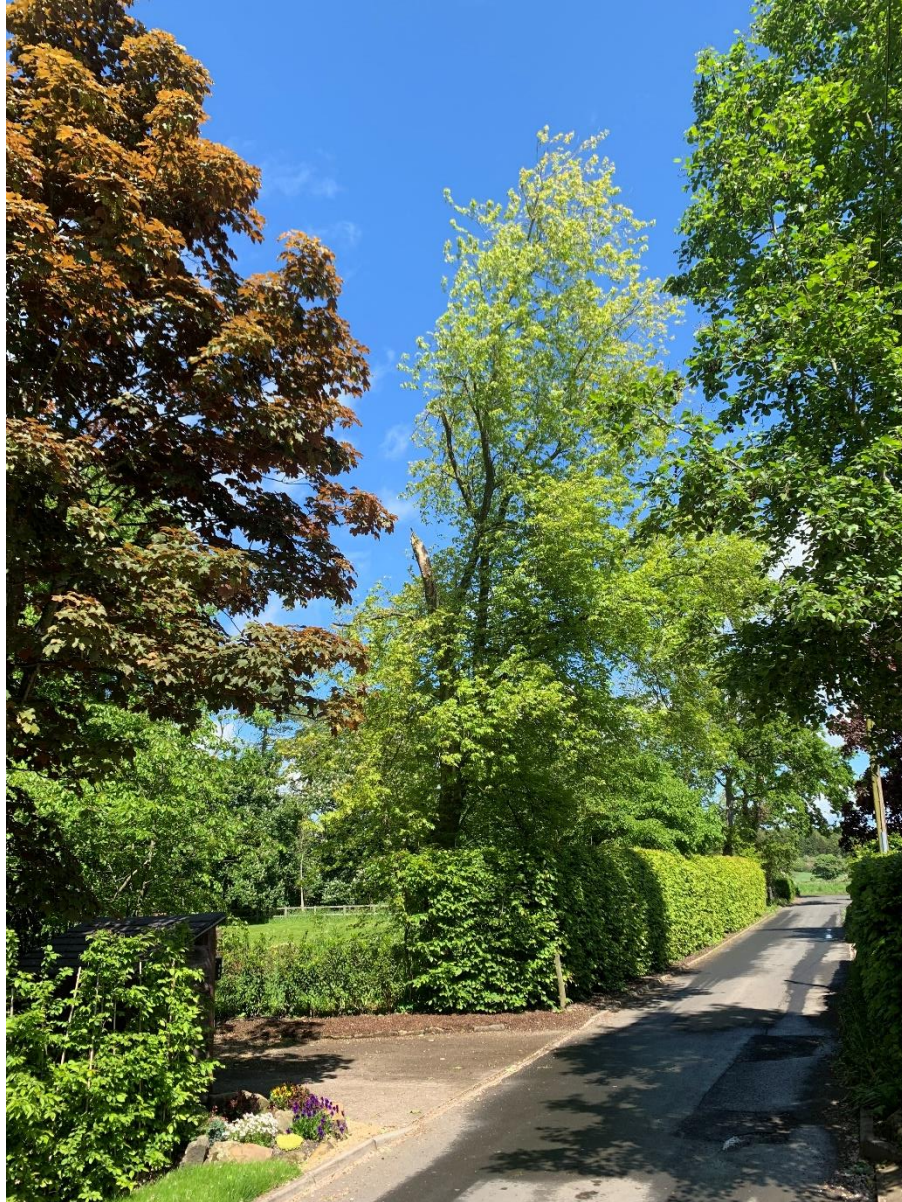
Photograph 1.

| Tree No. on Plan | Species | Hgt. (m) | Age Class | Past Management | General Comments | Defects | Tree Work Recommendation | Work Priority (mths) | Reinspection (mths) |
|---|---|---|---|---|--|---|--|---|---|
| T10 | Silver Maple | 15m to 19m | Mature | No significant recent management. | Storm damaged crown to codominant stem at 6m above ground level. Asymmetric crown shape biased towards road with newly exposed vulnerable codominant stem. | Included union observed at main bifurcation point, no signs of failure at point of inspection. Located due North of access drive. | Crown reduce to 6-7m above ground level, reshaping crown to maintain balanced flowing crown shape. | 12 | 36 |

Above: Tree T10, storm, damaged crown.

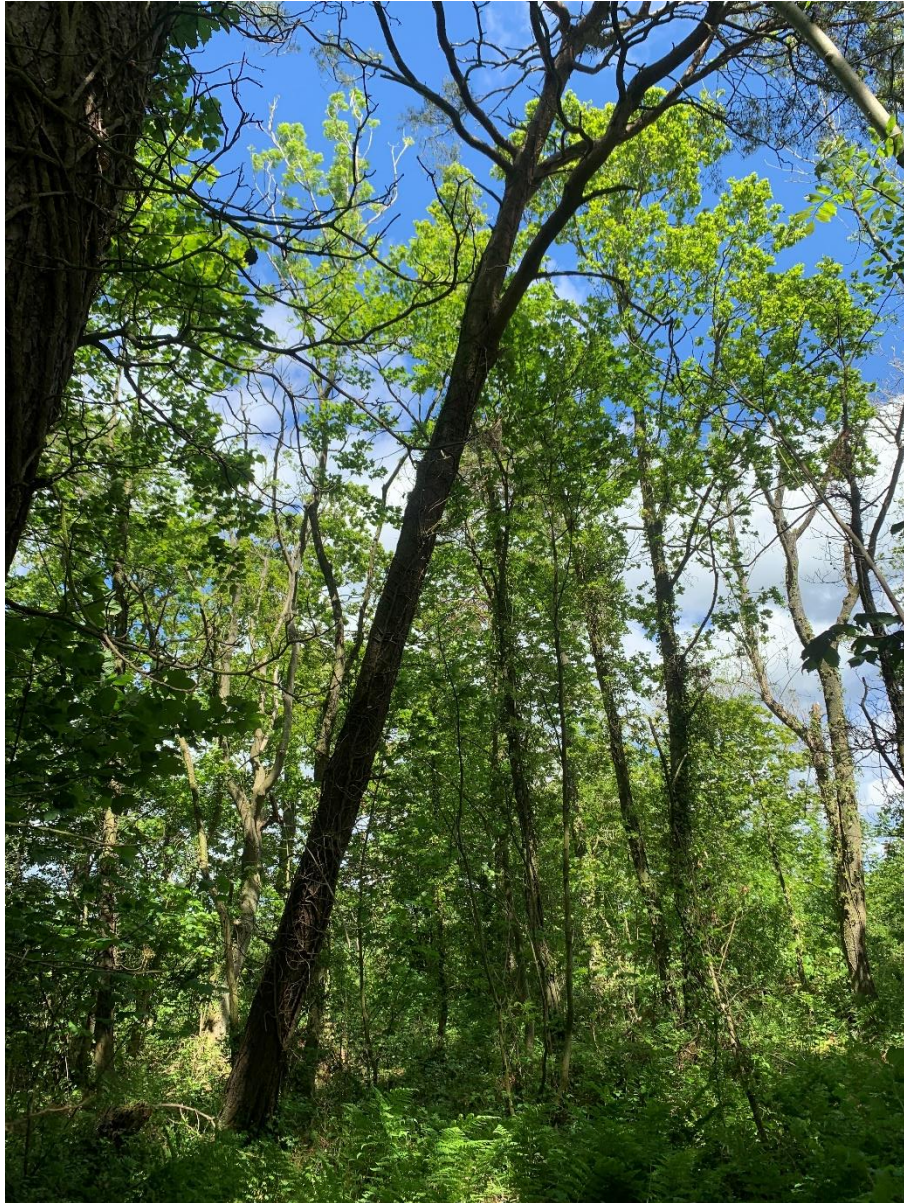
Photograph 2.

Above: T51, Scots Pine, leaning
Date of photograph: 26/05/2022

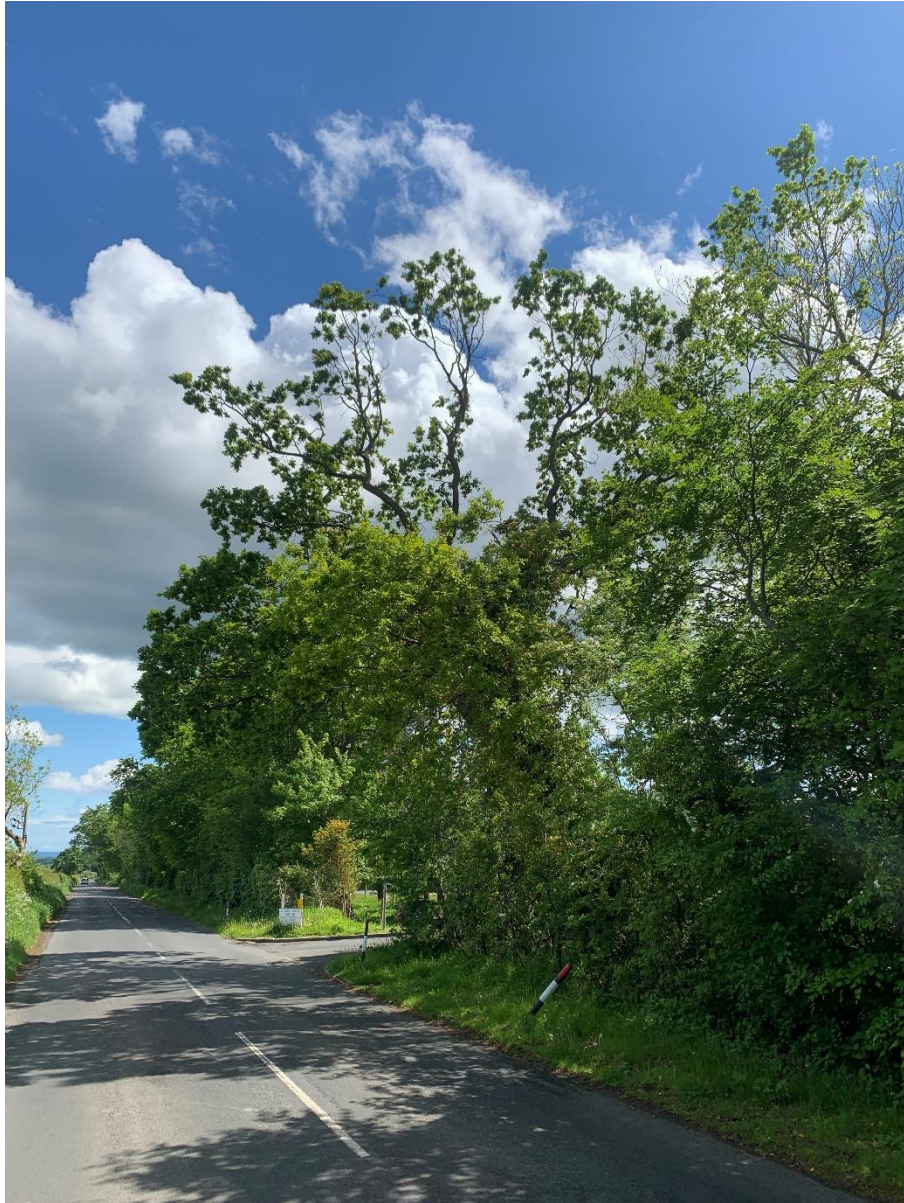
Photograph 3.

- 5.4 Storm damage has been noted throughout the site, with whole tree failures being confined to edge trees and crown damage to trees near to the Northern Boundary with Leamington Lane. Recommendations make provision for addressing the remnants of damage in the form of removals, clearing semi-fallen/leaning stems and crown pruning. This also accounts for newly exposed trees or canopies. The loss of such results in increasing exposure of those trees that remain. This is

Above: Trees bordering Leamington Lane
Date of photograph: 26/05/2022

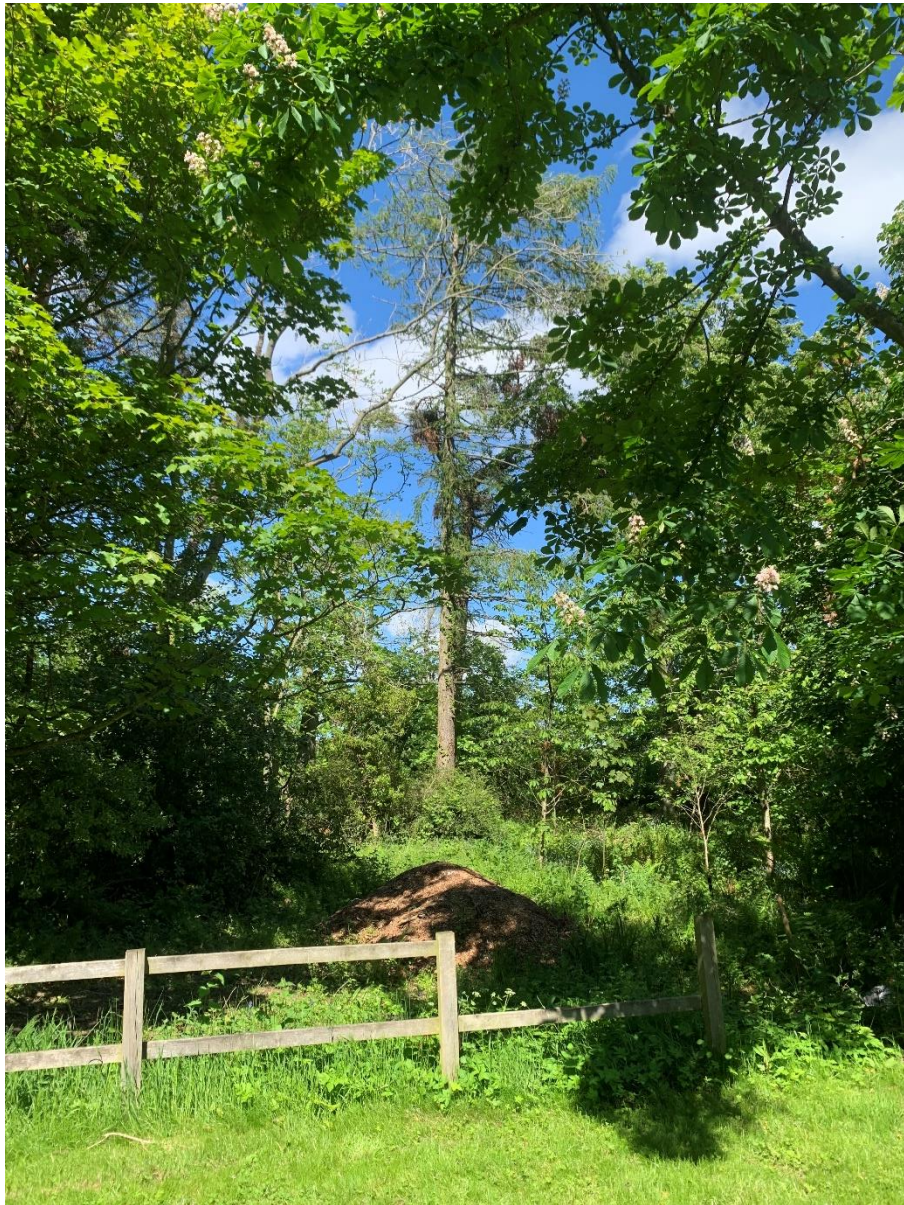
Photograph 4.

- 5.5 Of significance is tree T38 (a mature Larch). This tree has lost companion shelter. Mattheck *et. al.* (2002) identified that there is a significant failure rate of newly exposed solitary trees retaining Height to Diameter (H:D) ratio greater than 50. Whilst less significant, some trees with ratios between 40-50 were also subject to failure. The risk would undoubtedly increase as the H:D ratio progresses towards 50. The table below illustrates the H:D ratios for T38.

- 5.6 T38 retains a low HD ratio giving assurance it, theoretically, is not susceptible to windthrow. It is however advised that the tree continue to be monitored in accordance with general advice for all trees on the site.
- 5.7 All work recommendations are detailed within section 8.0 below. Notwithstanding advice regarding T28, T39 and TG6, it is advised that trees along Leamington Lane be subject to periodic reinspection by a competent arboriculturalist on an 18 month cycle. Remaining trees may be inspected on a 3 yearly cycle unless otherwise stated in section 8.0. This suggested regime should be reinforced by period checks by the landowner in accordance with advice given by the National Tree Safety Group (see further information within Appendix 1).

| Tree No. on Plan | Species | Hgt. (m) | Age Class | Past Management | General Comments | Defects | Tree Work Recommendation | Work Priority (mths) | Reinspection (mths) |
|---|---|---|---|---|---|--|---|---|---|
| T38 | Larch | 20m to25m | Mature | No significant recent management. | Incorrectly noted as Scots Pine in prior survey. Height = 17m. Stem diameter at 1.5m above ground level = 49cm. Unable to inspect buttressing and lower stem due to presence of vegetation. Well occluded cavity with what appears moribund decay to South of stem at c. 1m above ground level. Decay not considered greater than 1/3rd size of stem circumference. | Deadwood to North side of crown most likely due to loss of neighboring trees. Newly exposed. | No works | n/a | 18 |

Above: T38, Larch
Date of photograph: 26/05/2022

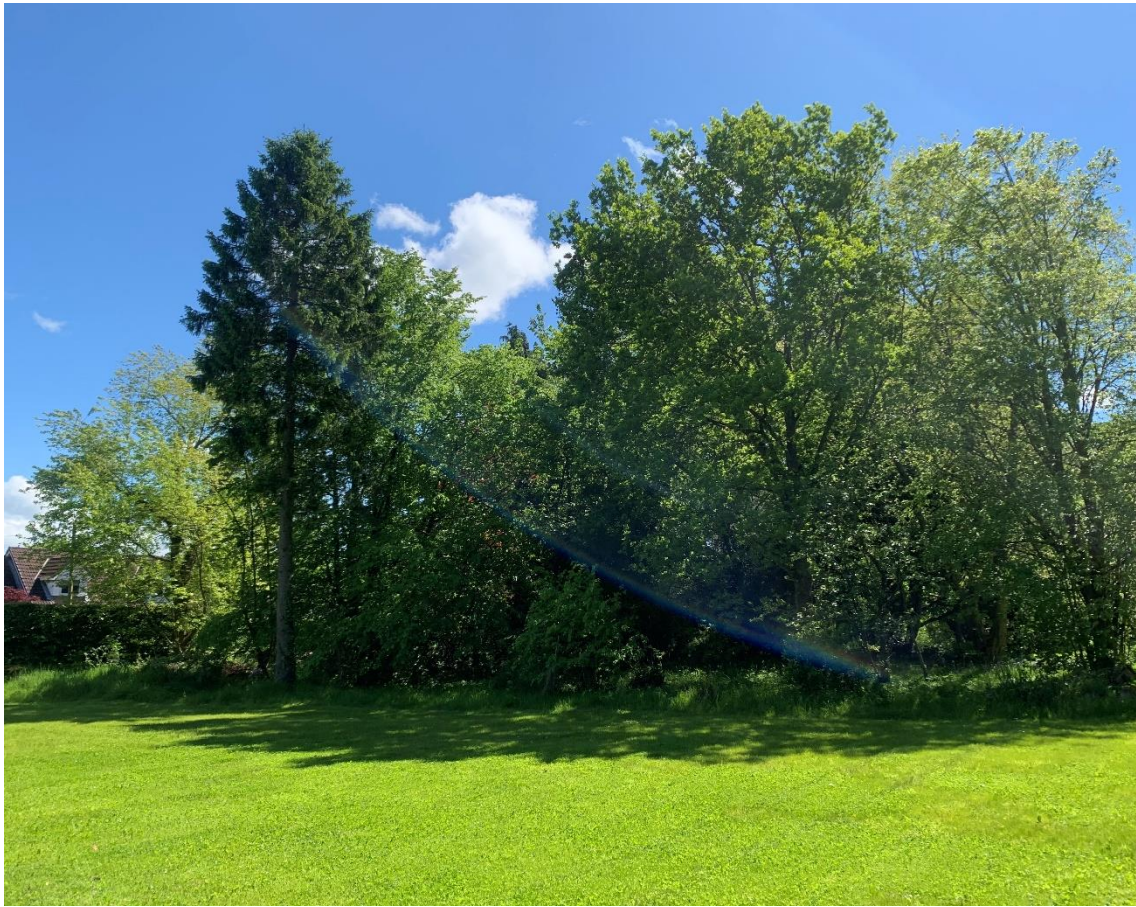
Photograph 5.

| Tree No. on Plan | Species | Hgt. (m) | Age Class | Past Management | General Comments | Defects | Tree Work Recommendation | Work Priority (mths) | Reinspection (mths) |
|---|---|---|---|---|---|--|---|---|---|
| TG2 | Mixed Species Group | 15m to19m | Mature | No significant recent management. | Group includes Cypress x4, Sycamore x1, Horse Chestnut x1, Ash x2, Yewx2 with some Goat Willow. Early signs of Ash Dieback noted in the group. | No gross defectnoted. | No Works. | Not Applicable | n/a |

Above: View towards TG2
Date of photograph: 26/05/2022
