**Structural Appraisal**  
*-supporting application for-*  
**Conversion of Agricultural Building**  
To  
**Welcome Barn**  
At  
**Church Farm, Fring**

July 2022

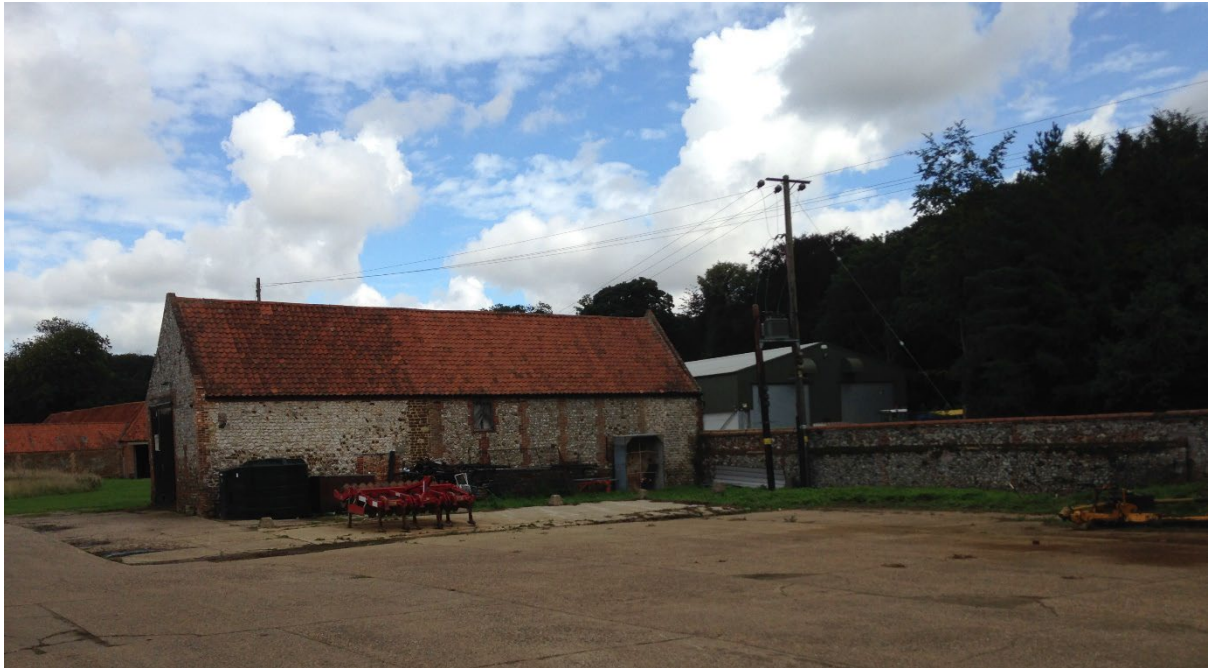
*Photo 1: South elevation (facing farm yard)*

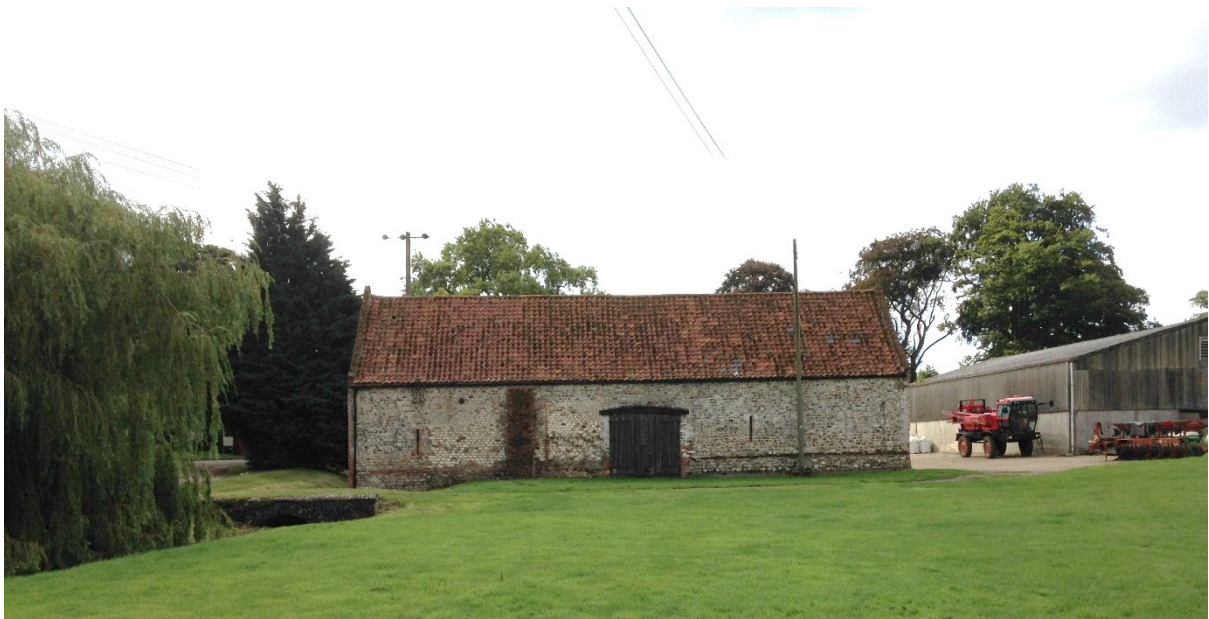
The northern elevation is supported by a substantial brick buttress extending to eaves height.

*Photo 2: North Elevation*

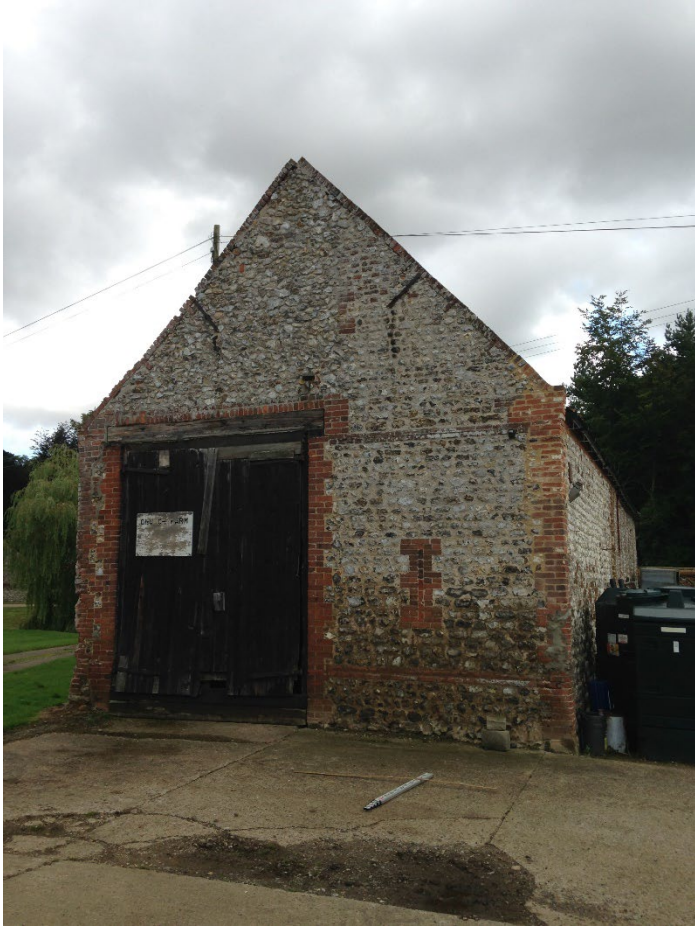
*Photo 3: West Elevation*

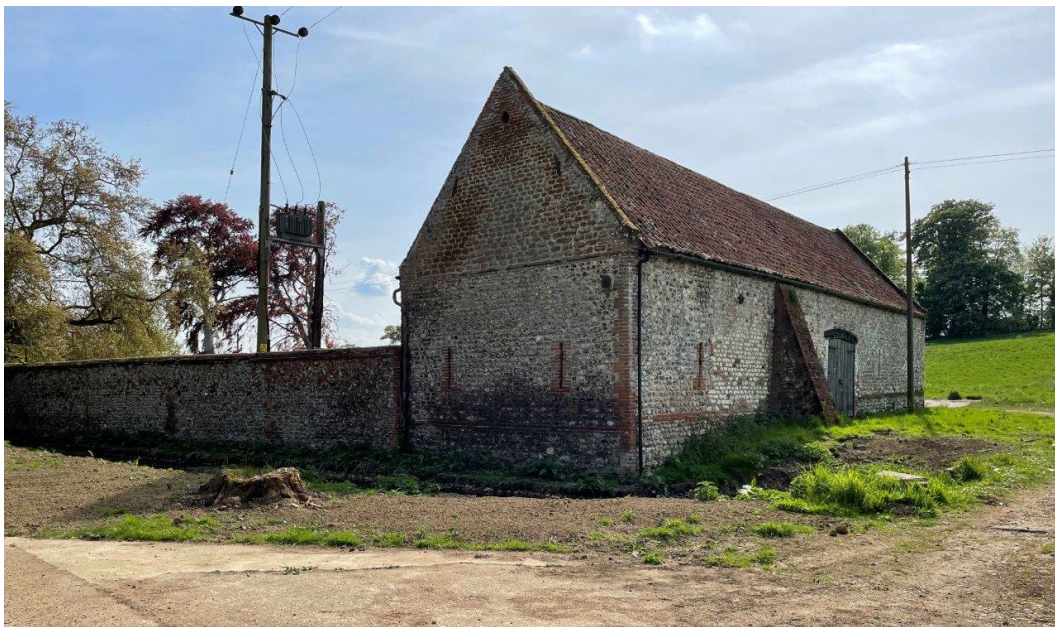
*Phot 4: East elevation*

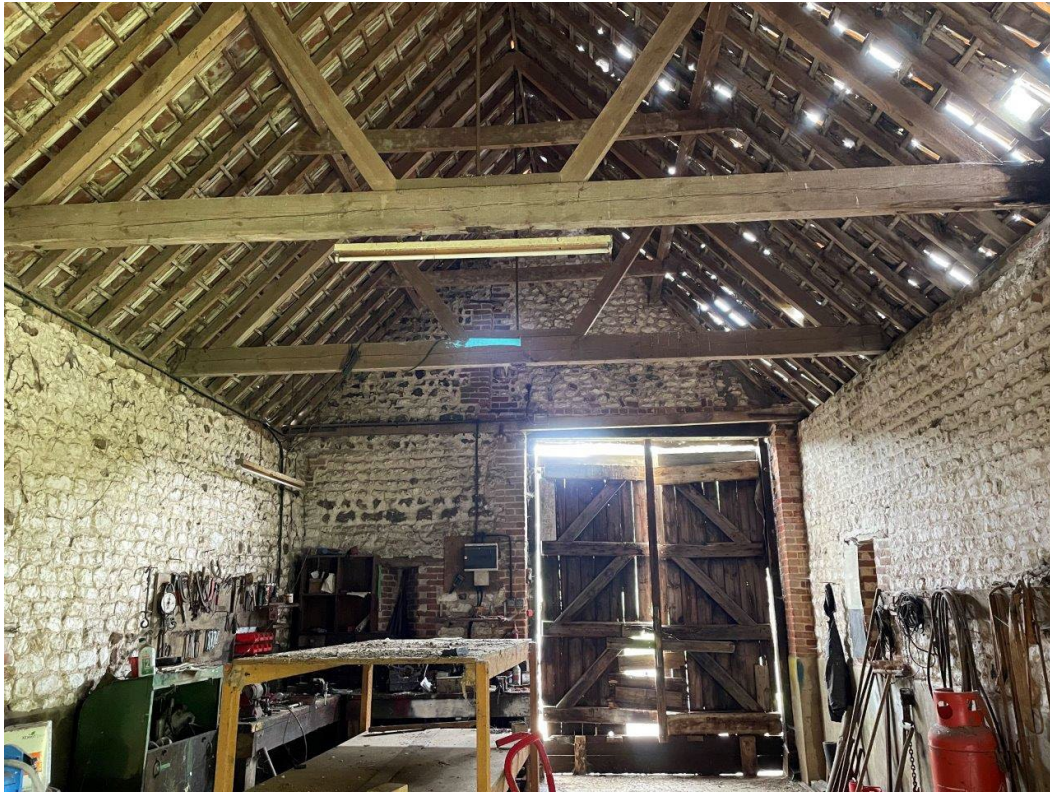
*Photo 5: Interior – showing western gable*

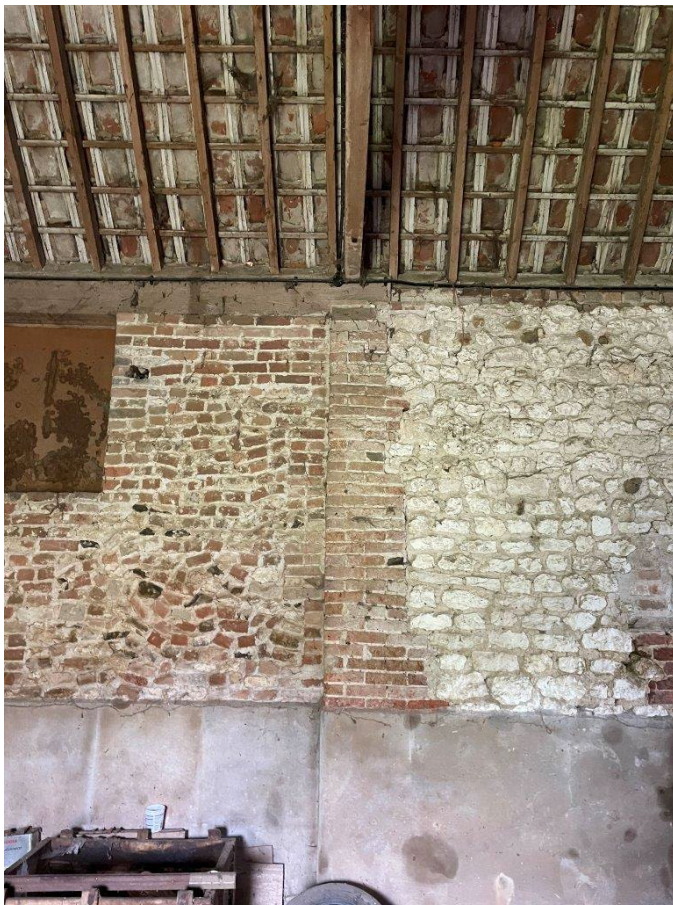
*Photo 6 Interior – showing infilled doorway in southern elevation*

As is common with historic buildings of his nature, the barn has been subject to change over its lifetime and adapted to suit agricultural needs over the years. In particular, it is noted that the original large opening in the southern elevation has, at some point, been infilled and reduced to a single small window at first floor level (see Photo 6, above).
