**Scottish Enterprise Lanarkshire
Gartcosh Industrial Park
Bothlin Burn Report**

May 2001

Document Reference No: SB/GSSS/11

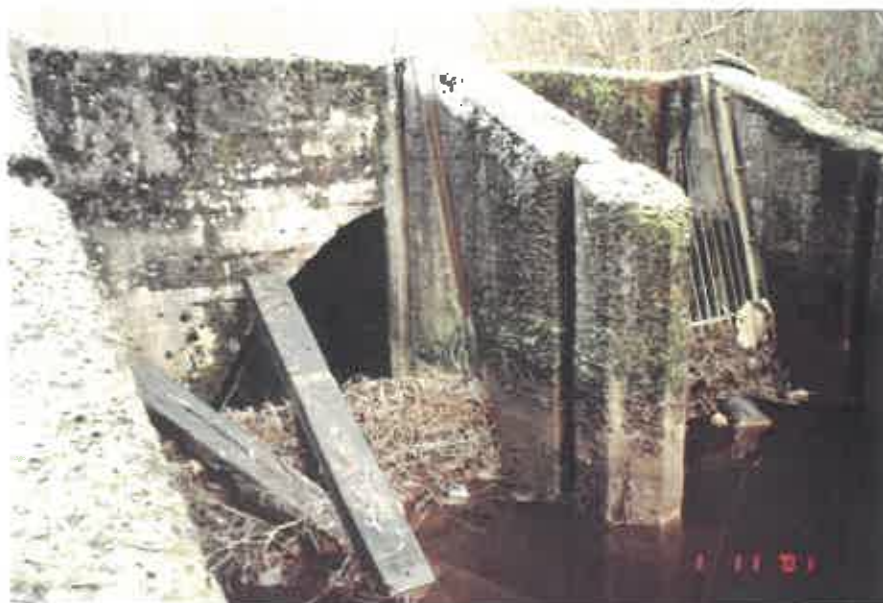
A debris screen has been installed at the inlet to the culvert in two panels with a central pier bearing against the culvert headwall at the crown. A significant amount of debris has built up on the screen and is currently impeding flow through the culvert. The upper part of the screen has been removed, presumably to permit water to pass when the screen is not cleaned. With this arrangement it is likely that debris is being carried into the culvert during every flood, which will over time lead to increased silt deposition within the culvert.

Inlet Debris Screen

The existing debris screen should be cleared in the near future to minimise the risk of flooding.

The debris screen is clearly unsatisfactory (refer to Photograph) and should be replaced with one which can be safely maintained. It is anticipated that such a screen with an access platform for maintenance could be built for around £15,000 (excl. VAT) inclusive of design fees.

It is considered that the culvert has sufficient capacity to handle a Q200 flood event, provided the inlet remains free of debris. The existing debris screen is choked with debris and is currently impeding the flow into the culvert. Investigations into possible redesign or replacement of the culvert will be required.

To reduce the risk of flooding it is essential that the design of the debris screen be reviewed with the view to improve its current design or replace it entirely. This will need to be undertaken in conjunction with an inlet maintenance programme that

will recommend the inlet be cleaned at regular intervals to prevent build up of debris and blockage of the culvert inlet.

1. Replacement of Debris Screen – highly recommended
2. Testing of Silt – Optional
3. Repairs to Concrete – Optional
4. General inspection of Culvert recommended at 5 yearly intervals to review concrete structure and silt levels
5. Improvement to vertical access shaft cover - Optional

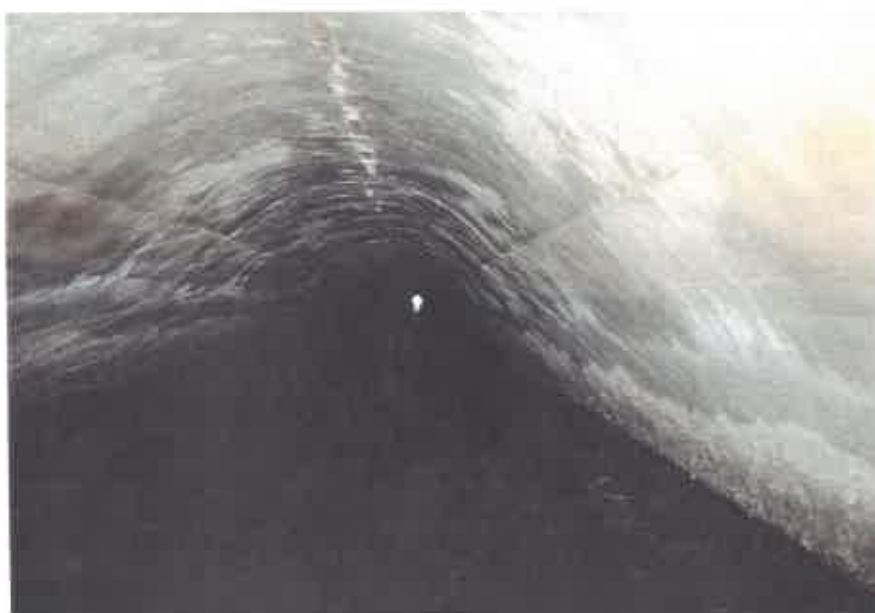
At the time of inspection a layer of silt was evident within the culvert and assumed to be of 300mm depth. For modelling purposes a silt depth of 600mm was also tested.

In 1998 a brief visual inspection of the Culvert was carried out from a boat by Halcrow Crouch. This inspection did not look in detail at either the condition of the concrete or the silt in the bed of the Culvert. The basic conclusion of the inspection was that the Culvert was in reasonable condition for a structure, which is approximately 40 years old. Around 10 areas of spalling concrete were observed and it is recommended that these areas are repaired to preserve the structural integrity of the Culvert.

Typical Internal View
