Carl Swainston Engineering Limited

Location: 1 & 2 Nelson Row Middleton in Teesdale Co Durham.

Date: 20/09/21

Structural Report

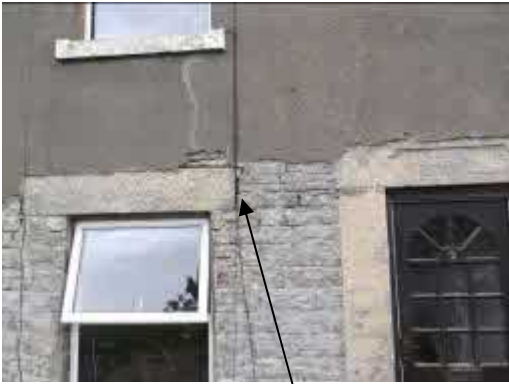
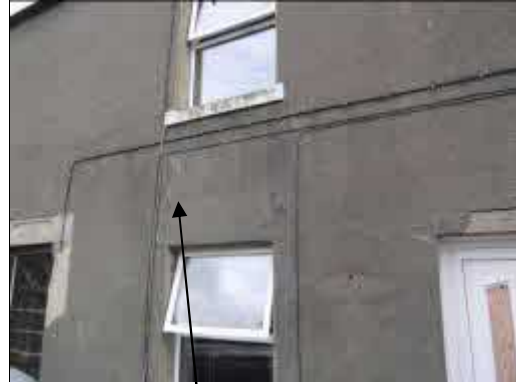
South Aspect Cracking

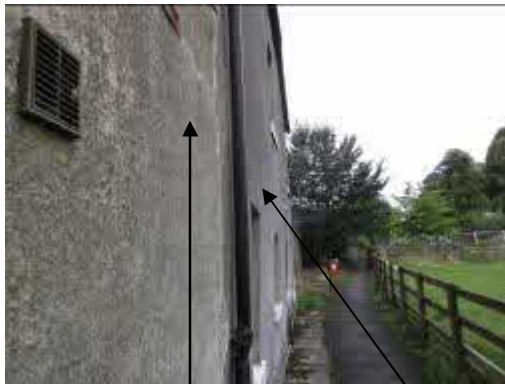
There is a visible out of plumb shift outwards on the elevation adjacent the public footpath of around 75mm over the length of the level (1200mm) which is possible wall separation.

North Aspect Cracking and Out of Plumb Shift

failed causing vertical cracking to all faces of the structure. There is evidence that the North wall has an out of plumb shift which is caused either by roof spread or the outer face of the stone wall separating from the inner face usually called wall separation.

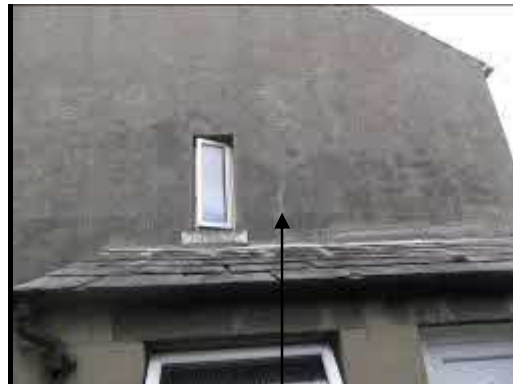
East Aspect Cracking

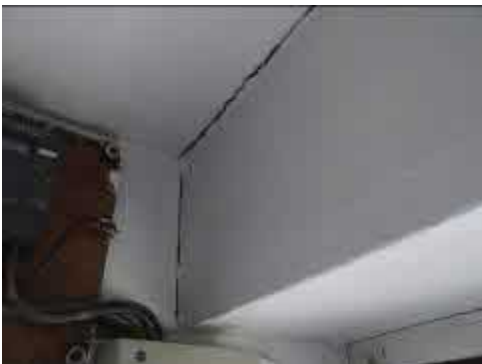
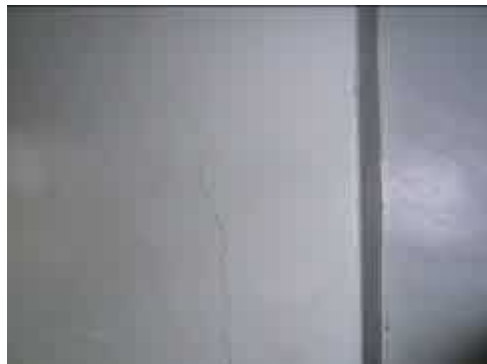
Internal Cracking at Door Head

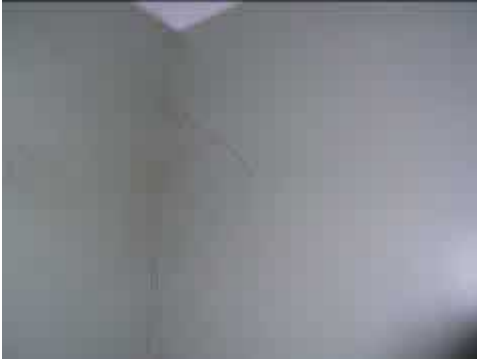
Internal Gable Wall Crack

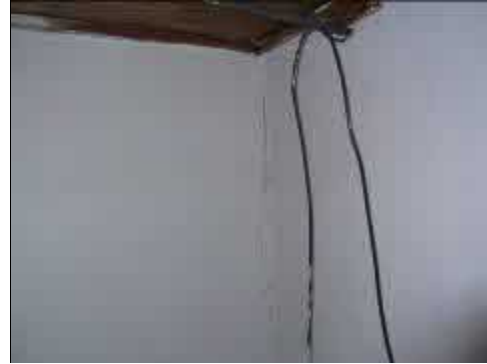
Bedroom North Wall Cracking

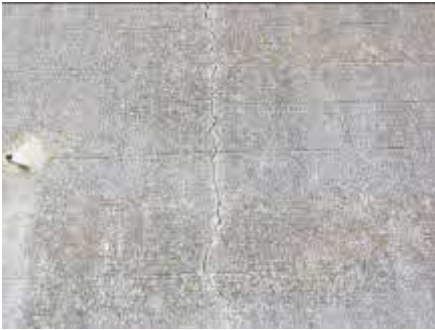
Major Crack Full Height of Gable

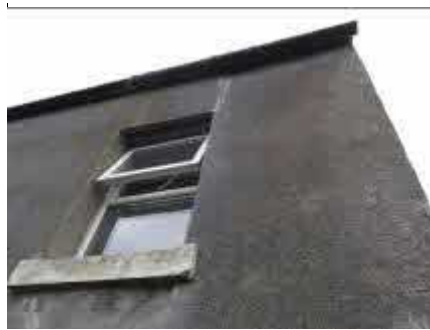
Major Crack at Eaves

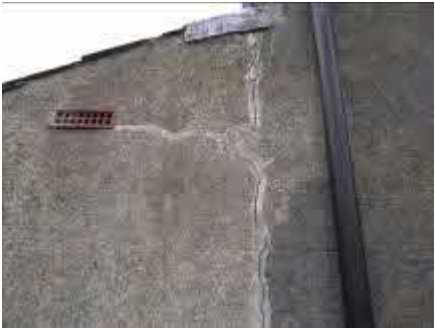
Gable Wall Cracking

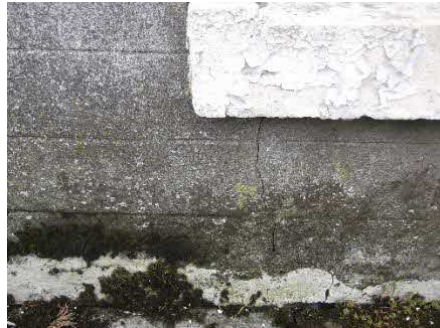
Cracking Under Cill
