STRUCTURAL INSPECTION OF REDUNDANT BARN.

ALLENS FARMHOUSE

Ref 4282

JUNE 2022

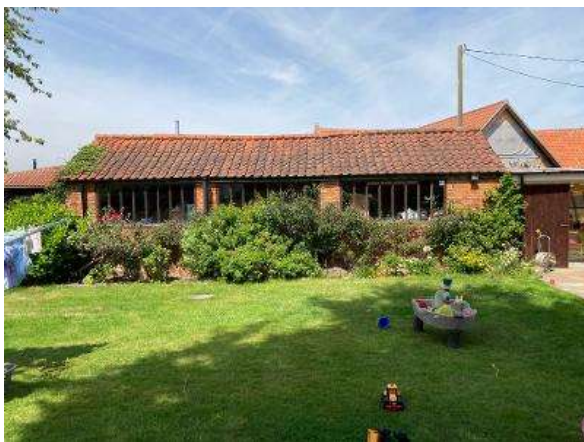
General view-front elevation

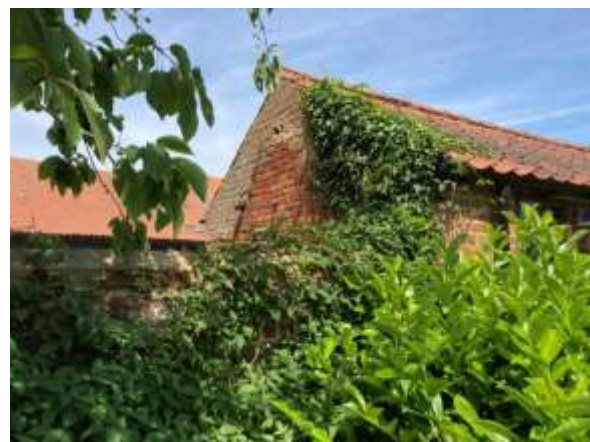
Gable return, note raised masonry

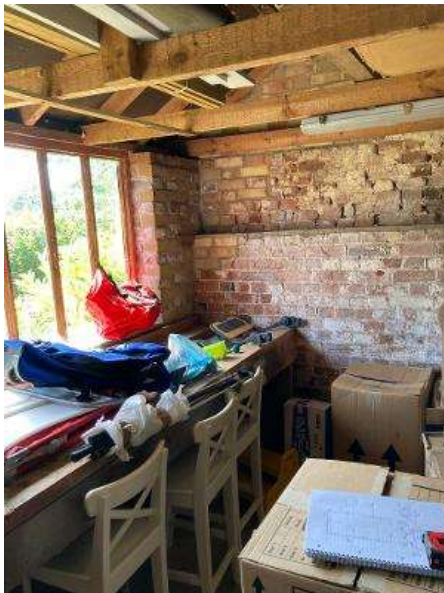
The original wall is generally 300mm thick soft red brick with a ledge formed where the “lift” masonry was added.

Internal masonry , note step

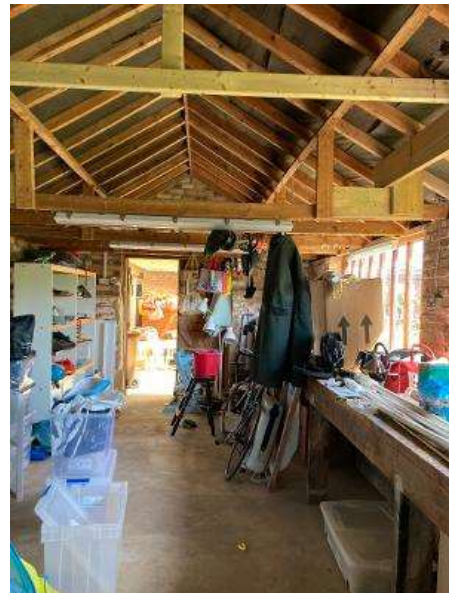
General view of roof and slab

The **slab** to the unit is generally a reasonable tamped concrete.

The roof to the barn appears to be of recent construction, but appears “a little random in its form”, it is clear the work has been carried out as a full maintenance, probably as the roof became ineffective and has been added to and stiffened as required by use. The roof is framed and triangulated and shows no signs of untoward distress or areas of leakage but it will require reassessment during any refurbishment work.

1. If the existing timbers are to be adopted, a design check must be made to ensure their suitability, should loadings patterns be altered or increased. It is probable strengthening will be required.

5. The introduction of loadbearing lining walls to ensure future serviceability. These walls will also help accommodate the insulation requirement
6. The existing floors are unusable. The floors are to be broken out and a well compacted hardcore should be placed to support a proposed semi-raft/slab foundation which is support the walls and internal partitions. Consideration must be given to sub-floor formation in relation to the existing and proposed ground and slab levels

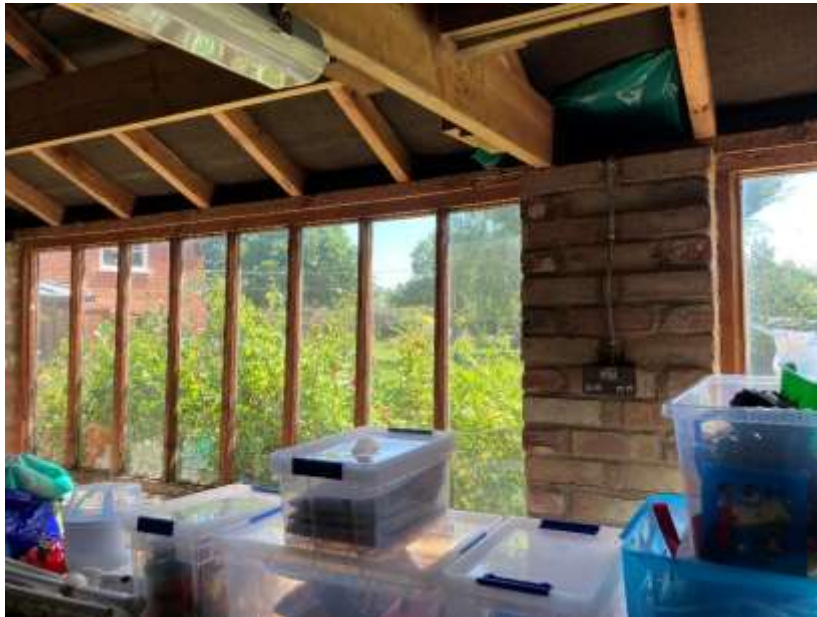
The large windows to the garden elevation are divided by substantial masonry piers which display an outward lean, almost certainly the result of horizontal thrust applied by the original roof frame. The more recent **roof** frame appears

to have has addressed this problem as no recent distress was present. No lintels were evident supporting the roof frame between the openings.

Window piers, note lintel

The masonry shell is reasonably sound, but will require attention with respect to the window piers and the introduction of lintels over the openings.
