CL REF: 9334154

## SITE RECORD DETAILS

INSURED: Gilbert

ADDRESS: Old Infant School

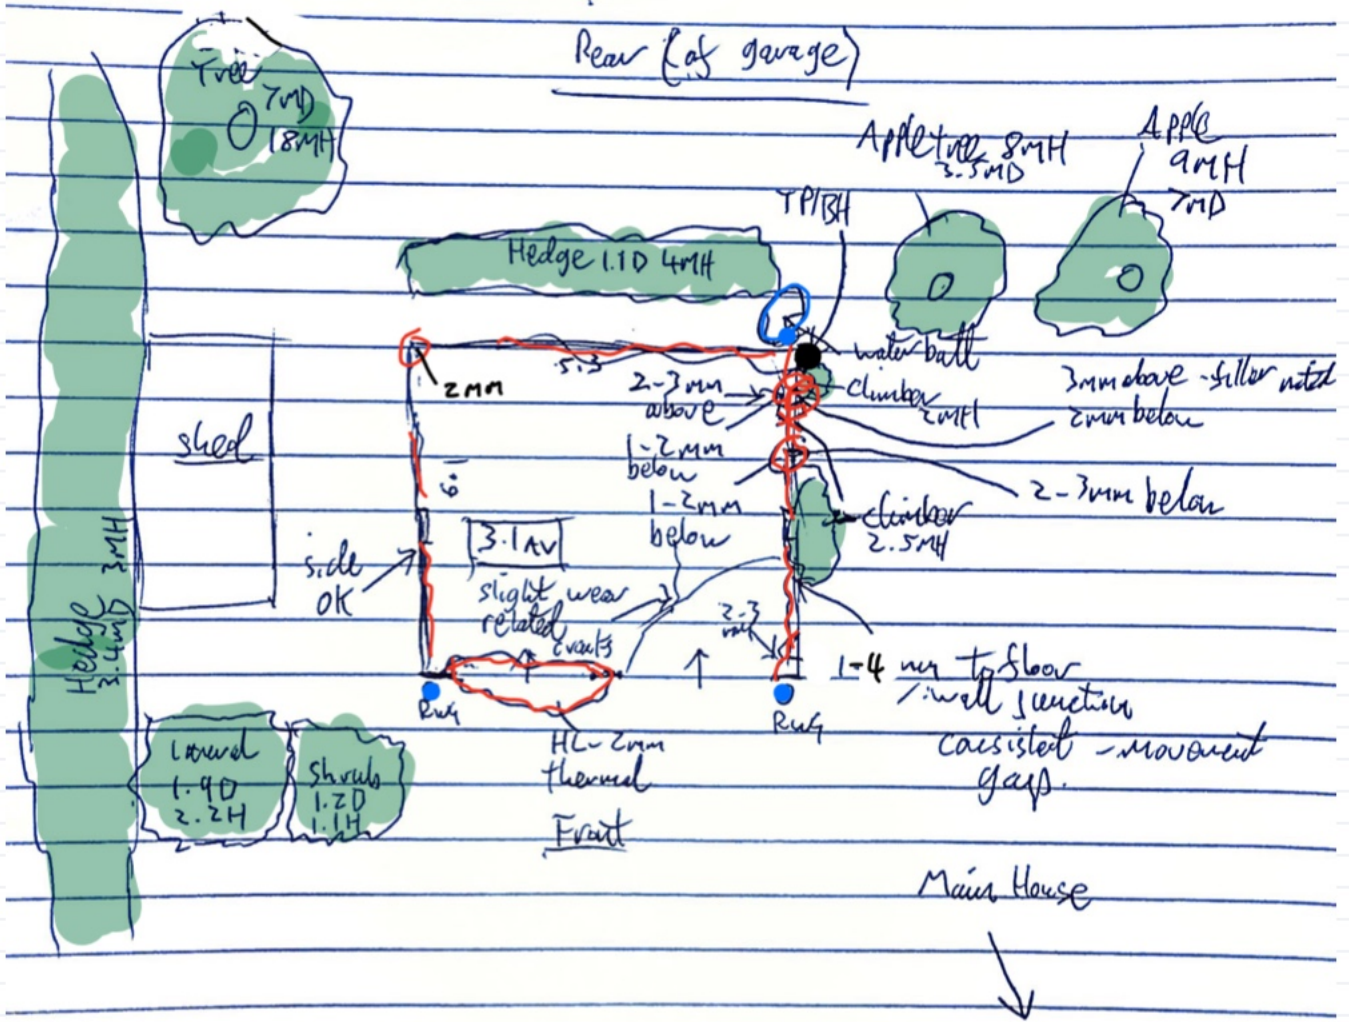
**LOCATION:** Sketch plan- Garage

Front and rear walls are double skin thick  
 side walls are single skin rendered blockwork  
 with piers at mid-point

x window sticks - allow to adjust - timber

Area of main concern is the rear right corner

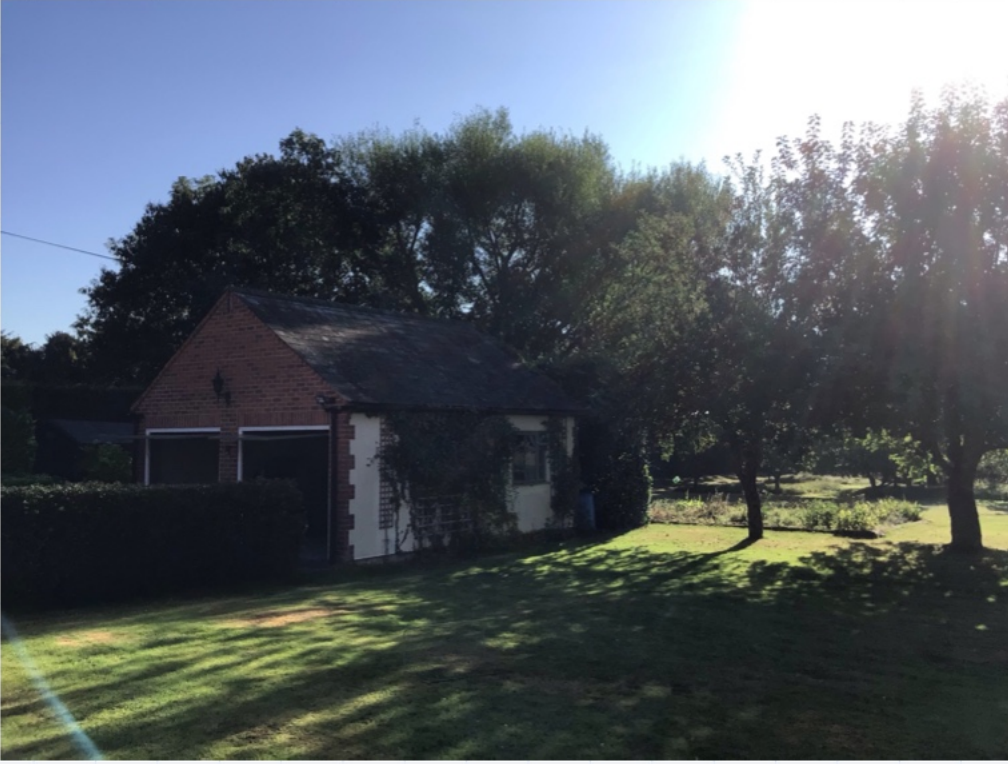
**LOCATION:** Vegetation adjacent to the garage

View from  
the front

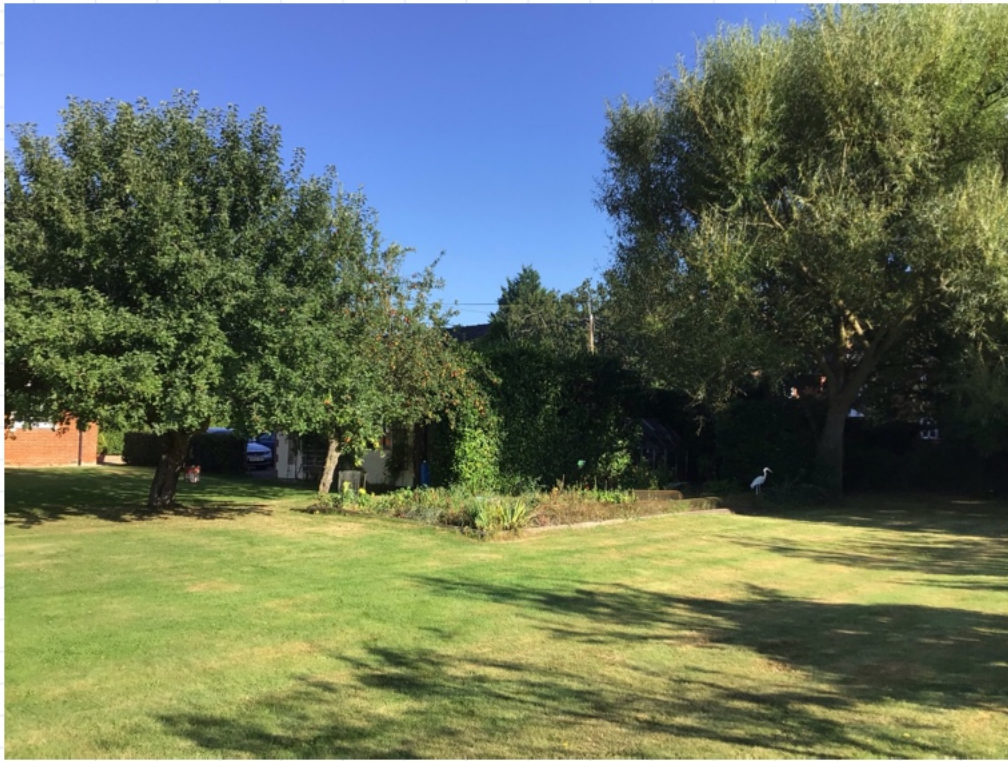
View from  
the rear

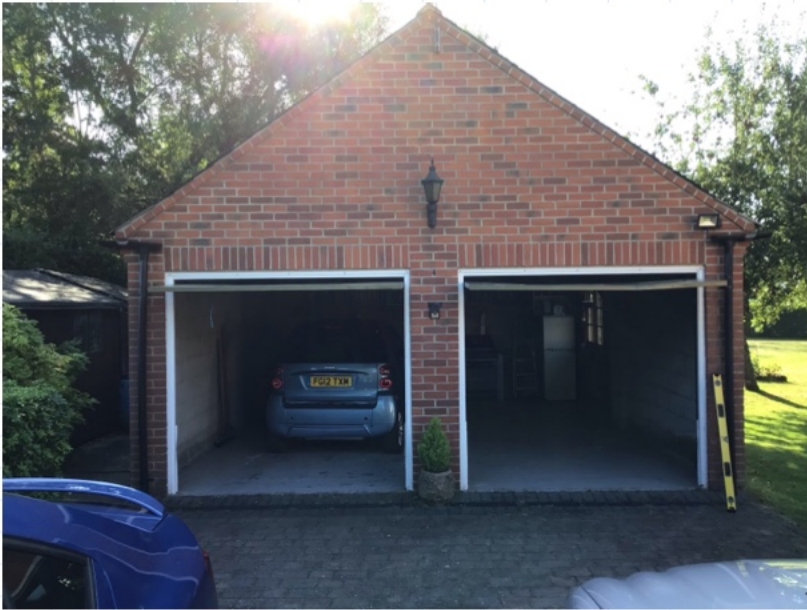
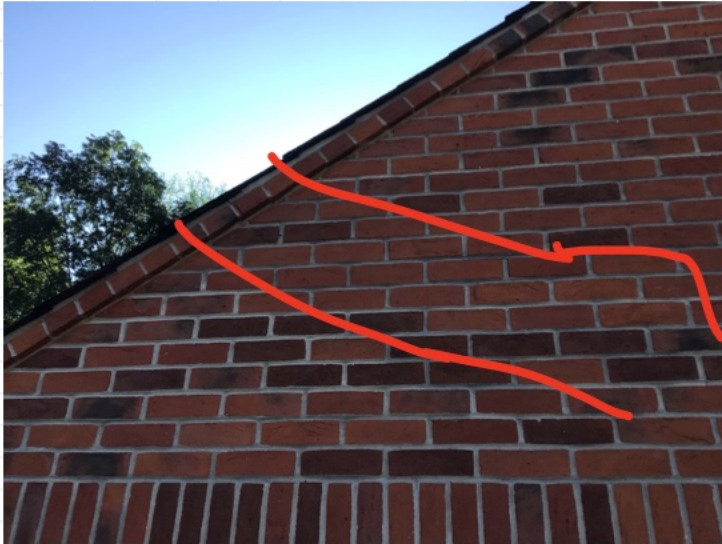
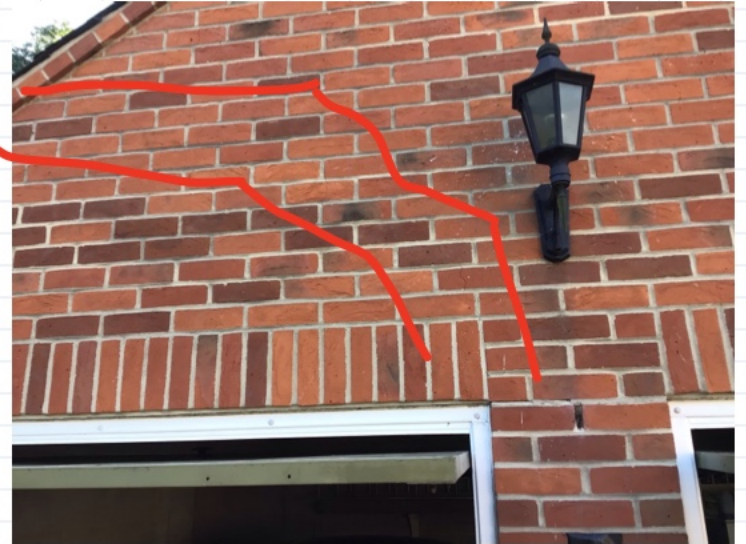
**LOCATION:** Front elevation

Slight thermal cracking above the door opening noted - issue not due to subsidence, damage not covered as part of the claim

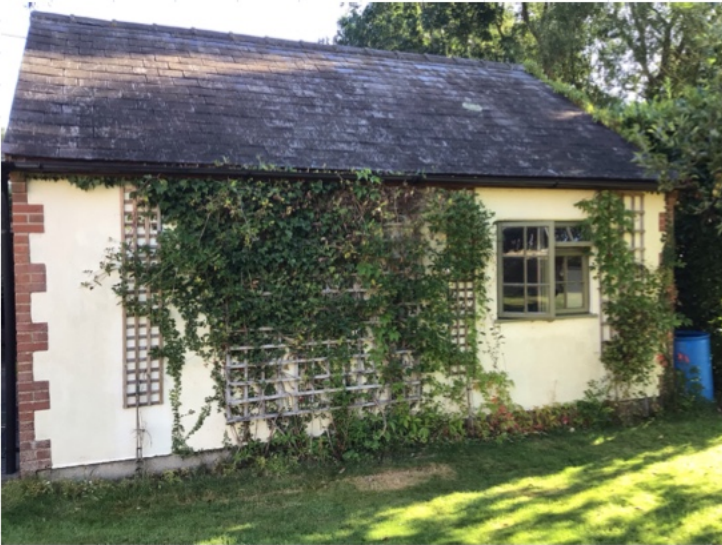
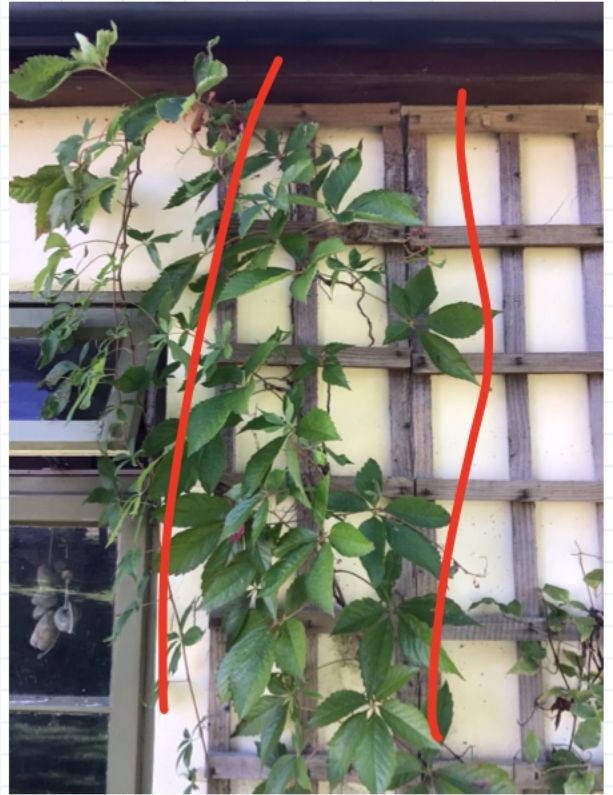
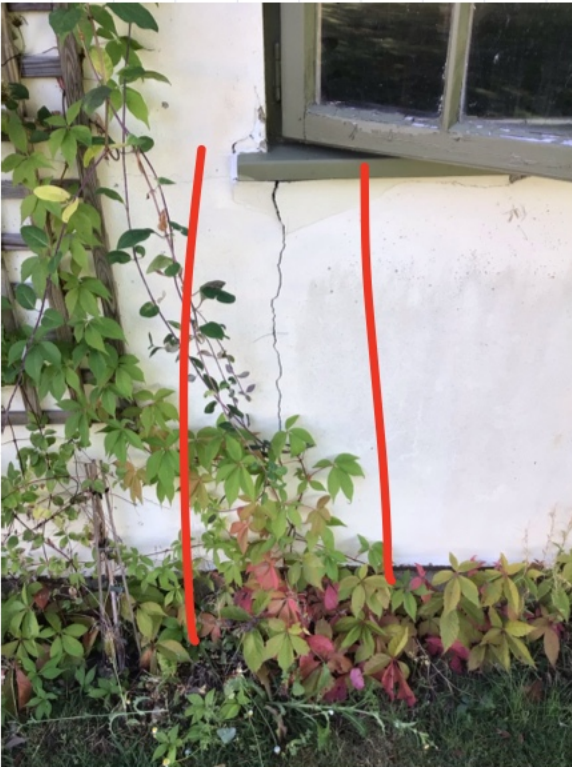
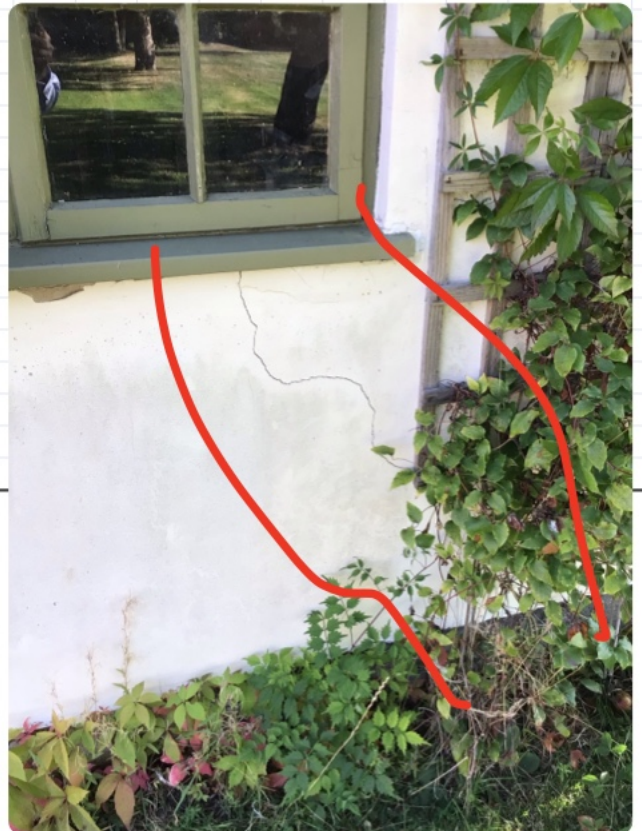
**LOCATION:** Right elevation - main area of concern

2-3mm cracking around right side window.  
Timber window also found to be sticky.

Allow to repair using EML and allow to repaint the whole elevation. Allow to ease and adjust the window.

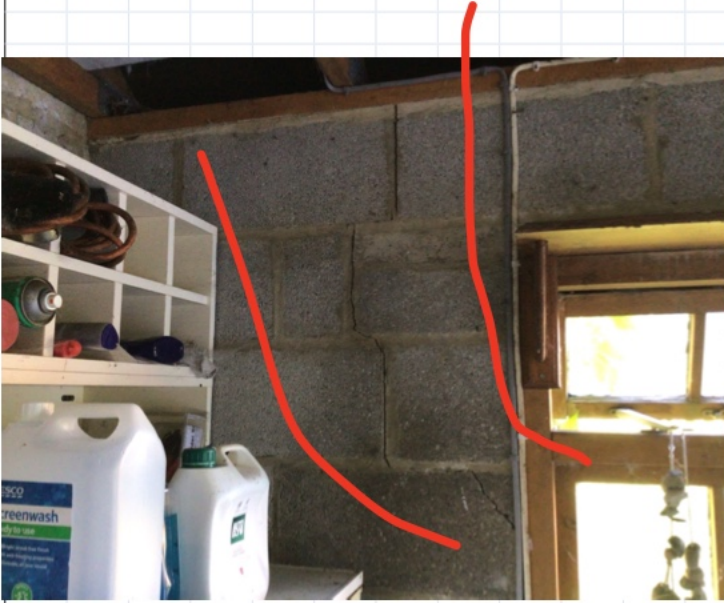
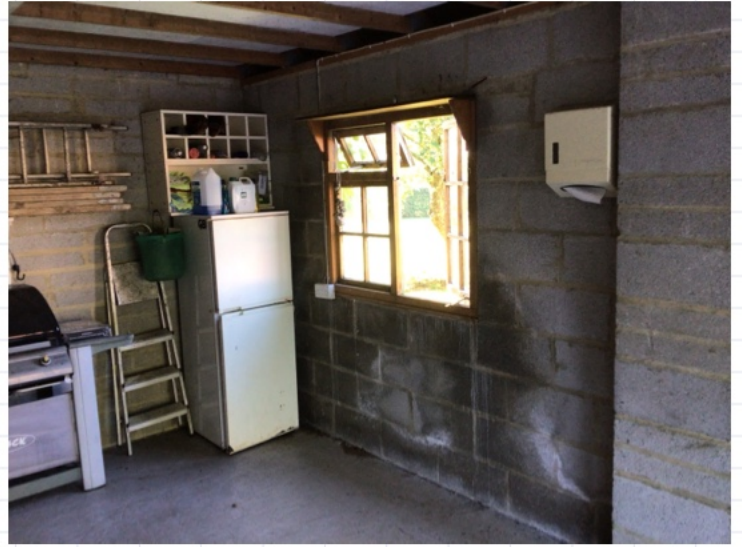
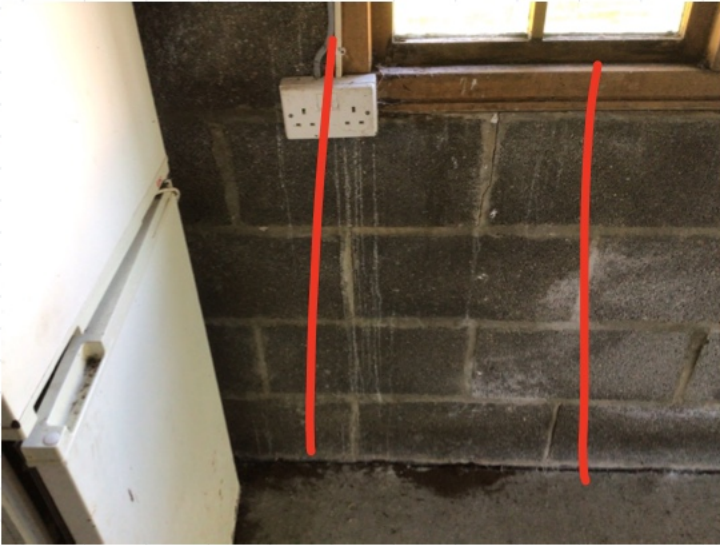
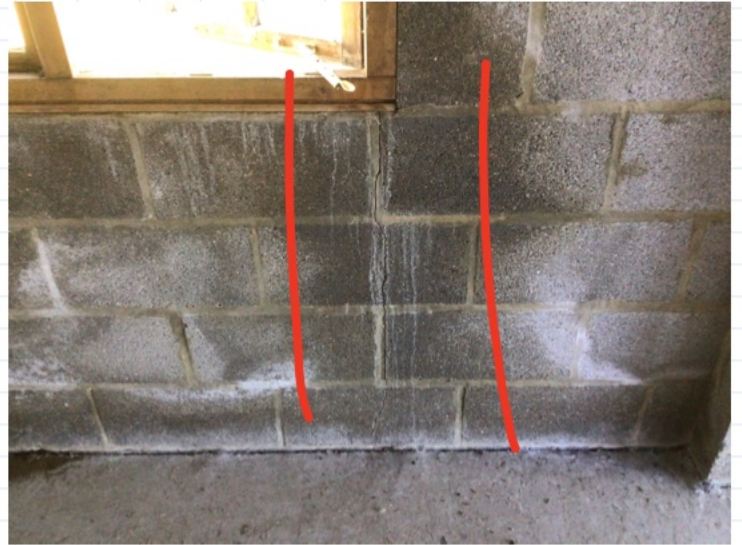
**LOCATION:** Garage- internal - area of concern

2-3mm cracking around window - allow to rake out and fill cracking and make good with cementitious grout

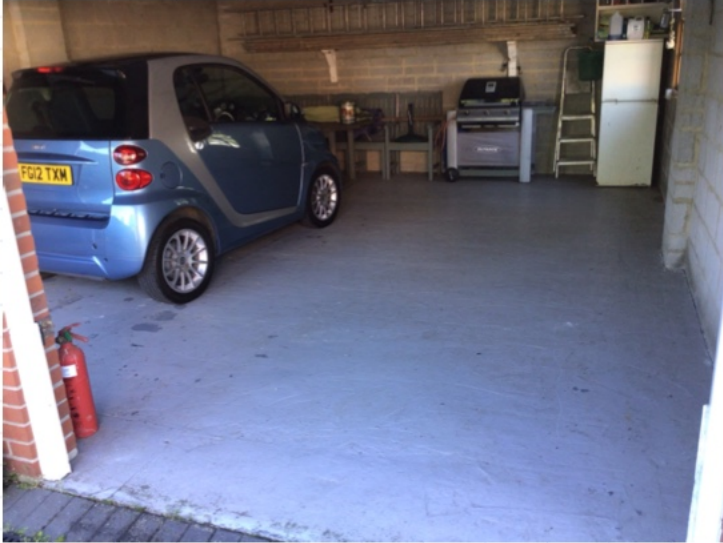
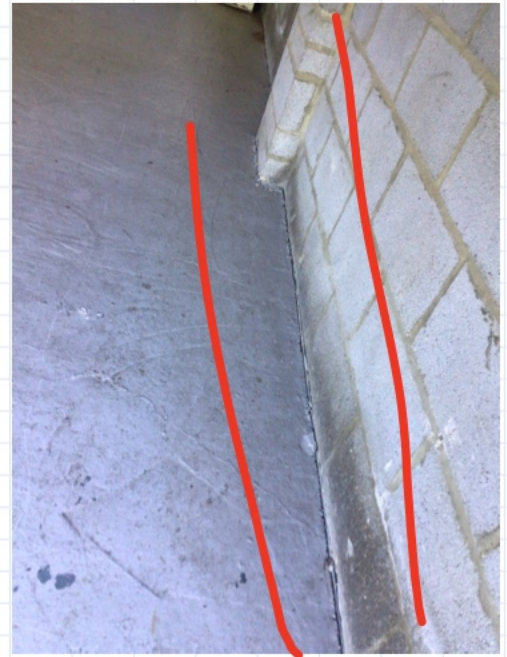
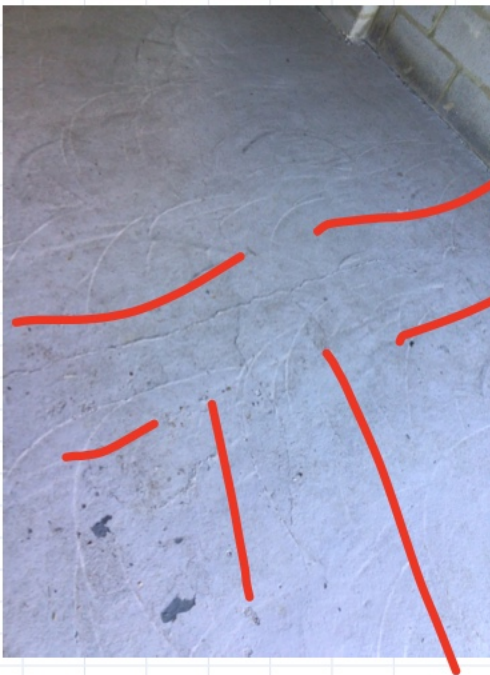
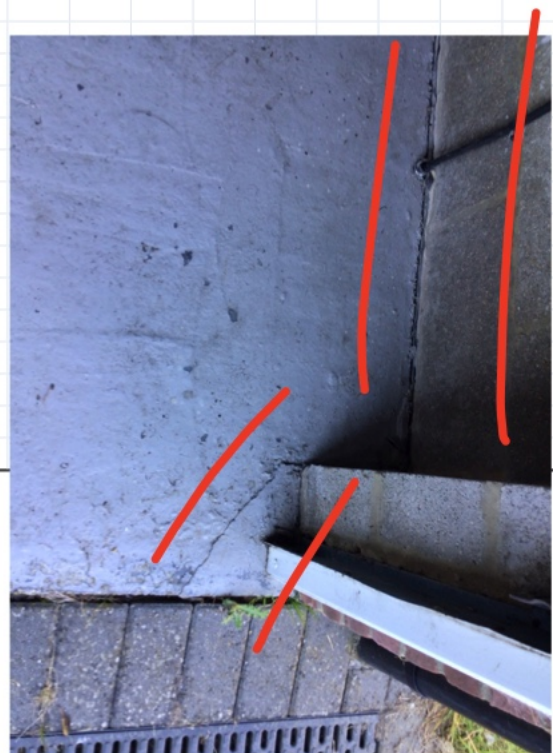
**LOCATION:** Garage- internal

Slight wear related defects noted to the garage floor. Defects are not structurally significant and are not due to the subsidence to the rear right corner. Defects not covered as part of this claim
