## PHOTOGRAPHIC PLATES

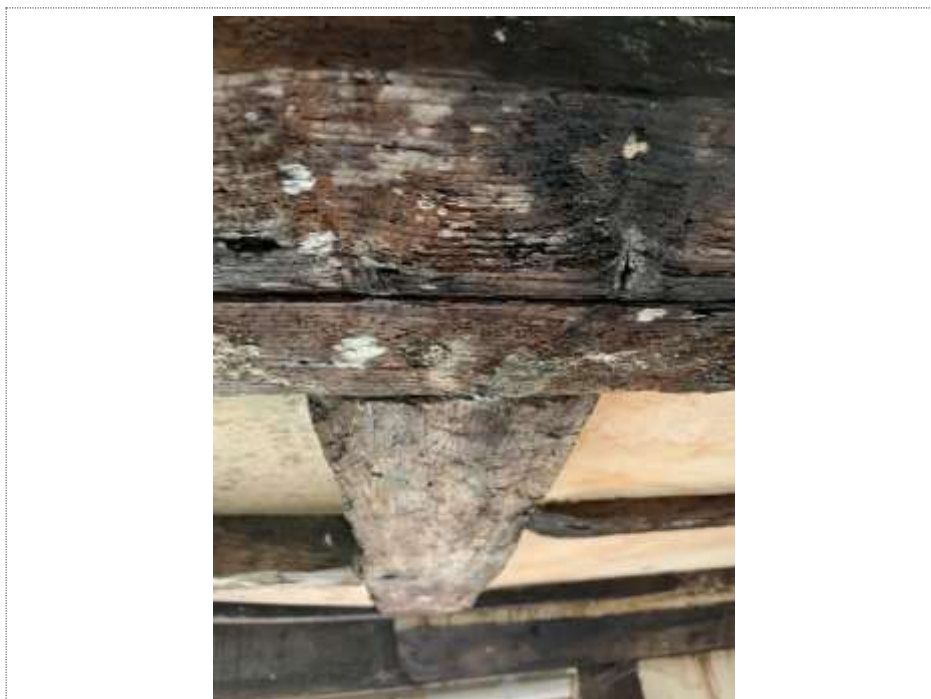
Plate 1. Rot on internal timbers.

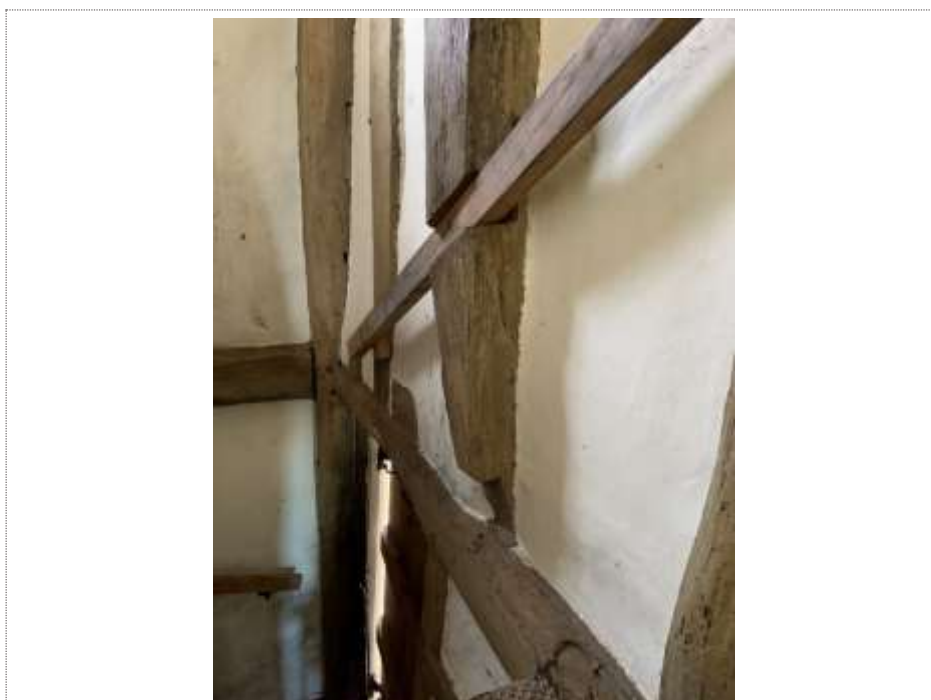
Plate 2. Some structural timbers have been cut to accommodate internal alterations.

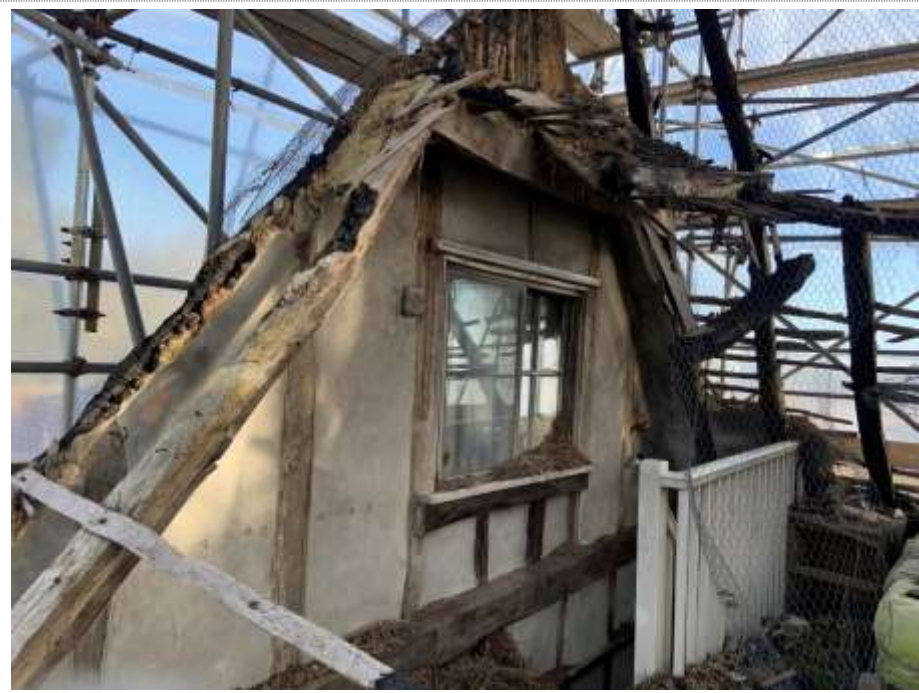
Plate 3. Roof 1 – Lower left-hand side.

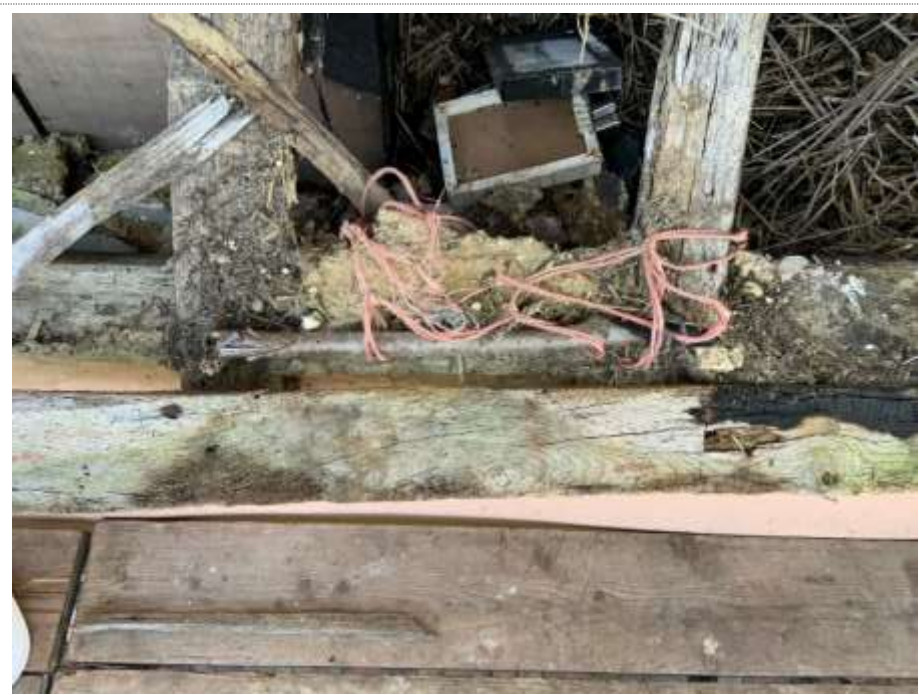
Plate 4. Branches used as battens.

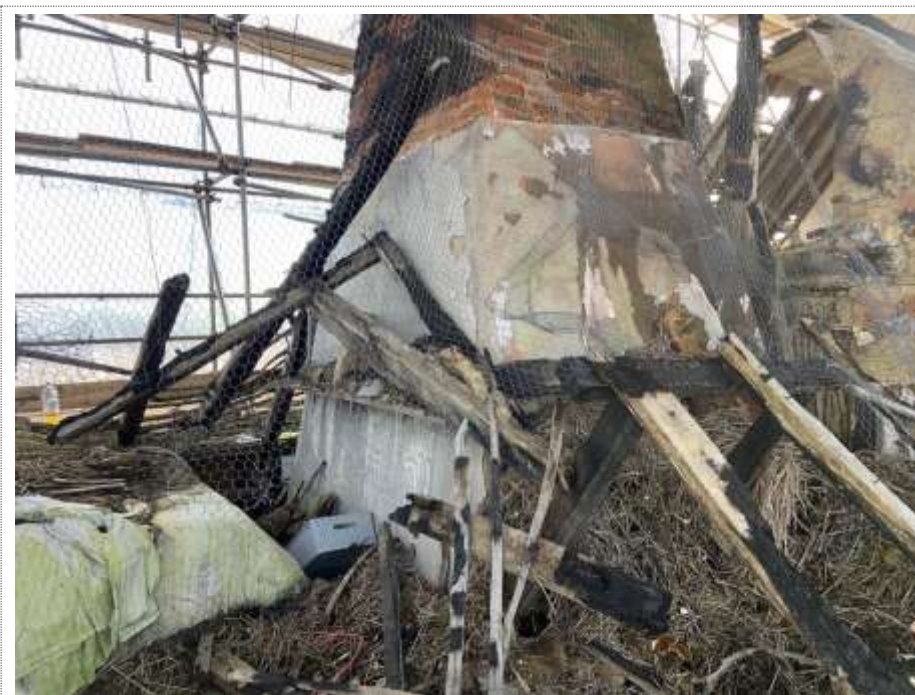
Plate 5. Bracing around the chimney structure.

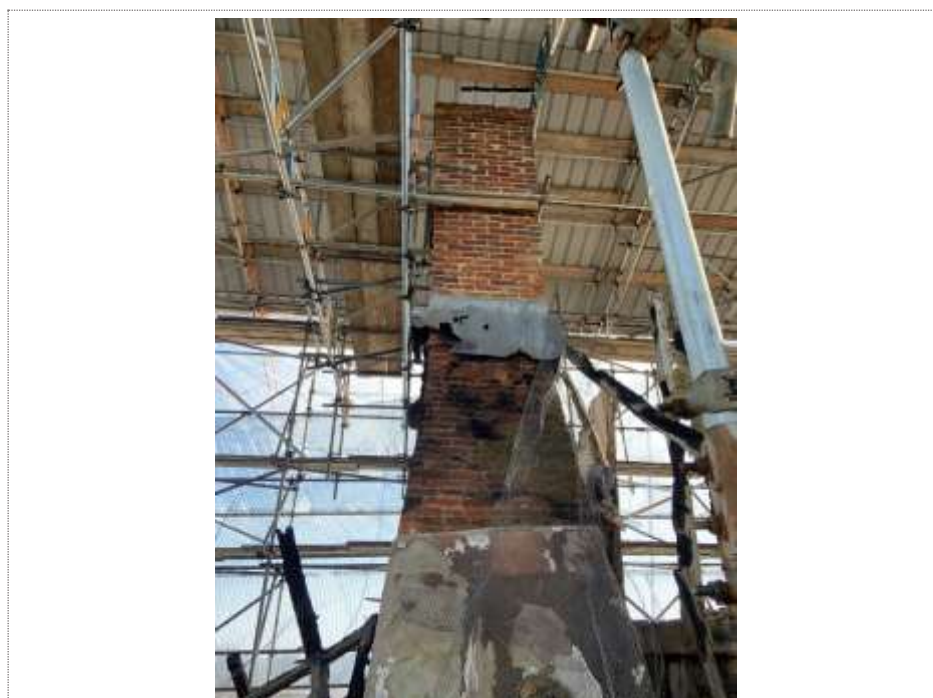
Plate 6. Internal chimney.

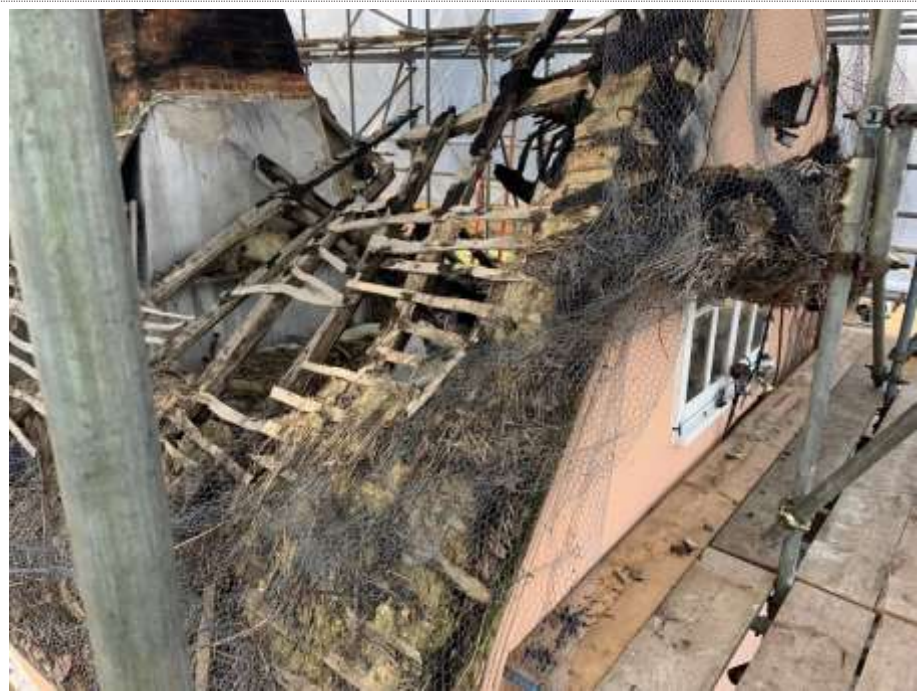
Plate 7. Back of Roof 1.

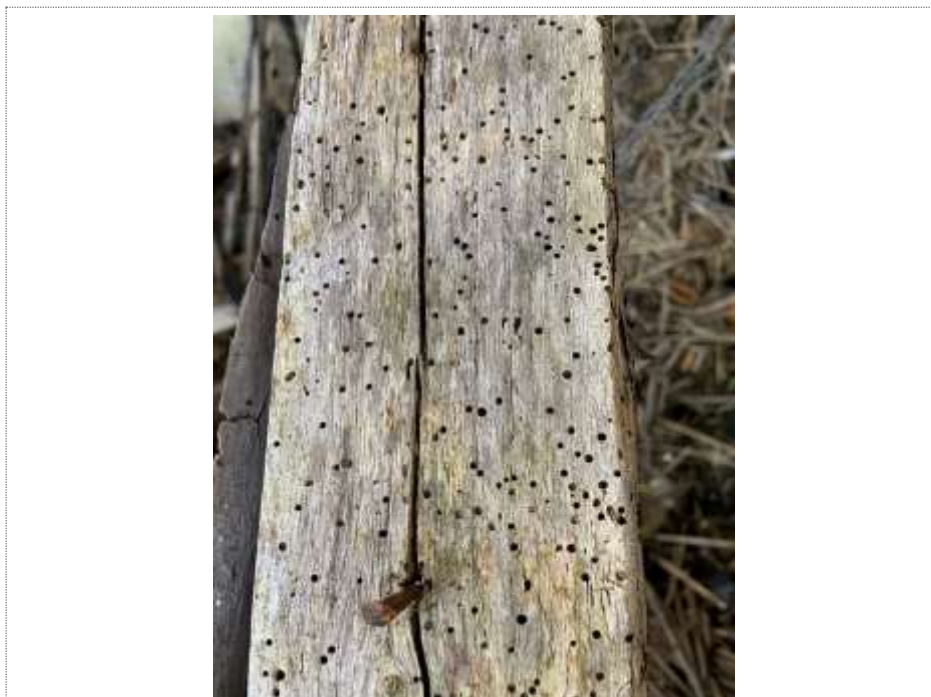
Plate 8. Historic termite/insect attack.

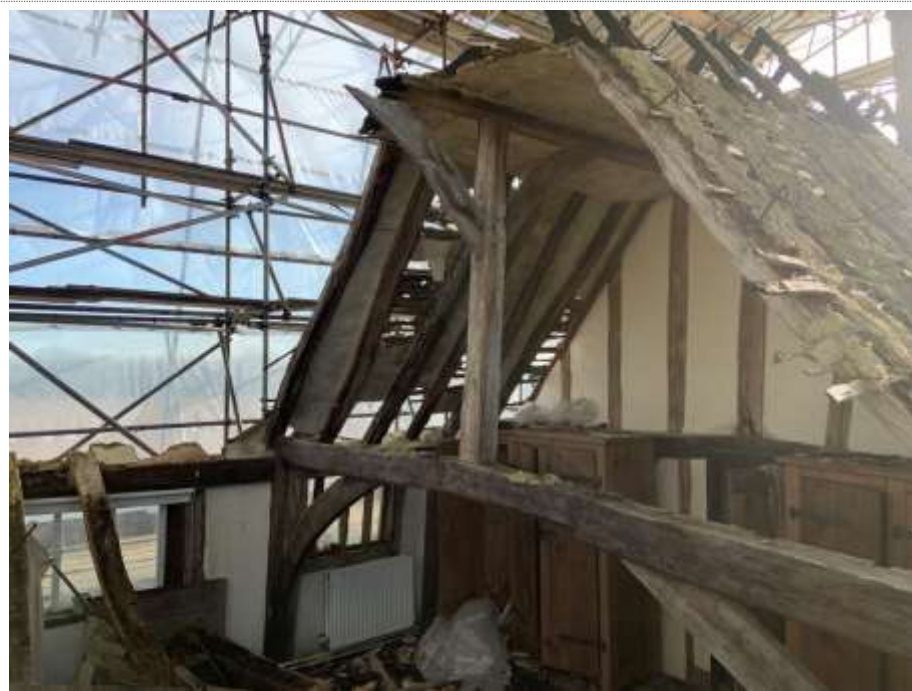
Plate 9. Roof 2 – Middle roof with 2-dimensional frame.

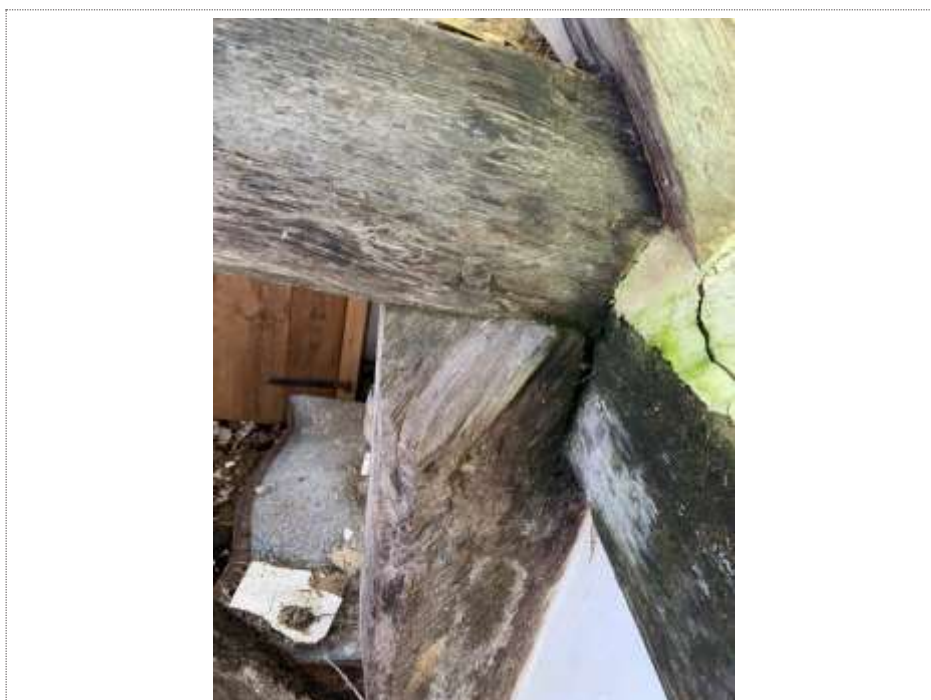
Plate 10. Tie beam to column connection point.

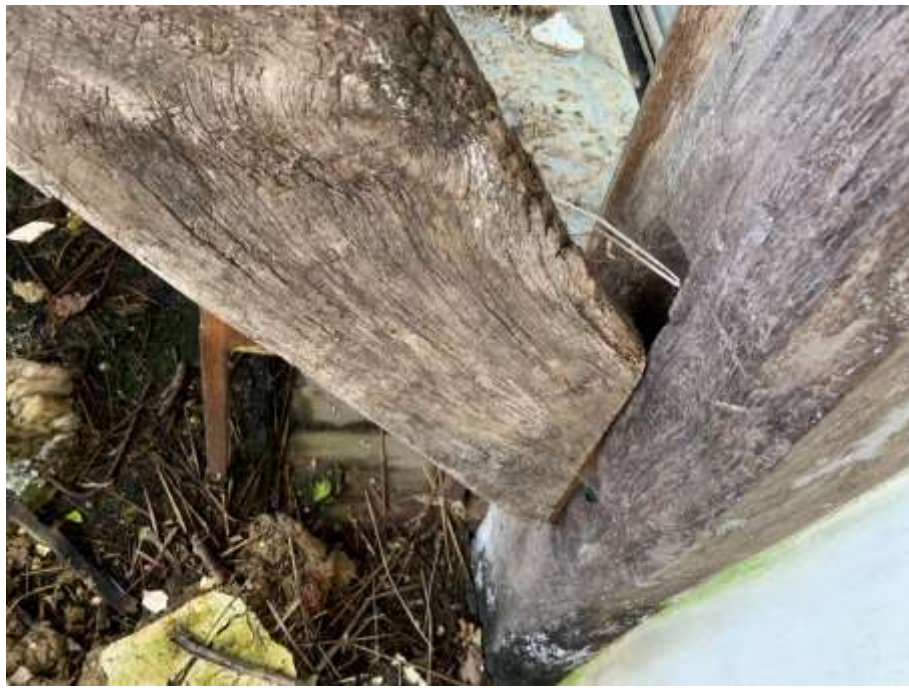
Plate 11. Gallows bracket to column connection.

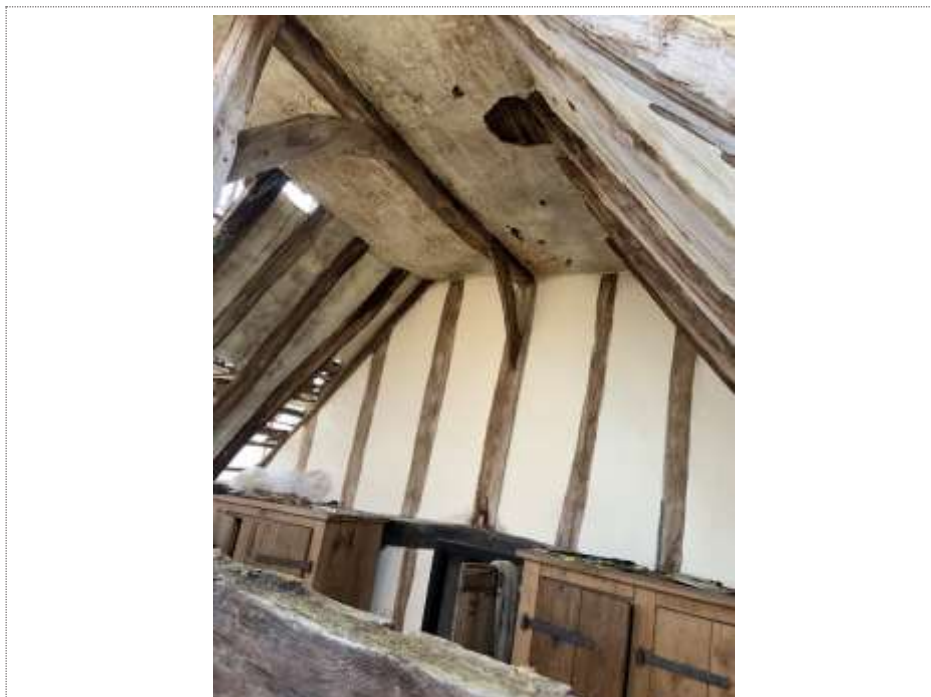
Plate 12. View on the frame parallel to front elevation.

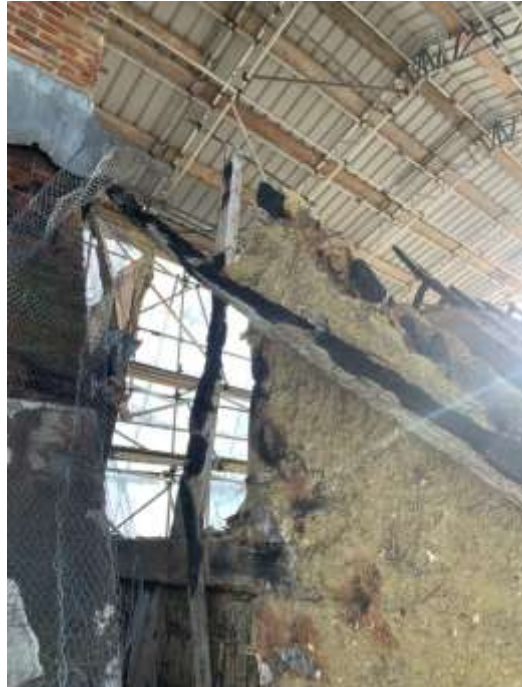
Plate 13. Timber framed, cob infill internal gable wall.

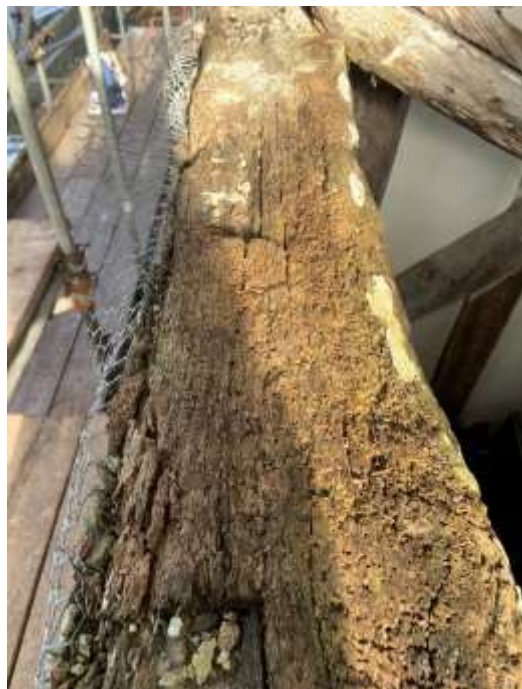
Plate 14. Wall plate at the front wall.

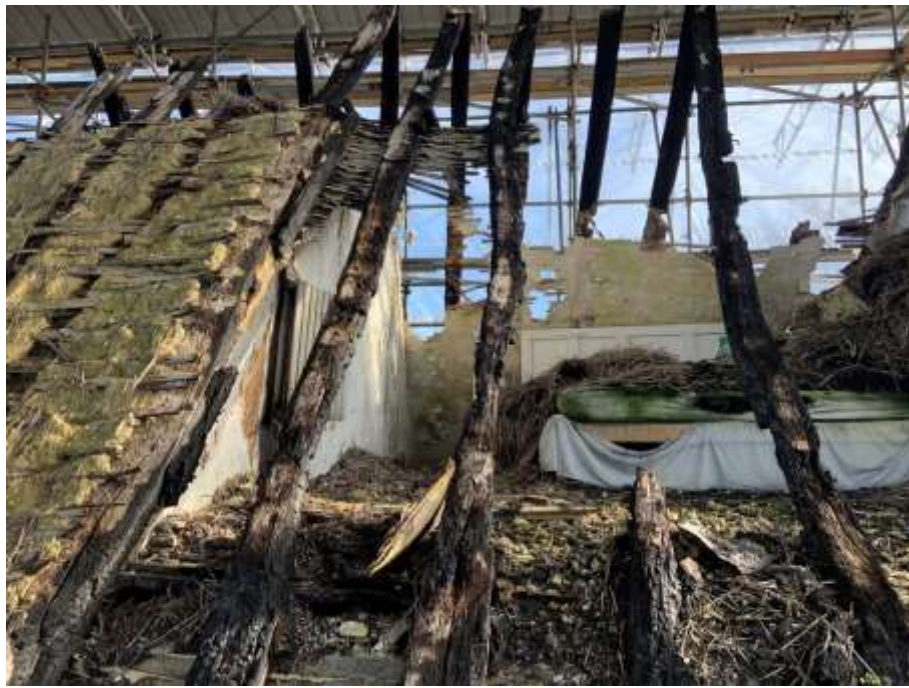
Plate 15. Roof 3 – Right-hand side upper level roof.

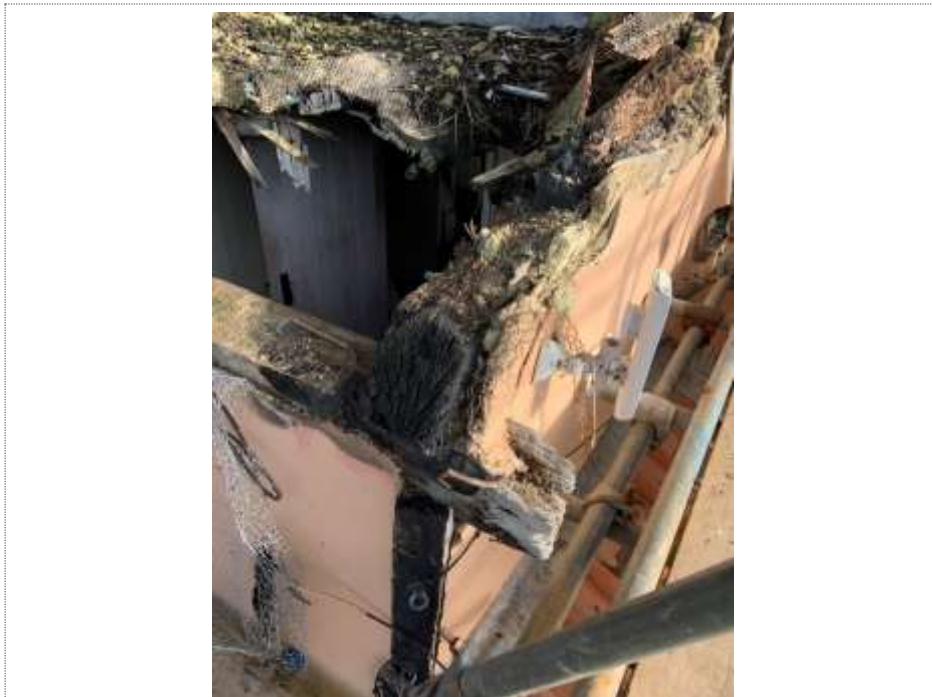
Plate 16. Wall plates overlapping and extending over the edge of the wall.

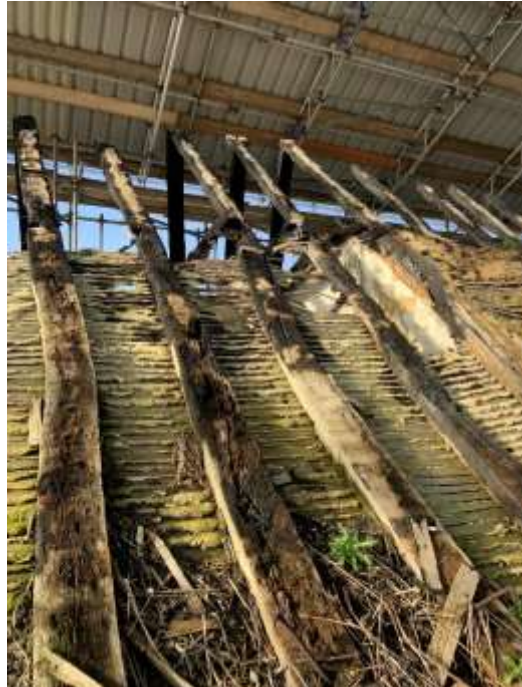
Plate 17. Vegetation growing at the back of Roof 3.

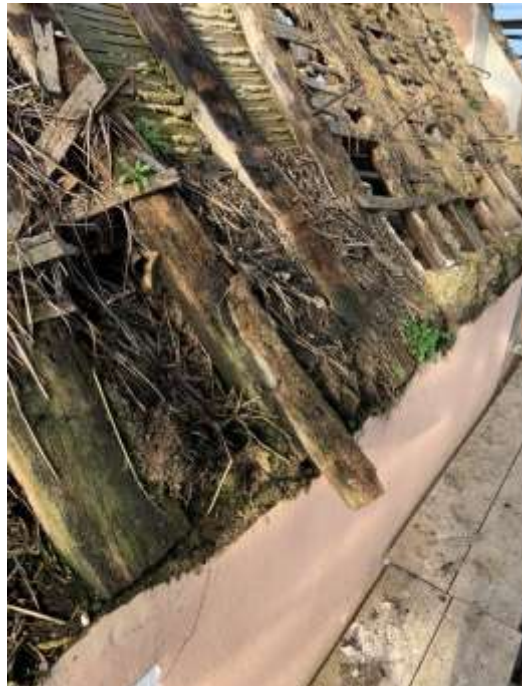
Plate 18. More modern lath and plaster finish on Roof 3 compared to Roof 2.

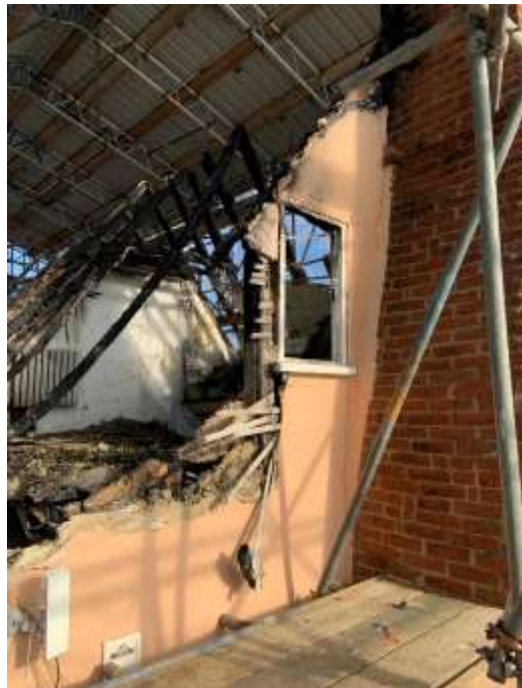
Plate 19. Damaged timber framed gable wall.

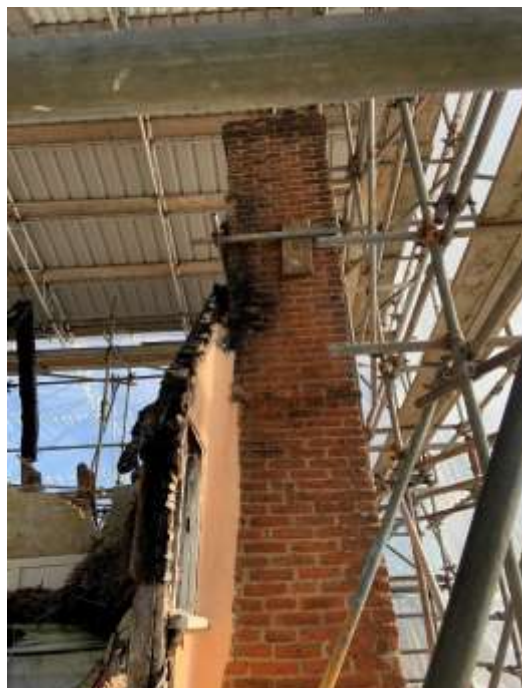
Plate 20. Soot residue on the chimney.

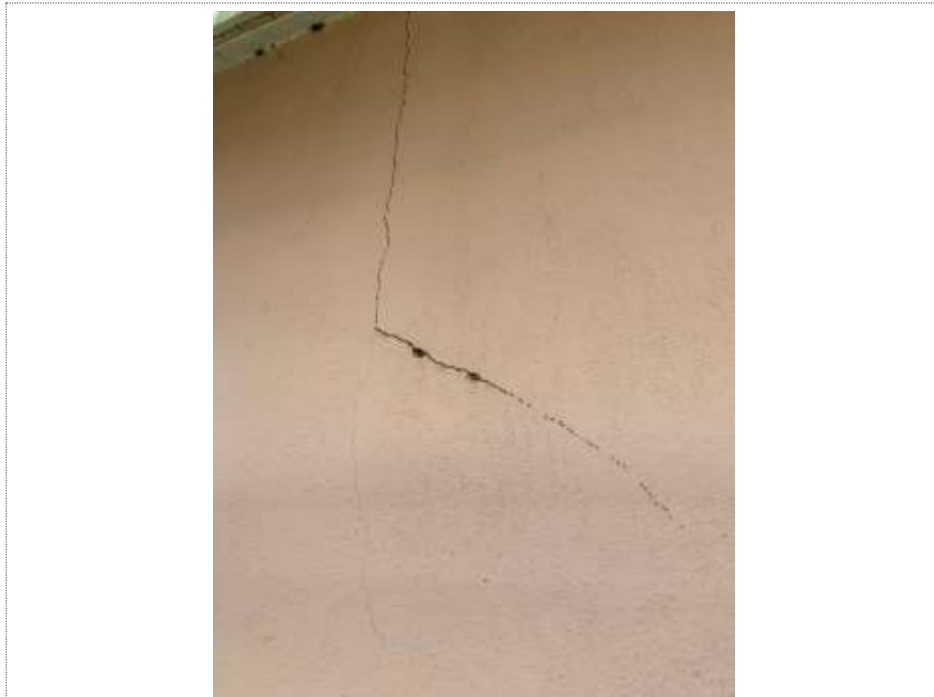
Plate 21. External cracking.
