## Schedule of Works for Wall Construction.

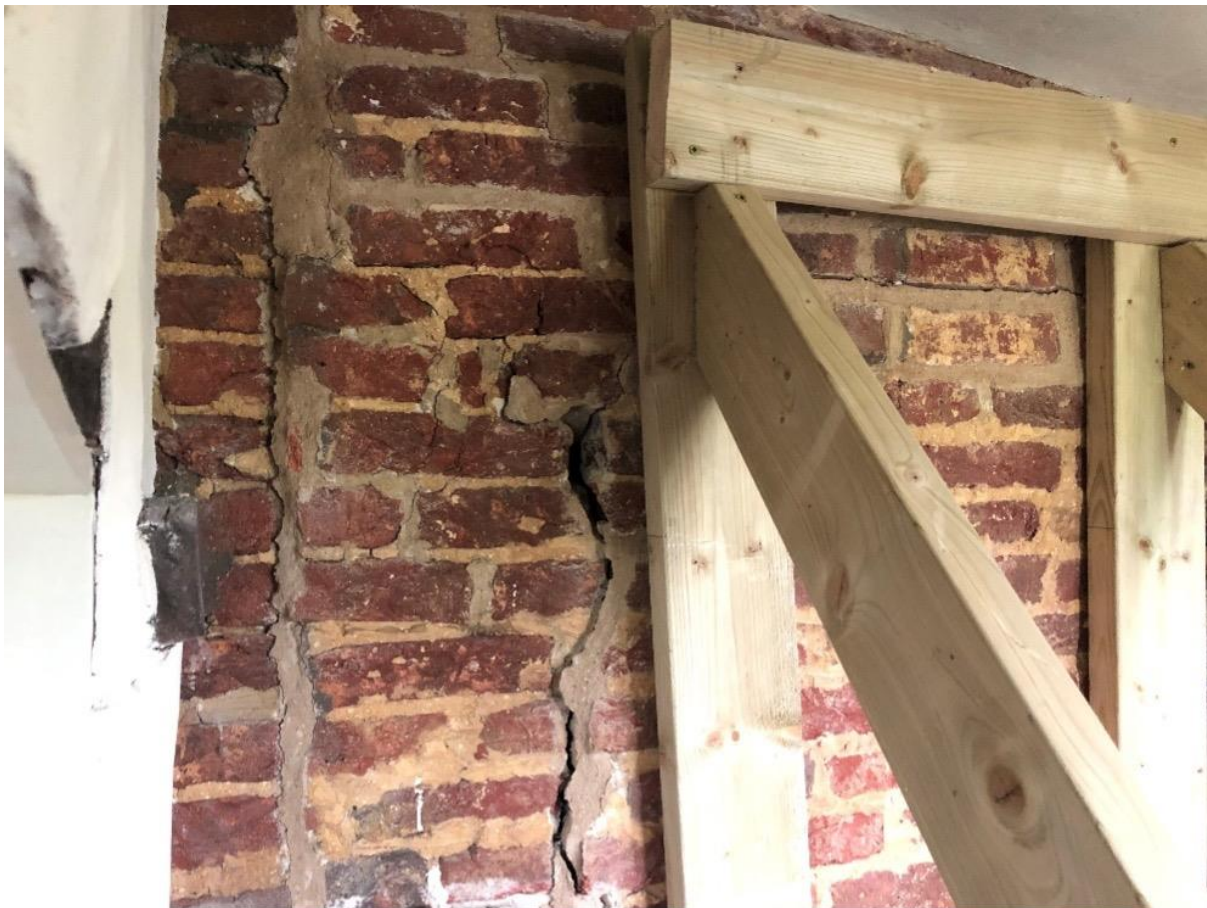
The chimney had been subsiding and caused a significant series of cracks to appear in the first floor east bedroom chimney wall. These cracks were large enough for someone's hand to be inserted into it and grew at an alarming pace.

Our children were moved out of the bedroom and a temporary structured wooden brace was erected in the bedroom to prevent the wall (and likely chimney) from subsequent collapse.

The emergency work was carried out in accordance with Geoff Dentons (Adam Power Ltd, Structural Engineers) specifications, with the work completed as quickly as possible owing to the delicate and dangerous nature of the operation.

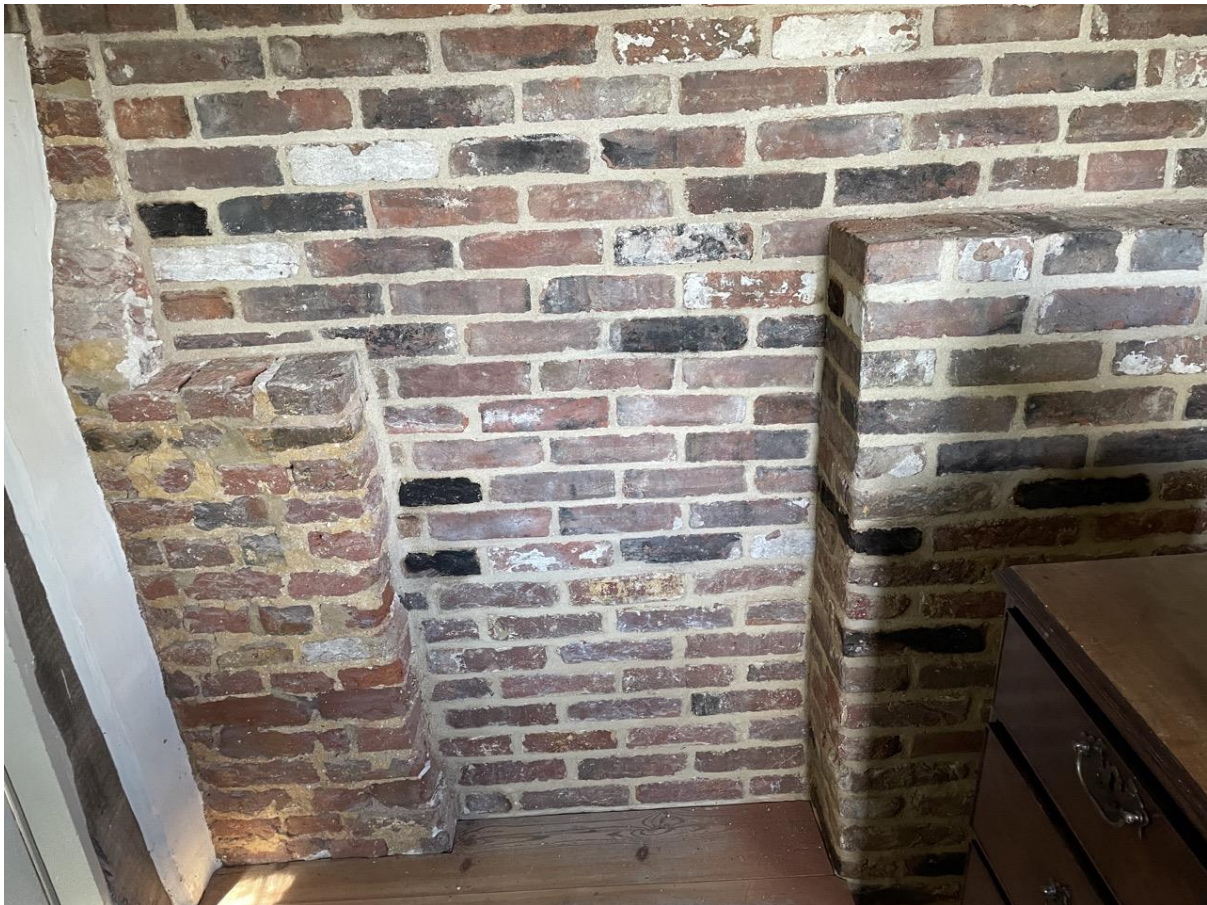
It was then visible and thus discovered at this stage that the midfeathers wall was floating and also in a precarious state.

The area was cleared and made good for the new wall to be rebuilt. This was built straight, so that the midfeathers wall that was floating could be tied in, which is likely how the wall originally would have been. To enhance the strength of the structure, helifix crack stitching was used to tie all the walls together.

The chimney buttress on the right hand side was not replaced to its full height, with the structural engineer recommending that no additional/unnecessary weight was placed on the chimney and the associated screw piles that support the foundations i.e. to help prevent further subsidence in the future.

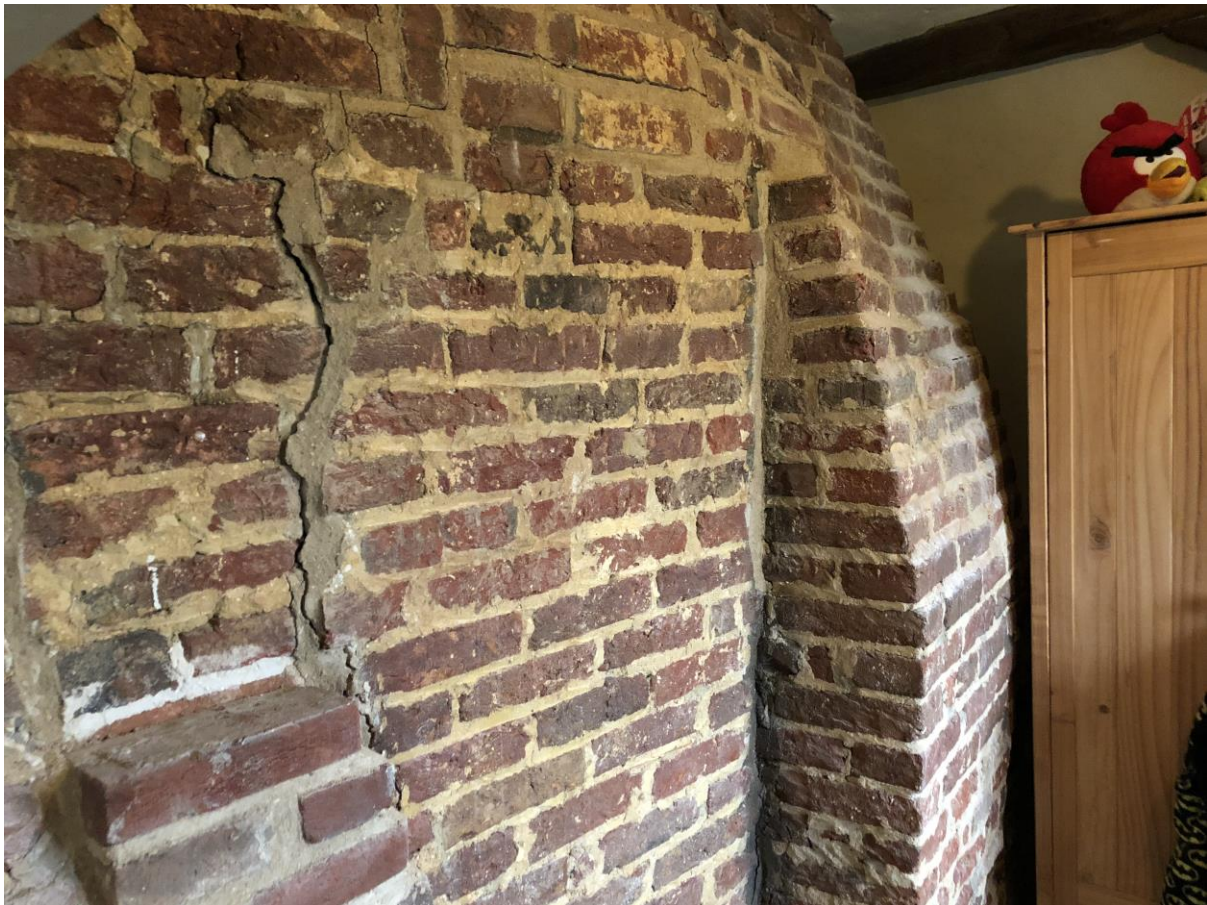
Wall just before the cracks started to go critical.
