Bellister Castle

Window Condition Report

Martin Johnson & Co (York) Ltd

April 2021

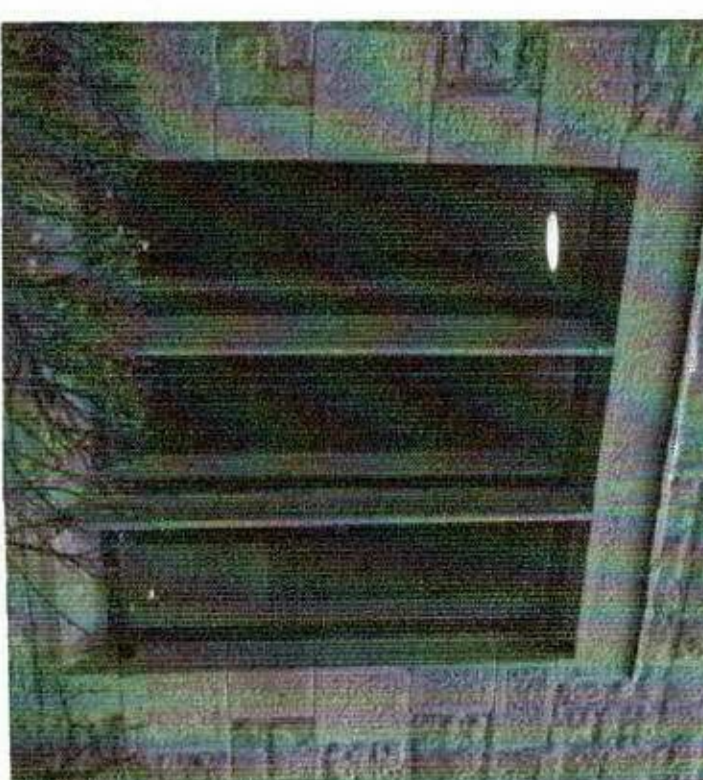
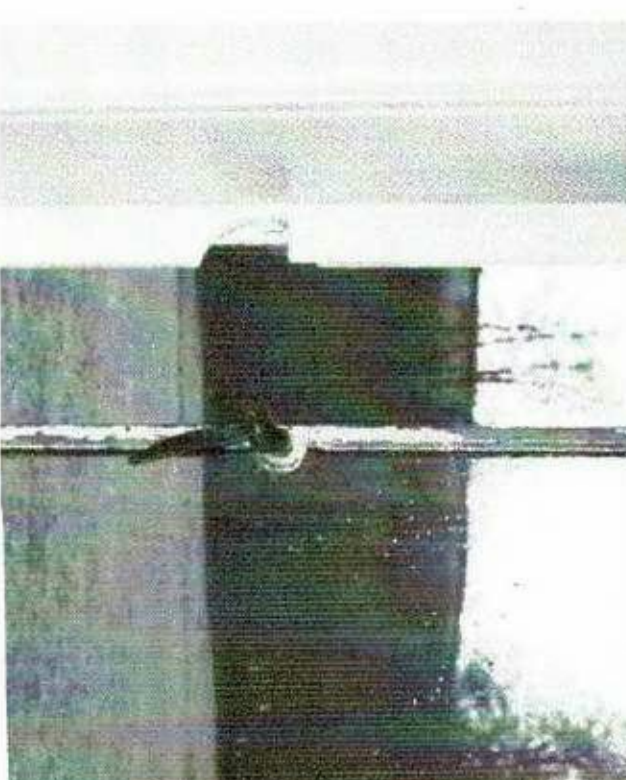
4.1 Window WG1

Description	3 lights: <i>a</i> and <i>c</i> lights are openers, <i>b</i> light is fixed		
Dimensions	All lights 430 x 1300mm		
Condition	Both opening lights are operable		
Proposed works	Refurbish all lights in-situ

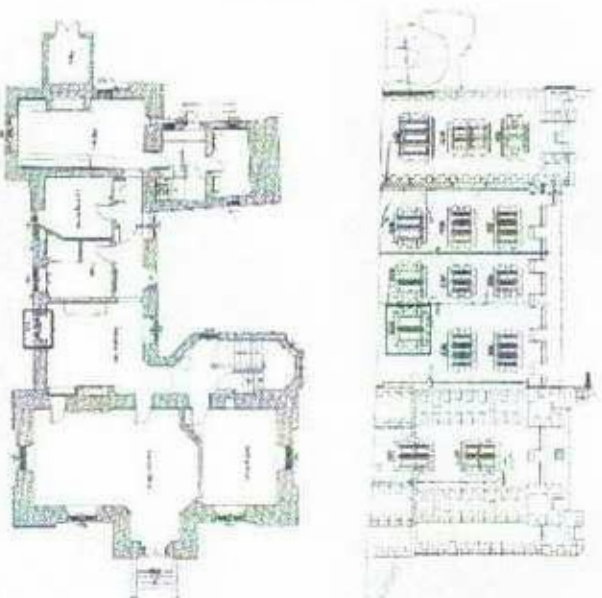
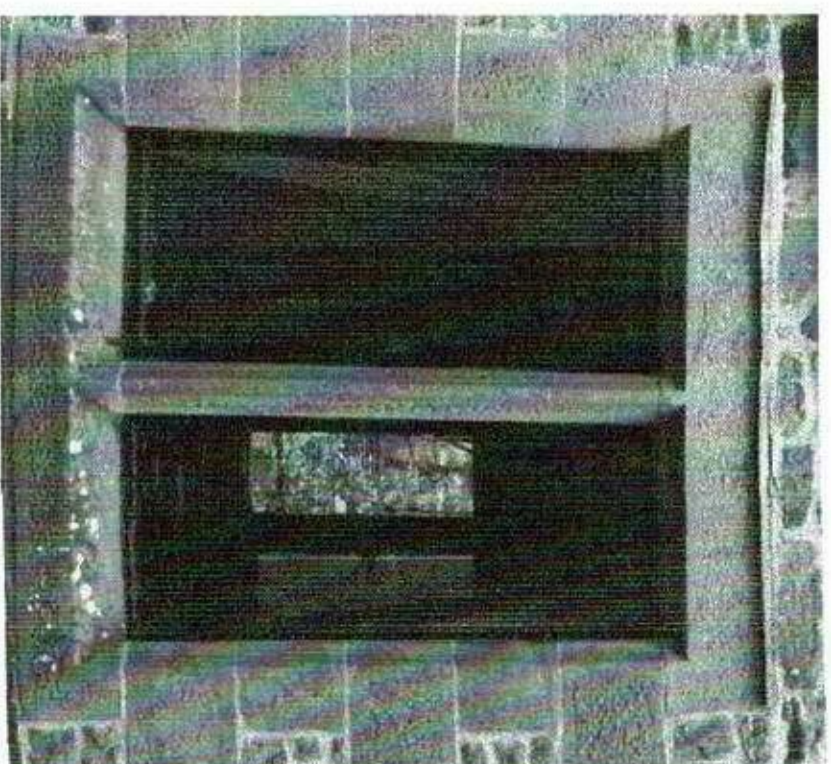
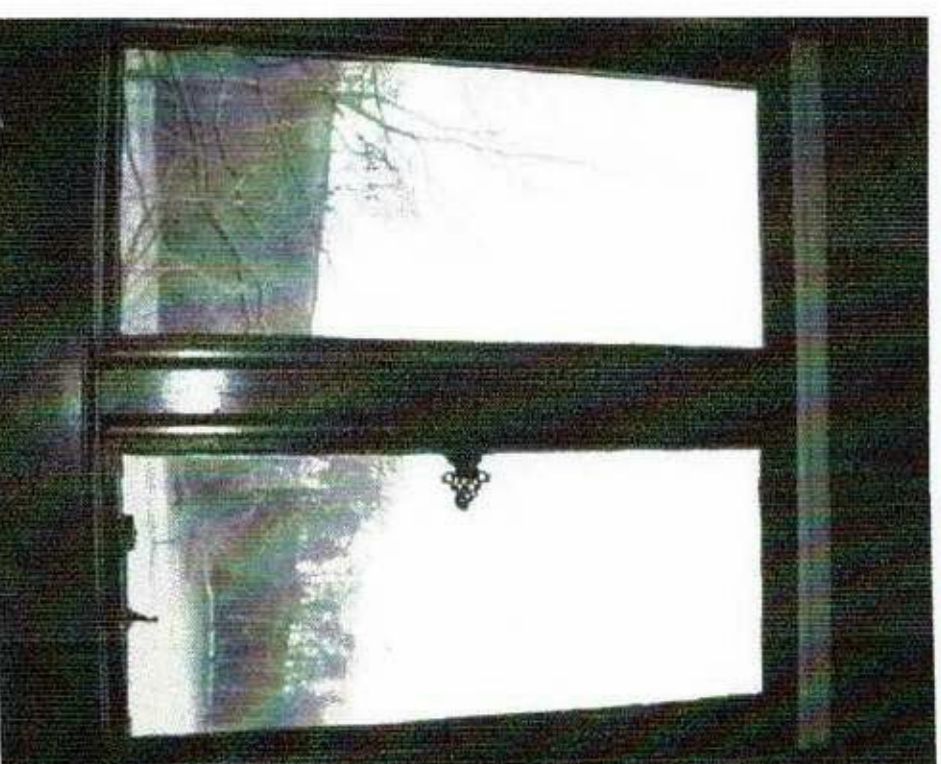
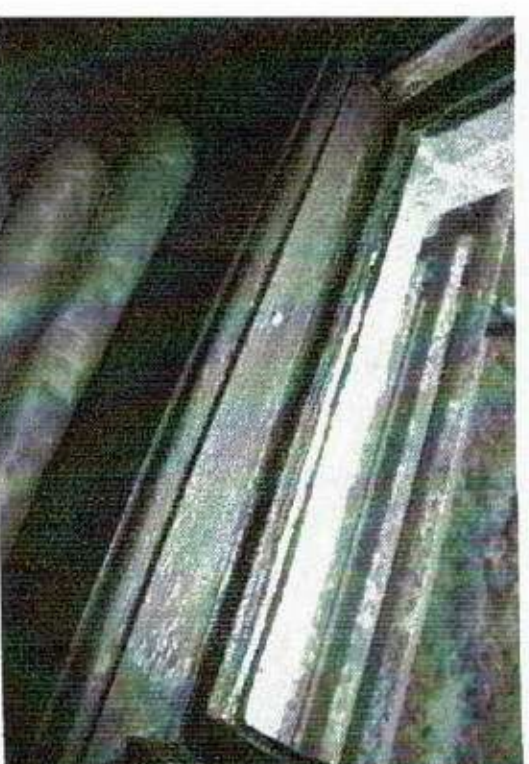
4.4 Window WG4

Location	South elevation Ground floor reception hall window
Installation	Steel frames
Description	2 light window: <i>a</i> light fixed, <i>b</i> light operer
Dimensions	Both lights 530 x 1200mm
Condition	<i>a</i> light has been reglazed, and is rusting at base <i>b</i> light – opener is sealed shut and inoperable
Proposed works	Remove both for refurbishment

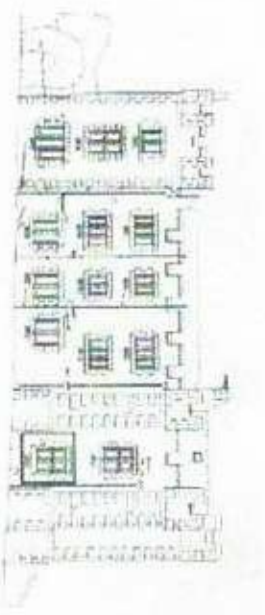
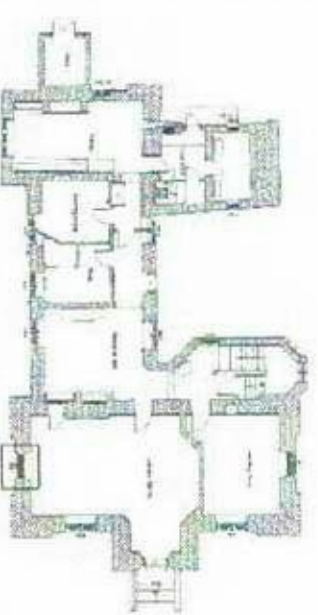
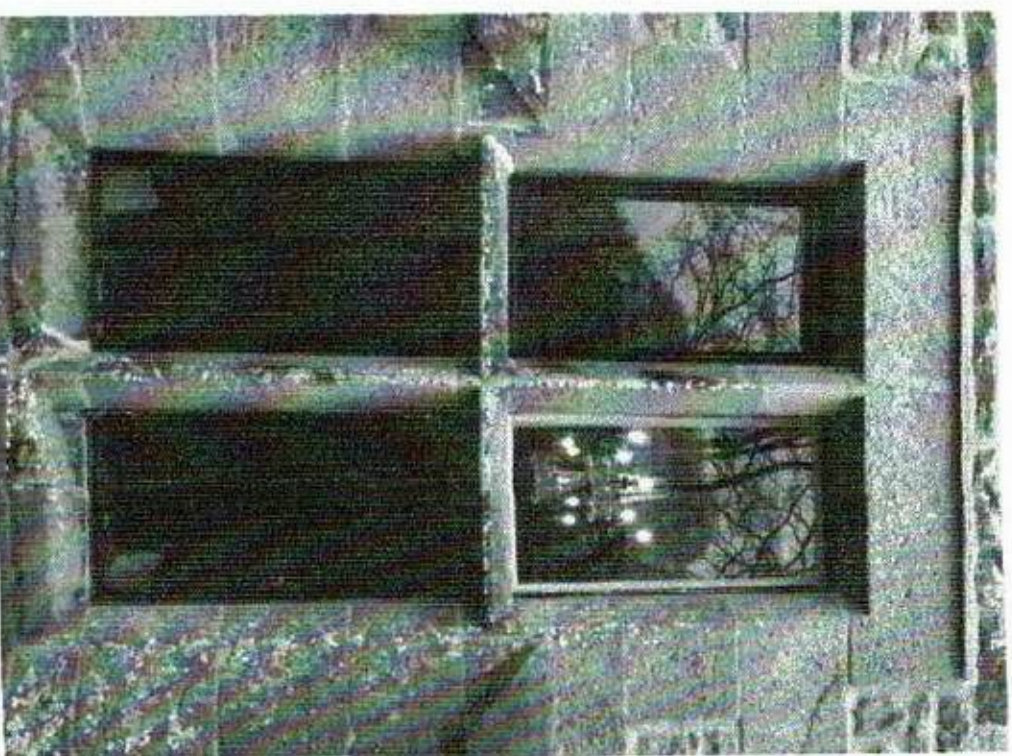
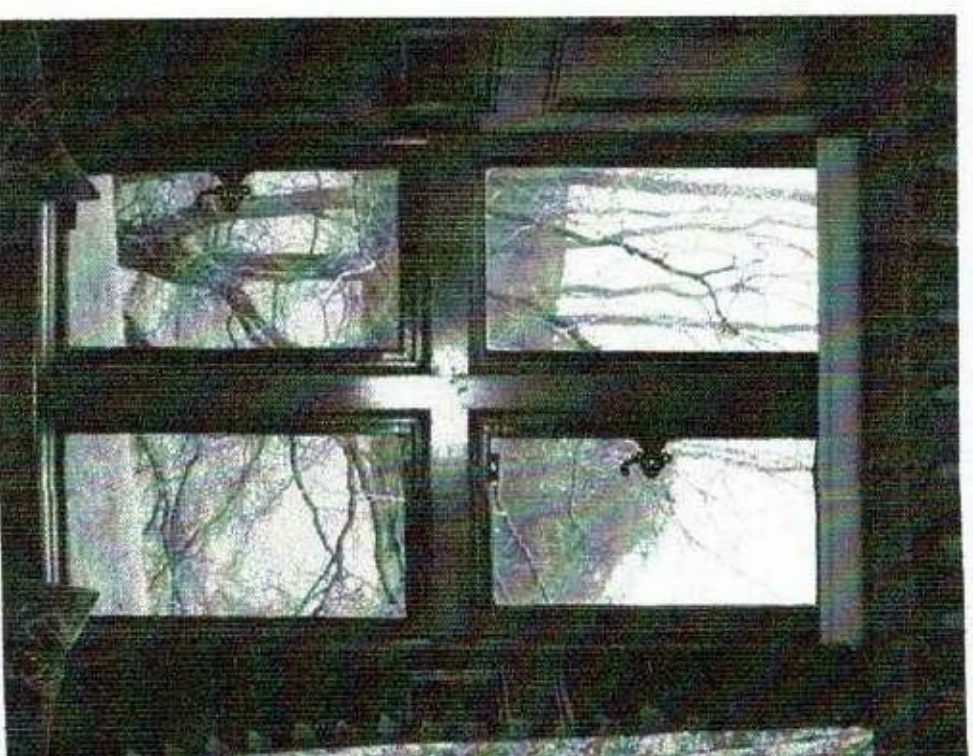
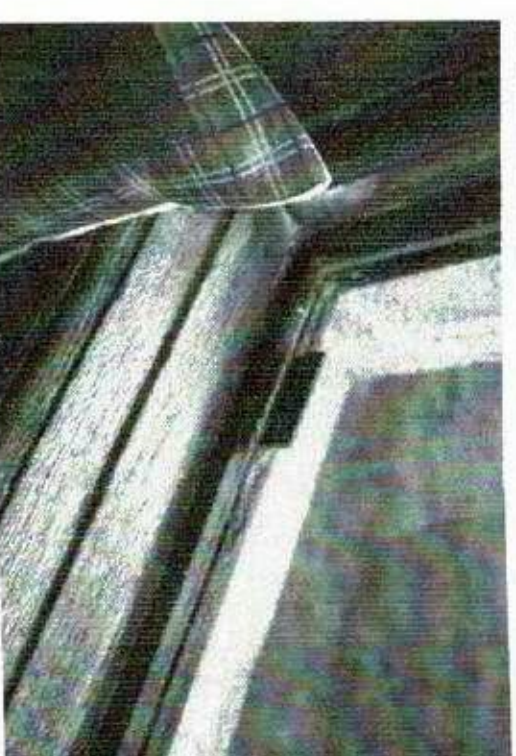
4.5 Window WG5

Location	South elevation, east-most Ground floor lounge window
Installation	Steel frames
Description	4 light window, with upper and lower panels <i>a</i> and <i>d</i> lights have openers, <i>b</i> and <i>c</i> lights are fixed
Dimensions	All lights 435 x 800mm
Condition	Both openers are inoperable and are missing window stays (see photo below)
Proposed works	Remove and refurbish both openers, and provide new stays Refurbish fixed lights in-situ

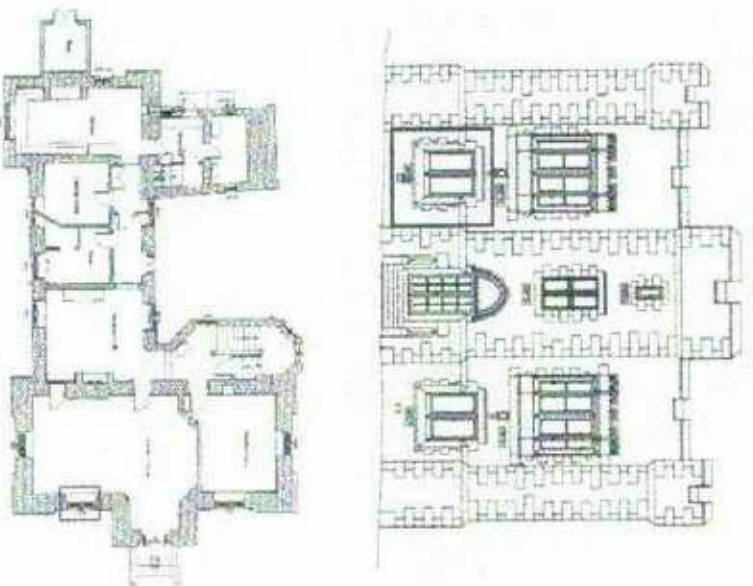
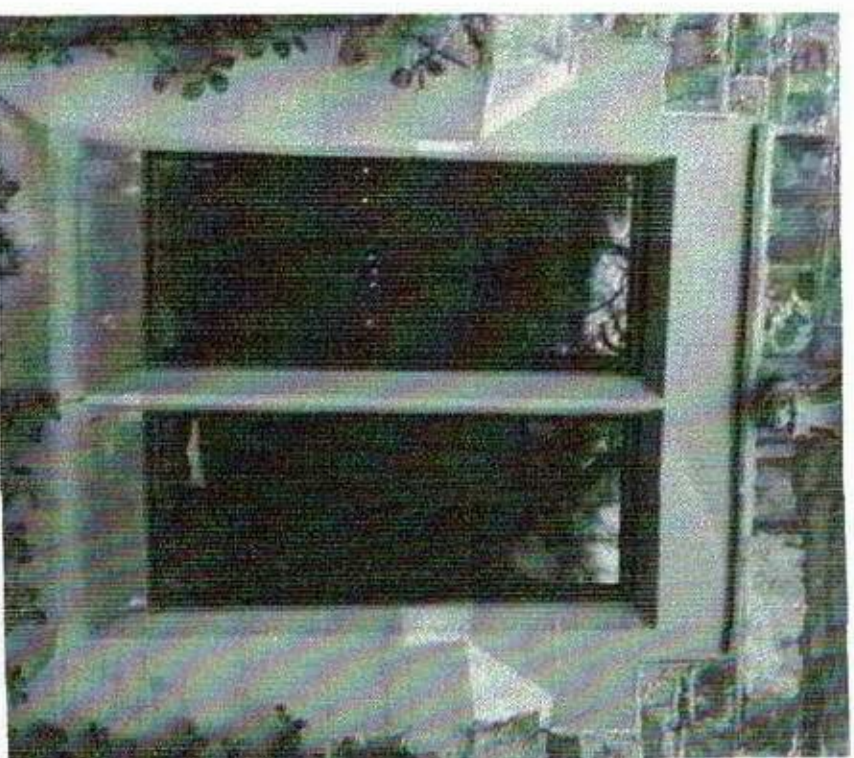
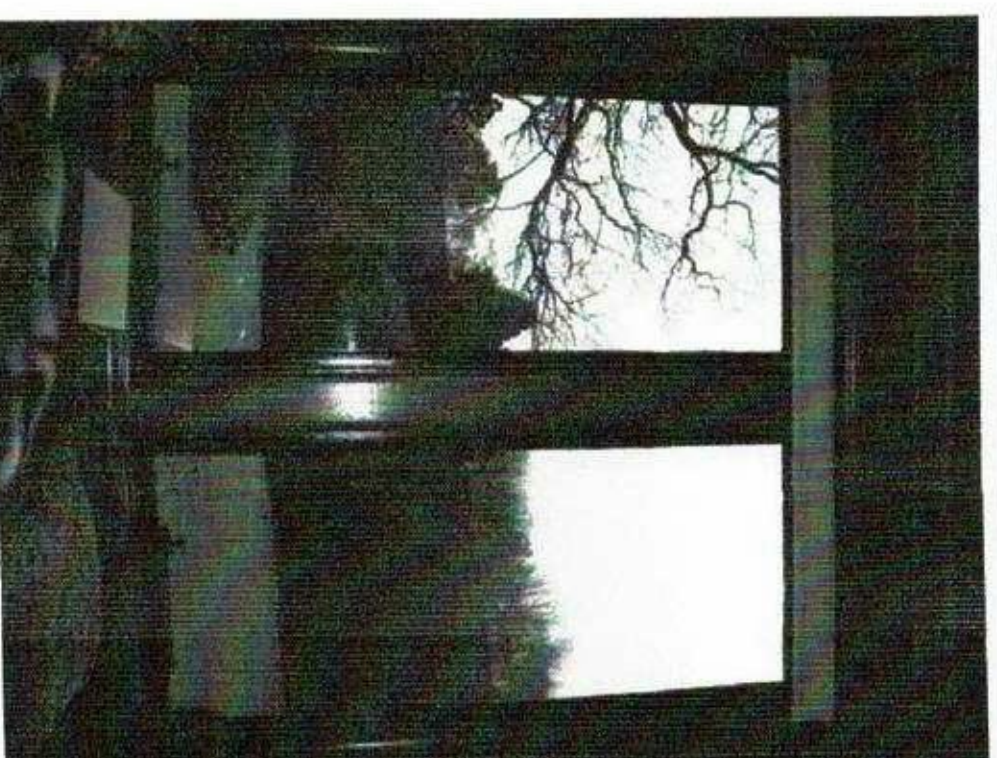
4.6 Window WG6

Location	East elevation, south-most Ground floor lounge window
Installation	Steel frames
Description	2 light window, both lights are openers
Dimensions	Both lights 600 x 1350mm
Condition	Both opening lights are inoperable
Proposed works	Remove and refurbish both openers

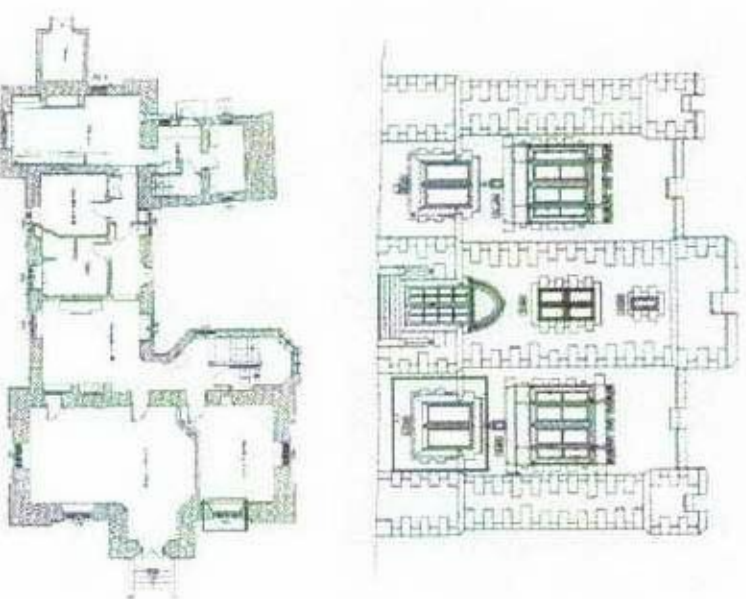
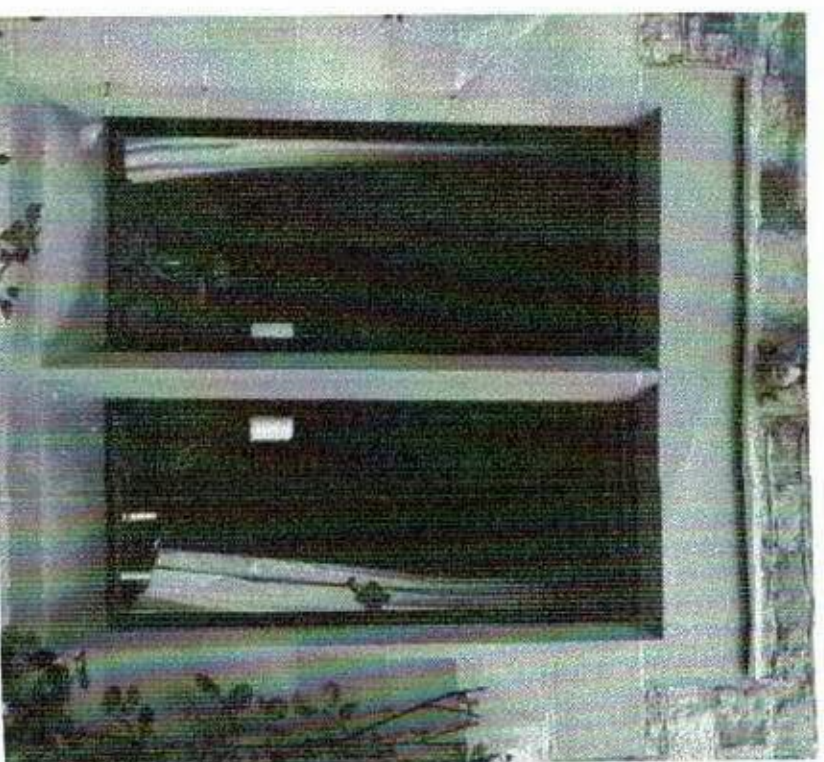
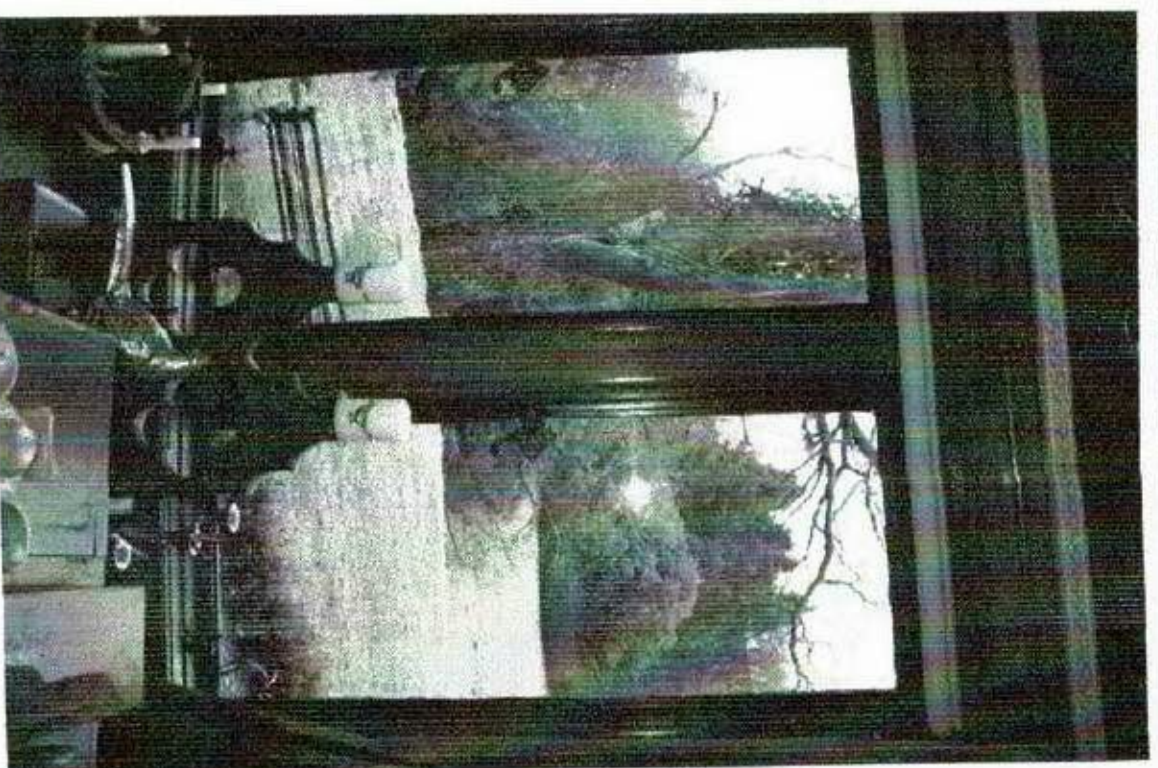
4.7 Window WG7

Location	East elevation, north-most Meeting room window
Installation	Steel frames
Description	2 light window, both lights are openers
Dimensions	Both lights 600 x 1350mm
Condition	Both opening lights are inoperable
Proposed works	Remove and refurbish both openers

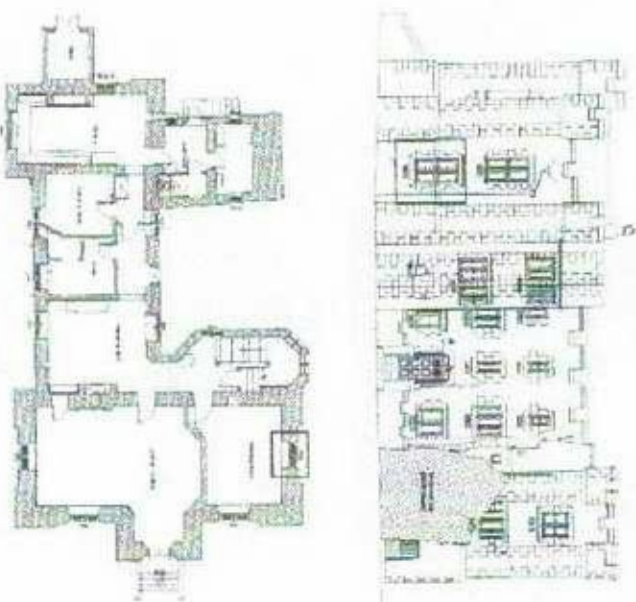
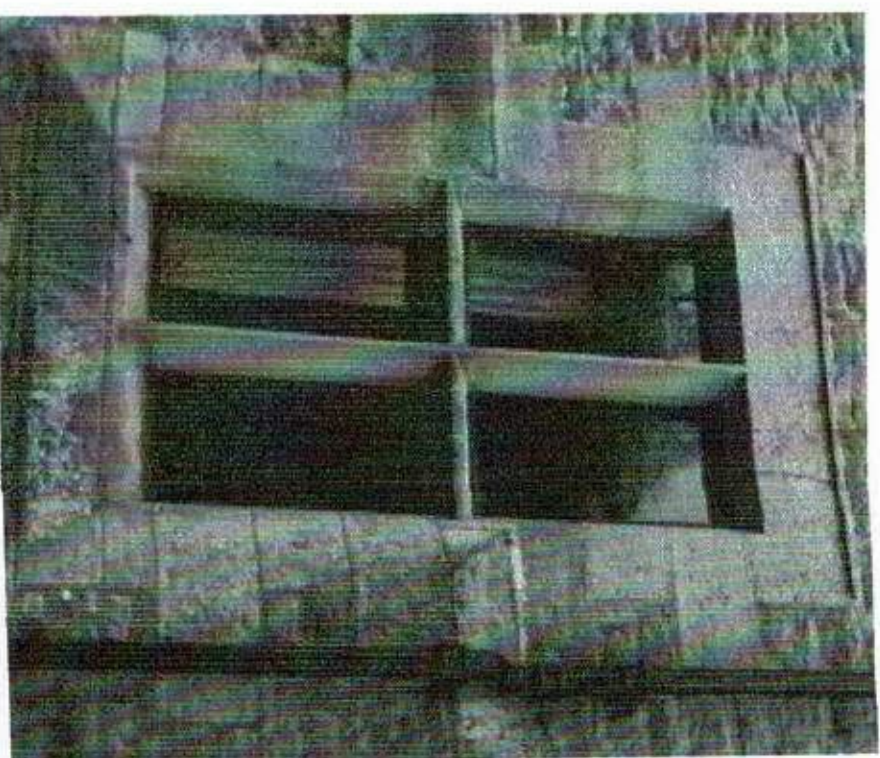
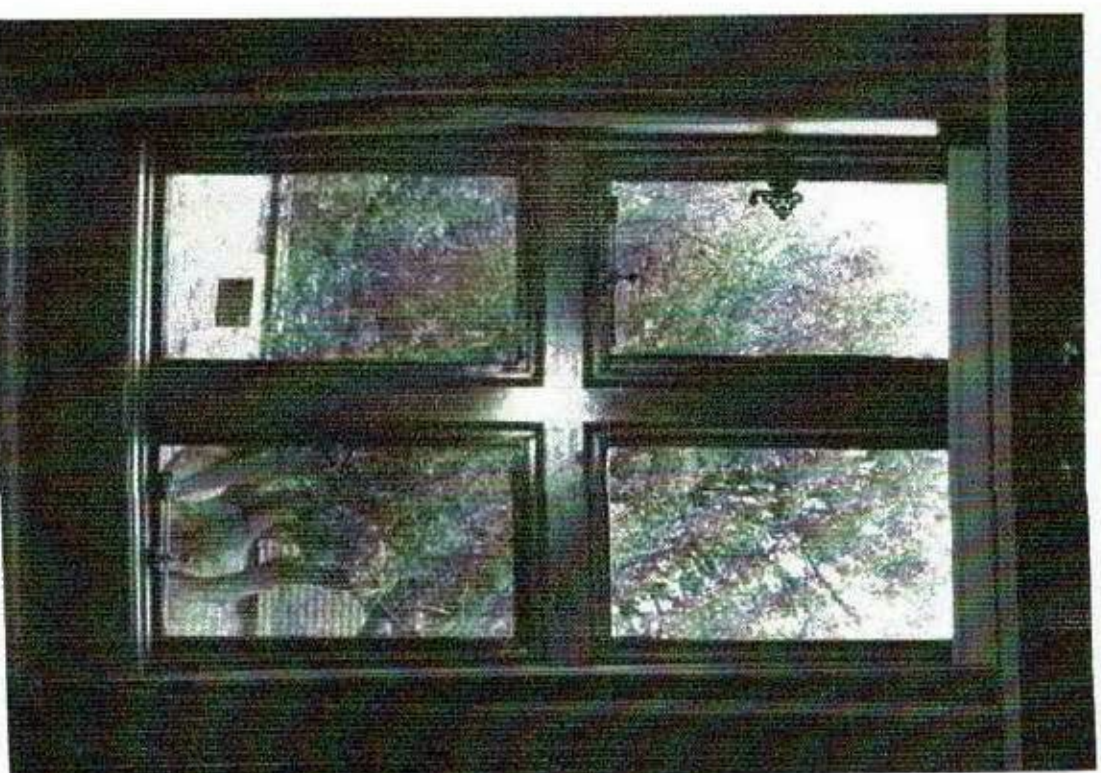
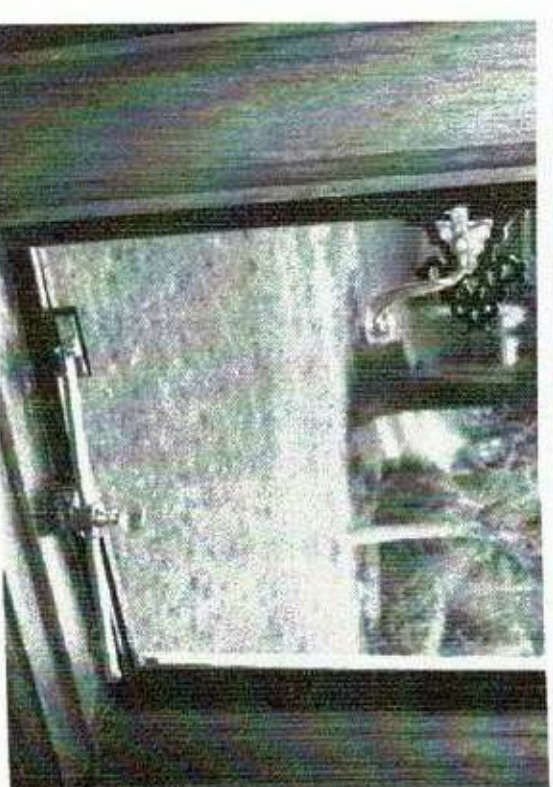
4.8 Window WG8

Location	North elevation, east-most Ground floor meeting room window								
Installation	Steel frames								
Description	4 light window: <table border="1"> <tr> <td><i>a</i> light</td> <td>Fixed</td> </tr> <tr> <td><i>b</i> light</td> <td>Opener</td> </tr> <tr> <td><i>c</i> light</td> <td>Opener</td> </tr> <tr> <td><i>d</i> light</td> <td>Fixed</td> </tr> </table>	<i>a</i> light	Fixed	<i>b</i> light	Opener	<i>c</i> light	Opener	<i>d</i> light	Fixed
<i>a</i> light	Fixed								
<i>b</i> light	Opener								
<i>c</i> light	Opener								
<i>d</i> light	Fixed								
Dimensions	All lights 450 x 800mm								
Condition	<table border="1"> <tr> <td><i>a</i> light</td> <td>Sound, has been reglazed</td> </tr> <tr> <td><i>b</i> light</td> <td>Trial done (photo below)</td> </tr> <tr> <td><i>c</i> light</td> <td>Opener inoperable</td> </tr> <tr> <td><i>d</i> light</td> <td>Sound, has been reglazed</td> </tr> </table>	<i>a</i> light	Sound, has been reglazed	<i>b</i> light	Trial done (photo below)	<i>c</i> light	Opener inoperable	<i>d</i> light	Sound, has been reglazed

<i>a</i> light	Sound, has been reglazed								
<i>b</i> light	Trial done (photo below)								
<i>c</i> light	Opener inoperable								
<i>d</i> light	Sound, has been reglazed								
Proposed works	Remove opener in <i>c</i> light and refurbish. <i>a</i> & <i>d</i> lights to be refurbished in-situ

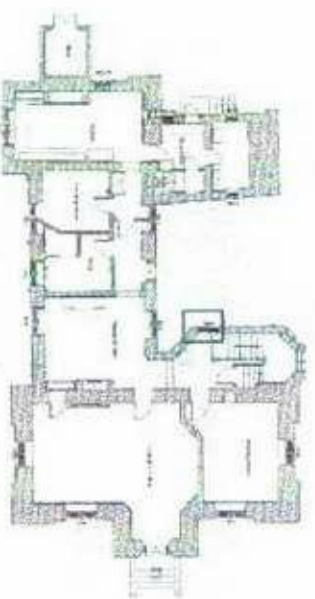
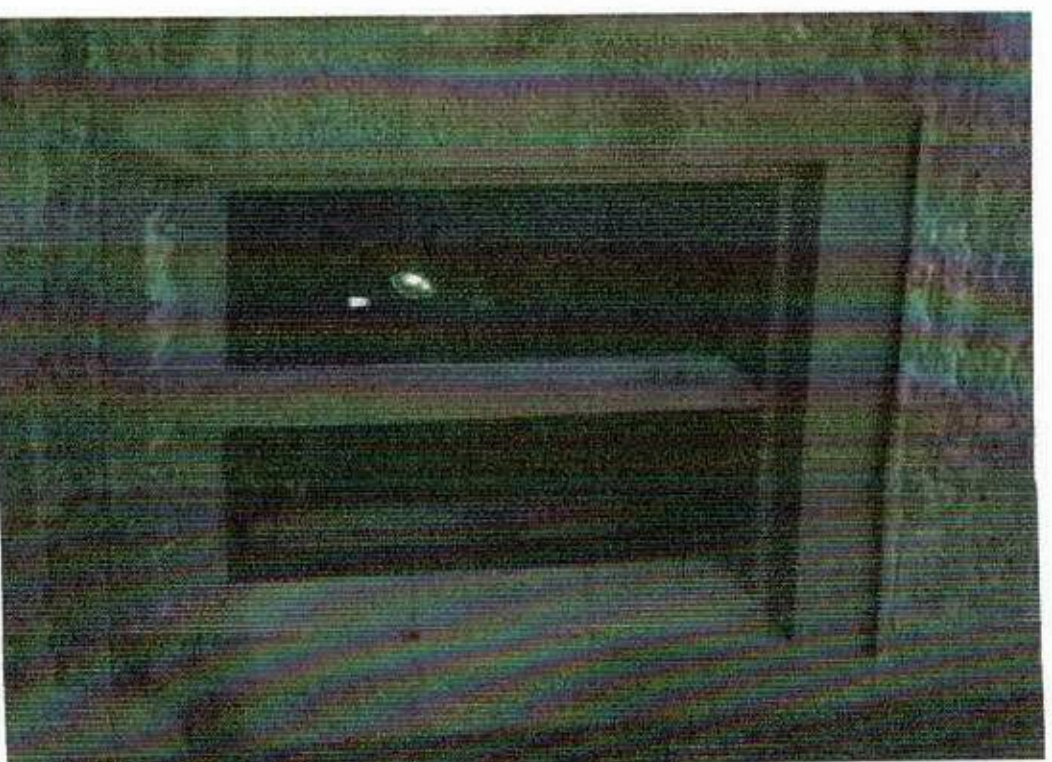
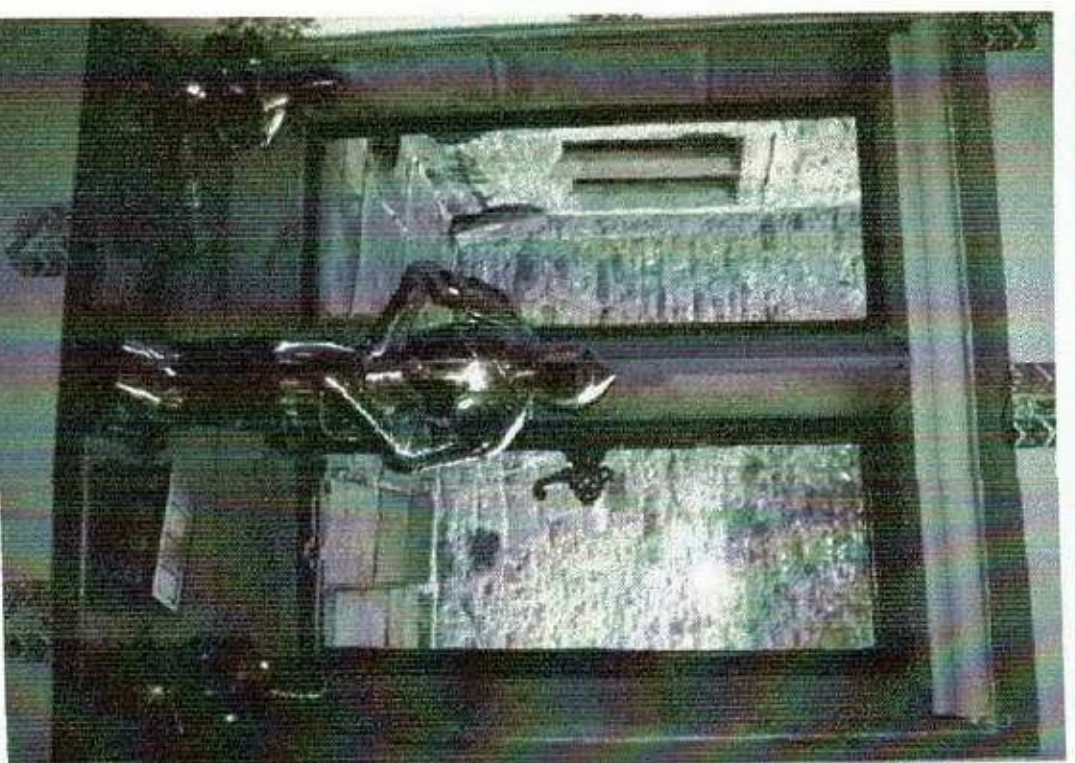
4.9 Window WG9

Location	North elevation, west-facing Ground floor stairwell window
Installation	Steel frames
Description	2 light window: <i>a</i> light fixed, <i>b</i> light opener
Dimensions	Both lights 535 x 1100mm
Condition	Opening light (<i>b</i>) is inoperable
Proposed	Refurbish <i>a</i> light in-situ
works	Remove <i>b</i> light and refurbish

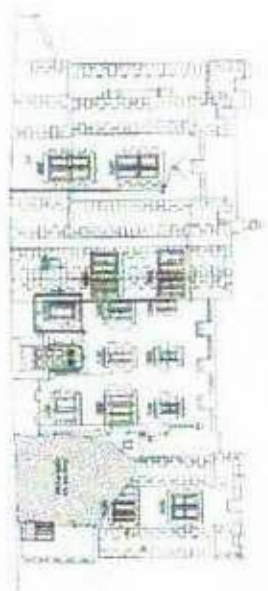
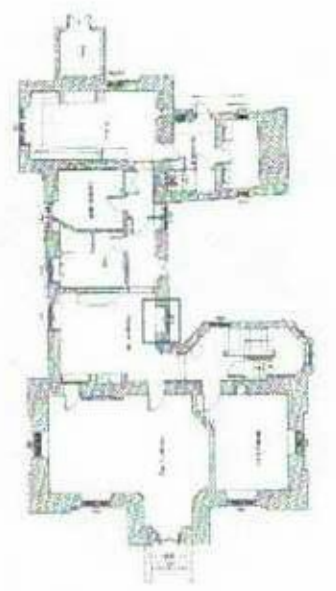
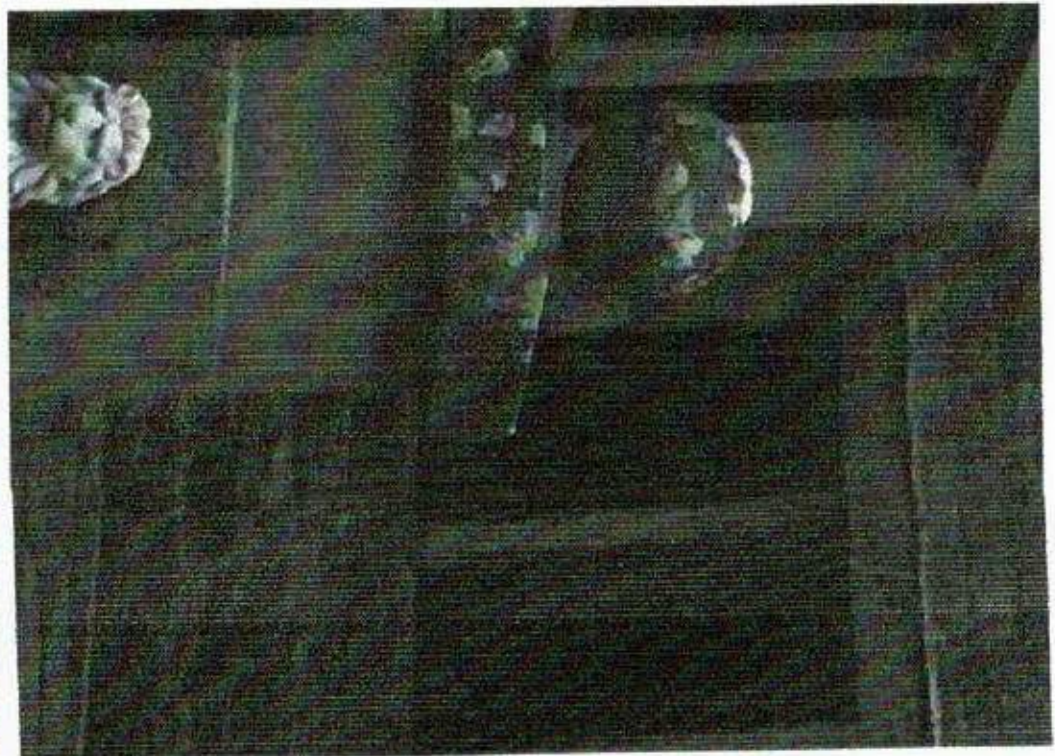
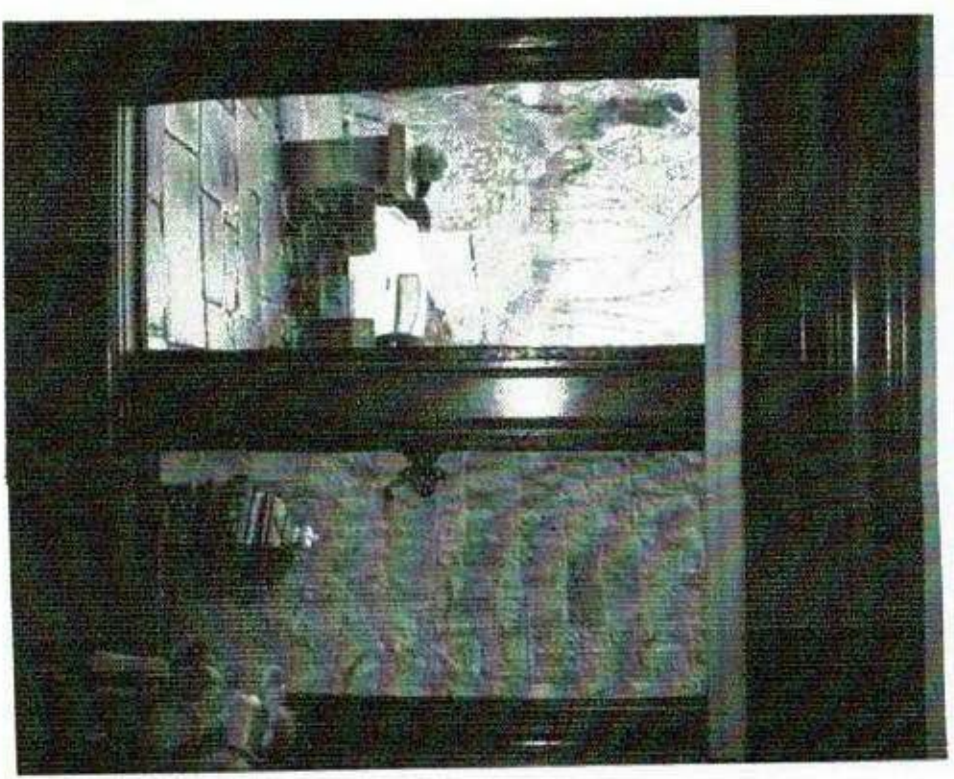
4.10 Window WG10

Location	South elevation Ground floor reception hall window
Installation	Steel frames
Description	2 light window: <i>a</i> light fixed, <i>b</i> light opener
Dimensions	Both lights 535 x 1100mm
Condition	Opening light (<i>b</i>) inoperable
Proposed	Refurbish <i>a</i> light in-situ
works	Remove <i>b</i> light and refurbish

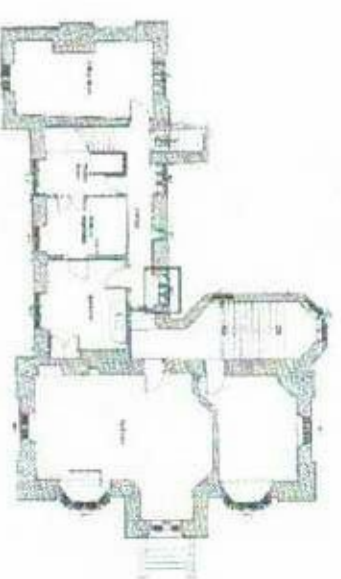
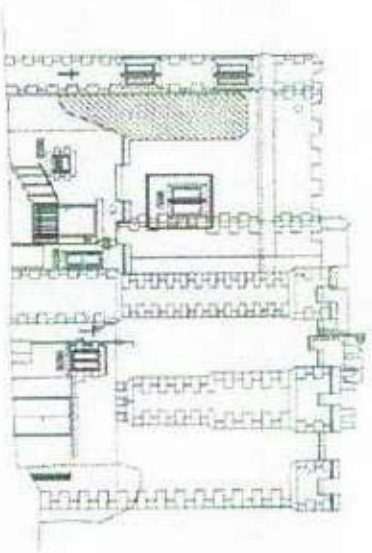
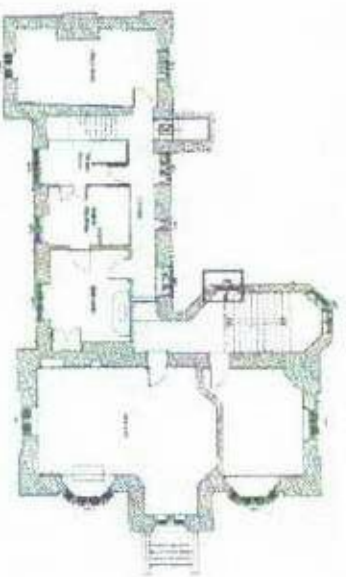
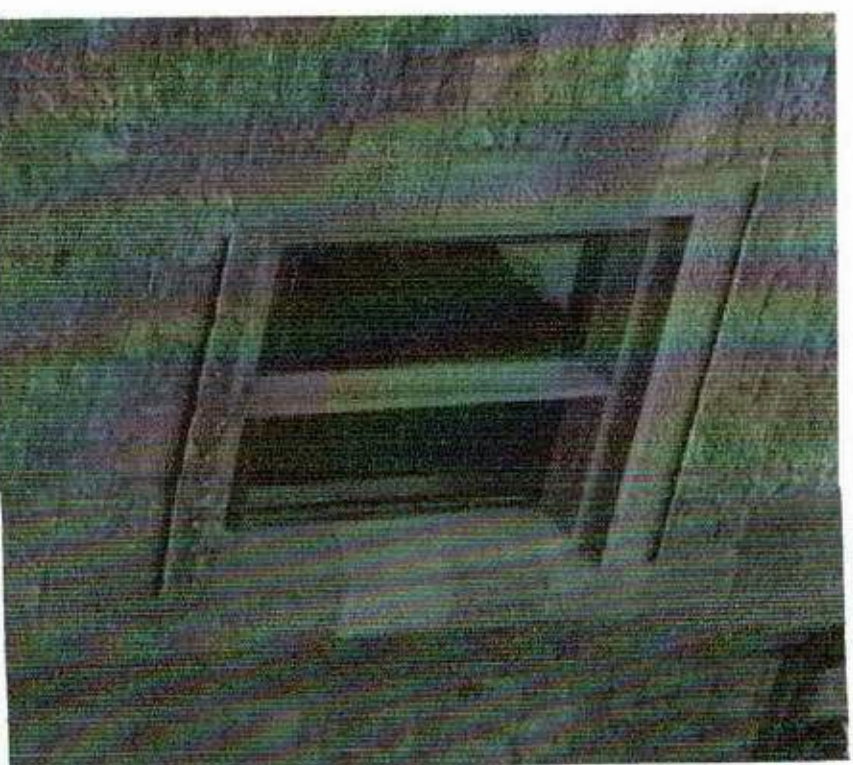
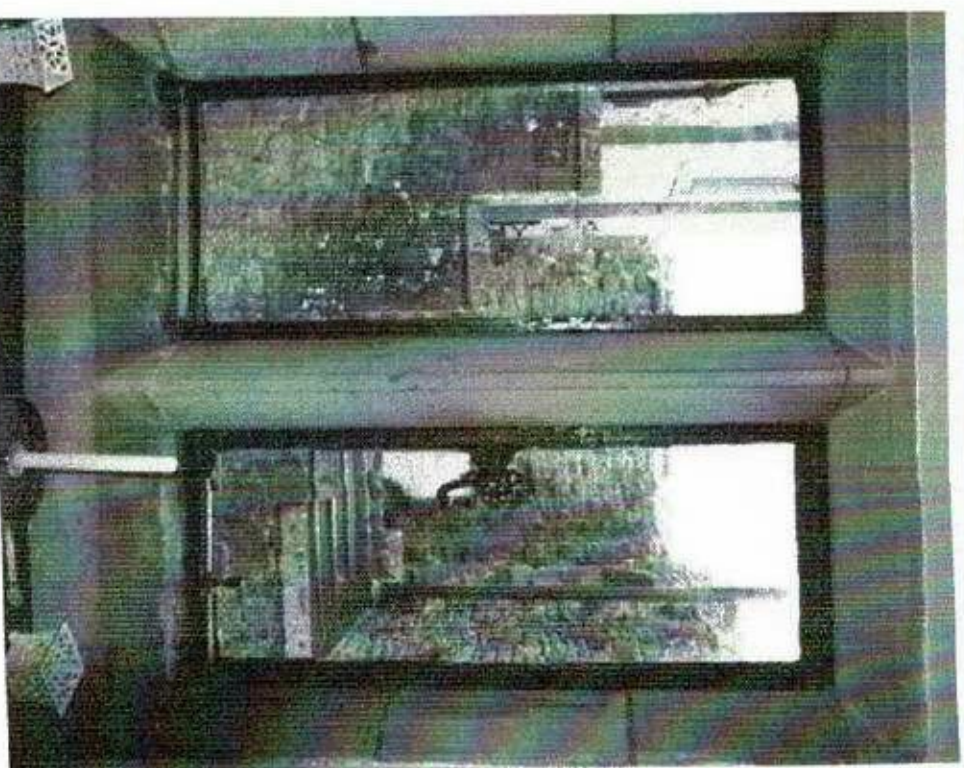
4.20 Window WF5

Location	First floor west-facing stairwell window
Installation	Cast iron frames
Description	2 light window: <i>a</i> light fixed, <i>b</i> light operable
Dimensions	385 x 910mm
Condition	Fixed light (<i>a</i>) is rusting at base, Operable is inoperable
Proposed works	Remove both frames for refurbishment

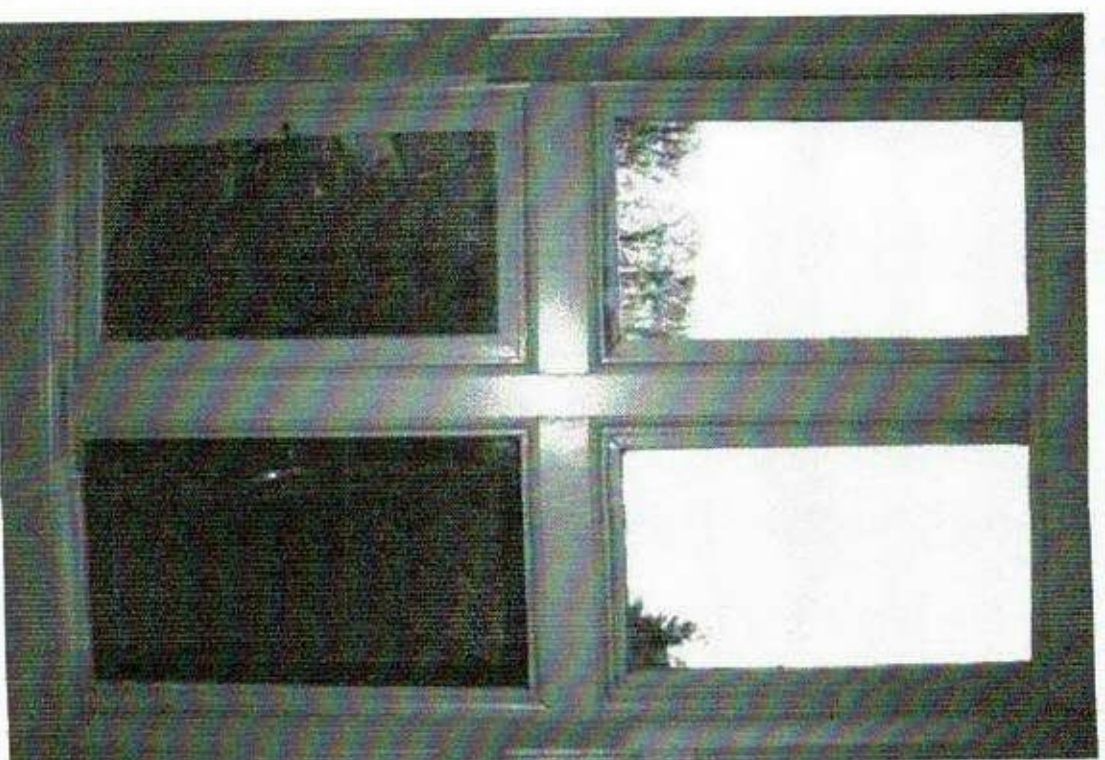
4.22 Window WF7

Condition	<i>a</i> light	Sound
	<i>b</i> light	Trial panel
	<i>c</i> light	Sound
	<i>d</i> light	Sound

Proposed works Refurbish all frames in-situ

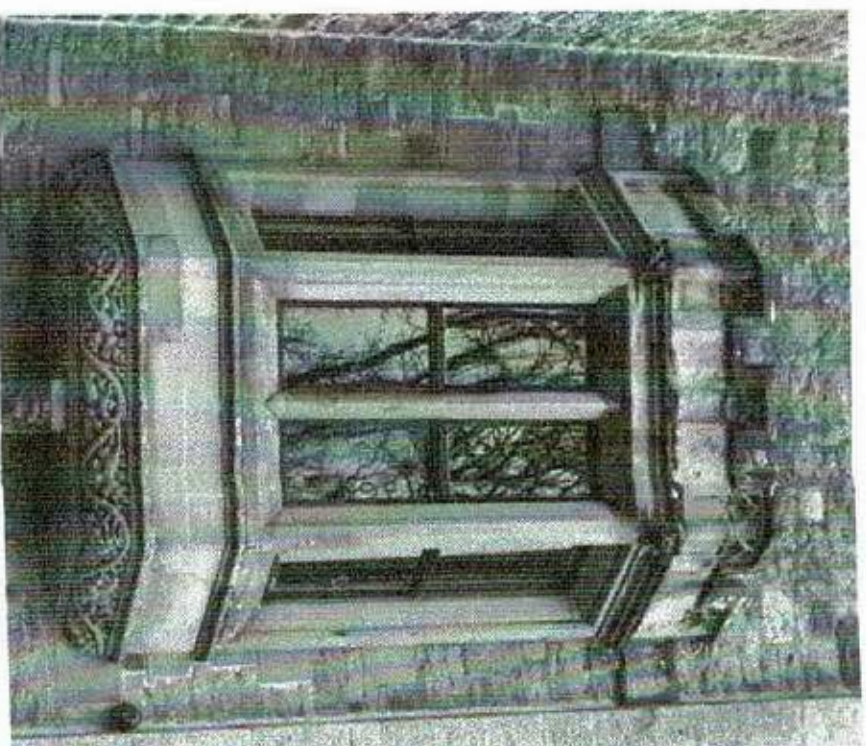
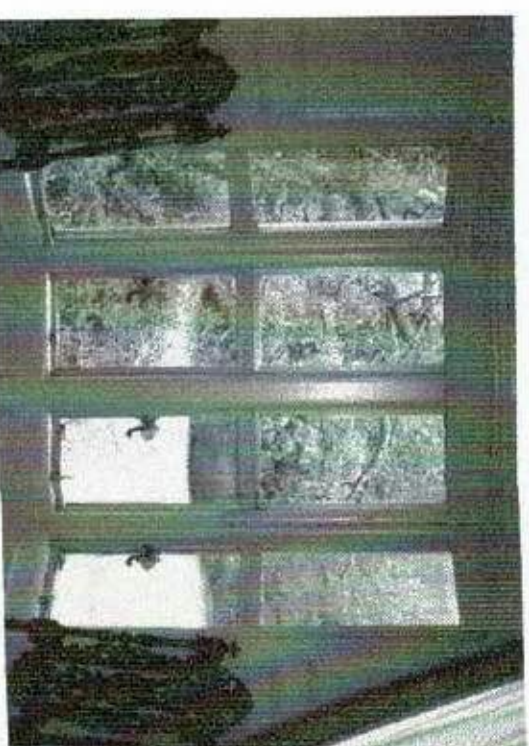
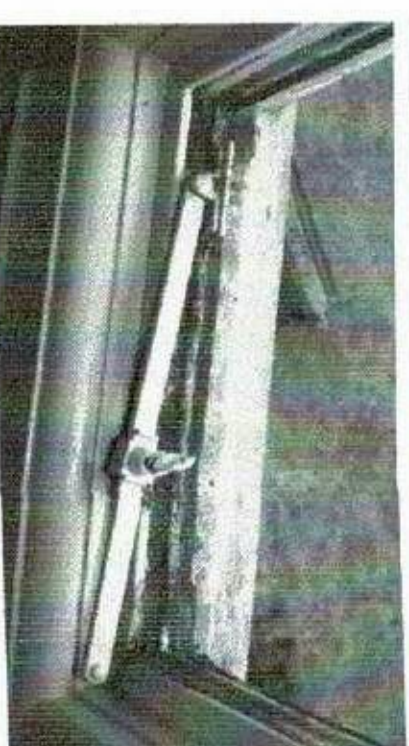
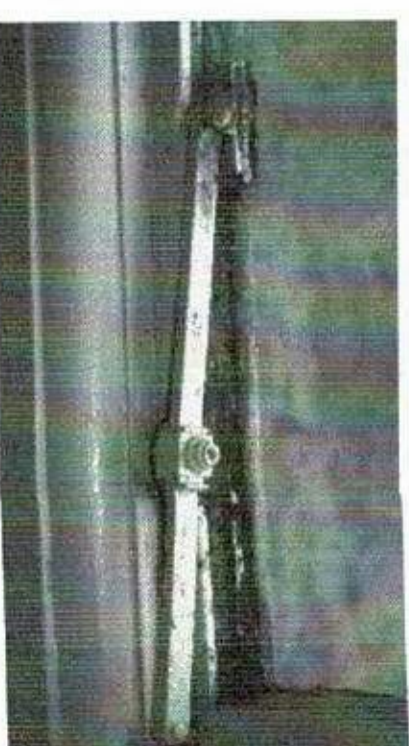
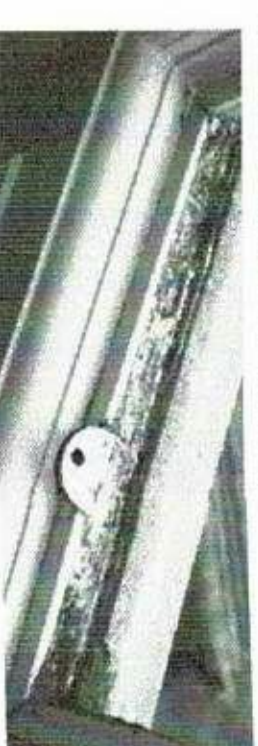
4.23 Window WF8

Condition *a* light Inoperable, thumb turn missing

b light Inoperable, stay missing

c light Inoperable

d light Inoperable, thumb turn missing

e light Rusting at base

Proposed works Remove *a, b, c, d & e* for refurbishment & replace furniture
 Refurbish *f, g & h* in-situ

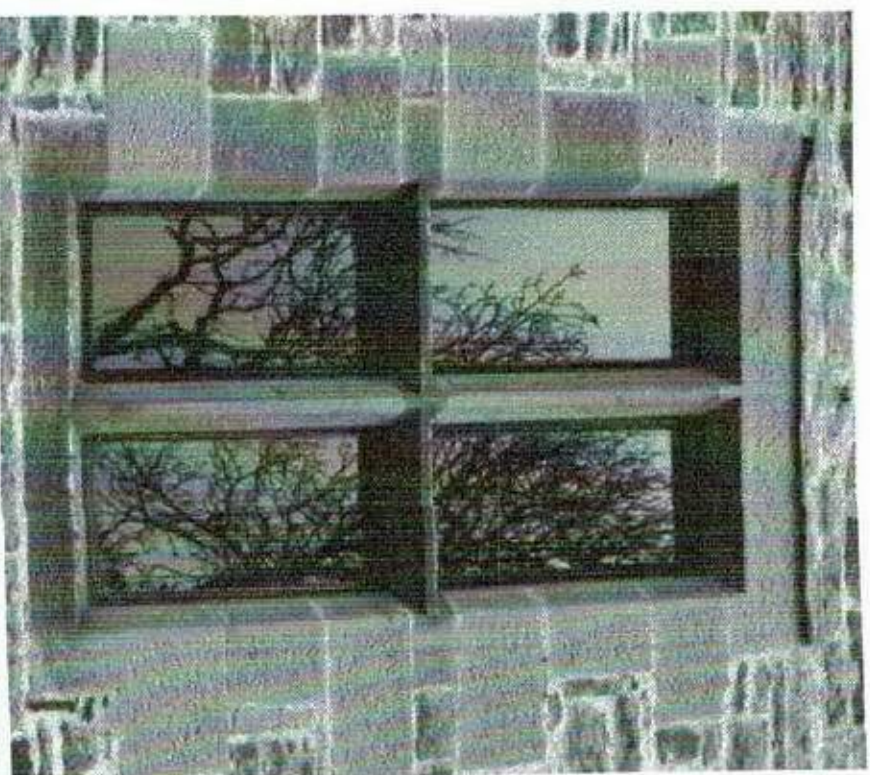
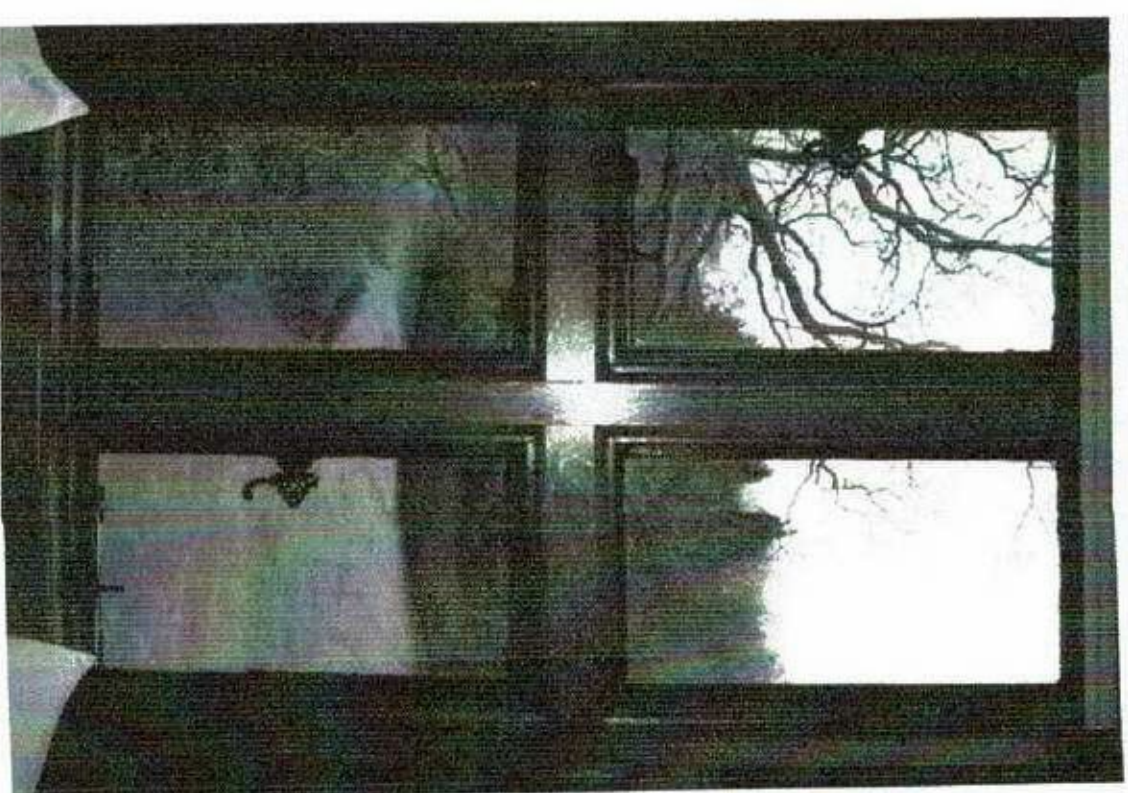
4.24 Window WF9

Condition *a* & *d* are sound, *b* & *c* are inoperable

Proposed works Remove *b* & *c* for refurbishment, *a* & *d* to be refurbished in-situ
