Bellister Castle

Window Condition Report

Martin Johnson & Co (York) Ltd

April 2021

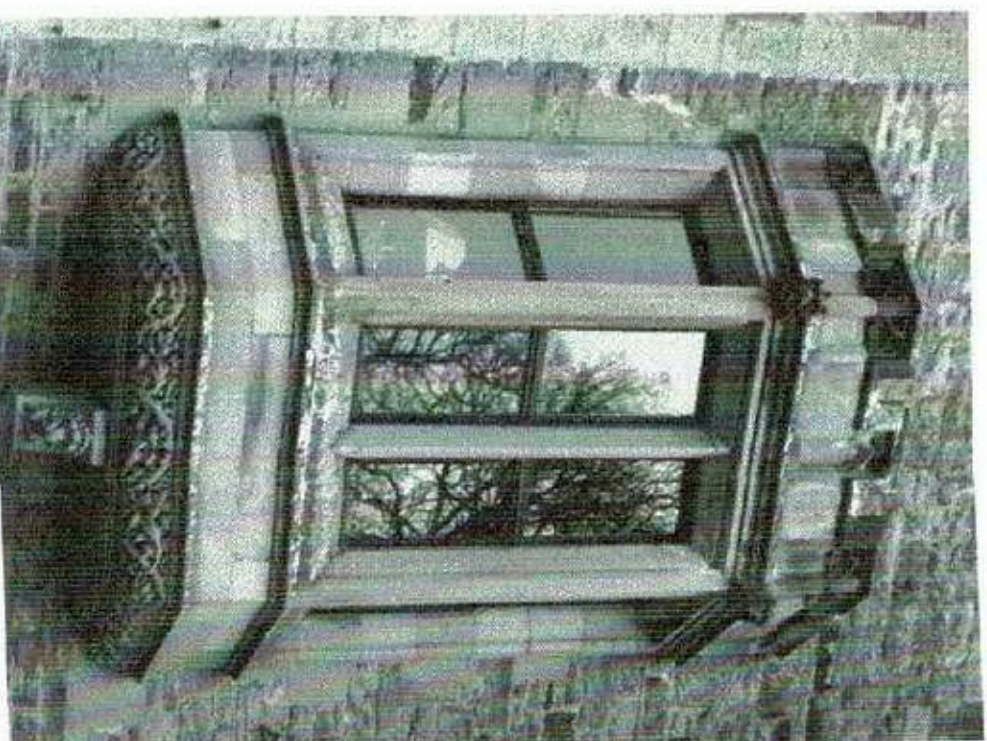
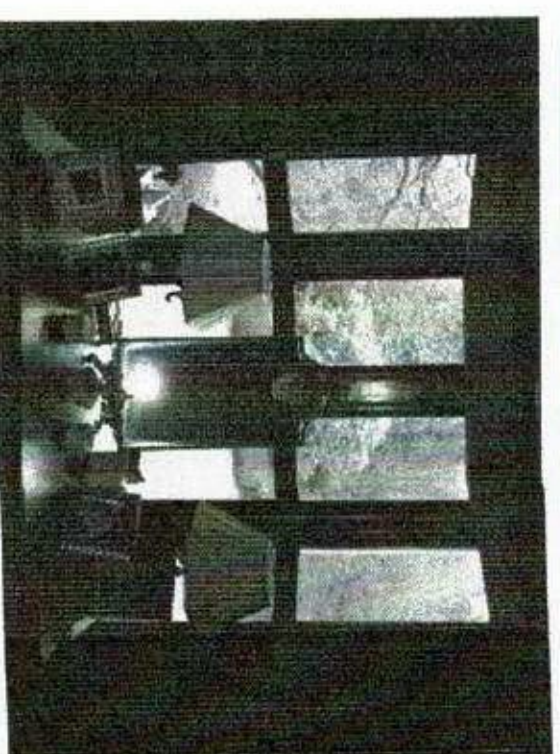
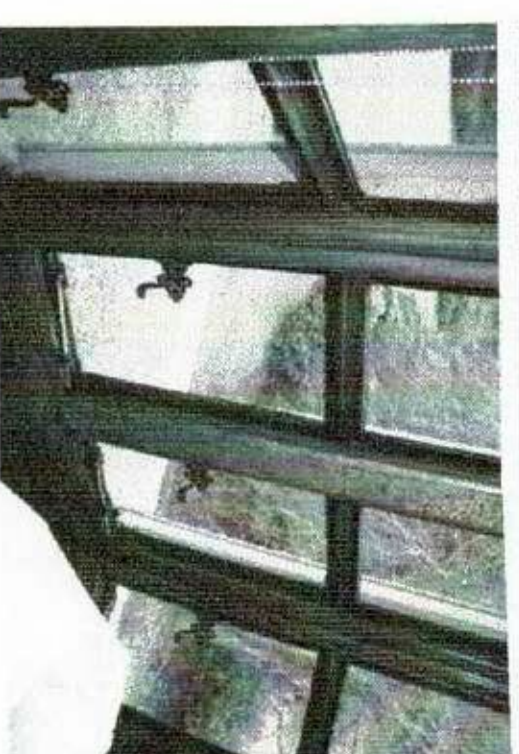
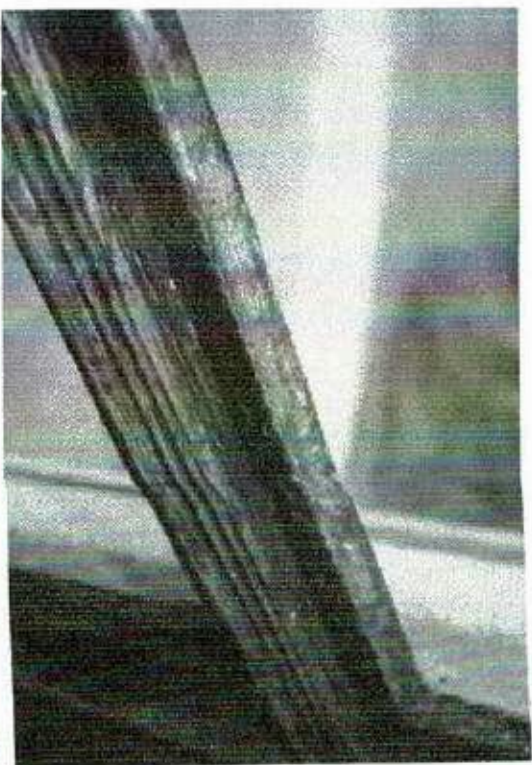
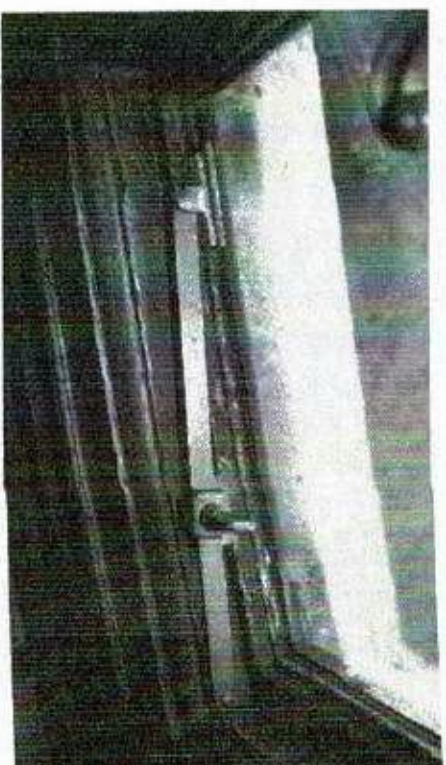
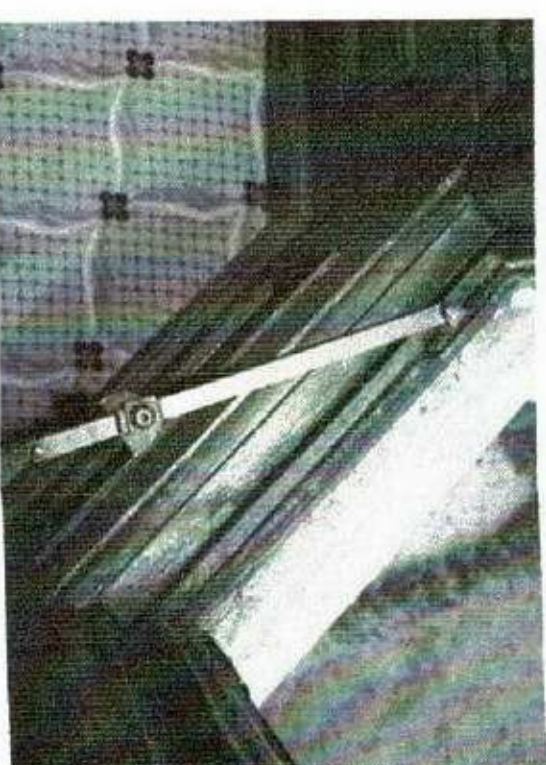
4.25 Window WF10

Condition *a* light Inoperable

b light Inoperable, thumb turn missing

c light Inoperable

d light Inoperable

<i>g</i> light	Sound, though previous glass replacement not correctly installed.
	<i>h</i> light	Sound
Proposed works	Remove and refurbish <i>a</i> , <i>b</i> , <i>c</i> & <i>d</i> . Refurbish <i>e</i> , <i>f</i> , <i>g</i> & <i>h</i> in-situ. Consider re-fitting of glass in <i>g</i> light

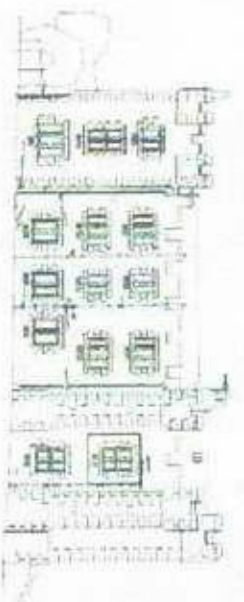
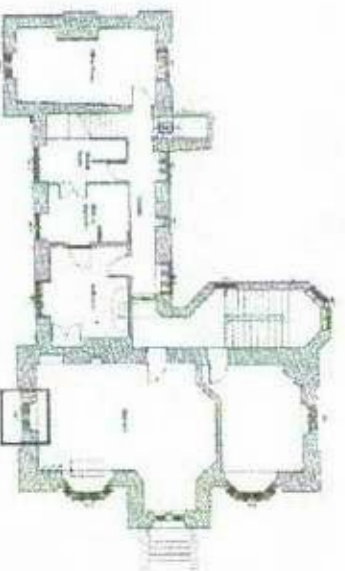
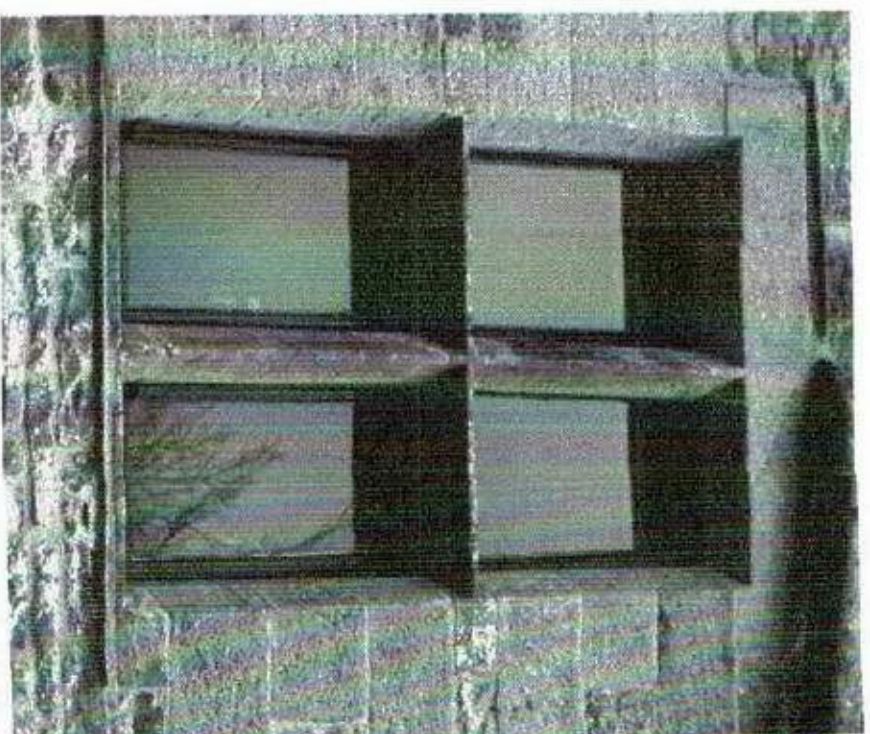
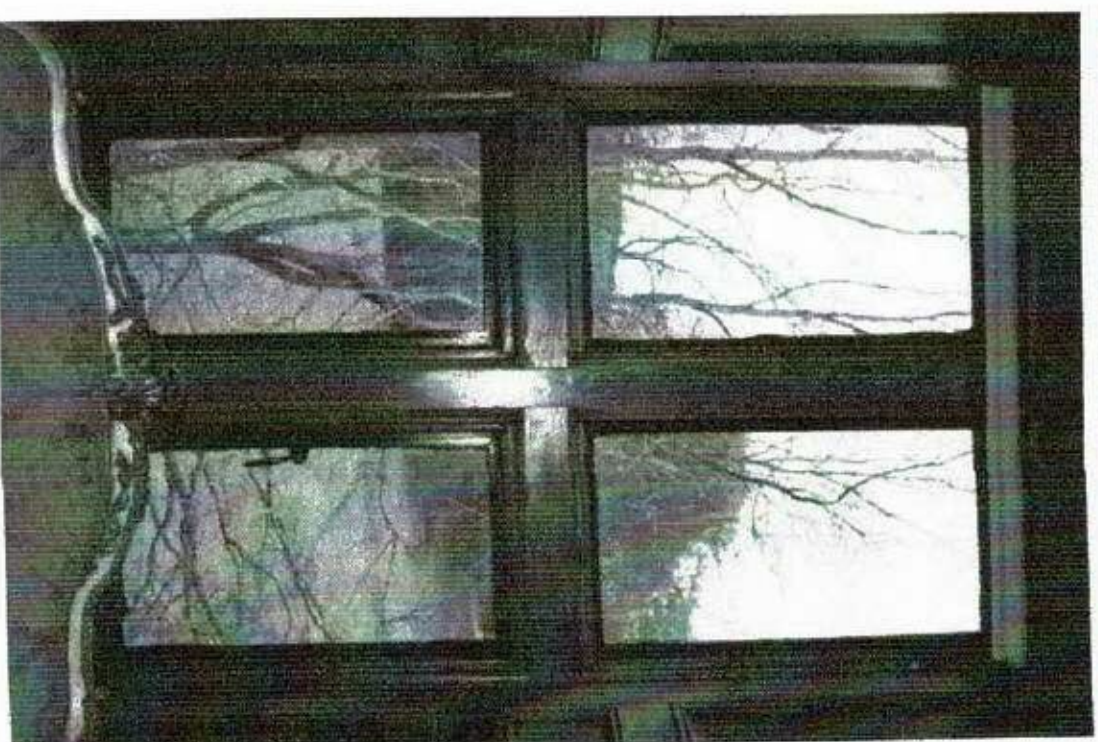
4.26 Window WF11

Installation	Steel frames			
Description	4 light window:			
	<i>a</i> light	Opener		
	<i>b</i> light	Opener		
	<i>c</i> light	Fixed light		
	<i>d</i> light	Fixed light		
Dimensions	All lights 435 x 800mm			
Condition	<i>a</i> light	Opener inoperable		
	<i>b</i> light	Opener inoperable		
	<i>c</i> light	Sound		
	<i>d</i> light	Sound		
Proposed works	Remove both openers for refurbishment (<i>a</i> and <i>b</i> lights) Refurbish both fixed lights in-situ (<i>c</i> and <i>d</i> lights)

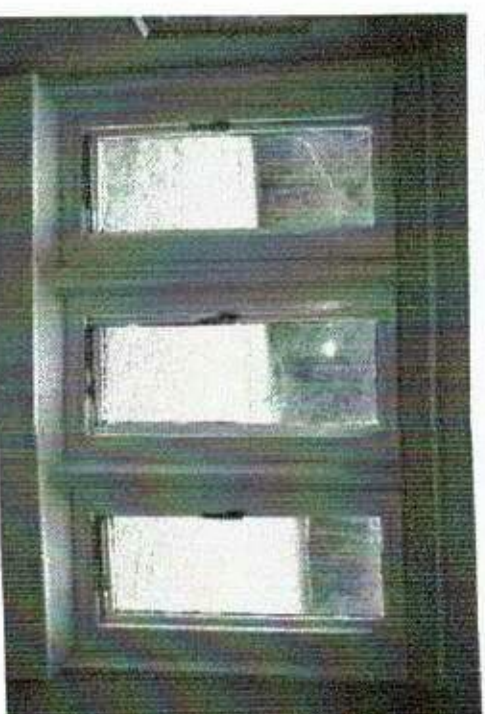
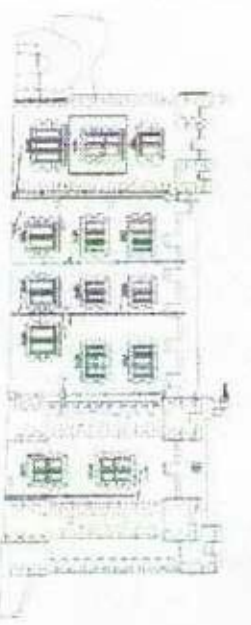
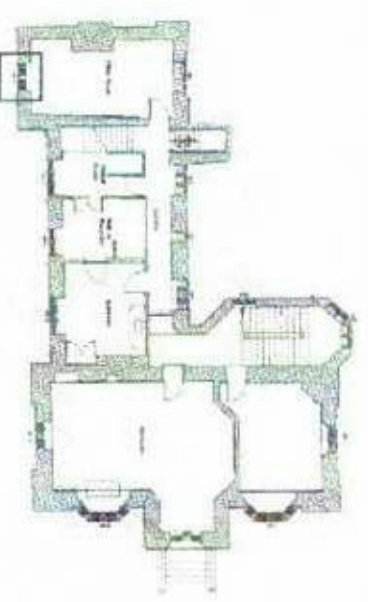
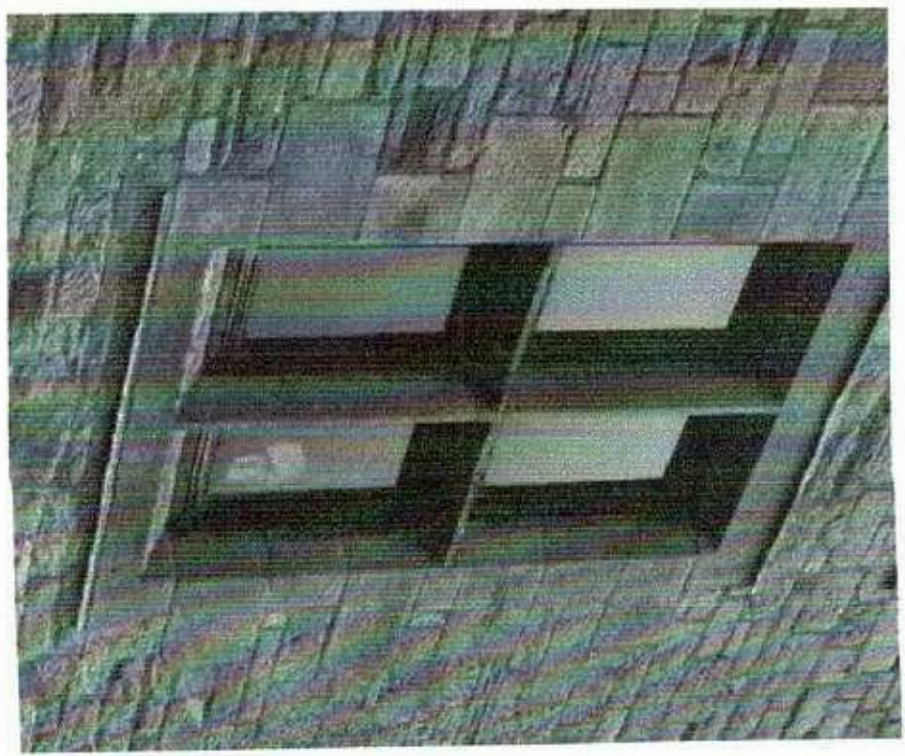
4.30 Window WF15

Location	South elevation, first floor – Office room	
Installation	Steel frames	
Description	4 light window:	
	<i>a</i> light	Opener
	<i>b</i> light	Opener
	<i>c</i> light	Fixed light
	<i>d</i> light	Fixed light
Dimensions	3 no. @ 460 x 790mm	
Condition	<i>a</i> light	Inoperable
	<i>b</i> light	Inoperable
	<i>c</i> light	Sound
	<i>d</i> light	Sound
Proposed works	Remove both openers for refurbishment (<i>a</i> and <i>b</i> lights), fixed lights to be refurbished in-situ (<i>c</i> and <i>d</i> lights)

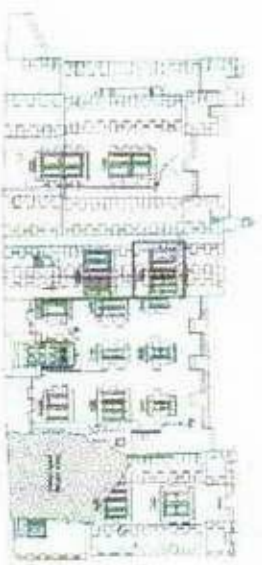
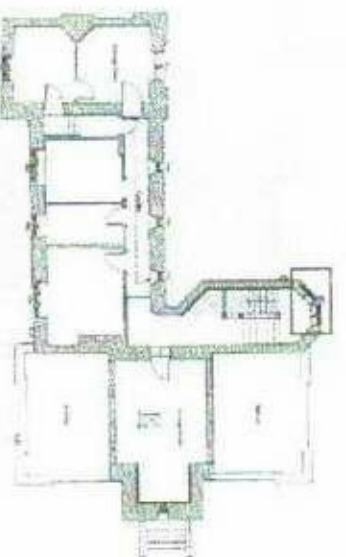
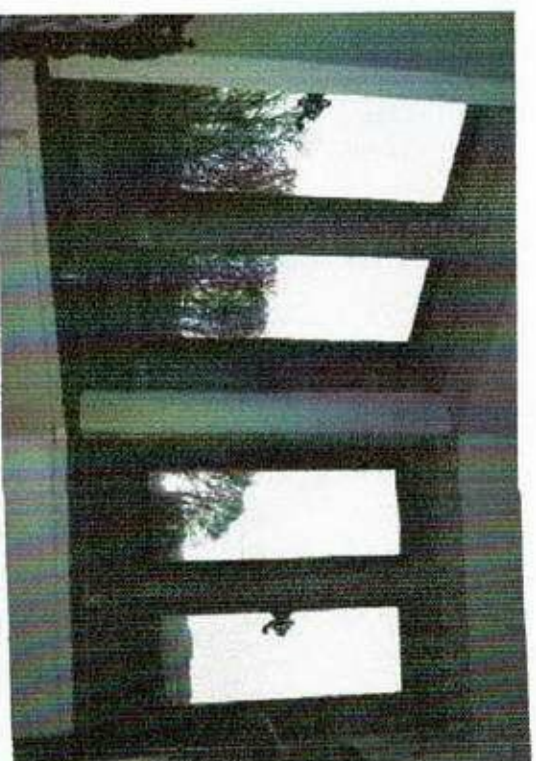
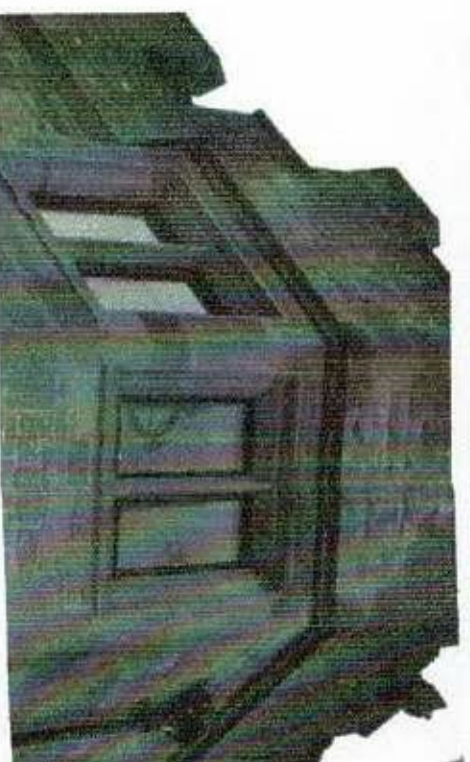
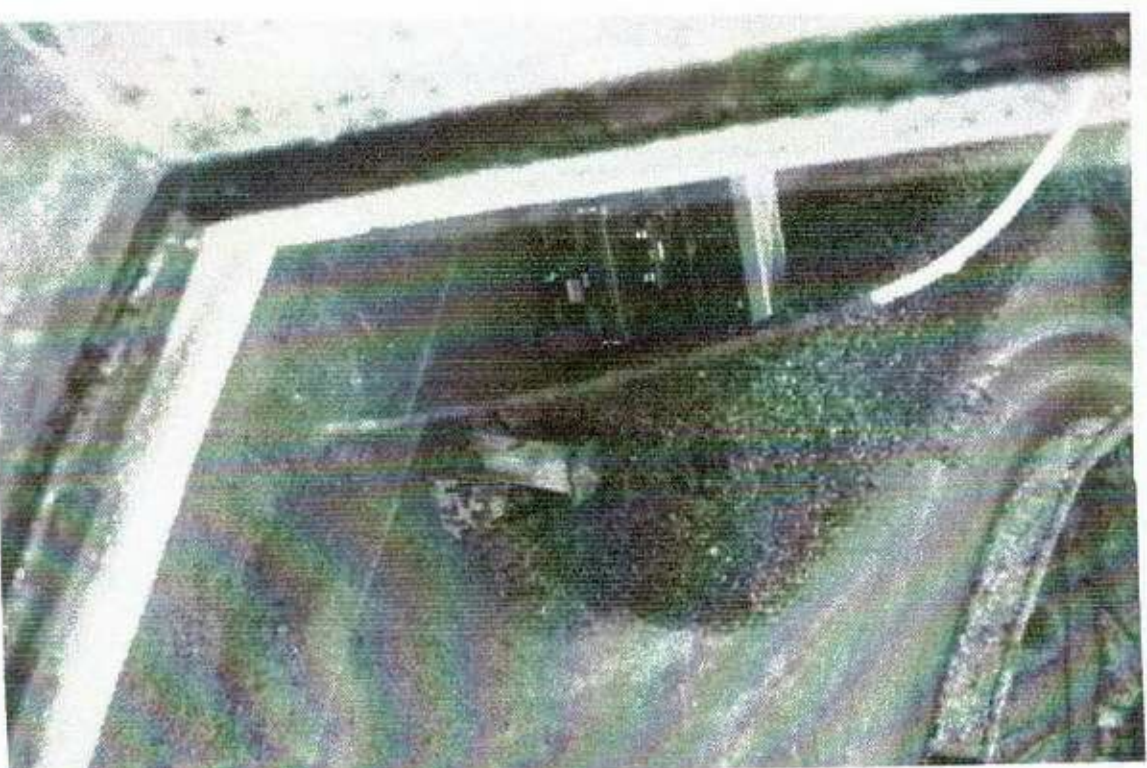
4.36 Window WS6

Installation	Cast Iron frames	
Description	<i>a</i> light	Opener
	<i>b</i> light	Fixed light
	<i>c</i> light	Fixed light
	<i>d</i> light	Opener
Dimensions	4 no. @ 380 x 910mm	
Condition	<i>a</i> light	Inoperable
	<i>b</i> light	Rusting at base, glass cracked
	<i>c</i> light	Sound
	<i>d</i> light	Inoperable with modern stay attached
Proposed works	Remove <i>a</i> , <i>b</i> & <i>d</i> for refurbishment. Refurbish <i>c</i> light in-situ
