Arboricultural Impact Assessment

1 The Cottage, Old Cassop

August 2022

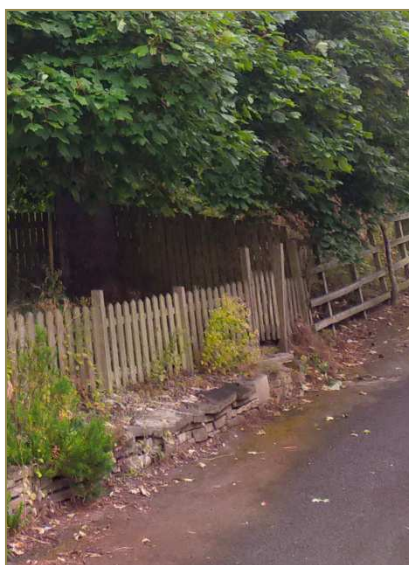
2.2.3 On this site it is likely that the root protection areas are not as indicated on the plans, there is a large amount of hard surfacing and some level changes that may have affected the root spread. However without investigations it should not be assumed that the roots are not beneath the hard surfaces and they will need to be lifted in the appropriate way (see later sections).

Figure 1. Some of the hard surfacing and level changes around the trees.

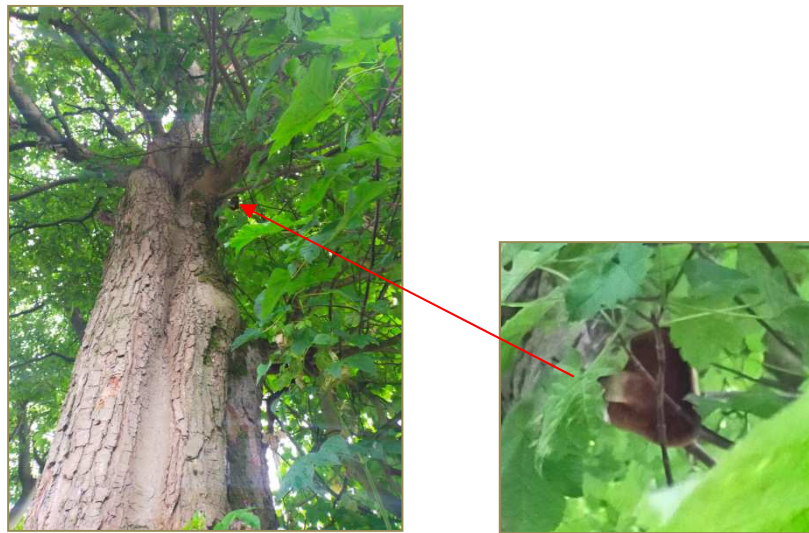
2.3.1 Tree 3 is recommended for removal due to the presence of *Polyporus squamosus* (Dryad's Saddle).

2.3.2 Dryad's Saddle bracket attached to the trunk at a stump of a previously lost branch (figure 2) and a mature bracket has fallen to the floor (figure 3). These brackets usually appear on an annual basis during the summer and autumn months; although the decaying degraded brackets can often be seen all year round. They are commonly found on old pruning wounds. This fungus feeds on the heartwood of the tree and produces white rot. The implication of this is that the wood can become

brittle and affected limbs may be more susceptible to failure. There is no certain way of accurately estimating when this may occur and other factors such as adverse weather conditions could also contribute to their failure not solely their condition.

Figure 2. Dryad's Saddle on tree 3.

3	Sycamore	15.0	8.0	9.0	6.5	8.5	930	11.2	1	0	3.0 W	Mature	Fair	Poor?	<10	U	Previous pruning and decaying stumps within the crown. Epicormic growth. A mature Dryad's Saddle bracket has fallen from the tree and an young bracket is attached to the	The tree should be removed due to the identified fungus and limited life expectancy (more detail in section 2.3).

2.3.3 Given the location of the tree being surrounded by buildings and an access road to other properties it would be prudent for the tree to be removed. This will remove the risk of damage should the tree or limbs fail.

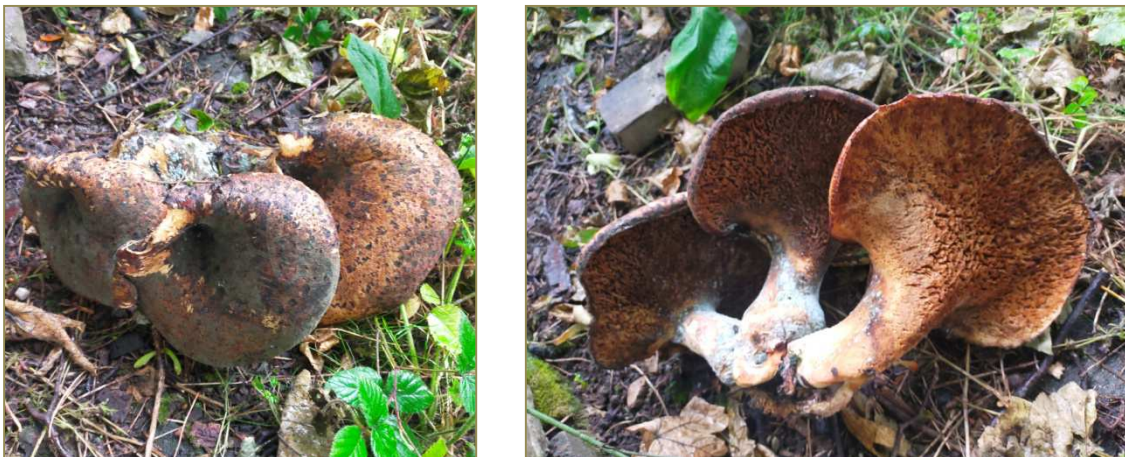
Figure 3. (a & b) Mature Dryad's Saddle on floor at base of tree.

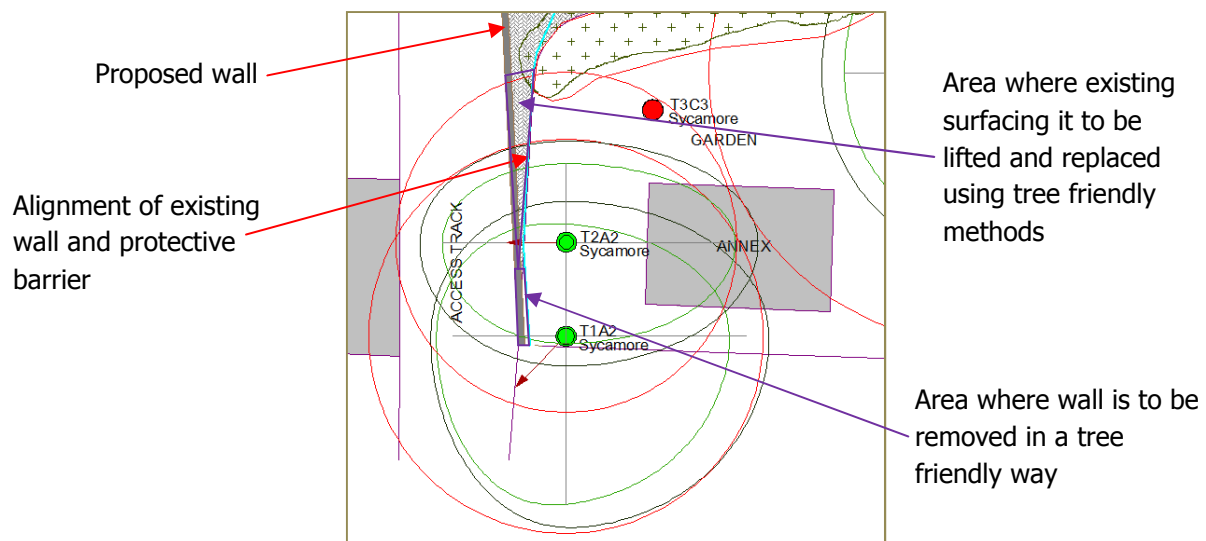
4.1.1 The existing hard surfacing (tarmac) and a small section of the low retaining wall is to be removed and replaced as part of the development. The root protection areas of the trees are shown to extend into these locations. Given the constraints of the hard landscaping and level changes the root spreads may have been affected. However without investigations it should not be assumed that the roots are not beneath the hard surfaces and they will need to be lifted in the appropriate way. This means where possible by hand, it is accepted that this may not be possible for all elements of the works. Where it is necessary to use machinery it should be positioned a sensible distance from the trunk of the trees on the hard surfacing to be retained and care taken when using the arms/boom to not cause damage to any trees or roots discovered beneath the surface. Any roots encountered must be treated in the appropriate way. There must be no level changes within the root protection areas of the trees. This all applies to trees 1 and 2 (indicated in figure 4) and tree 4. This phase of the development must only take place once the protective barriers as indicated on the Tree Protection Plan in appendix 2 have been erected and the extension of the dwelling completed.

Figure 4. Areas for alternative tree friendly methods to be used

4.2.2 For new/replacement hard surfacing within the root protection areas of trees it will be necessary to use a no-dig tree friendly option. (If it is agreed that there are no roots in these areas following the lifting of the surfacing traditional methods can be used.)
