**REPORT on VISUAL STRUCTURAL INSPECTION**  
**STEEL FRAMED BARN**  
**AT**  
**TILHAM FARM**  
**BALTONSBOROUGH**  
**GLASTONBURY**

**CLIENT**      Mr Robert Peto

**REF**            21-186

18 March, 2022

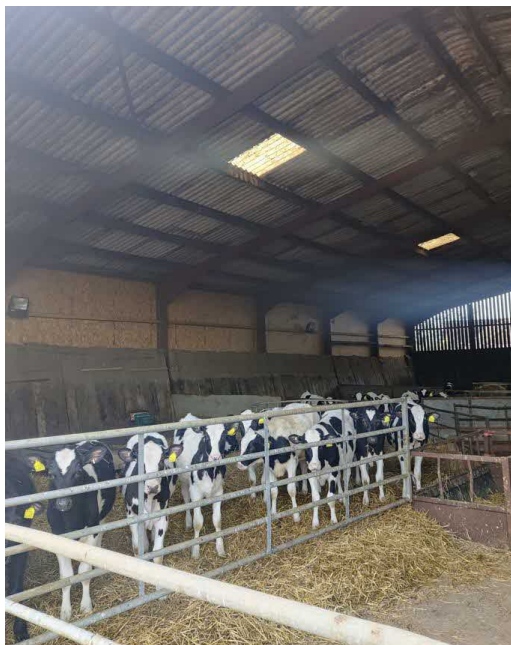
Figure 4 - Internal view from NE

- 4.4 Internally the visible steelwork appeared to be in good condition with no signs of significant corrosion or distortion.
- 4.5 The roof cladding was also in good condition, suggesting that excessive deflection of the timber purlins has not occurred.

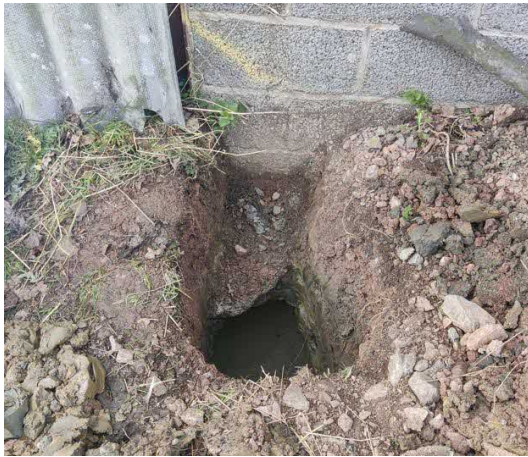
### TP1

Approximately 1m square concrete pad foundation formed on to firm clay. Estimated allowable ground bearing pressure in excess of 100kPa.

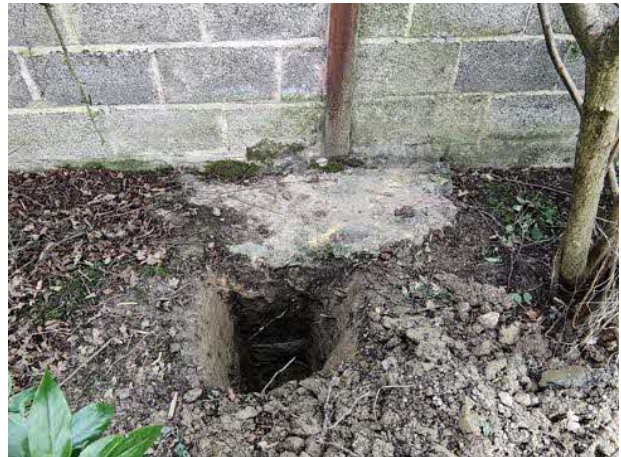
### TP2

100mm thick concrete slab overlying made ground overlying approximately 1m square concrete pad foundation formed on to firm clay. Estimated allowable ground bearing pressure in excess of 100kPa.
