**KDK Archaeology Ltd**

**Gun Hill House & Outbuildings**

**Historic Building Appraisal**

**Report Reference: 242/BOS/1**

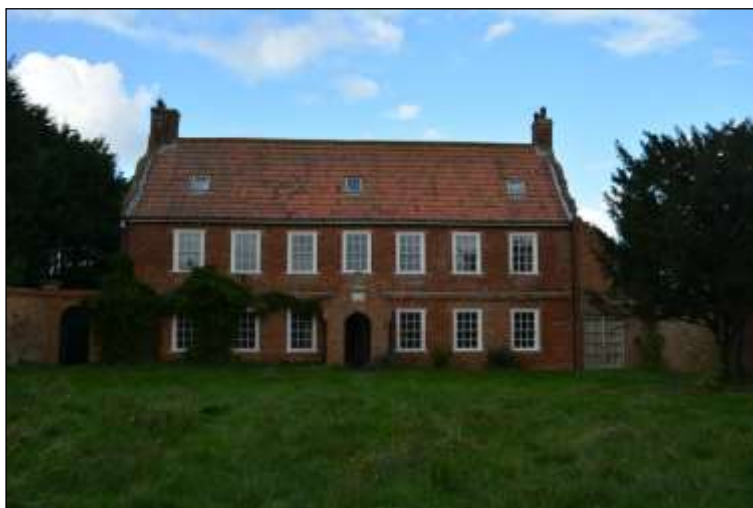
Plate 1: South elevation

Project No/code: 226/BOS	Project: Gun Hill Burnham Overy Staithe	Elevation: South
<p><b>Doors:</b> Main entrance within centrally located porch. French doors in extension to the east.</p>		
<p><b>Windows GF:</b> Three 6 over 6 timber sash windows to either side of the door. Deep frames and narrow glazing bars. Some have queen closers but others do not. All under flat segmental arch</p>		
<p><b>Windows FF:</b> Seven window in the same style as on the ground floor</p>		
<p><b>Walling material:</b> Brick built with offset plat band largely obscured by wisteria. Various rebuilding/repair events evident in the change in brick use, loss of queen closers to openings and the use of cement mortar to repoint. Bricks measure 23x10.5x5cm and are well puddled with few stone inclusions. Horizontal skintling apparent on one of two of them.</p>		
<p><b>Other Architectural Features:</b> Brick built porch with stone heraldic device over opening and stepped gable. This is a later addition but utilising bricks with diagonal skintlings to match those on the west elevation. Bricks of similar size to main wall.</p>

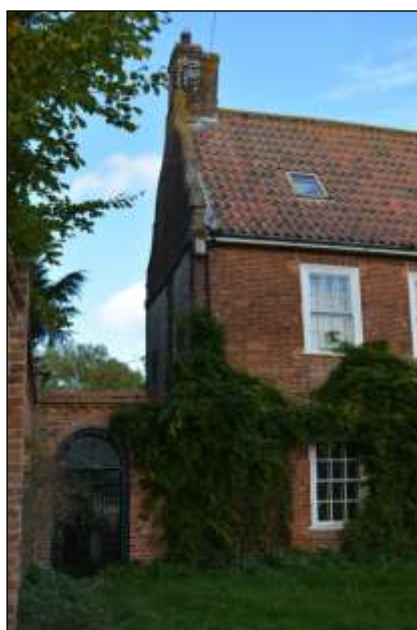
Plate 8: West elevation from the southwest

Project No/code: 226/BOS	Project: Gun Hill Burnham Overy Staithe	Elevation: West
Doors: -		
Windows GF: --		
Windows FF: -		
<p><b>Walling material:</b> Upper and lower sections are of brick with a chalk and brick section between. Dutch gable. Lower section is splayed on both planes and acts as buttress to the wall. The bricks in the lower are set in English bond in cement mortar and measure 23x11x6cm. The bricks forming the chimney stack within the clunch have diagonal skintlings. If original this could date the chimney to the late 17<sup>th</sup> or early 18th century. The bond in the upper section appears to be Flemish.</p>		
<p><b>Other Architectural Features:</b> Square brick panels are set into the chalk wall on either side of the chimney. A brick and stone stair gives access to the north terrace.</p>		
Recorder: KK	Survey date: 22.10.16

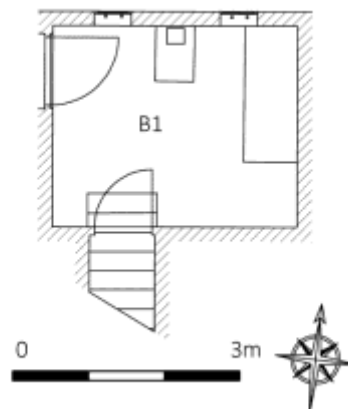
Plate 11: Basement plan (scale 1:100)

Project code: 226/BOS	Project: Gun Hill Burnham Overy Staithe	Room no: B1
Location: Basement		Function:
Wall form & decor: The basement has been tanked, floor walls and ceiling		
Ceiling / roof structure: -		
Windows: Two small top hung metal windows in north wall, with 2 bars in front to both		
Doors: Half glazed reclaimed front door with 4 panels and blocked letter box to south. Made from diverse reclaimed fragments specifically for this room Ledge and braced door to west to long storage area below conservatories.		
Floor: -		
Fireplace: -		
Staircase: 9 stone steps to south, very worn		
Other architectural details: Long gap beneath conservatory floor has breeze block ceiling, concrete floor and late 20th century brick wall to north. This is subdivided by breeze block wall beyond which is a window		
Recorder: KK		Survey Date: 14.07.16

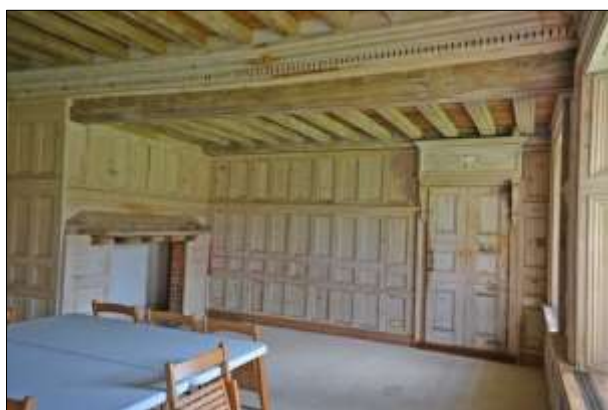
Plate 12: G1: east wall

Project No/code 226/BOS	Project: Gun Hill Farm, Burnham Overy Staithe	Room no: G1
Location: Ground floor, west end		Function: Reception
<p><b>Wall form &amp; decor:</b> East wall: Reused 4 panelled door to north and south of fireplace. Panelling above clearly modern as there are carpenter's pencil and scribe marks as well as metal pins fastening mouldings. Mixture of reused timbers such as doors and possibly panelling above the rail, but modern inserts are clearly evident in the columns with Ionic capitals, pediments over the curved doors to north and south and infill within the panelling itself.</p> <p>North wall: Modern skirting with reclaimed panelling above. Modern cornice. Panelling on west return wall of fireplace from reclaimed material below the dado and modern above. Panelling above fireplace made from reclaimed timber with modern fillers.</p> <p>East wall: Modern skirting. Panelling made from reclaimed and modern timber.</p> <p>South wall: Ditto. Panelling between the two windows is a rebuilt door.</p>

<p><b>Ceiling / roof structure:</b> Two binding beams with tool marks. Joists to east, like the eastern beam have roll moulding. Joists to west are plain. Floorboards above probably replaced historically.</p>		
<p><b>Windows:</b> Reveals panelled with new and reclaimed timbers.</p>		
<p><b>Doors:</b> Reclaimed 6 panelled door to east with ghost of original strap hinges. Brackets and pediment modern additions. Two curved doors in west wall are both reused and heat curved to fit. That in the north west corner has ghost of door lock on the side that is now hinged.</p>		
<p><b>Floor:</b> -</p>		
<p><b>Fireplace:</b> The western fireplace surround is a modern pastiche using reclaimed material. Surround is screwed to the wall. Northern fireplace has a massive lintel and thick timber mantel poorly supported by large timber brackets. The whole fireplace is modern.</p>		
<p><b>Staircase:</b> -</p>		
<p><b>Other architectural details:</b></p>

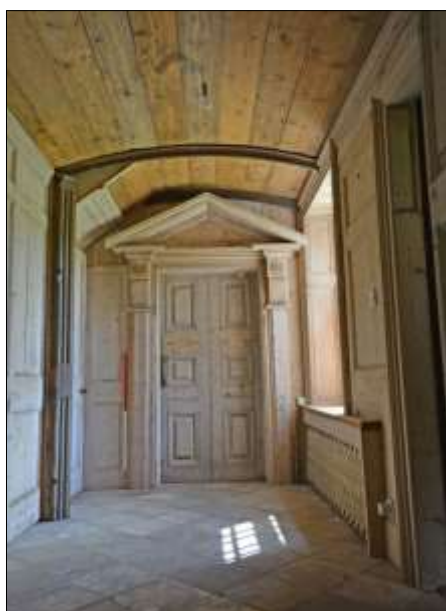
Plate 18: G2: view to east

Project No/code 226/BOS	Project: Gun Hill Farm, Burnham Overy Staithe	Room no: G2
Location: Centre of the ground flor		Function: Hall
Wall form & decor: Panelling throughout made from reclaimed and new timber, including two heavily moulded beams reused as posts on the north wall.		
Ceiling / roof structure: Timber barrel vaulting using reclaimed timbers.		
Windows: -		
Doors: Door to west reclaimed (see G1 sheet). Door to east similar but the back has been cut off and poor quality moulding added. Reclaimed door to north, cut down to fit. Good quality oak door to south; historical but unlikely to have been the original. Hood, pediment and brackets all modern additions. Half glazed timber door to staircase purpose built.		
Floor: -		
Fireplace: -		
Staircase: Closed string staircase with barley twist balusters and newel posts. Possibly 18th century but could be early 20th century addition. Historical panelling on the stair wall inserted at some unknown date, possibly with the staircase in the 1980s. Balustrade on first floor landing made from reclaimed material of good quality. Newel post on half landing has replacement upper half

Other architectural details: Columns with capitals and Jacobean cupboard doors over the stair are a later addition , as is the softwood panelling along south side of staircase.		
Recorder: KK	Survey Date: 14.07.16

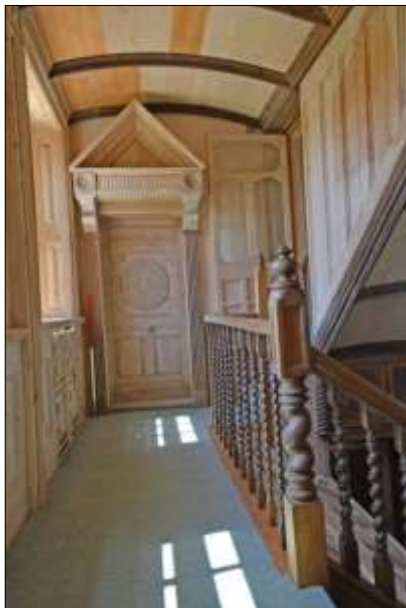
Plate 32: F1: view to west

Project No/code 226/BOS	Project: Gun Hill Farm, Burnham Overy Staithe	Room no: F1
Location: Centre of first floor		Function: Landing
Wall form & decor: Good quality historical panelling lining the stairs. Modern to south wall and above stairwell.		
Ceiling / roof structure: Timber barrel vaulting with northern side utilising same moulded timber as in the hall below (now used as posts)		
Windows: 6 over 6 timber sash x2 in each opening to form double glazing. Reveals are panelled.		
Doors: Doors made from reused timbers with unusual opening mechanism (also modern manufacture using historical materials) to east and west. Reclaimed medieval timber door to north. Frame of medieval door is partly historical and partly of new timbers. Brackets and hoods modern.		
Floor: -		
Fireplace: -		
Staircase: Closed string staircase with barley twist balusters and newel posts. Possibly 18th century but could be early 20th century. Historical panelling on the stair wall presumably added when the staircase was installed in the 1980s. Balustrade on first floor landing made from reclaimed material of good quality, worth keeping. Newel post on half landing has replacement upper half

Location	Proposals	Significance	Impact	Comments
House: F1	Removal of timber panelling and doors	Modern insertion	Positive	
House: F1/F6	Removal of medieval door in partition wall	Historic feature imported recently into the house	Positive	
House: F2	Window in north wall to be moved to make the window symmetrical	Loss of historic fabric	Negative	Minor loss that is counterbalanced by improved aesthetics
House: F2 & F4	These will be integrated to form en-suite	Uncertain date	Neutral	Considerable re-working of the interior would suggest that the integrity of the building will not be compromised by this proposal
House: F3	Insertion of three new windows in the north wall	Loss of historic fabric	Negative	This is counterbalanced by the improved aesthetics of the north elevation and improved light within the room
House: F4	Recesses to either side of fireplace to be replaced with wardrobes	Alteration from cupboard & entrance to bathroom; no loss of historic fabric	Neutral

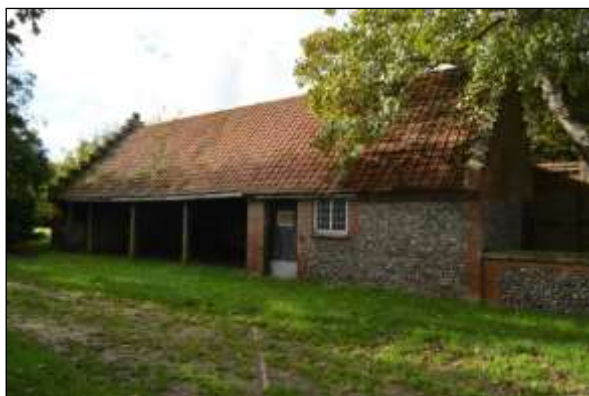
Plate 72: Cart shed: east elevation from the northeast

Project No/code: 242/BOS	Project: Gun Hill Farm, Burnham Overy Staithe	Building: Cart Shed
<p>Single storey structure under a clay tiled roof with crow-stepped gables. Located to the south of the house and is aligned north-south. The rear elevation now forms part of the eastern garden wall. A half height wall extending northwards from the east elevation. The main body (C1) is open to the east with a former stable (C2), garage (C3) , tack room (C4) to the north.</p>		
Visited by: KK		Date of visit: 22.10.16

Cart shed: South elevation	Will be largely rebuilt	Loss of historic fabric	Positive	Although there will be loss of fabric, the wall is structurally unfeasible and will be rebuilt using similar building materials

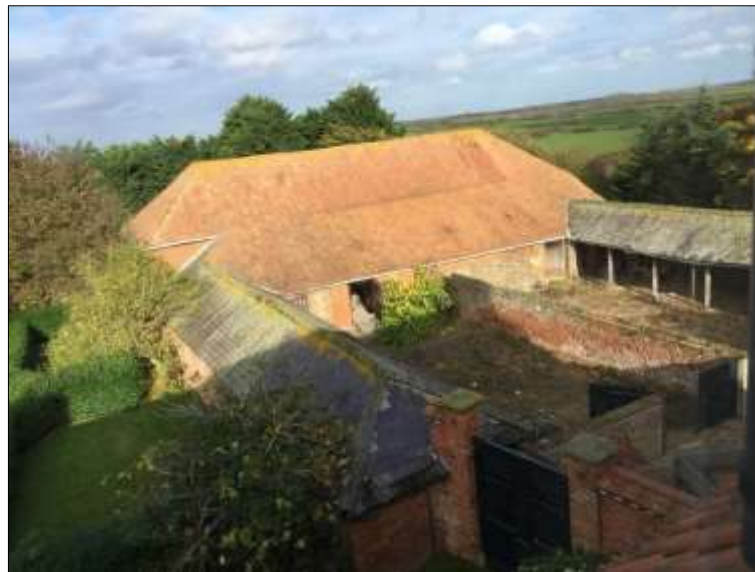
**Plate 79:** Barn complex from the southwest

Project No/code: 242/BOS	Project: Gun Hill Farm, Burnham Overy Staithe	Building: Barn
<p>The barn forms the northern element of a 3-sided complex facing the rear of the farmhouse. It is largely brick built under a clay tiled, hipped roof and is subdivided to form a livestock area to the east of the main barn. The main body of the barn (B1) has 5 bays with a double door to the north. To the east of this is a room formerly used for livestock (B3) with a hayloft over. An annexe to the south houses additional spaces (B2, B4 and a room that was not accessible during the survey).</p> <p>The yard to the front of the barn is subdivided by a brick wall runs north-south between the barn and the perimeter wall. The two ranges on either side of the barn are described separately.</p>		
Date of visit: 22.10.16	Visited by: KK

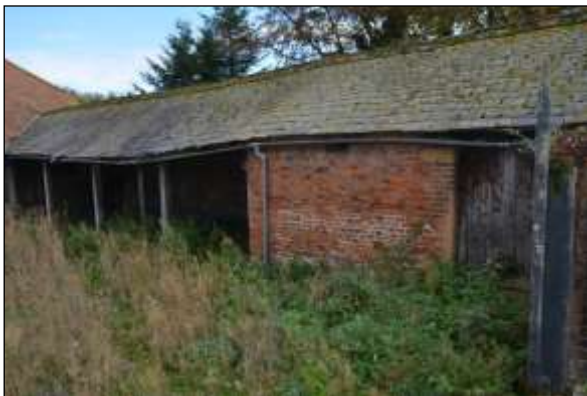
**Plate 101:** East Range: view to north east

<b>Project No/code:</b> 242/BOS	<b>Project:</b> Gun Hill Farm, Burnham Overy Staithe	<b>Building:</b> East Range
<p>Although brick has been used here, the east range is largely flint and cobble with some clunch. The roof is covered with slate rather than clay tiles, but is also hipped at the southern end.</p> <p>This is dominated by the central open fronted section which is of 4 bays with a king post roof and dirt floor(E1). To the north of this is Room E2, which is lit by an opening in the south wall and another in the east wall.</p> <p>Room E3 to the north has a raised floor and a half height wall to the south. At the southern end of the range is a completely separate room with a brick floor, a window in the south wall and a plank and batten door to the west (E4).</p>		
<b>Date of visit:</b> 22.10.16		<b>Visited by:</b> KK

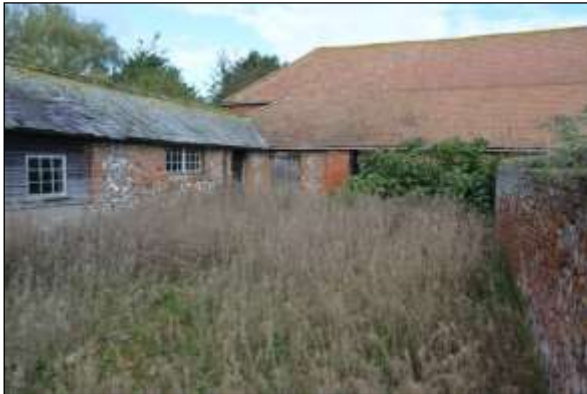
Plate 111: West Range from the southeast

Project No/code: 242/BOS	Project: Gun Hill Farm, Burnham Overy Staithe	Building: West Range
The west range comprises two completely enclosed spaces. W1 is a 6-bay former livestock shelter with a runnel to the east. W2 to the south is a fuel store, but was formerly a stable. This is weatherboarded to the east, which could suggest it was once open fronted.		
Date of visit: 22.10.16		Visited by: KK

Enclosing open fronted structure with timber cladding and 2 doors		Neutral	
	Covered walkway		Neutral	
West Range	Metal roof covering	Loss of historic fabric	Negative	Whilst this will impact the historic fabric and the present setting of the complex, the new roofing programme for the complex overall will provide a new setting with materials that define the hierarchy of the buildings in a manner that is commonplace on farm complexes
	Covered walkway		Neutral	
	East wall to be rebuilt and partially clad in timber	Loss of historic fabric	Negative	Despite loss of historic fabric this is structurally necessary
	Shuttered openings to be created in west elevation	Loss of historic fabric	Negative	Counterbalanced by improved overall appearance of the west elevation and the provision of extensive views to the west
Cattle Shed	Demolition of all but the north wall		Positive	The building is in very poor condition and of little

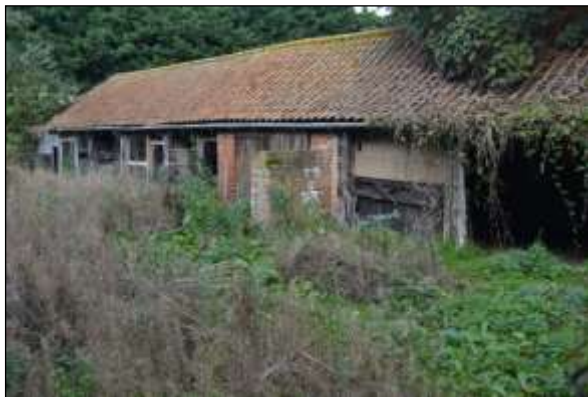
**Plate 116:** Cattle shed from the southeast

Project No/code: 242/BOS	Project: Gun Hill Farm, Burnham Overy Staithe	Building: Cattle Shed
<p>These are open fronted, brick and flint/cobble built with queen posts supporting clasped purlins. The eastern space is of three bays with the western end demarcated by a later brick and cobble wall (S1). To the west of this is an enclosed space with a timber door to the south, brick wall to the west and brick and cobble wall to the north (S2).The western end has been subdivided very rudimentarily with timbers and corrugated sheeting (S3), beyond which is another open fronted section with brick, flint and cobble walls to the north and west (S4).</p>		
Date of visit: 22.10.16		Visited by: KK
