Historic Building Appraisal

Gun Hill House & Outbuildings Burnham Overy Staithe Norfolk

Author	Karin Kaye MA MCIfA & Ellen Shlasko PhD	Version	242/BOS/1	Date	4 th May 2017
Editor	David Kaye BA ACIfA	Version	242/BOS/1	Date	4 th May 2017
Revision	Karin Kaye MA MCIfA	Version	242/BOS/1.1	Date	4 th May 2017

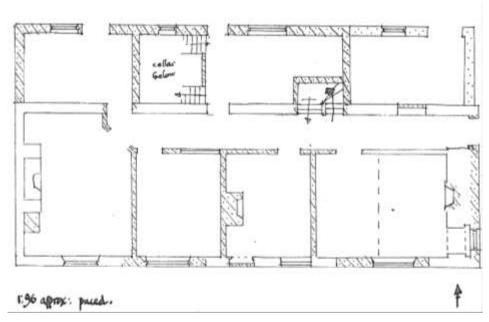
Figure 10: Ground floor plan in 1976 (not to scale)

After the RCHME report was made the house was acquired by a local builder. He demolished the rear lean-to extension (with planning permission) and added a central porch to the facade (without permission) the latter spoiling the elevation. All the facade windows were replaced with a not very accurate form of wooden-cross casements. The interior was gutted (except, thankfully, for the upstairs panelled room) and various odd features added.

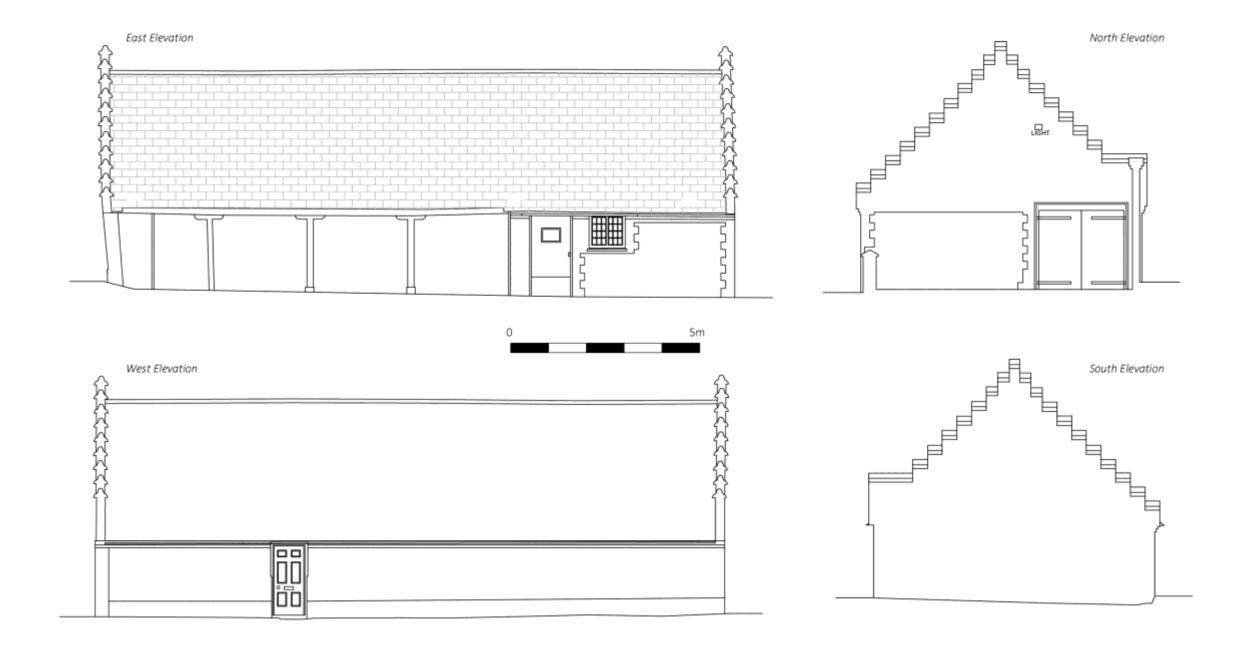
Figure 19: Cart shed elevations as existing (scale 1:100)

The cart shed to the southeast of the house will also be converted to residential use, which will require the complete rebuilding of the south wall, which is structurally unsound, the restructuring of the east elevation, which is currently partially open fronted, and the creation of a new window opening to the west to provide light into the proposed kitchen and a view of the walled garden from the same. Internal alterations include the reconfiguration of the ground floor and alterations to the roof structure to allow for a mezzanine floor. Here, too, it is proposed to replace the tiles with black pantiles. Whilst some loss of historic fabric will occur, the overall impact to the building is positive as it is currently in need of attention.
