Tree Structural Integrity Report

6 Eastfield Road
Redland
Bristol
BS6 6AA

JH.210690.R

16th December 2021

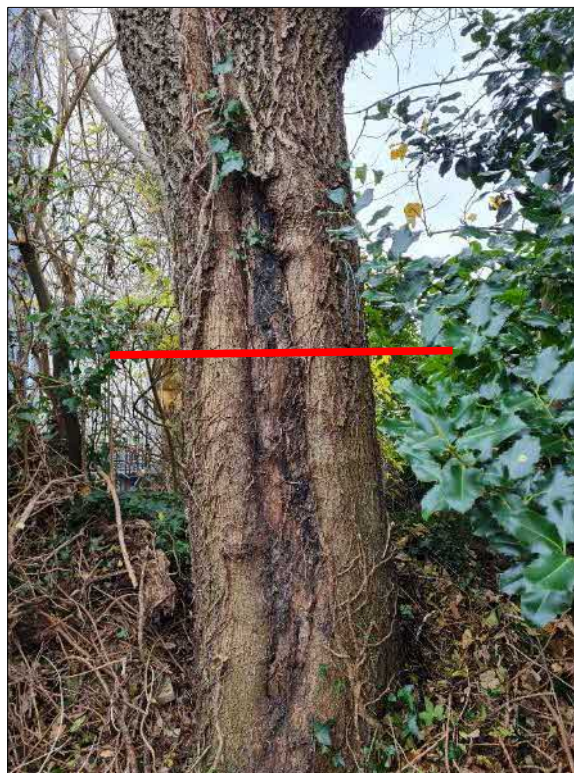
Due to the presence of the wounding and decay column, a total of three (3) tests were conducted at 1.5 metres height on the main stem of the Ash tree. The tests were positioned to the northeast, south and northwest sides of the stem, triangulated around the decay column, to assess the presence of internal decay.

Figure 3: Image of IML-RESI Powerdrill® Test Plane on Ash at 6 Eastfield Road, Bristol

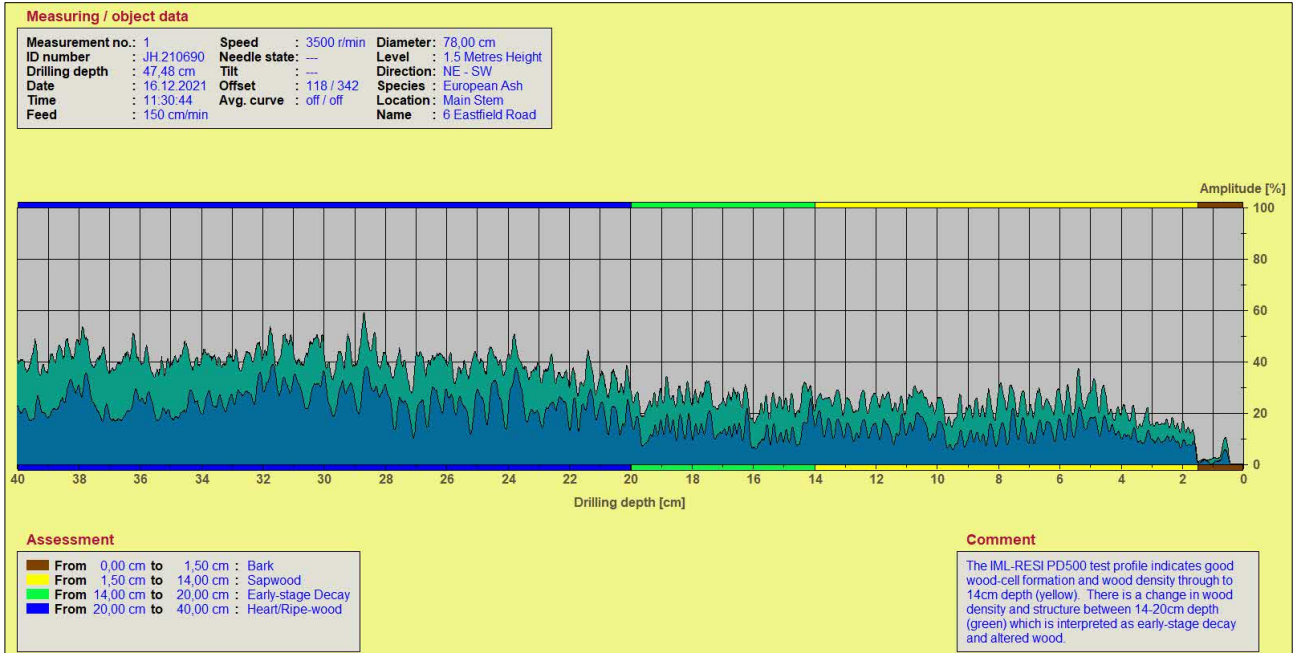
· Test 01: 1.5 Metres Height, Main Stem, Northeast Orientation

Test 1: The test profile is interpreted as indicating good wood density and structure through the sapwood region, spanning approximately 2 – 14 centimetres depth, as coloured yellow on the test profile. There is a distinct variation in wood cell structure and density between 14 – 20 centimetres depth, which is interpreted as altered and decayed wood, and coloured green on the test profile. There are no indications of deep-seated decay or hollowing of the stem beyond the 20 centimetres depth.

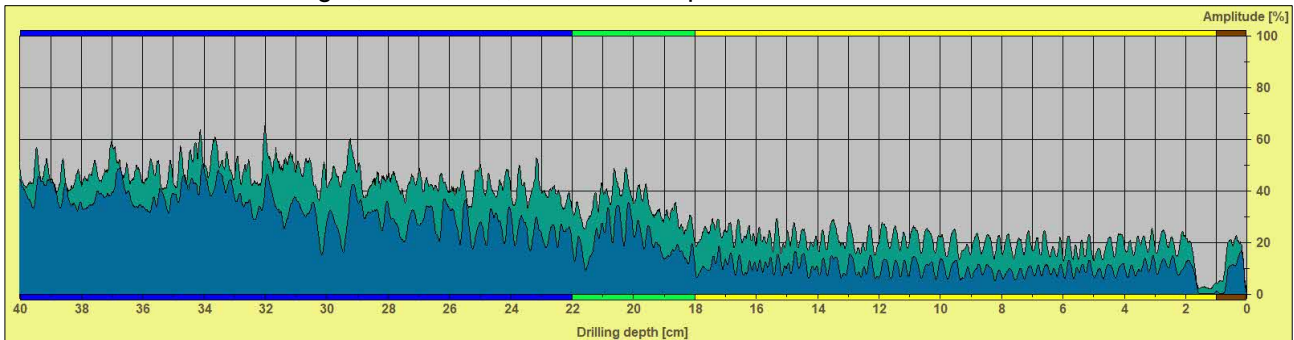
· Test 02: 1.5 Metres Height, Main Stem, Northwest Aspect

Test 2: The test profile is interpreted as indicating good wood density and structure through the sapwood region, spanning approximately 2 – 18 centimetres depth, and coloured yellow on the test profile. There is a distinct change in wood structure and density between 18 – 22 centimetres depth, which is interpreted as altered and decayed wood, and shown as green on the test profile. Again, there are no indications of deep-seated decay or hollowing of the stem beyond the 22 centimetres depth.

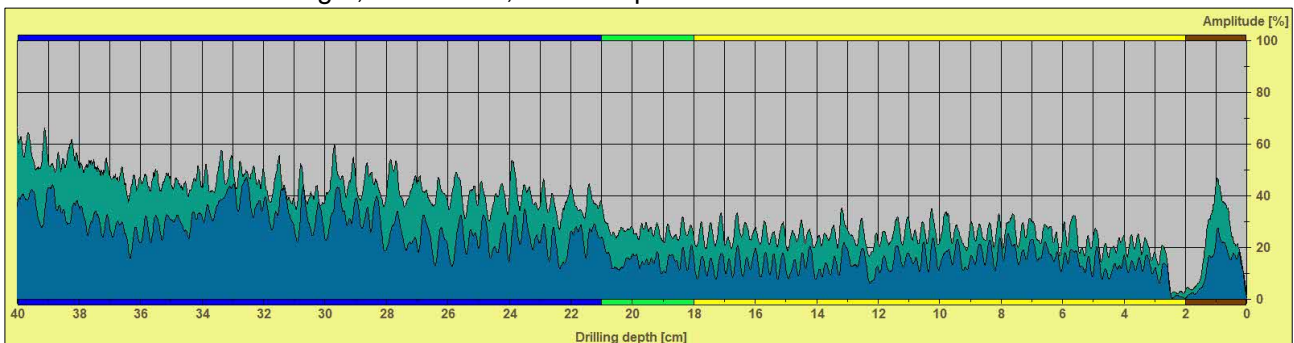
· Test 03: 1.5 Metres Height, Main Stem, South Aspect

Test 3: The test profile is interpreted as indicating good wood density and structure through the sapwood region, again, spanning approximately 2 – 18 centimetres depth, and coloured yellow on the test profile. There is a more subtle, but noticeable, change in wood structure and density between 18 – 21 centimetres depth, which is interpreted as altered and decayed wood, and shown as green on the test profile. Again, there are no indications of deep-seated decay or hollowing of the stem beyond the 21 centimetres depth.

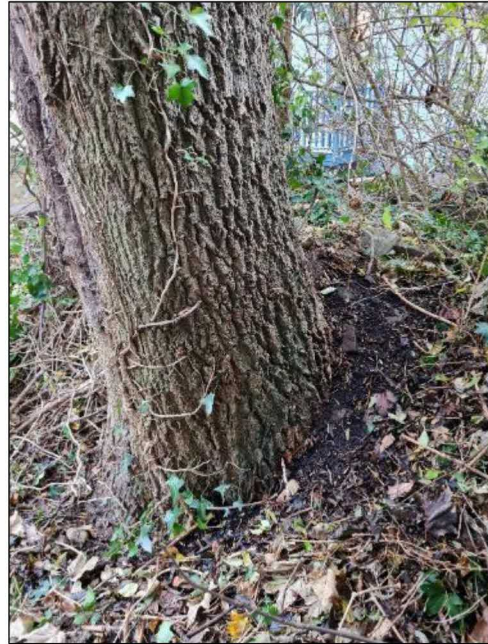
Figure 5: Image Showing Partially Buried Root Collar

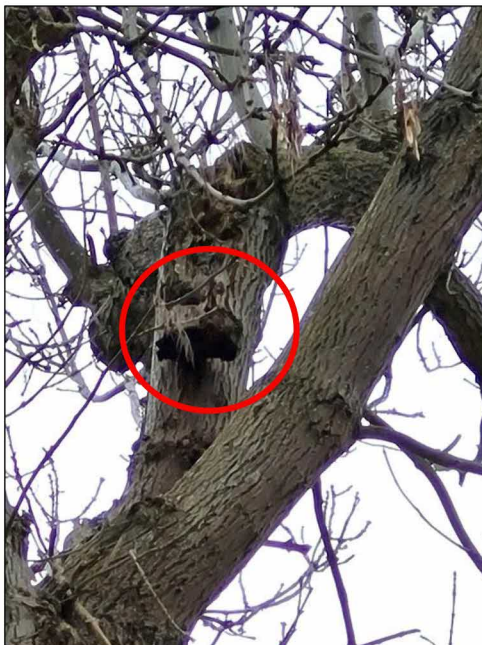
Figure 6: Image Showing Dysfunction & Decay at Old Cutting Points as well as Fungal Fruiting Body (Circled)

At the conclusion of the visual tree assessment, the Ash tree has not responded well to past management, with sapwood decay and cavity development at old pruning (topping) points, as well as the presence of fungal fruiting bodies at and below these features / locations. As typical in response to this type of tree pruning, epicormic branches have grown from the pruning points, which is poorly attached to the tree branch with a higher likelihood of failure. Added to these features, the eastern primary branching structure is exhibiting significant dieback and decline, with numerous dead branches.

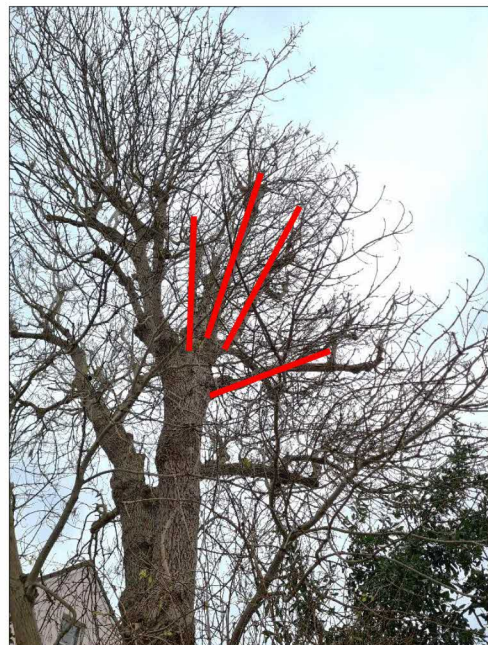
Figure 7: Image Identifying Dead Primary Limbs (Red Lines) Throughout Eastern Canopy
