Drawing Title
**Topographical Survey of Land at:
Barchester Arbour Lodge
Buxton Lane, Marple**

Project Name: 12639 SURVEY OPS ARBO	Project number: 12639	Date: 29/03/2019	Contact: Ian Thompson	
--	--------------------------	---------------------	--------------------------	--

Inspection report

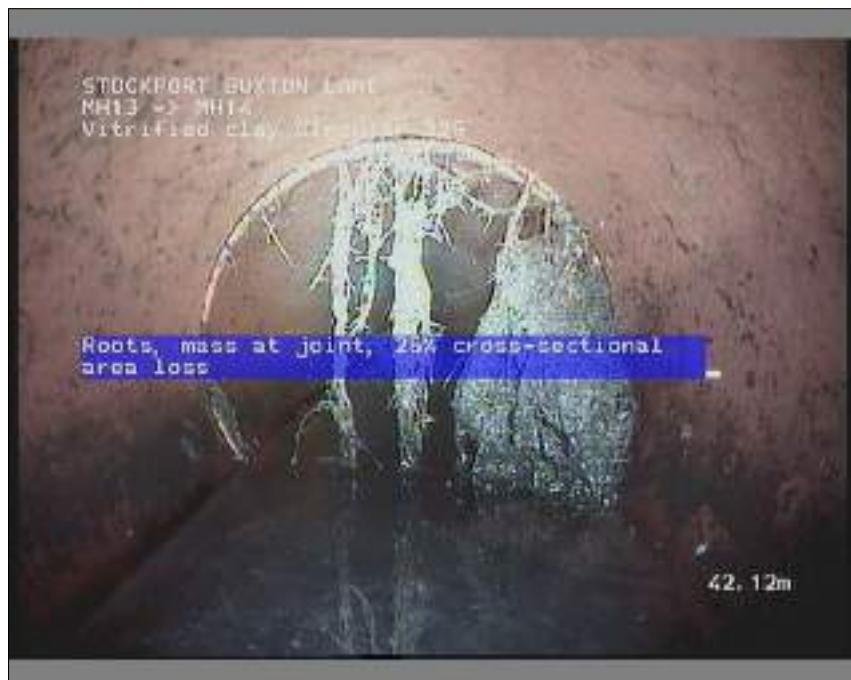
Photo: 002.JPG
42.1m, Roots, mass at joint, 25% cross-sectional area loss

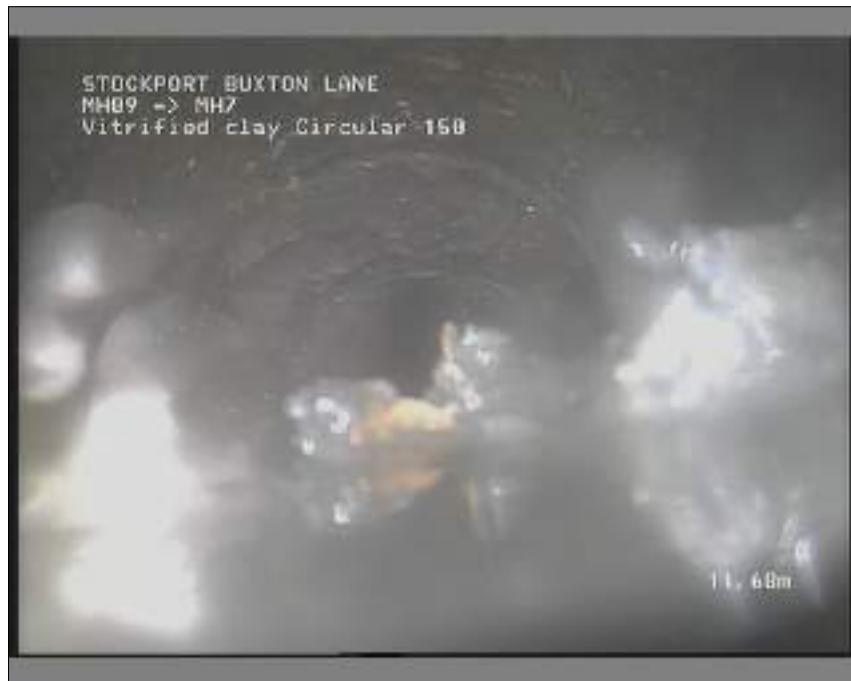
Photo: 012.JPG
11.68m, Settled deposits, fine, 40% cross-sectional area loss

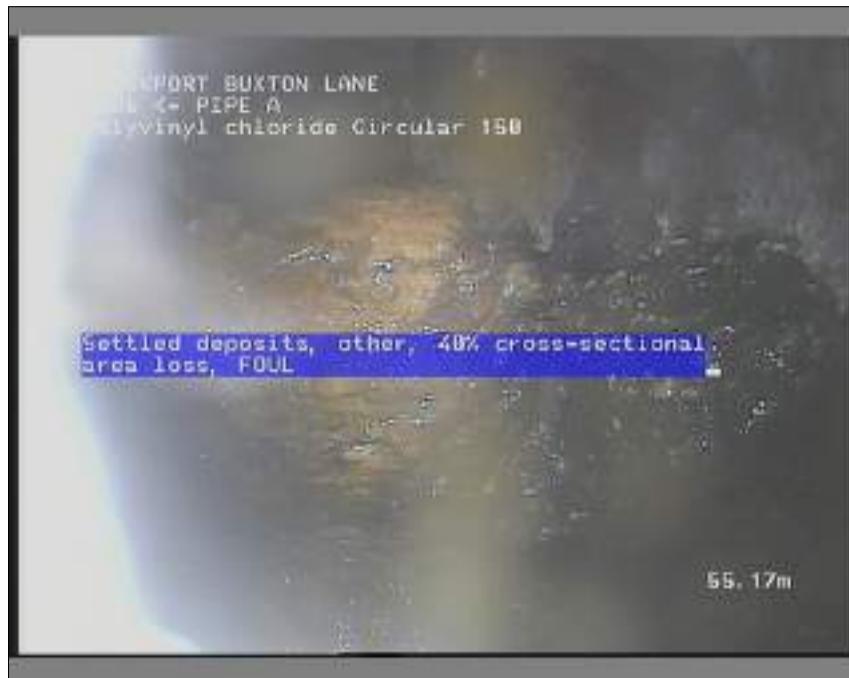
Photo: 025.JPG
55.17m, Settled deposits, other, 40% cross-sectional area loss Remarks: FOUL
