Morton & Hall Consulting Limited

Ref: H8379/MH/sg

ENGINEER'S INSPECTION REPORT

CHAMBERS FARM

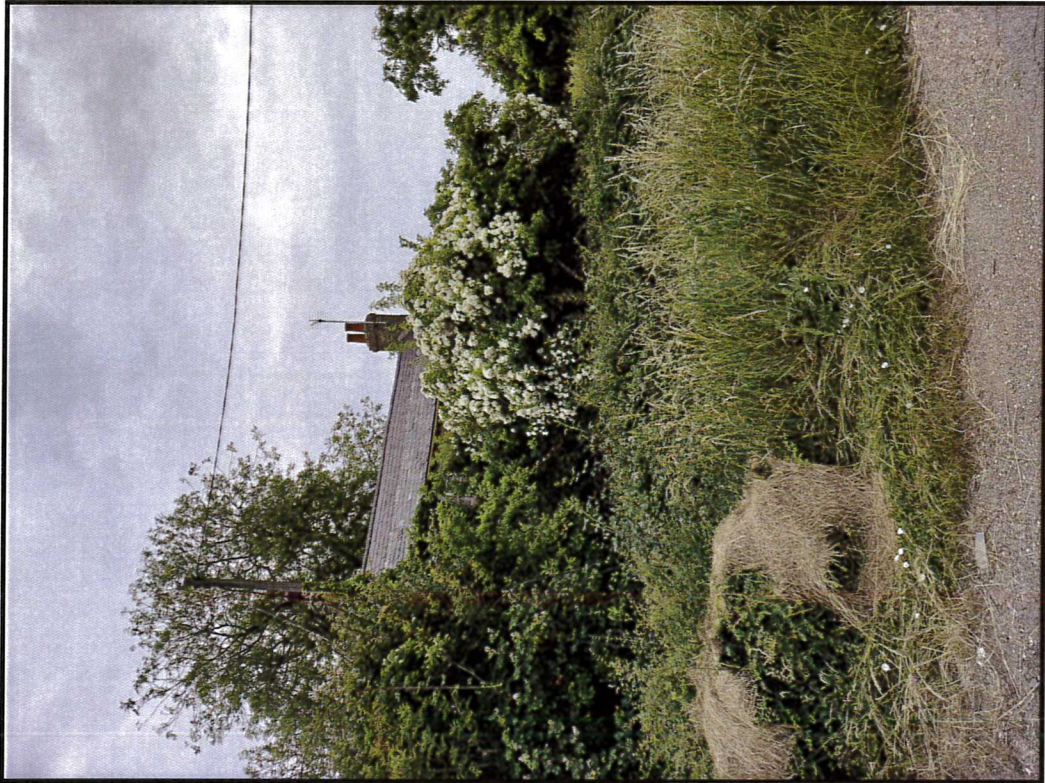
H8379_01

1. Overall view of the property from the main road.
2. View of the drainage ditch to the front of the site.
3. View of vegetation to the front of the site.

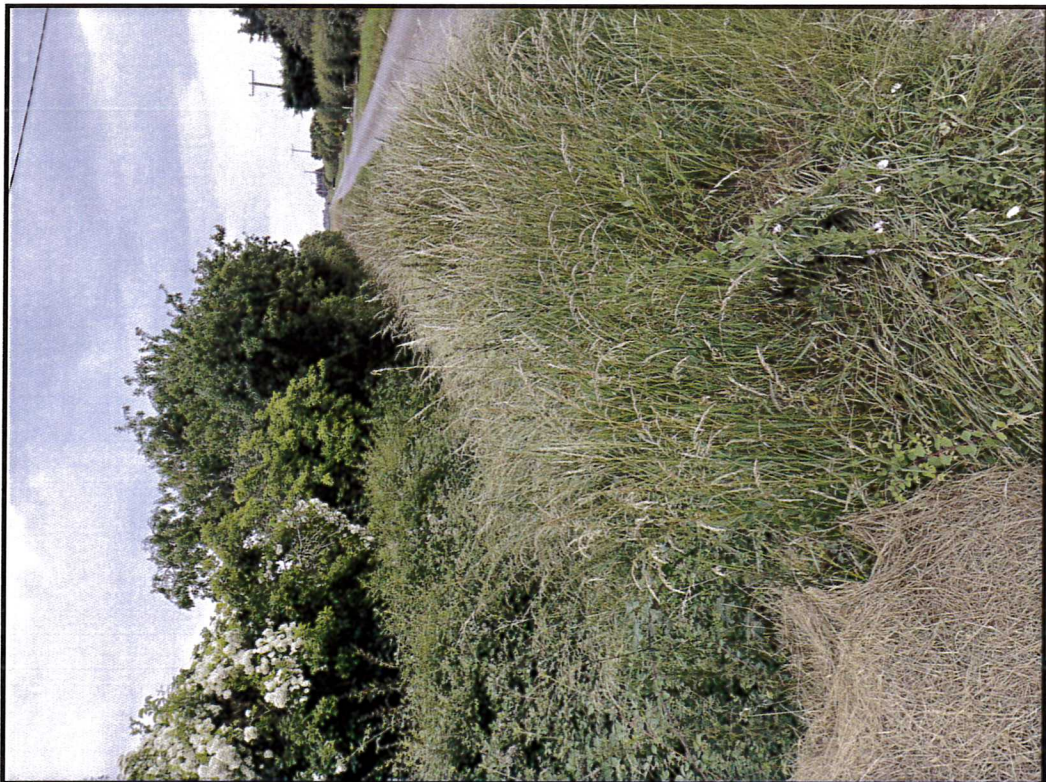
H8379_02

Adjacent to the main road there was a drainage ditch approximately 1.5m in depth, which would be approximately 7m from the front wall of the property.

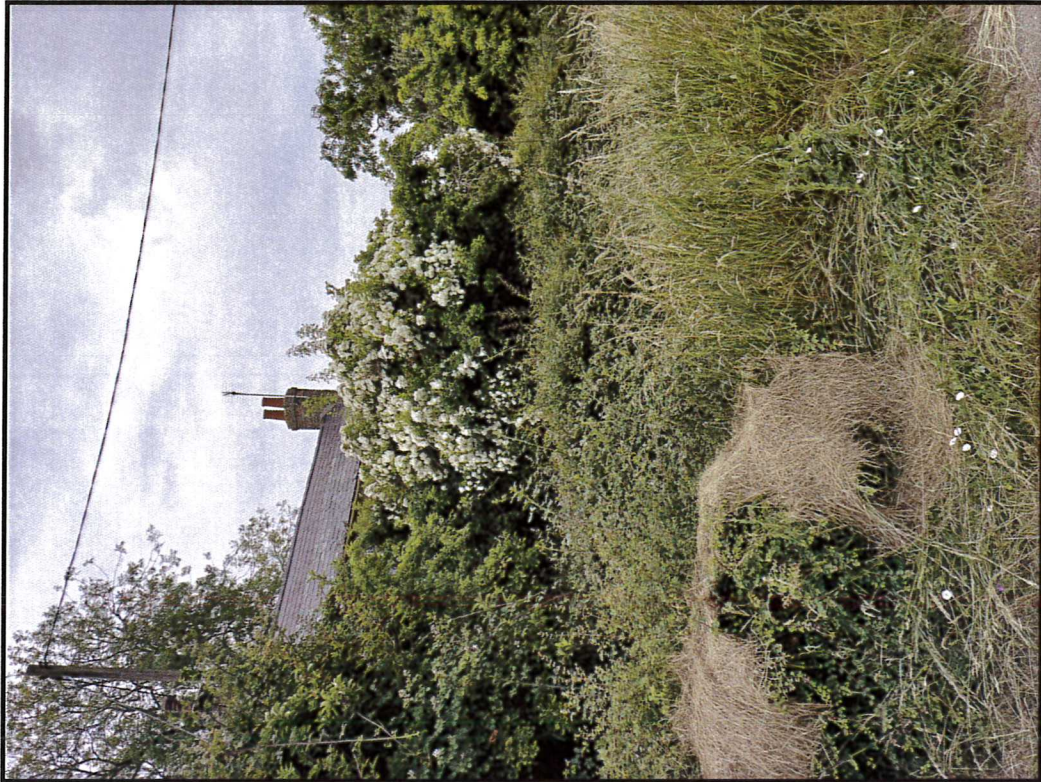
H8379_03

Along the front boundary and all in front of the front elevation of the property, the site was overgrown with vegetation and no access could be gained, with vegetation approximately 4m in height.

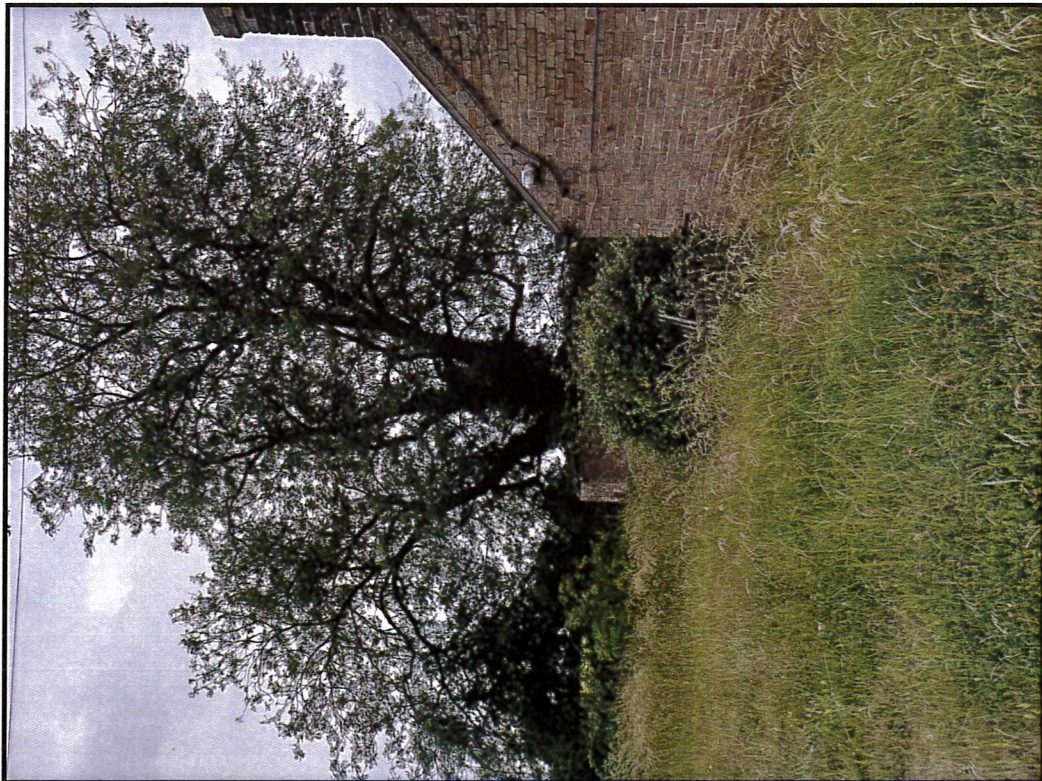
H8379_04

<u>Tree</u>	<u>Height</u>	<u>Location</u>
Ash	up to 18m	within 11m from the rear wall of the property
Willow	up to 18m	within 20m from the left hand side wall of the property

4. View of mature Ash tree to the rear of the site.
5. View of the left hand side gable end and rear elevation.
6. View about the right hand side gable end and conservatory which was in very poor condition.

As a general rule no trees or large shrubs should be planted within 5.0m of any building and elsewhere trees and shrubs should be kept pruned at heights no greater than their distance from any building.

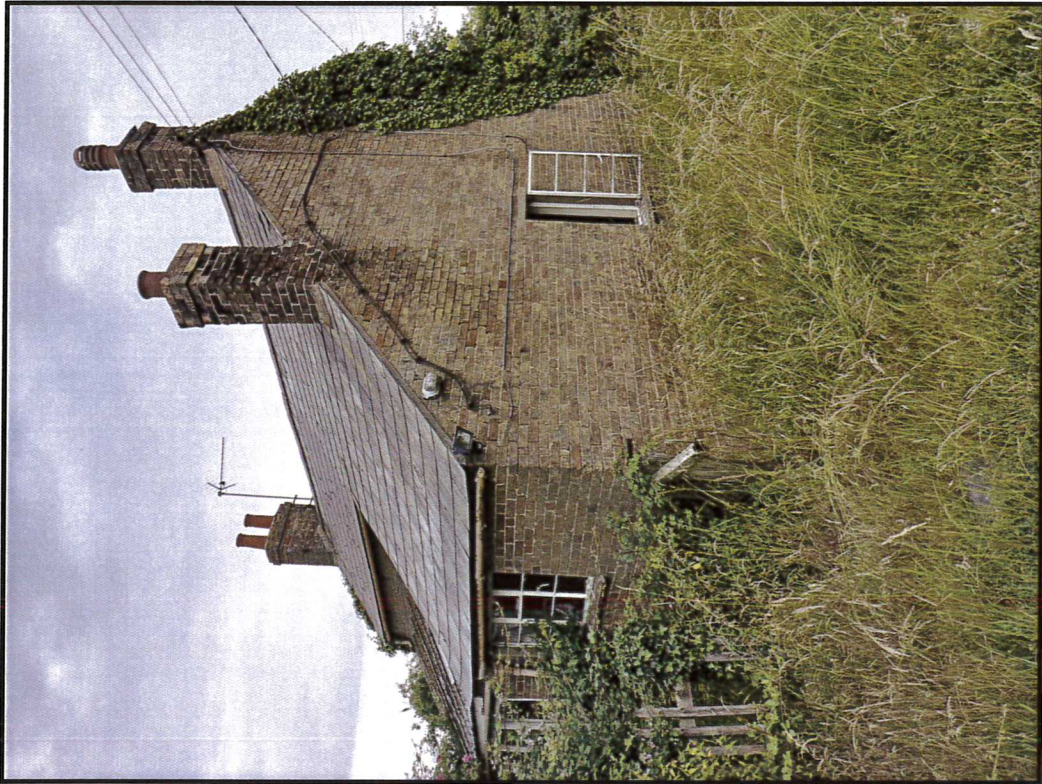
H8379_05

The left hand side gable end bowed above first floor level which continued to the ridge line.

Structural cracking was present adjacent the return of the wall at the left hand side gable end of up to 10mm thickness.

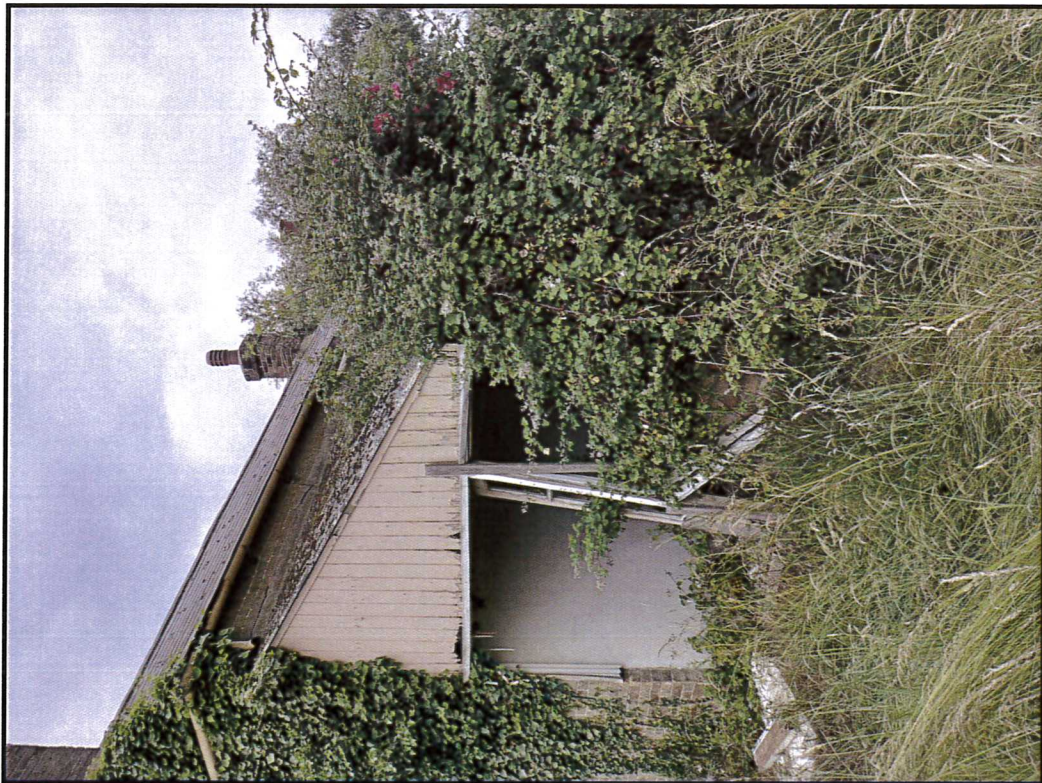
H8379_06

On viewing along the right hand side gable end, this also had bowed at first floor level, continuing beyond eaves level due to a lack of tie and the chimney stack being set to the gable.

The conservatory would need to be demolished and rebuilt.

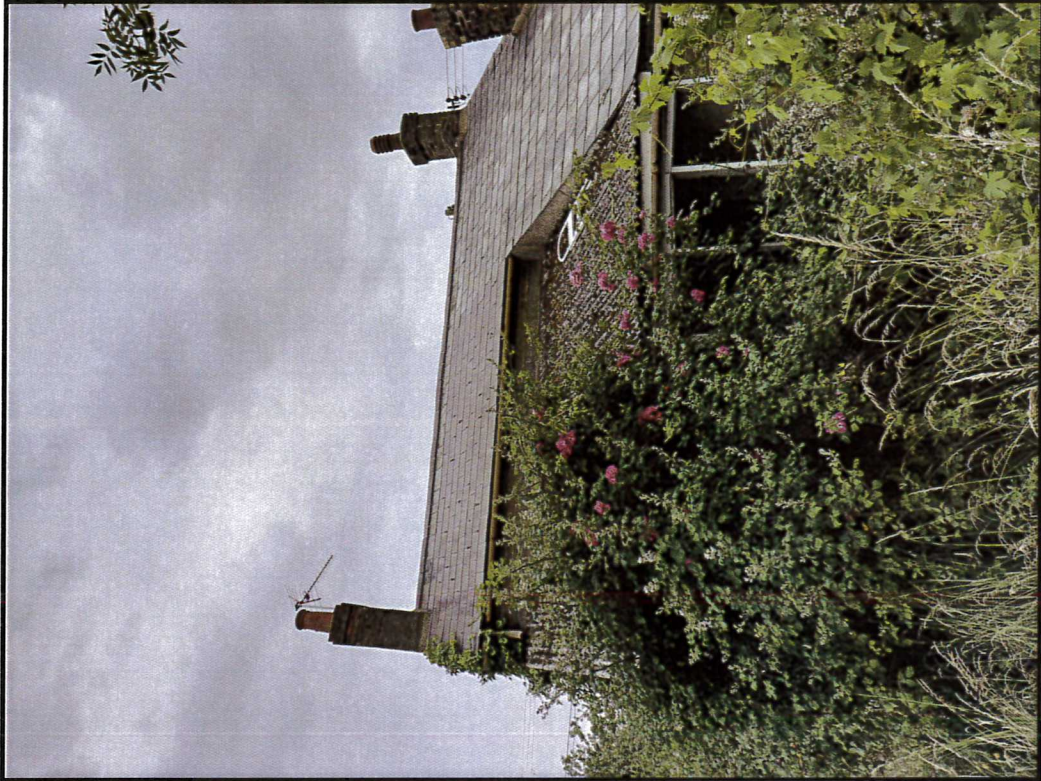
H8379_07

All stacks lean inwards as viewed from ground level.

There was no flashings set about the base of the stacks where these continued down to the roof slope, as there was merely cement set about.

Clay pots are set to all stacks and there was evidence of mortar erosion to the stacks.

7. View of the chimney stacks from the rear garden area above the roof line, showing these leaning inwards.
8. View of the conservatory being propped up and partially lost.

Chimney stacks would require to be demolished and rebuilt to line and level.

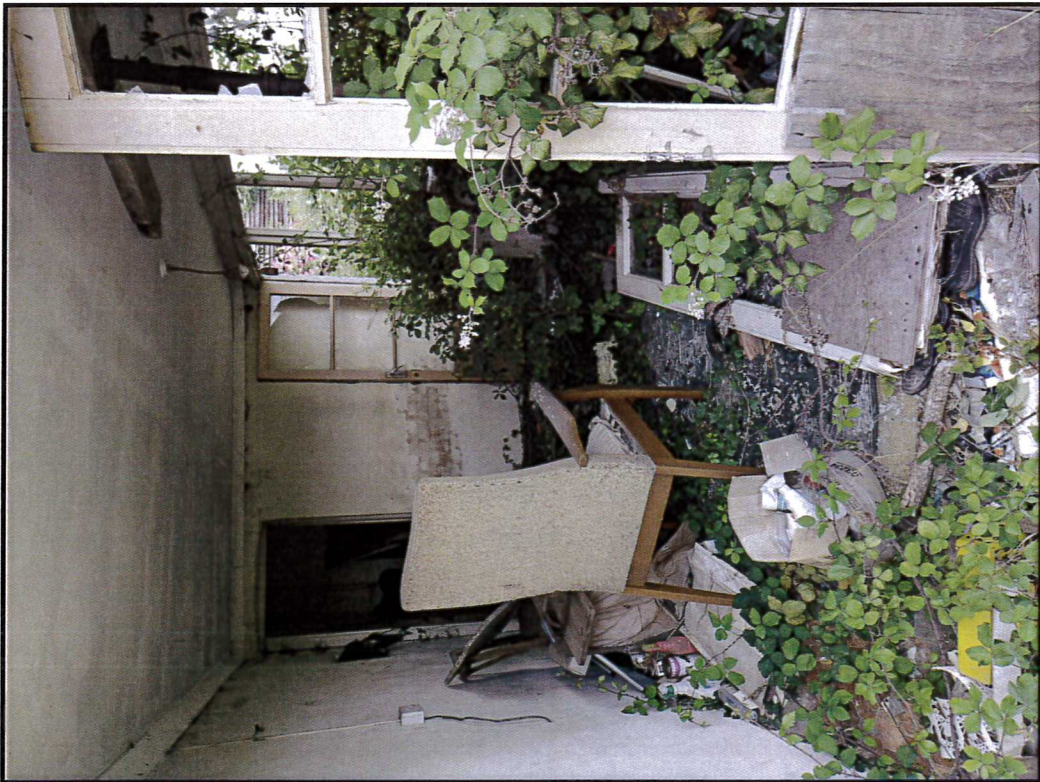
H8379_08

The continuation of this wall was the conservatory wing which the joinery had all been lost and was propped up by an acro prop.

The ceiling within the ground floor conservatory was being propped up by acro props and sloped approximately 100mm to the rear.

The single storey conservatory wing had partially been lost and propped up and was in a dangerous condition.

Reference should be made to the photographs, however this required to be demolished.

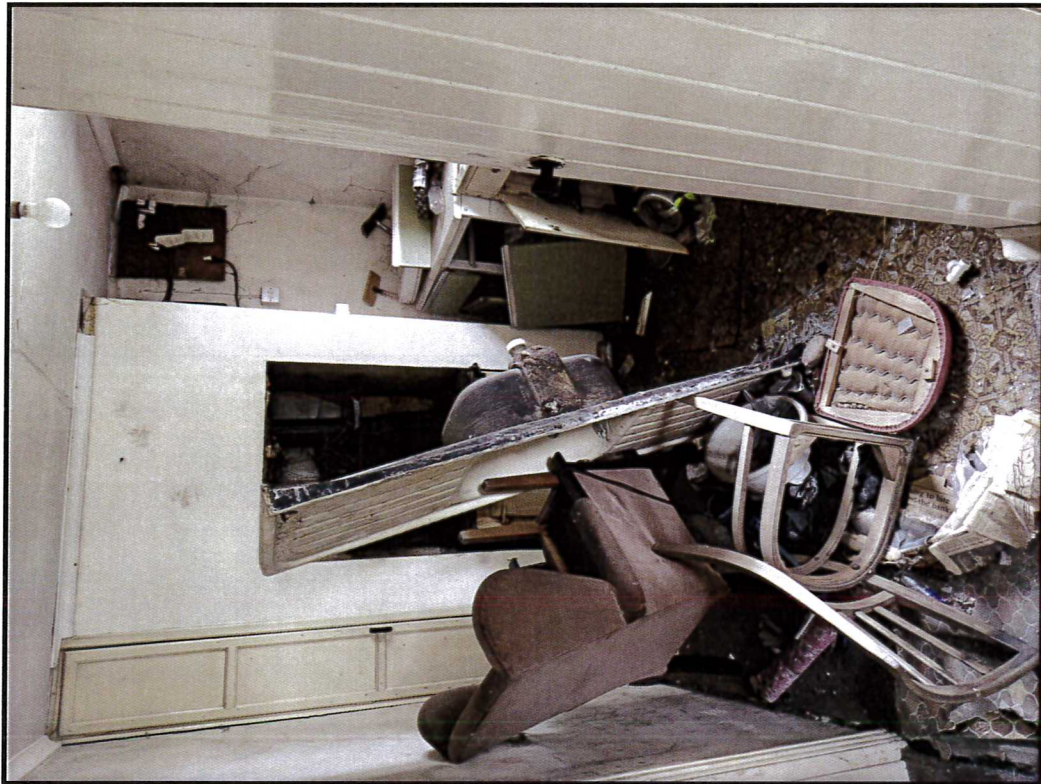
H8379_09

Within the single storey kitchen wing, there was debris over the floor, however it is expected that this is a minimal concrete slab.

On viewing this, this was very uneven underfoot and about doorways was cracked through.

9. View of the kitchen area showing debris and poor condition.
10. View of the dining room from the kitchen entrance door.
11. View of the lounge area from the entrance door.

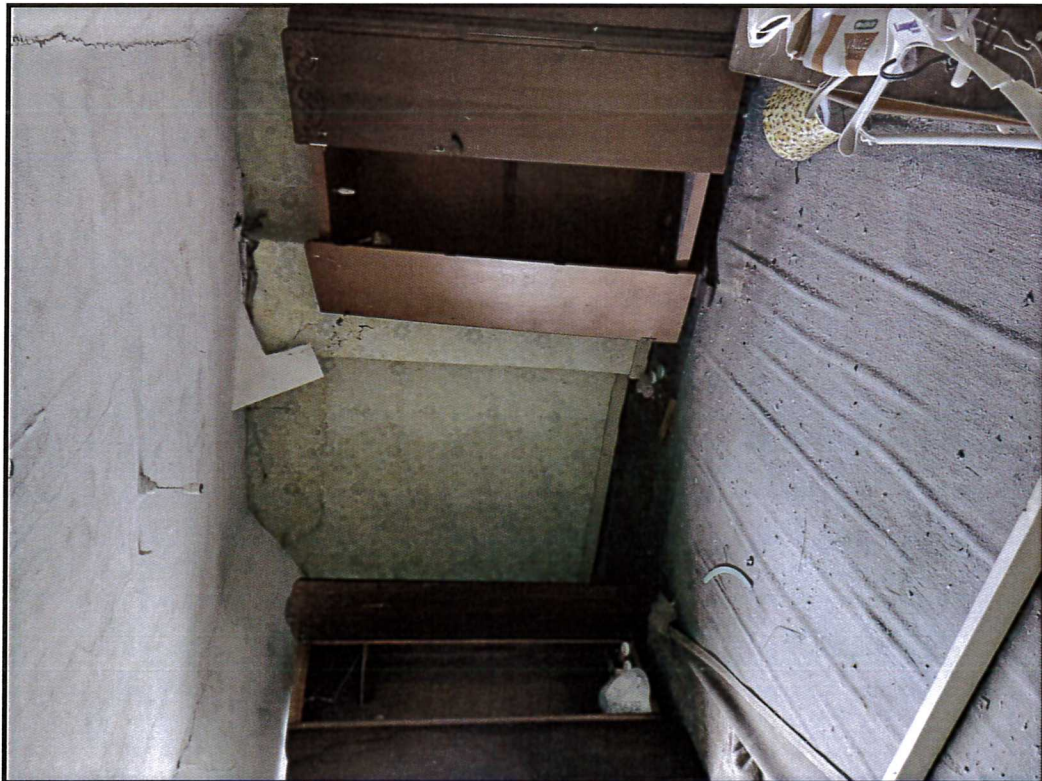
H8379_12

Within the left hand side bedroom, the floor had distorted where there was previously a banister.

12. View of the left hand side first floor bedroom, as viewed from the front.
13. Structural cracking through the rear wall finishes, as viewed from the staircase.

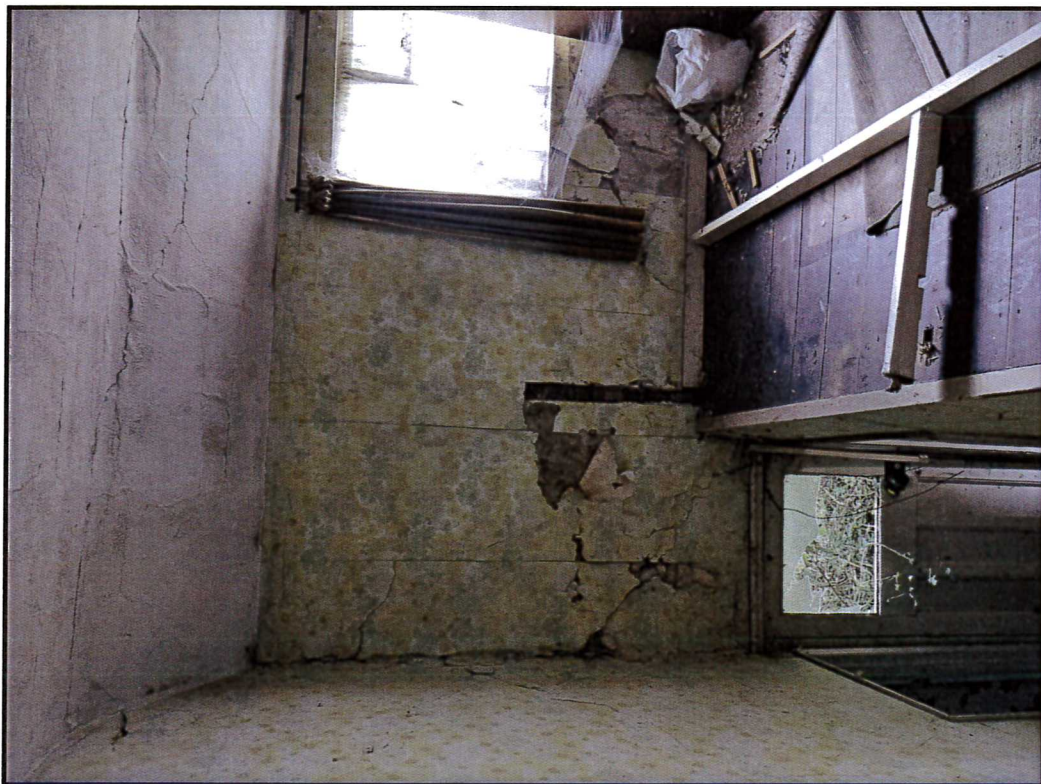
H8379_14

Partitions were structurally cracked through about door openings.

14. View of cracking through the front wall and internal partition as viewed from the landing area.
15. View of cracking through ceiling finishes at eaves level.

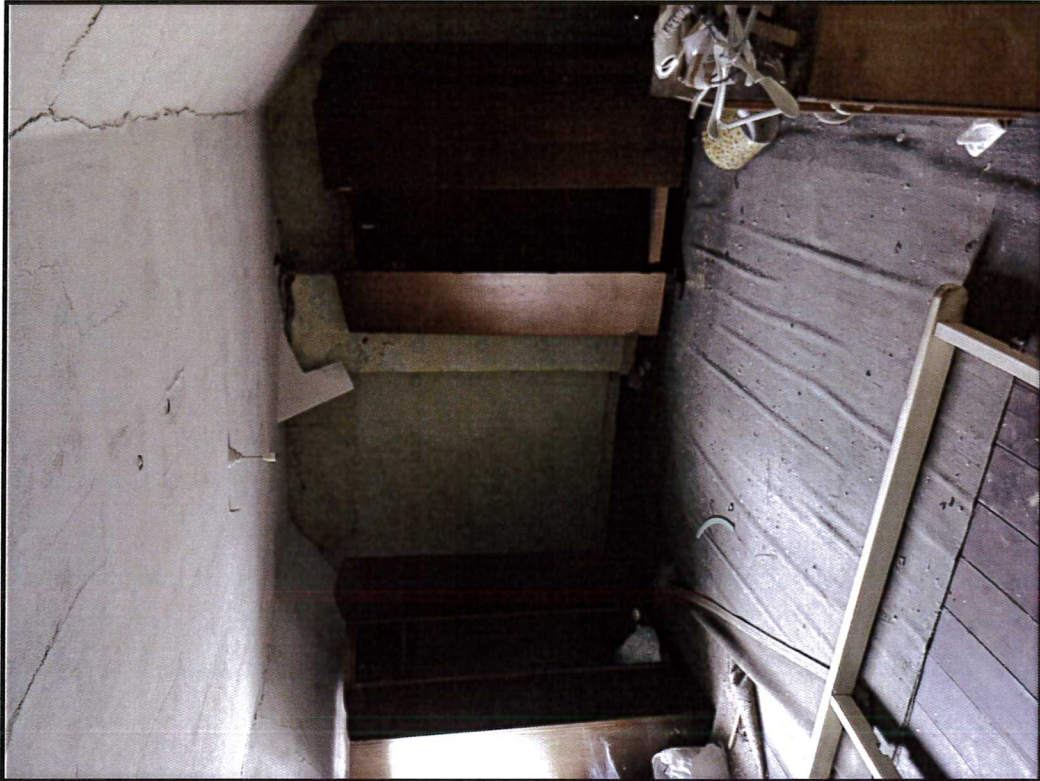
H8379_15

Ceilings were cracked through and were generally in a poor condition.

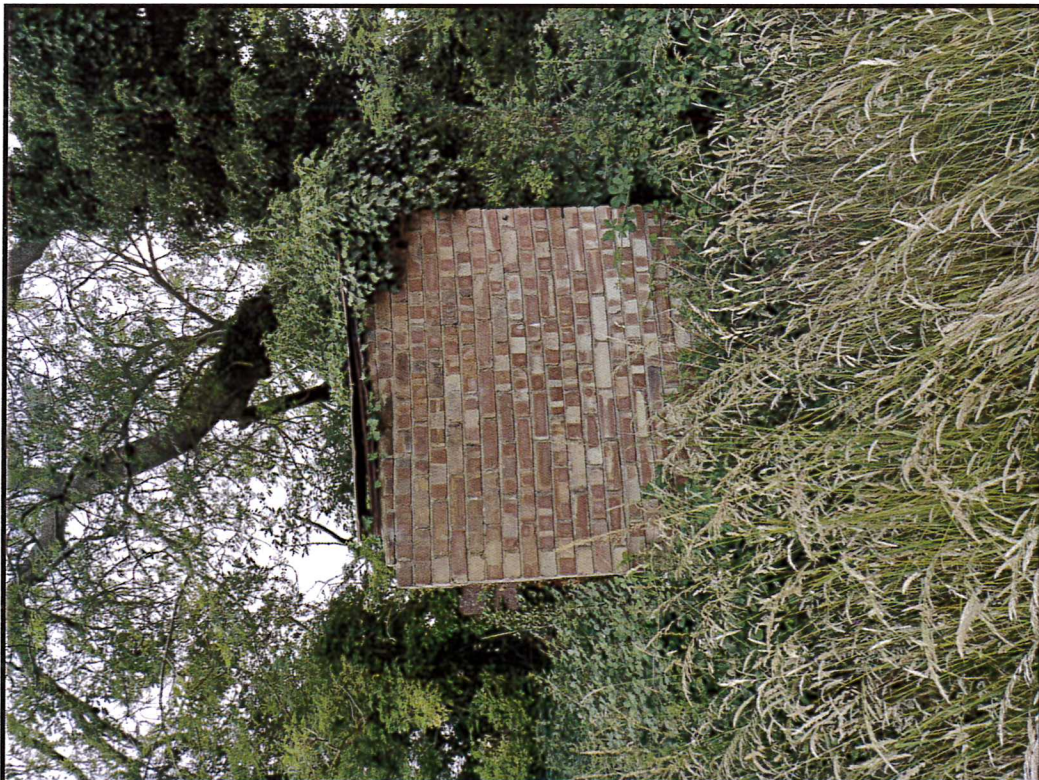
H8379_16

Where there was a brick outbuilding beyond the rear elevation of the property, it was expected that there would be a toilet within this building, however this was overgrown at the time of the site visit.

16. View of the outbuilding with assumed toilet internally.
