Arboricultural Decay detection report

For trees at
**Go Ape Rivington,
Rivington Lane,
Horwich, Bolton,
BL6 7SB**

Report issued; 04/07/2022

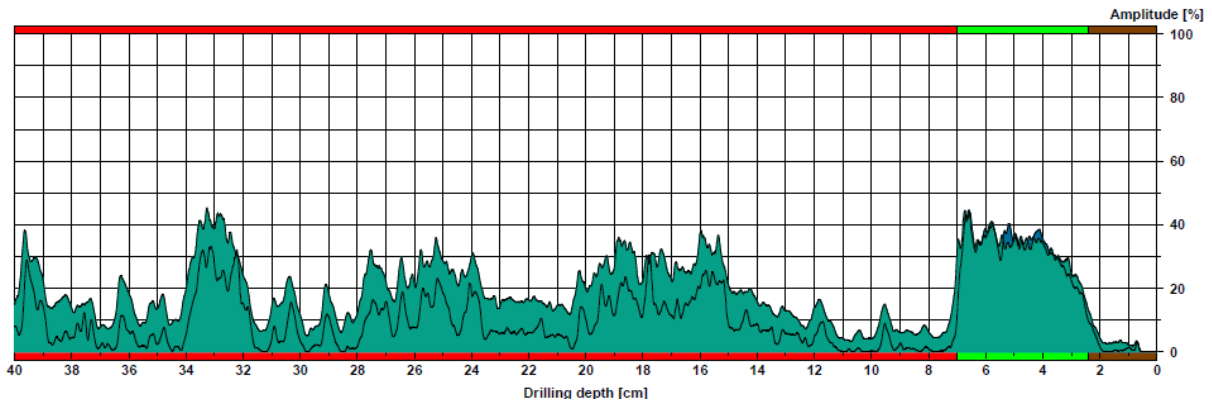
3.1.5 The total area of decay is estimated between 50 – 60%. Due to it's location off centre towards the south side and decayed buttress roots it's significance is greater compared with central decay.

Resi drill result from south buttress root

- 4.0.1 T428 has a large area of advanced decay off centre around the south side of the trunk. Ganoderma and Honey fungus are present. The risk of whole tree failure is high. It is recommended that the course is removed from this tree and the tree felled within the next 3 months of the date of this report.

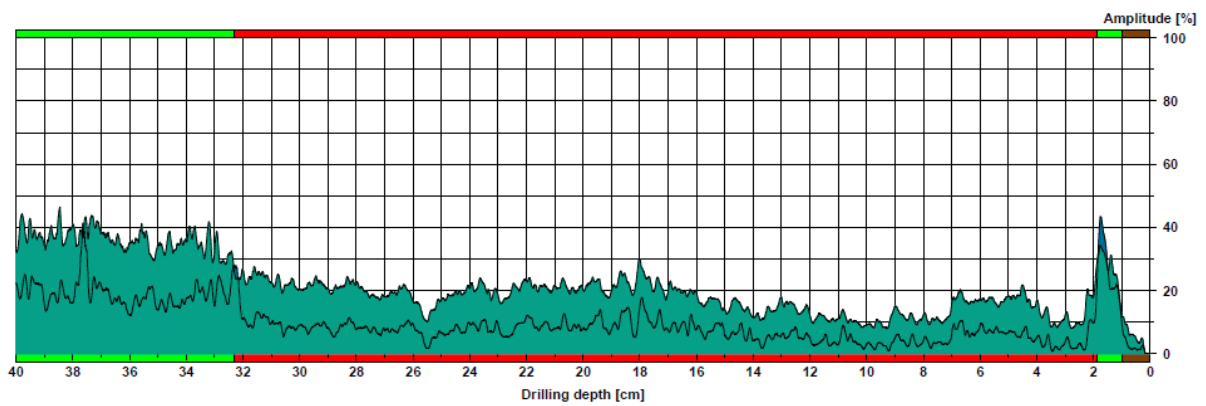
Resi drill result from South east side

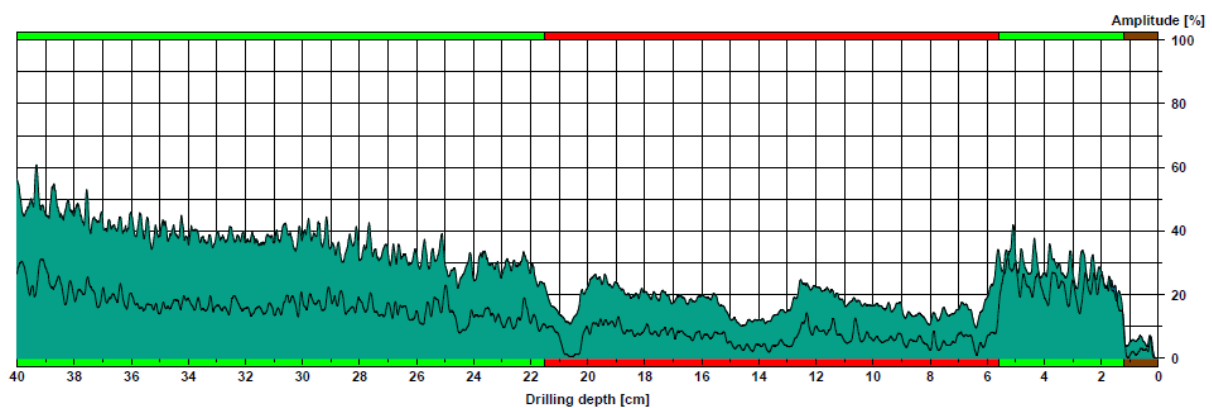
Resi drill result from North east side
