Class Q Barn Survey and Structural Assessment

Barn adjacent to College Farm House,
College Road, Wyverstone, Suffolk IP14 4SD

David Black & Son Ltd.

July 2022

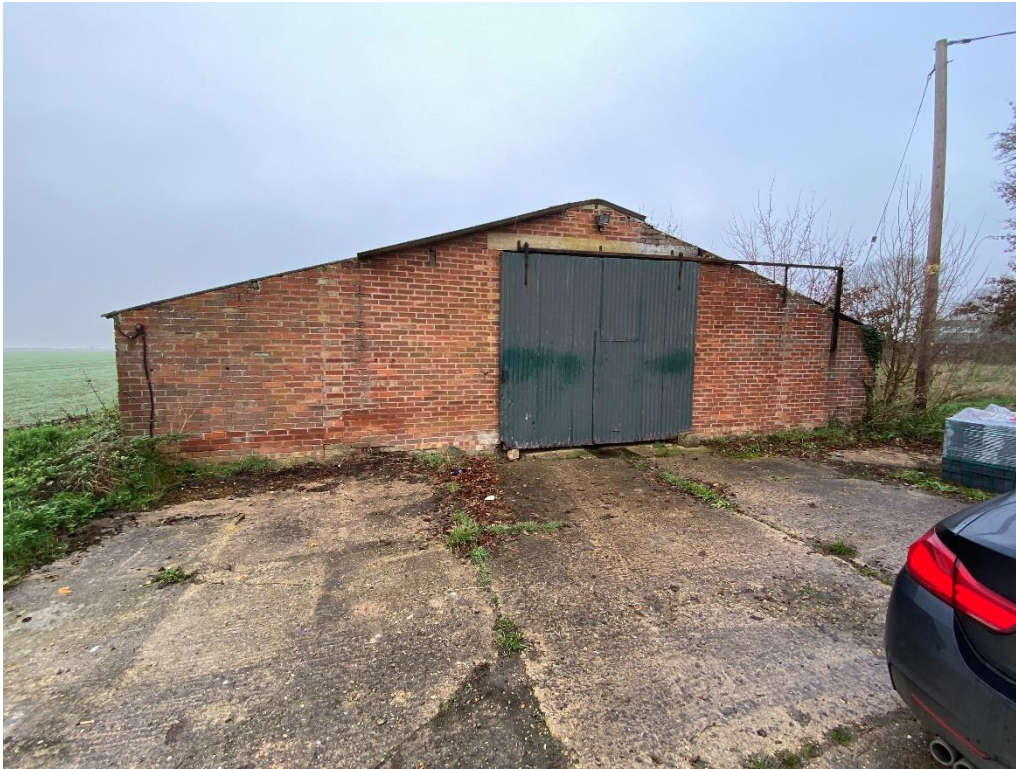
1. Front external view

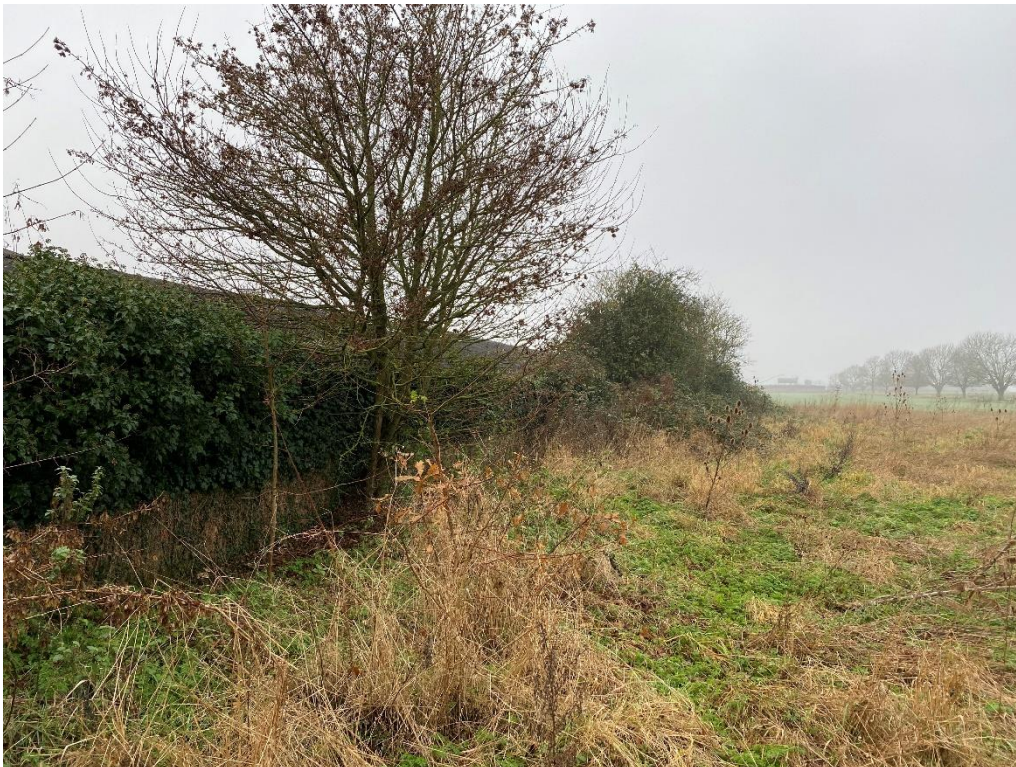
- 4.4 The brickwork flank walls are largely in a satisfactory condition and, where accessible, appear plumb and well aligned. It is noted that much of the right flank wall is covered externally with heavy vegetation growth whilst there is also slight vegetation covering some of the left flank wall.

2. Right hand external view from front corner

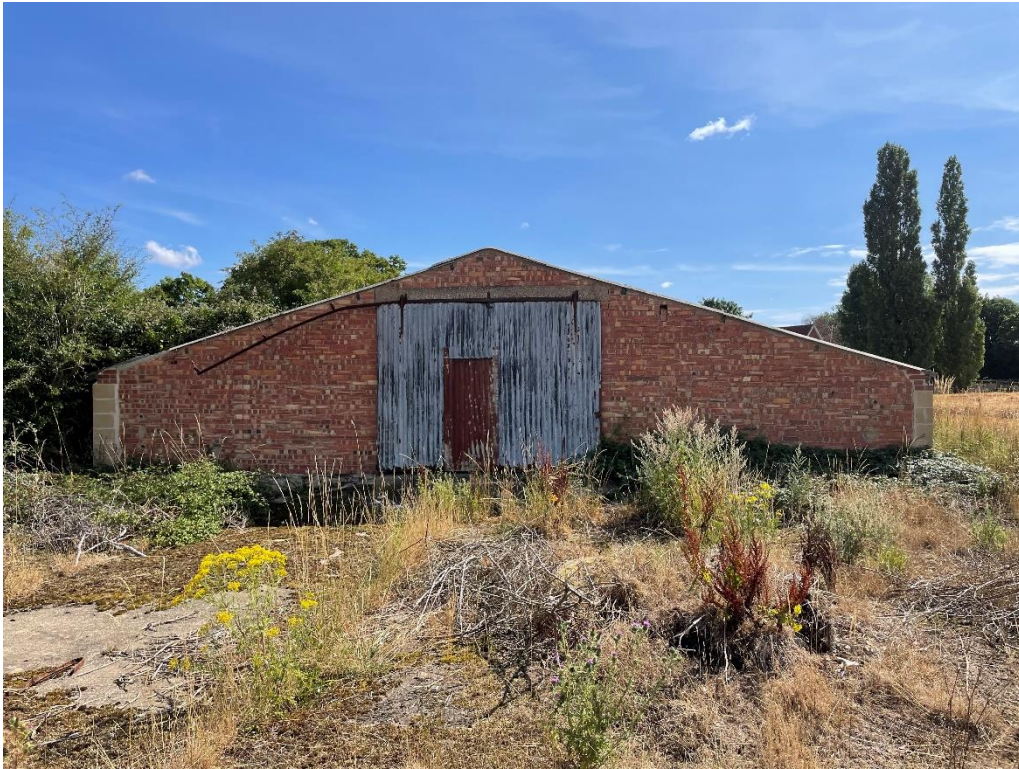
- 4.7 The brickwork gable walls are also in a satisfactory condition generally. To the rear, a narrow strip has also been rebuilt in concrete blockwork adjoining the right-hand corner, the reason for which is not clear, although there is evidence of very slight lateral distortion in the flank wall brickwork locally, which suggests the corner may have been subject to past slight separation.

3. Rear external view

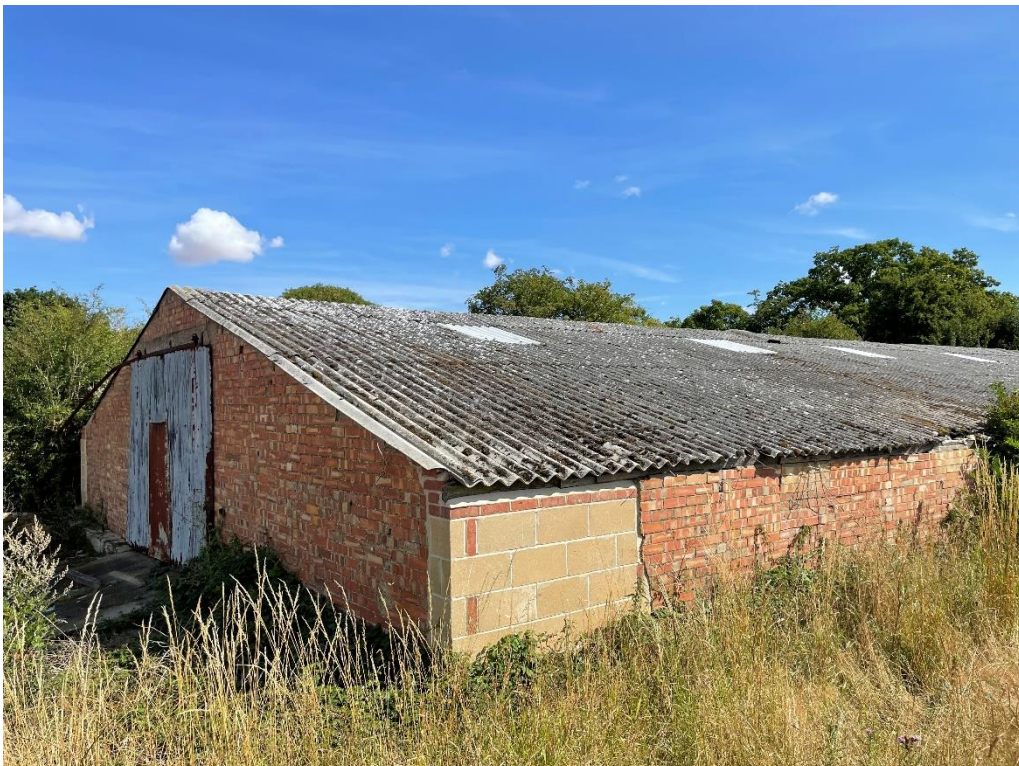
- 4.6 To the rear of the left flank wall, an area of the original brickwork, equivalent in length to approximately two thirds of the final bay, has been rebuilt in concrete blockwork. The reason for this work is not clear but there is little to suggest evidence of past foundation related movement.

4. Left hand external view from rear corner

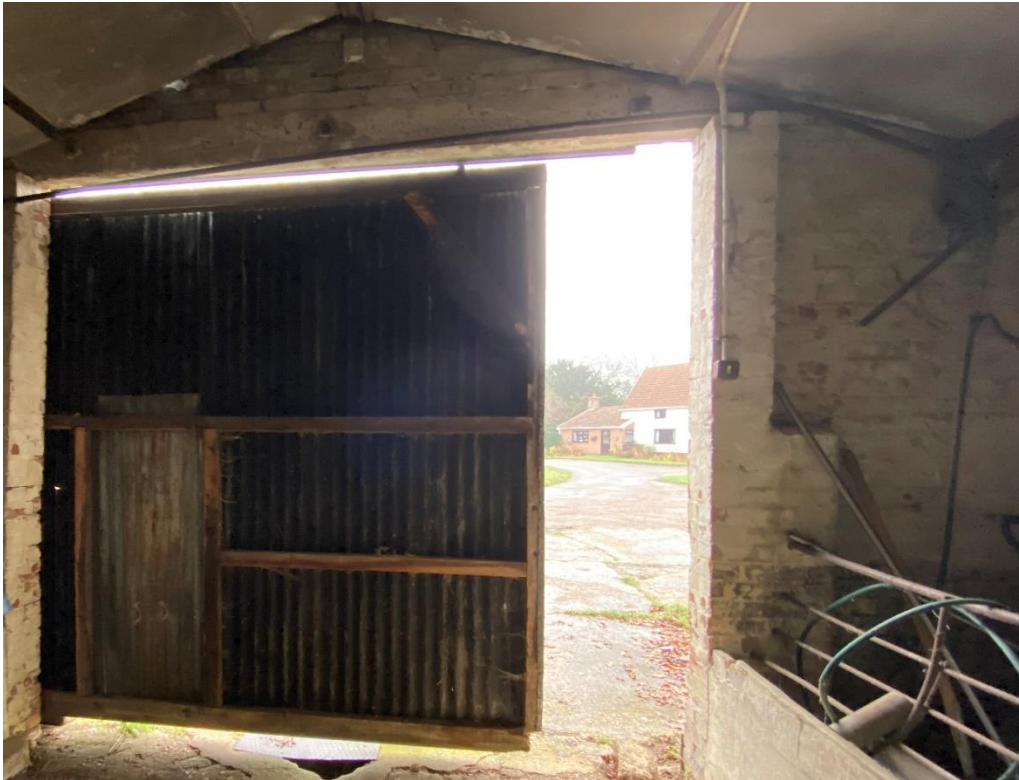
5. Front internal view

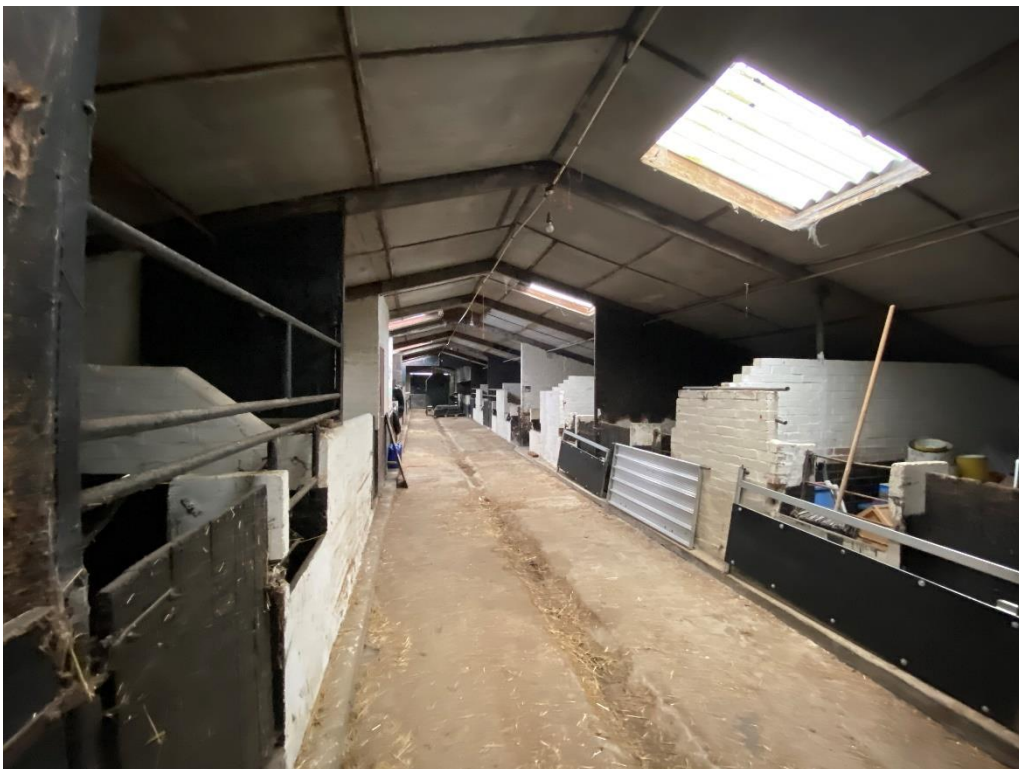
6. Internal view looking towards rear

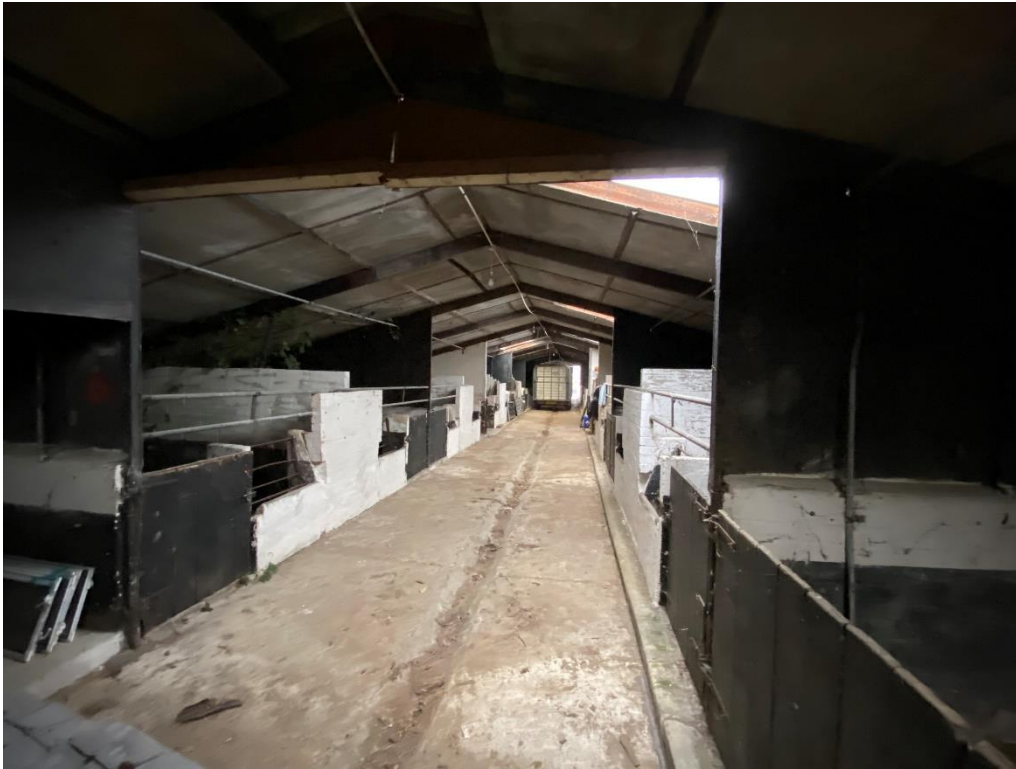
7. Internal view looking towards front

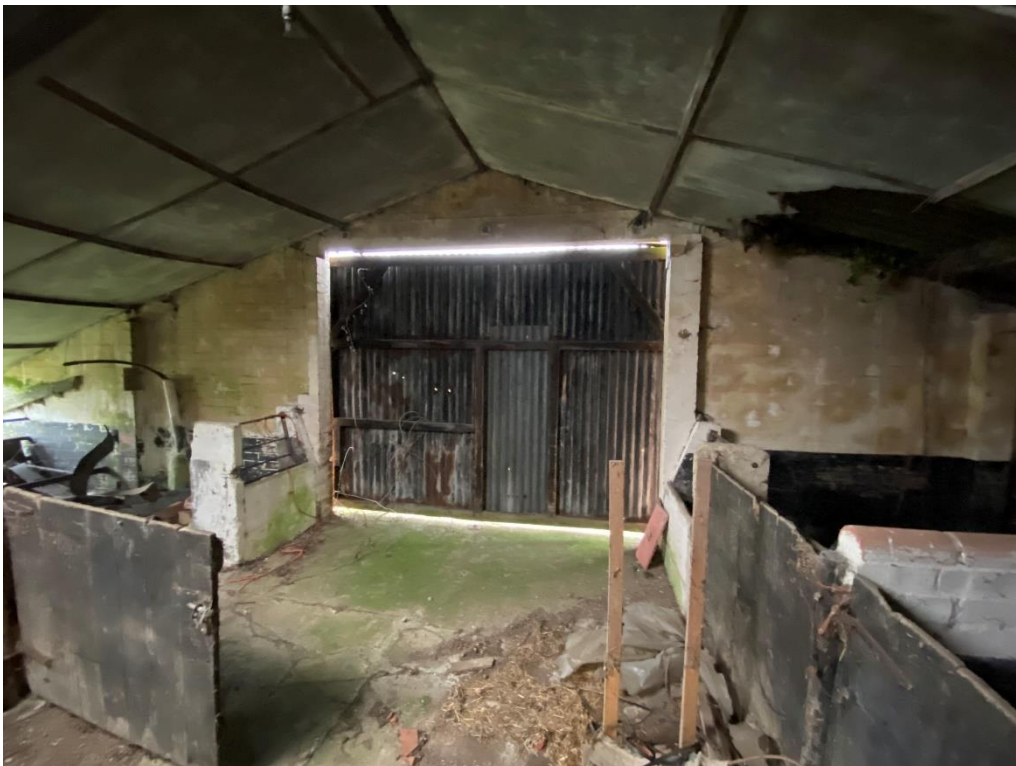
8. Rear internal view

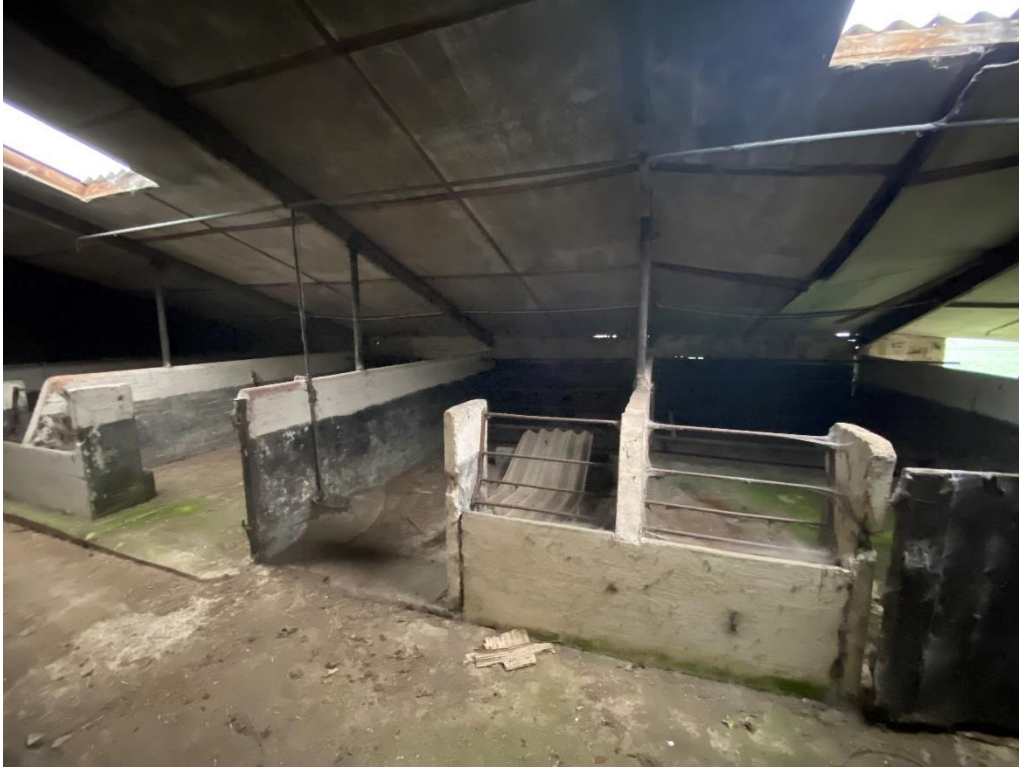
- 4.12 Much of the above damage is present in the dividing partition walls forming the former animal stalls. These will largely become redundant and therefore be removed as part of the proposed residential conversion and therefore the damage noted is inconsequential.

9. Typical stall arrangement

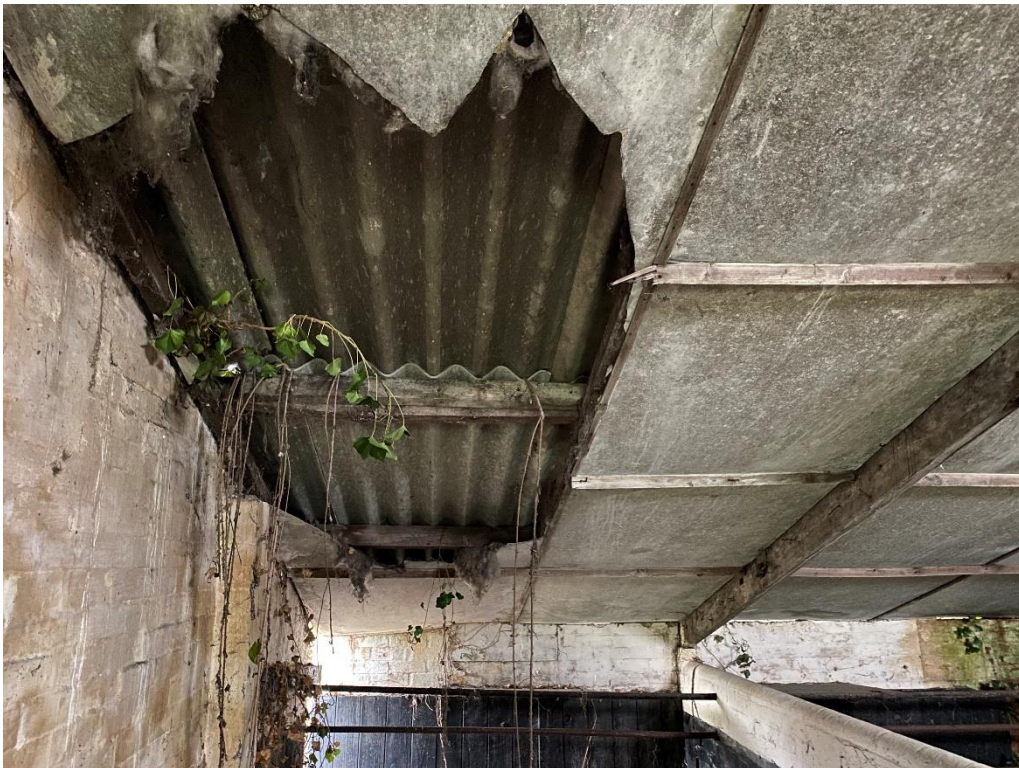
- 4.11 Internally, the roof liner sheeting remains in a satisfactory condition generally, albeit with some localised impact and other damage. Superficial scarring and minor damage is also evident to the internal faces of the brickwork walls from past operational impacts.

10. Roof construction viewed through damaged liner panel
