WILLOW CORNER COTTAGE
REF: PP-11059575

Annex to Design, Access and Heritage Statement

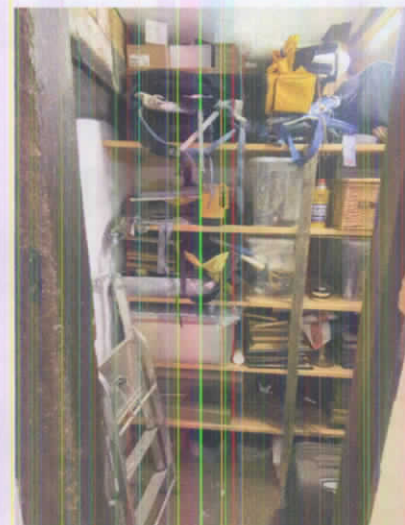
Photo 11: section of shelving to be removed

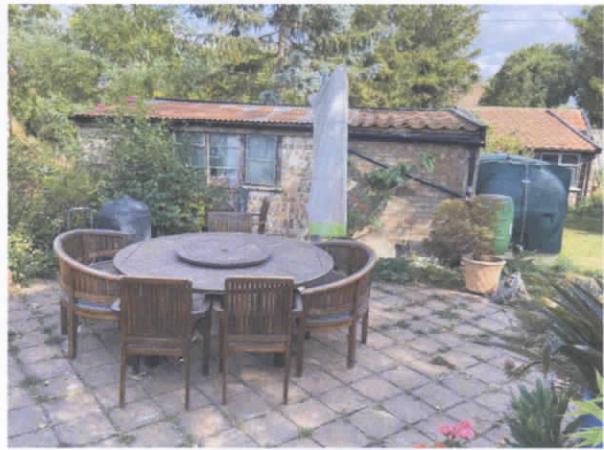
Photo 15: shed, W side, roof pantiled on S part and corrugated on N part

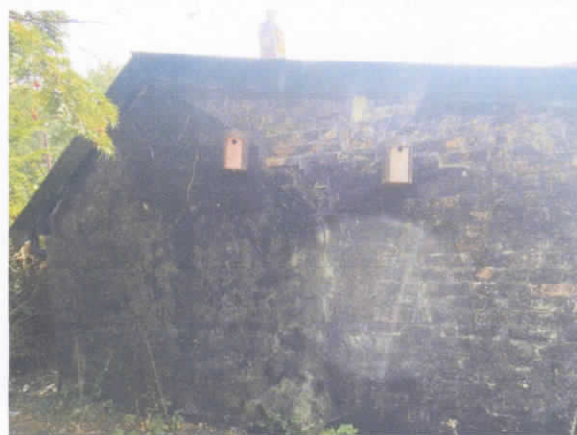
Photo 19: garage, N side, clay lump in E part (below gable) and brick in W part

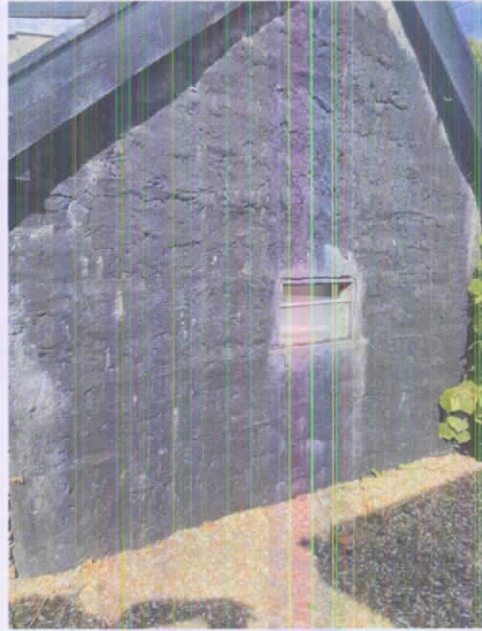
Photo 21: garage, glazing missing on S side

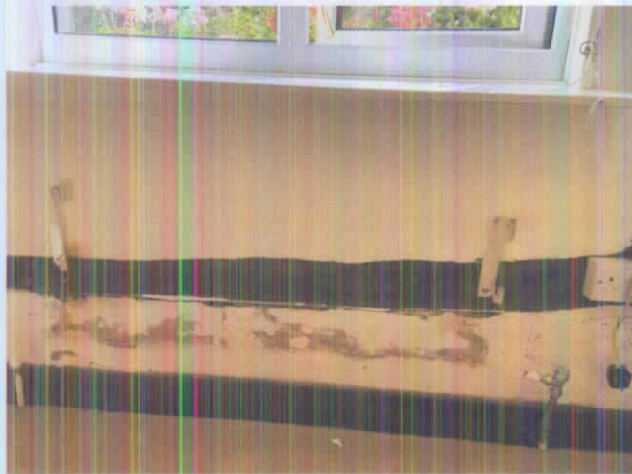
Photo 22: study, damp below sole plate on S side

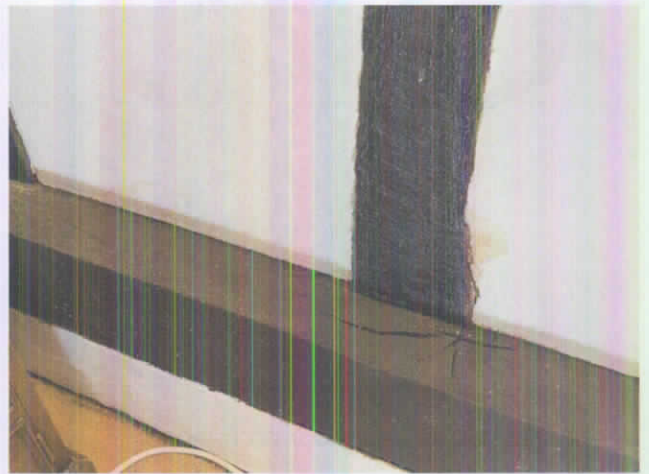
Photo 23: study, damp above sole plate on E side

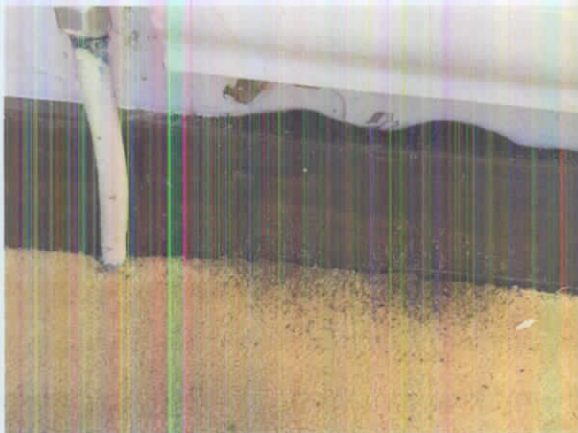
Photo 24: study, frass on S side

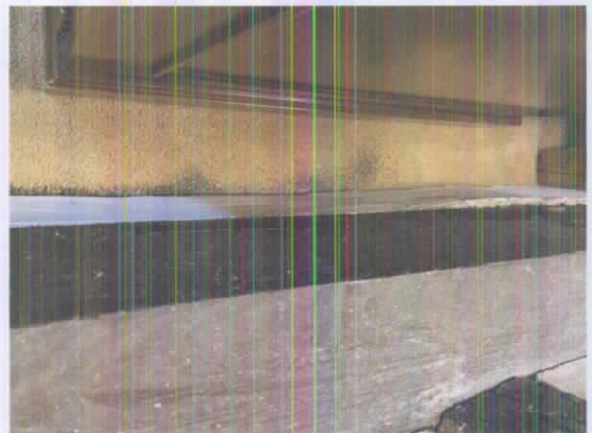
Photo 25: study, frass on E side

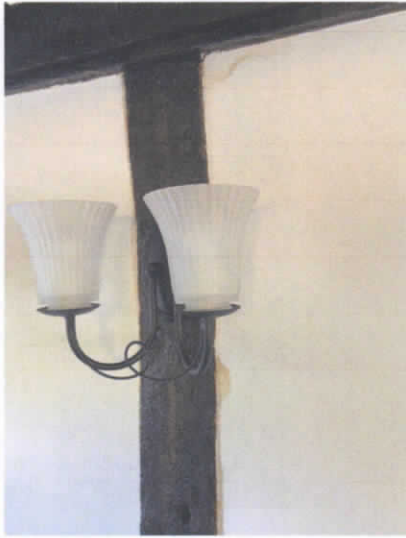
Photo 26: study, damp on E wall

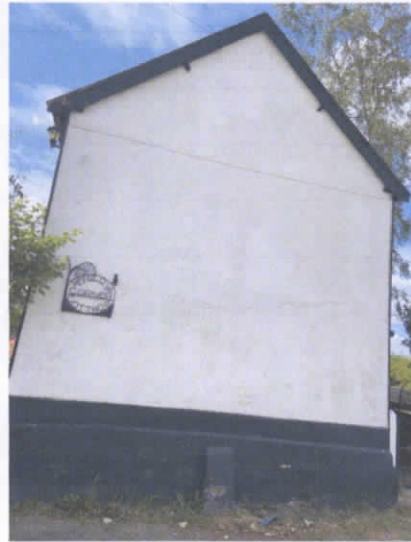
Photo 27: E elevation, cracked render

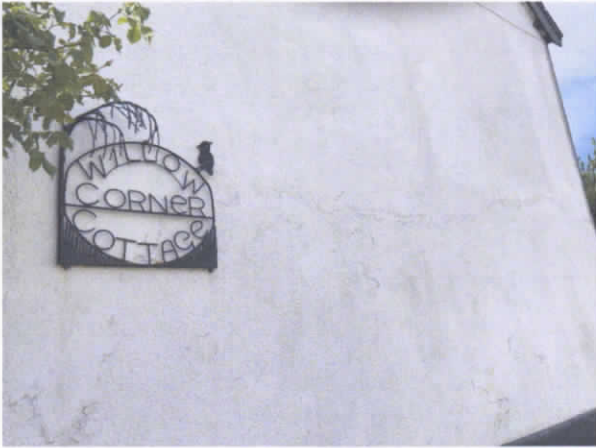
Photo 28: E elevation, cracked render

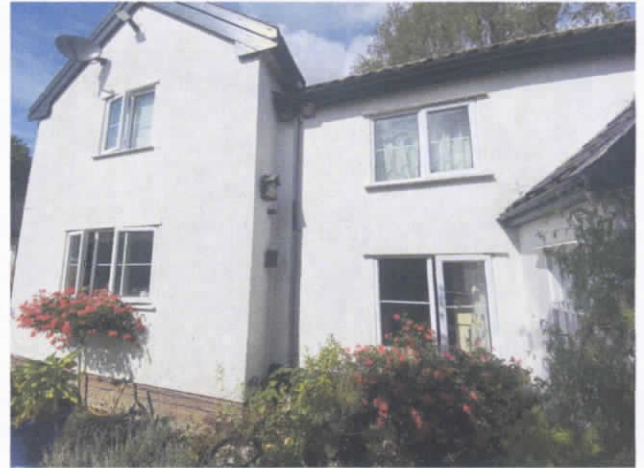
Photo 29: S elevation cracked render (gable is 20C, E of gable is 16C, 20C porch just seen on R)

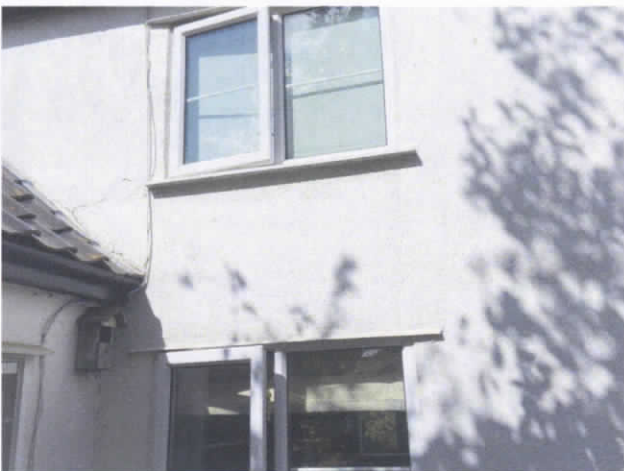
Photo 30: S elevation, cracked render

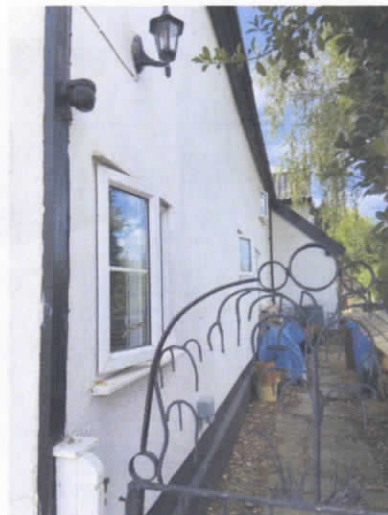
Photo 31: N elevation, bitumened 16C brick plinth

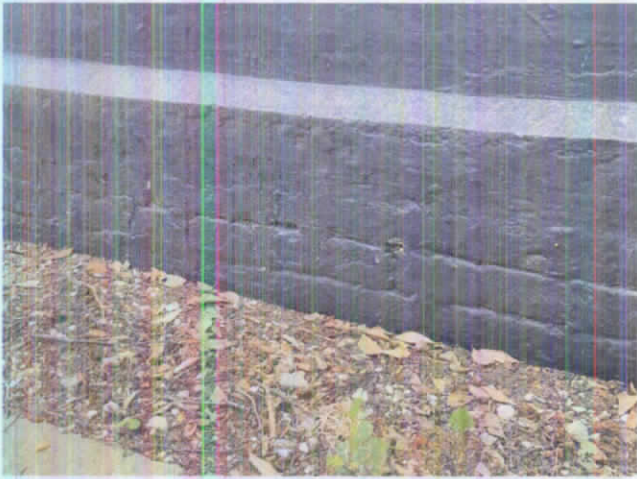
Photo 32: N elevation, bitumened 16C brick plinth

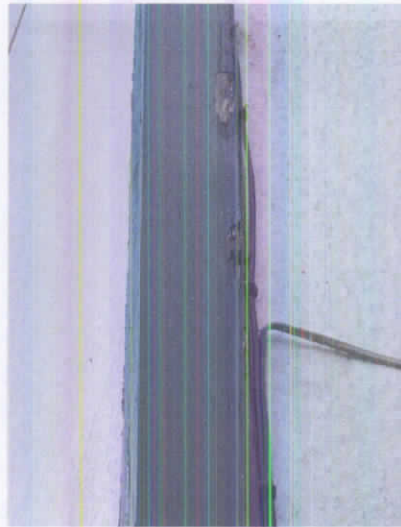
Photo 33: NE corner, rotten timber

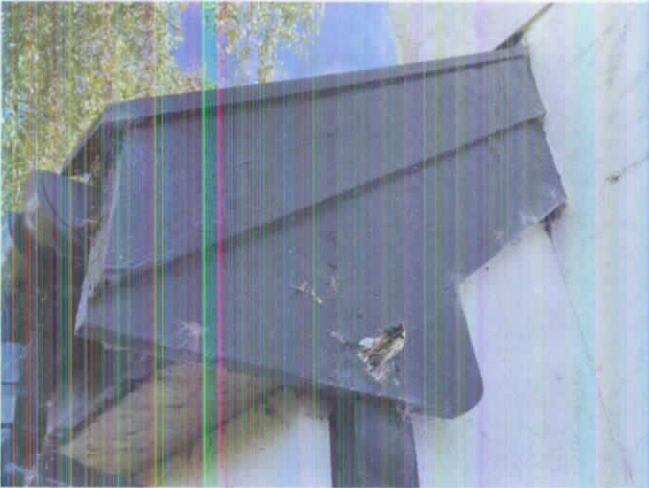
Photo 34: NW corner of shower room, rotten timber

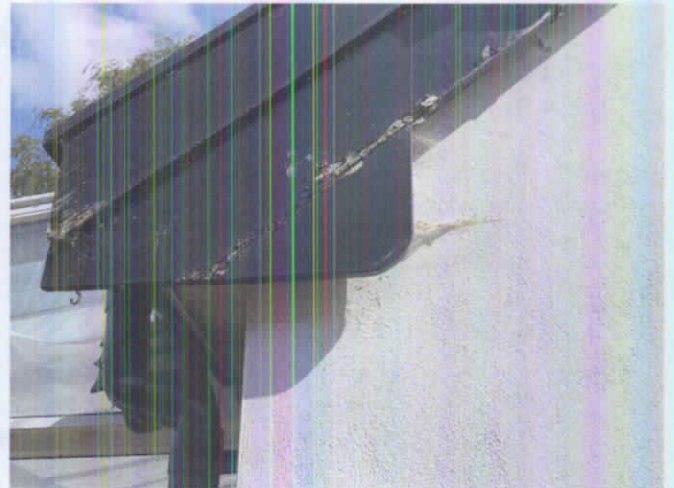
Photo 35: NW corner of garden room, rotten timber

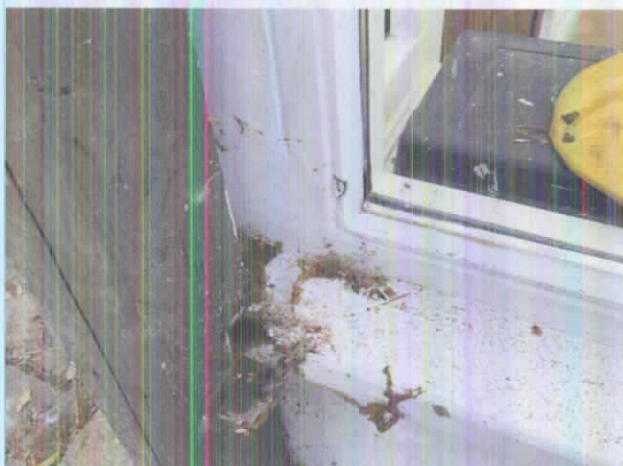
Photo 36: N side of conservatory, rotten timber

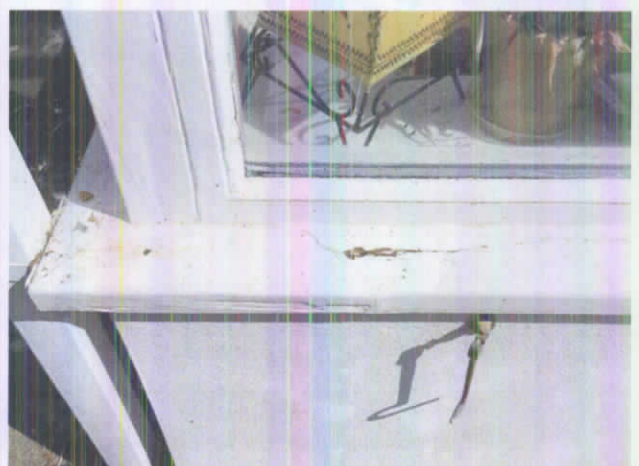
Photo 37: W side of conservatory, rotten timber
