Agricultural Building at High Pole Farm

Structural Inspection Report

May 2022

P3679-2

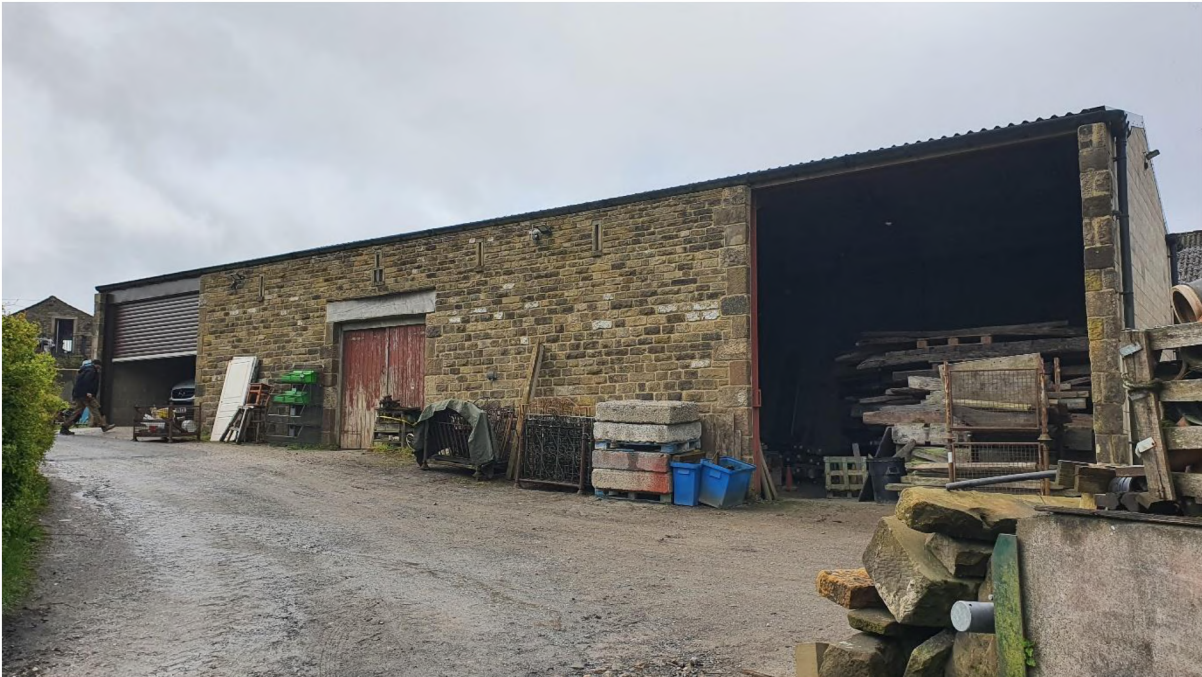
The building is a modern steel portal frame structure with full height masonry walls to all sides (Photograph 1). Stability is provided by tubular steel bracing in the roof to restrain the gables (Photograph 2). No longitudinal wall bracing could be seen, and it is possible that if any is present it will be in the wall cavity. Alternatively, longitudinal stability may be provided by the blockwork inner leaf which is built into the side of the columns.

Photograph 1. General view of north east elevation

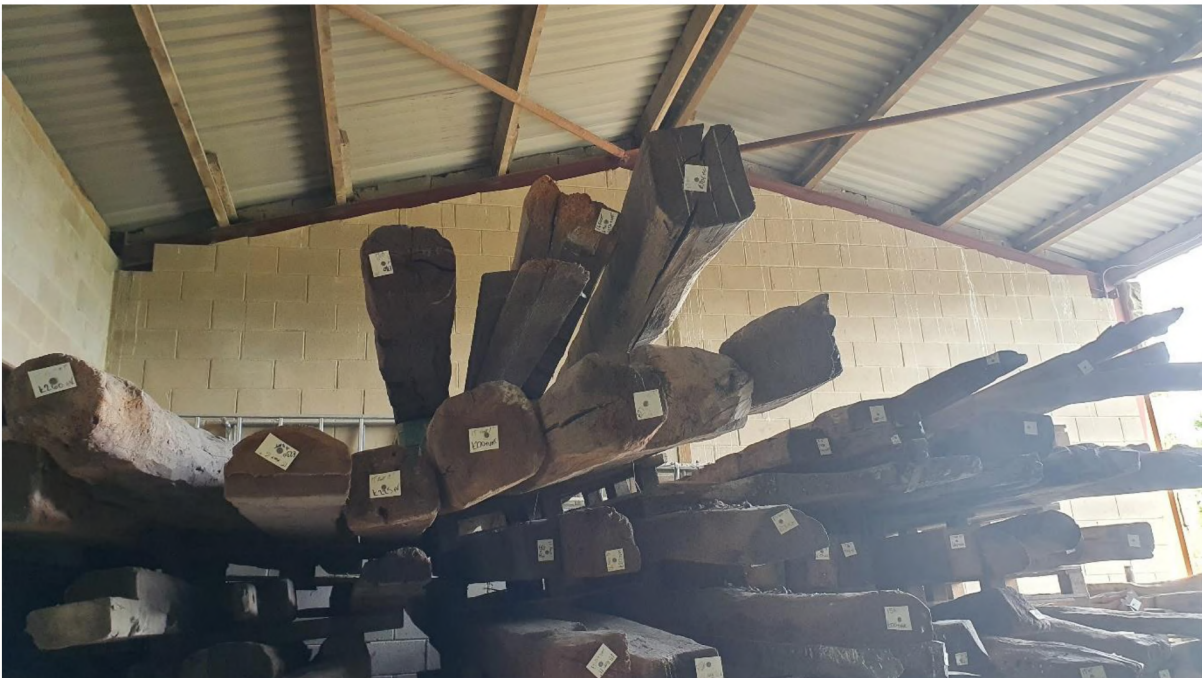
Photograph 2. Roof bracing

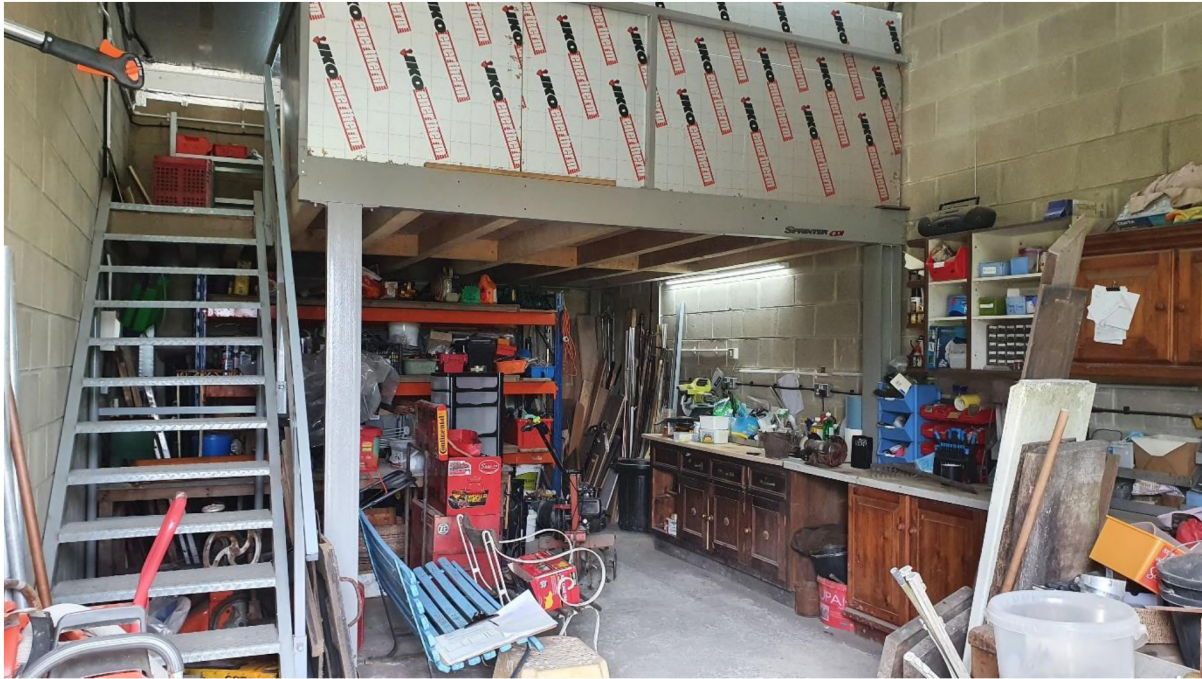
The central cell has a small mezzanine floor which is independent of the main structure (Photograph 3).

Photograph 3. Central cell mezzanine floor

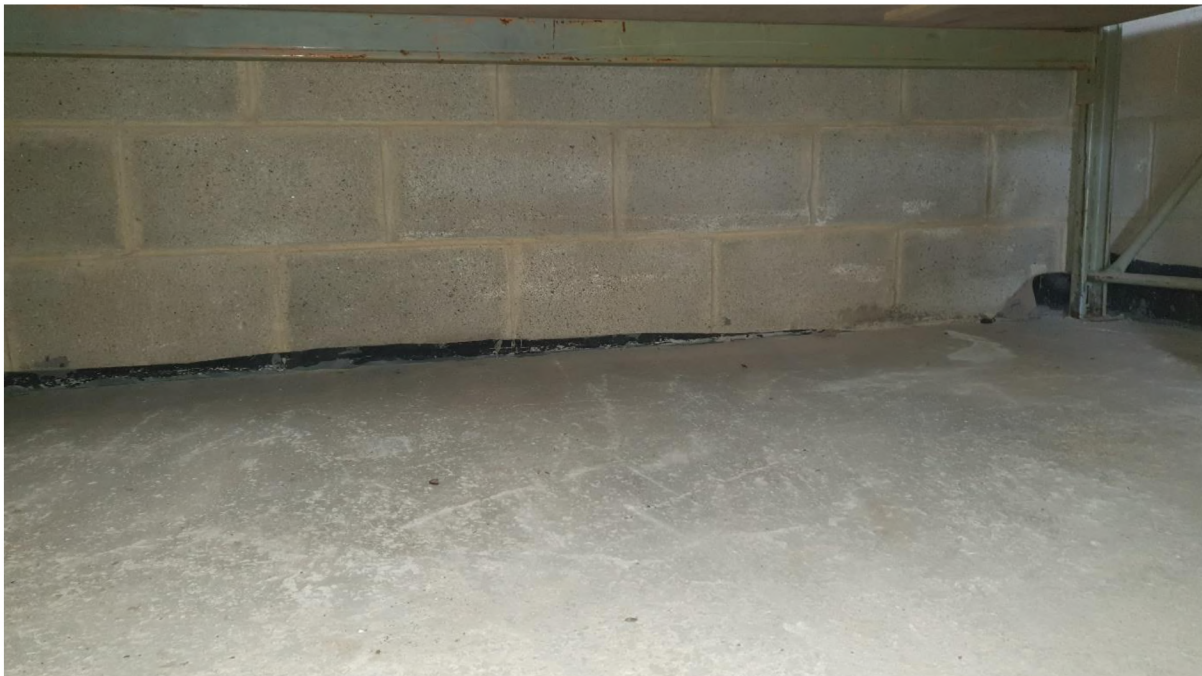
A damp proof course is visible in both the walls and the slab (Photograph 4).

Photograph 4. Slab damp proof membrane
