**Historical Analysis of
The North Barn
at
Bridgefield Farm, Cowlinge, Suffolk**

for
**Mr C Linford
Bridgefield Farm
Cowlinge
Suffolk CB8 9QA**

March 2010

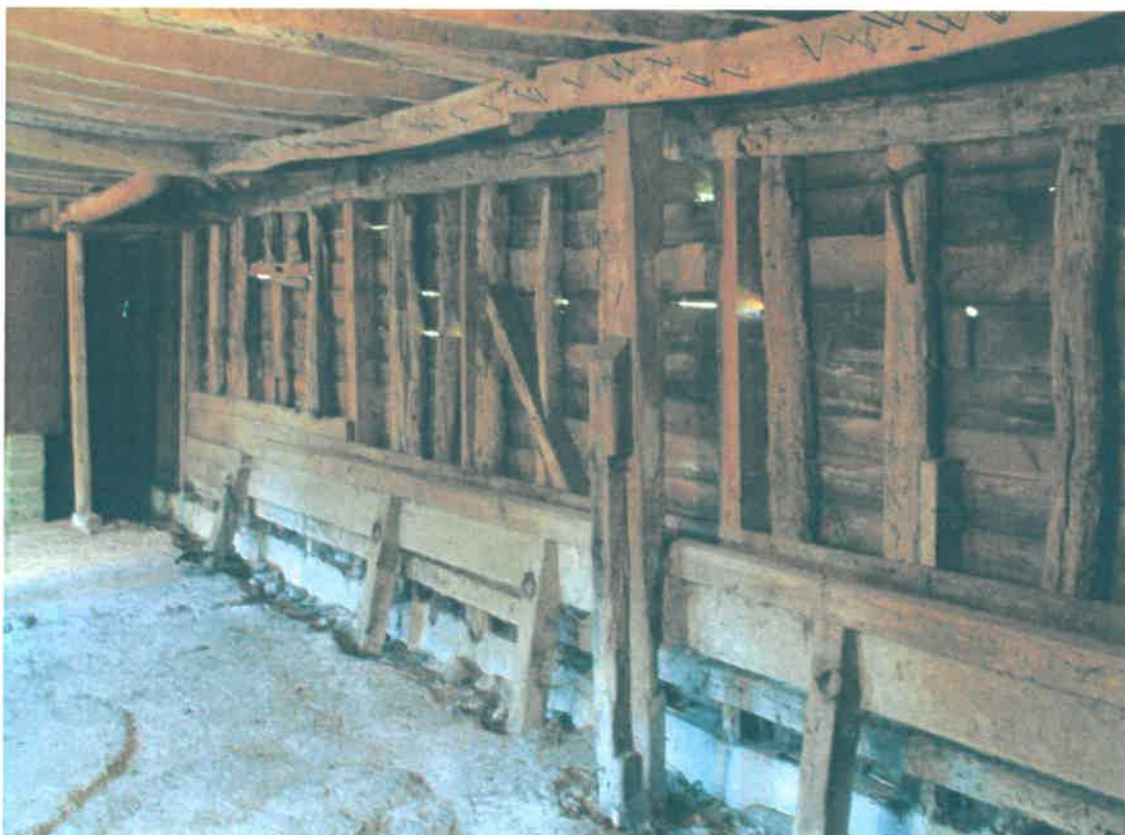
Part of the rear wall showing the original framing and inserted floor

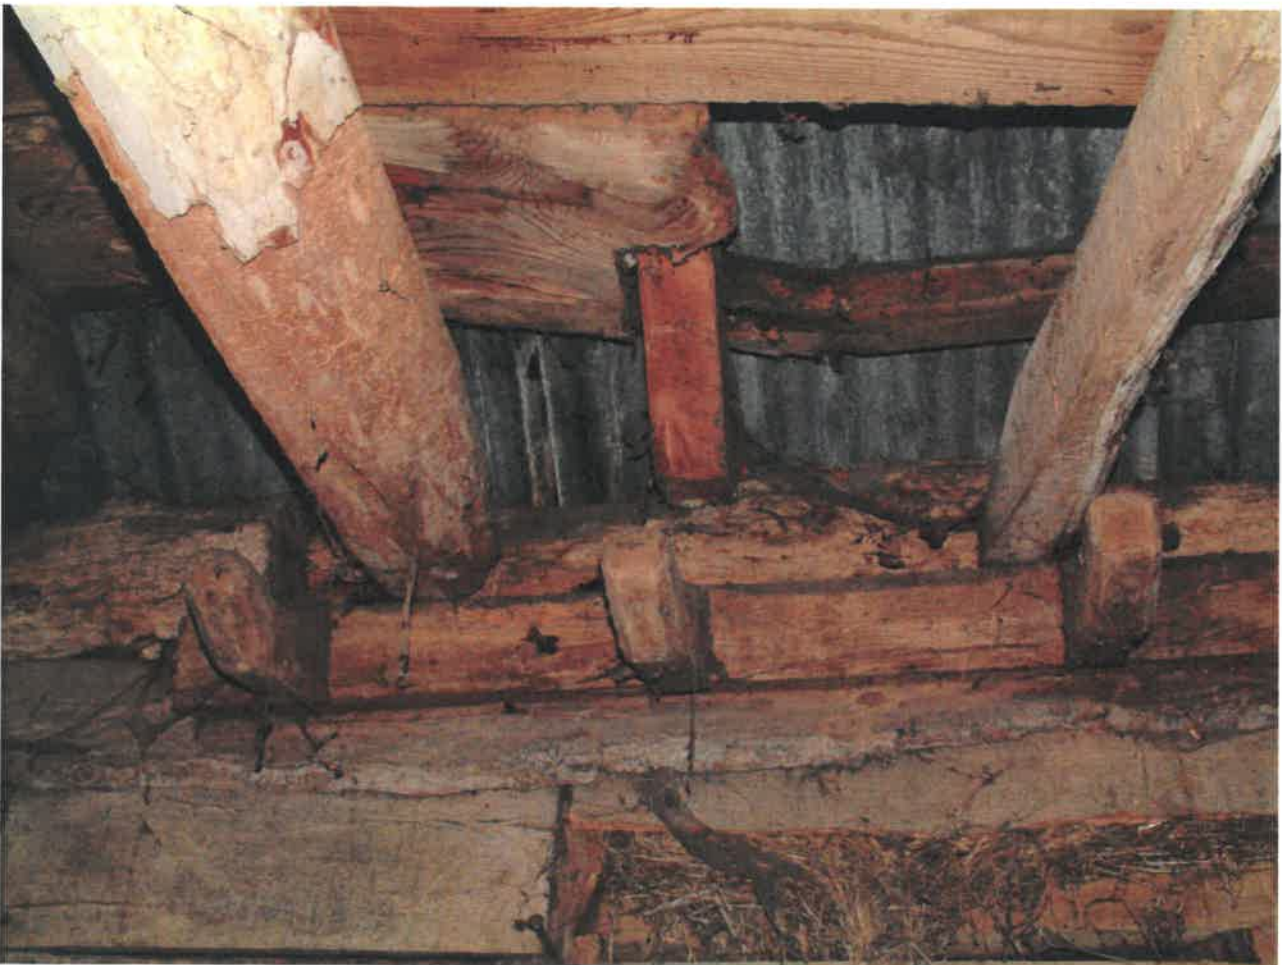
The only noteworthy feature is the pair of long boards holding crudely carved hooks along the eastern [front] wall. These are heavy enough to have taken such large equipment as horse collars, though they are perhaps too close together for that purpose. They appear to be original, because the joists of the later inserted floor make some of them unusable. However, there are tethering rings along the back wall [see above photo], which coupled with the central drain in the original brick floor could suggest that this was initially used as a milking parlour or a calving shed.

Some of the original timber hooks along the front wall, which have been compromised by the inserted floor

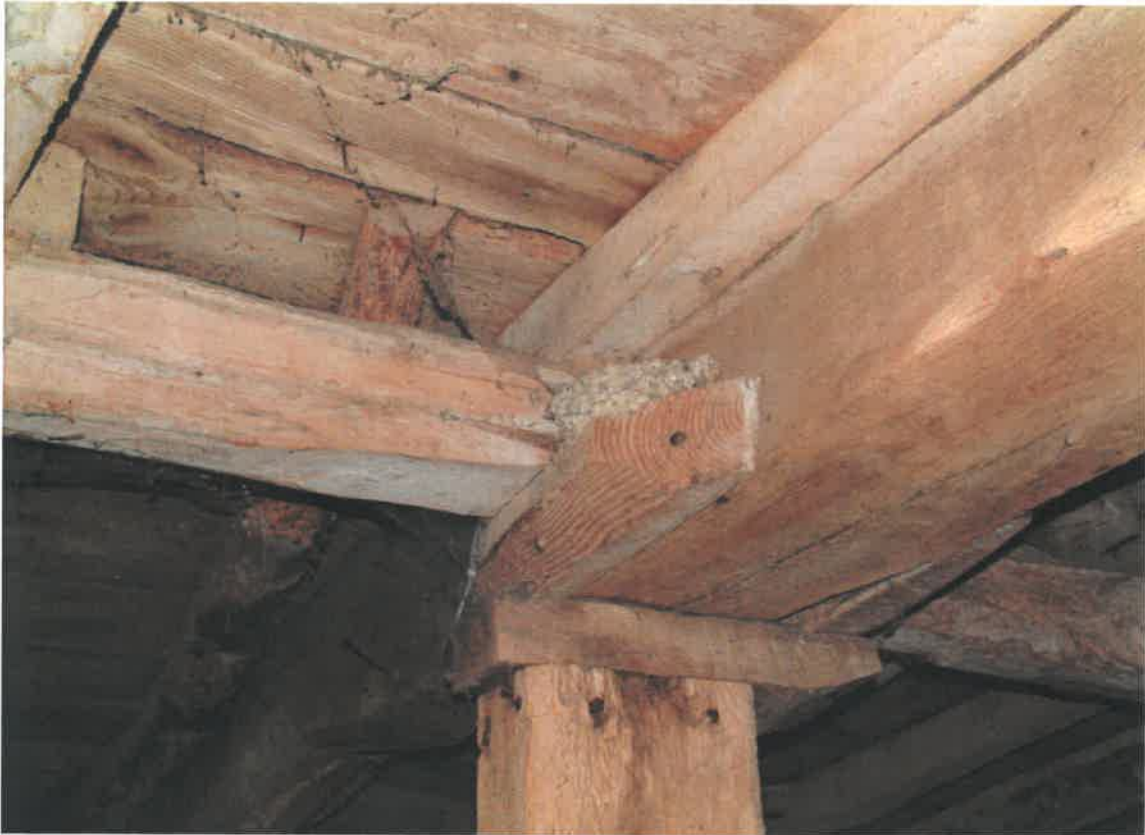
Later in the 19th century, an upper floor was added. This is supported by central Samson Posts and makes ample use of second-hand timbers, some of which may be 16th or 17th century in date. The construction is very crude, involving many packing pieces of various timber species. All the connections are nailed together; there is no longer any attempt at carpentry jointing.

One of the oak Samson posts supporting the inserted floor made of various second-hand timbers

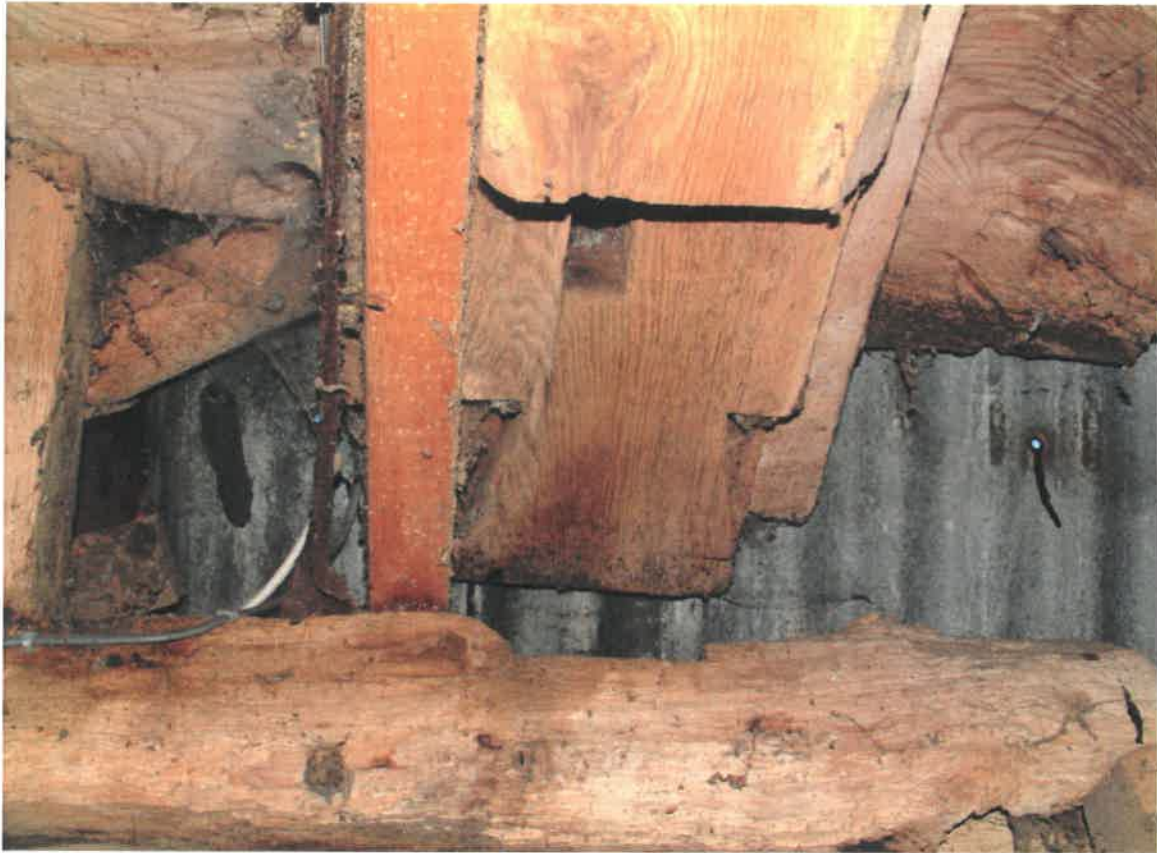
The spine beam of the inserted floor was never intended to connect to the frame, because it stops just short of the southern end wall. Where the re-used cross-beams met the wall-plate they were dovetailed together, but the original frame has subsequently twisted and dropped, leaving the beam ends suspended some distance above. This means that the upper floor is now supported by the Samson Posts and the more slender posts along the back wall. It is not connected properly to the main frame. Additionally, some of the floorboards have warped away from their supporting joists.

Detached dovetail from the inserted floor. Empty mortise for a tenon from its former use

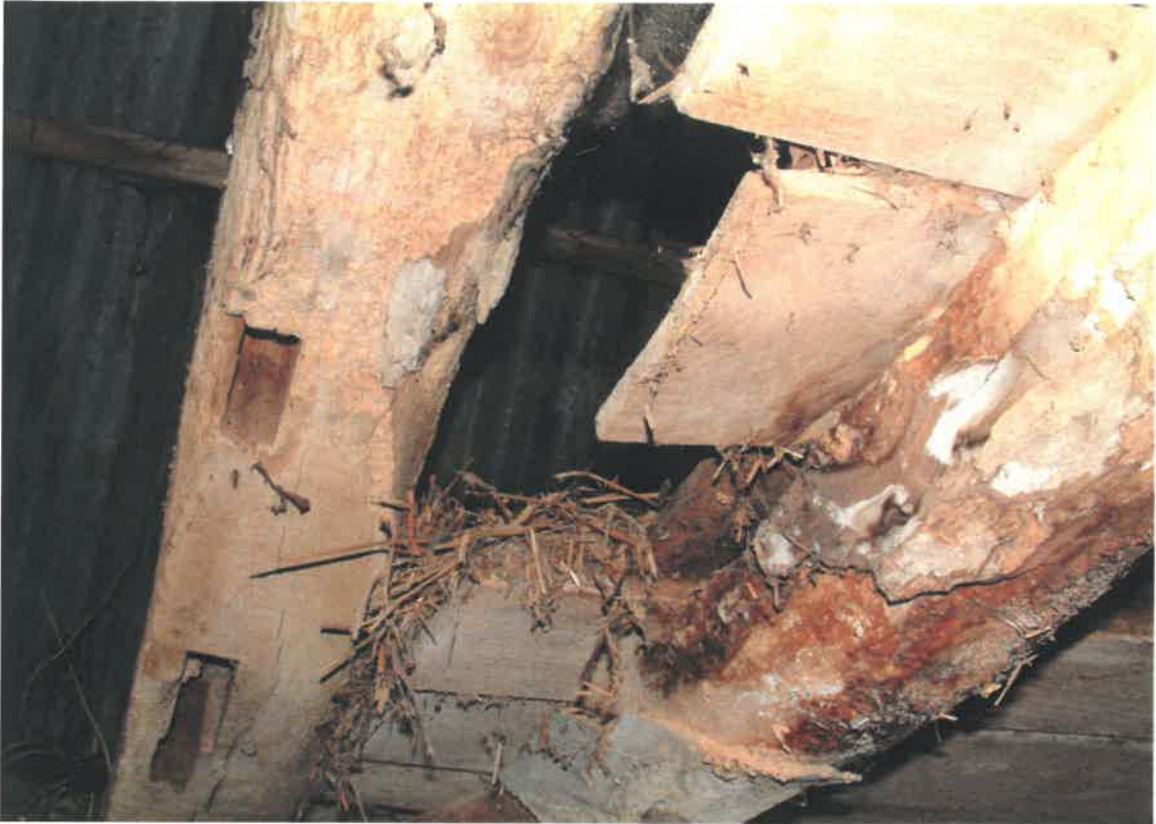
The quality and welfare of the timbers vary considerably. The best is the oak beam supporting the floor towards its southern end [see above], but many have been seriously damaged by worm attack, so that their structural ability is in major doubt [see photo overleaf]. This is widely noticeable amongst the floor joists, which are made of poplar or aspen. Both species are particularly vulnerable to insect attack and were never used in good quality carpentry.

The boards of the inserted floor have been repaired on more than one occasion and now consist of a varied collection of oak, elm and softwoods. Even so, many are badly decayed with worm and some have large holes in them. Currently, it would be unwise to attempt to walk on them.

Decayed re-used timbers at the northern end of the inserted floor

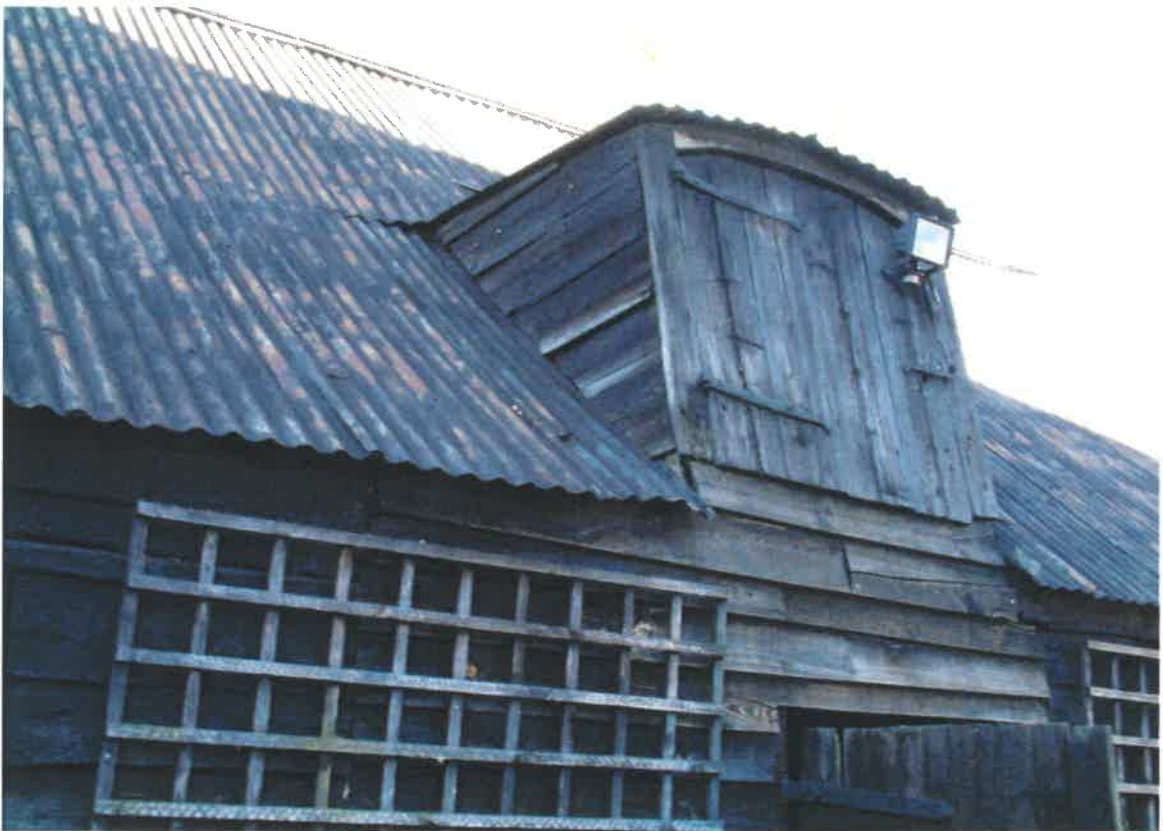
The hayloft has sunk backwards into the roof so that it would be very difficult now to open the door [see overleaf]. The future stability of this element of the barn is seriously questionable.

The hayloft has sunk backwards into the roof. This is not an optical illusion.
