27/01/2022

Ref No: CT\_6355.22

Re Mature Horse Chestnut, 49 Chapel Lane, Butleigh

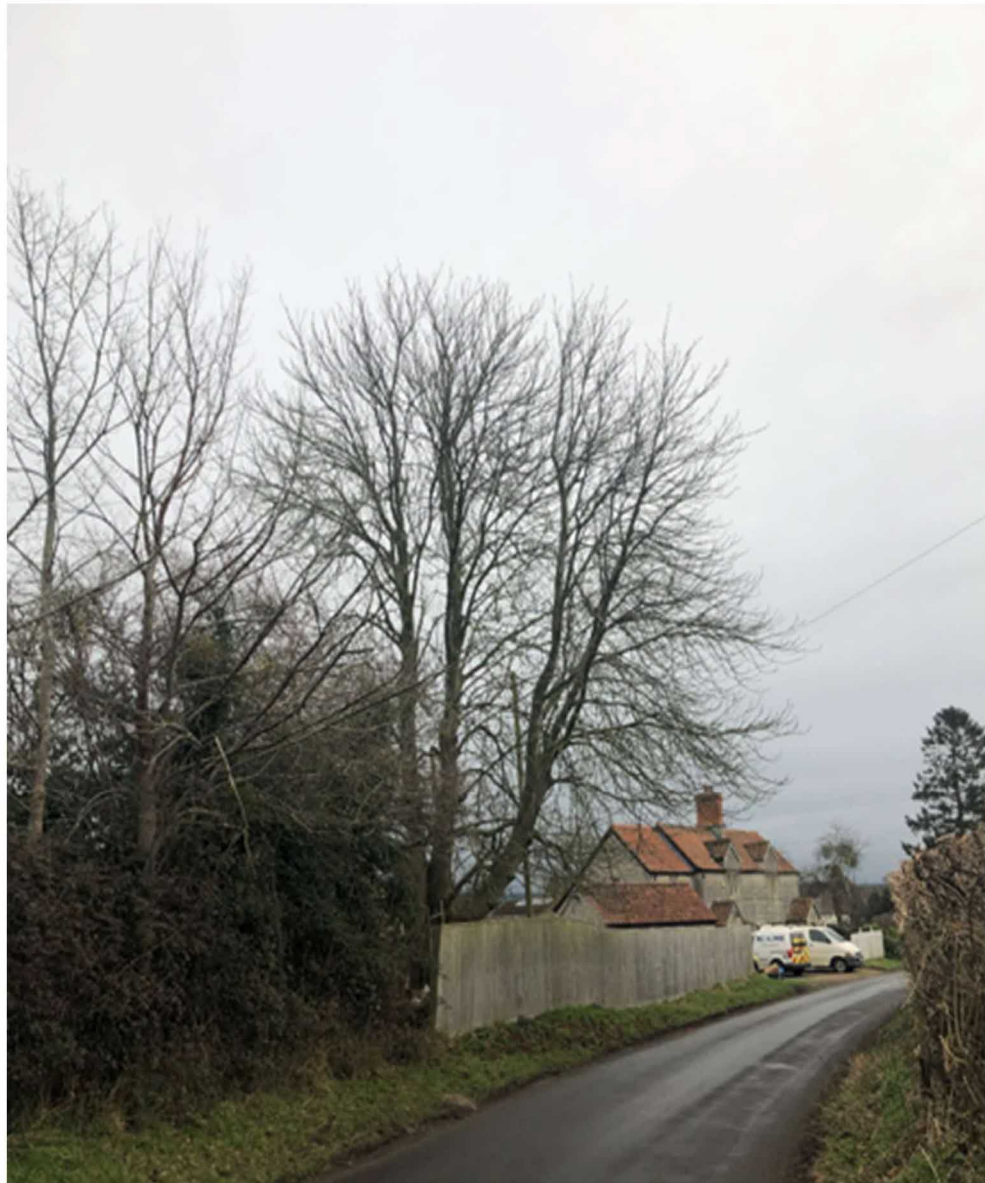
The Horse chestnut splits into 3 main stems each of which have a diameter of 48cm. The 3 primary stems are pursuing dominance. The southern stem grows horizontally before ascending to a similar height as the neighbouring stems whilst overhanging the road. A gap in the upper crown suggests that this large stem is beginning to subside and poses an elevated probability of failure. The branches on the Southern aspect of the tree overhang Chapel Lane and are often struck by passing high sided vehicles.

At the time of inspection, only minor defects were found. The tree has some minor deadwood within the crown, but this is deemed to be an acceptable quantity for the size, species, and location of the tree. When inspecting the tree, it was clear to see there is a significant, even amount of normal bud growth, indicating the tree has good vitality. No visible signs of significant pests or diseases were discovered.

The tree poses a tolerable level of risk. For the tree to pose a risk which is as 'low as reasonably practicable' it is recommended that the southern aspect of the tree is reduced by approximately 2m to lessen the stress on the branch union and overall weight of the branch. This is considered to be a cost-effective solution to mitigate the elevated likelihood of failure. As a site management task it is also recommended the tree is crown lifted over the road to 5.2m to avoid damage from passing high sided vehicles.

To conclude, at the time of inspection, the tree poses a tolerable level of risk. Pruning works are recommended for the tree to pose a reduced level of risk described as 'low as reasonably practicable'. The southern aspect of the tree should be reduced by approximately 2m to lessen the overall weight and probability of failure. The tree is to be pruned in accordance with the British Standard for tree pruning BS 3998 (2010). If pruning is carried out to BS 3998 (2010) it should result in only a minor impact on the health of the tree.

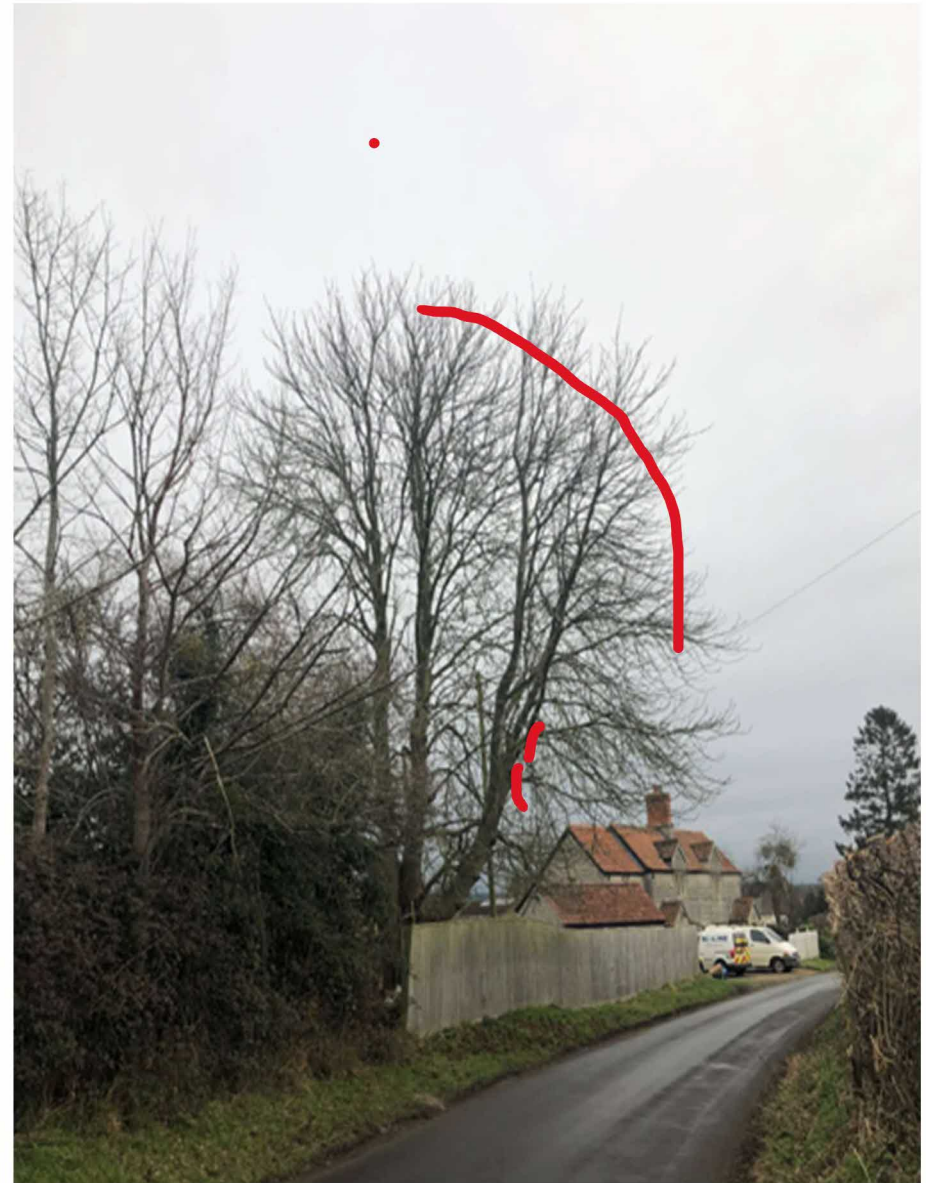
The tree is located at the far western aspect of the garden of 49 Chapel Lane, within the vicinity of the tree there are numerous targets and constraints including: Chapel Lane (South of the tree), powerlines (running through the north aspect of the crown), BT lines (running through eastern aspect of the crown), a stream with a brick wall defining the boundaries (1.5m north of the main stem).

The northern aspect of the crown has been 'through pruned' to allow the statutory clearance for the powerlines leaving a large gap in the northern aspect of the crown of the tree.
