Asbestos Pre-Refurbishment and Pre-Demolition Survey 2021

WOODLAND FARM RINSHALL STOWMARKET SUFFOLK, IP14 2LY

Survey Type Asbestos Pre-Refurbishment and Pre-Demolition Survey

Project Number TAL 04062

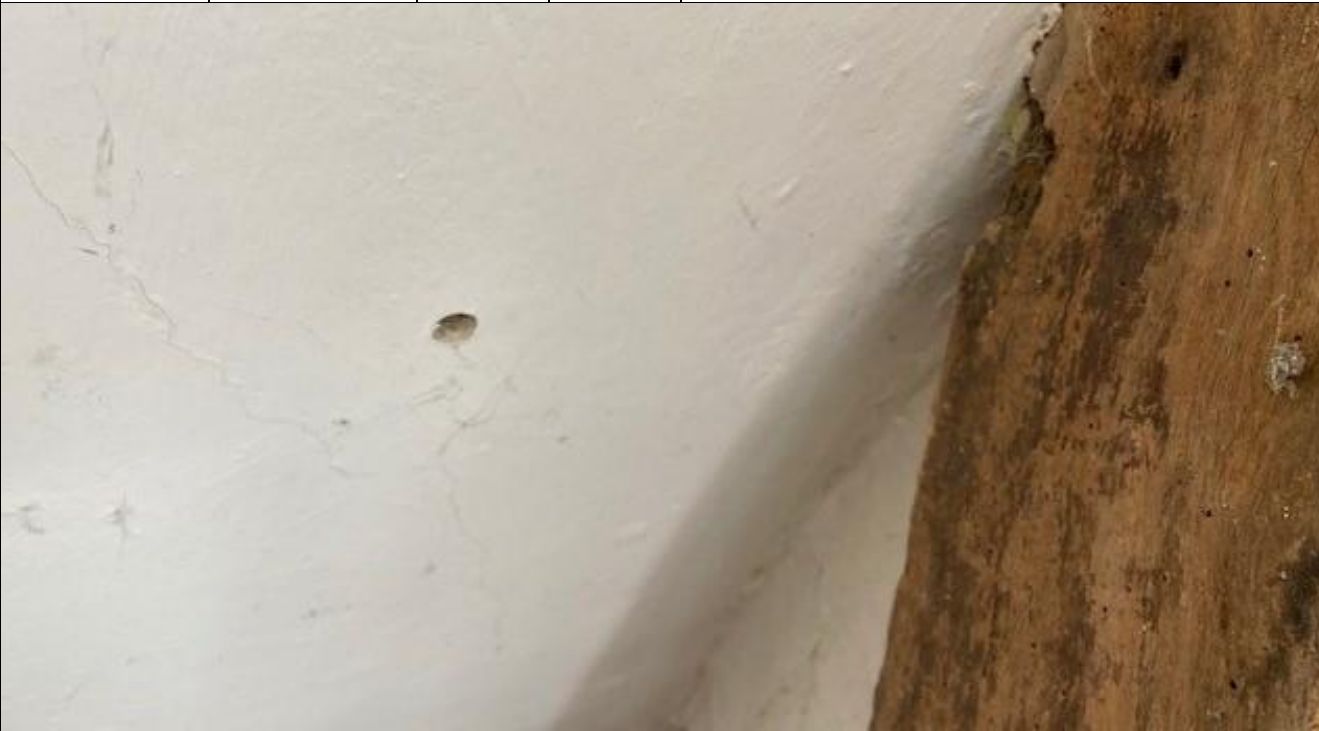
15.0 - Material Assessment Notes

Description	Ceiling Plaster			
Sample Reference Number Sample TAL 04062 - S01			Location	Original House Loft Bedroom
			Area Size	NA
Material Assessment Score			Priority Assessment Score	
Product Type	NA	NA	Location	NA
Extent of Damage	NA	NA	Accessibility	NA
Surface Treatment	NA	NA	Extent/Amount	NA
Asbestos Type	NA	NA	Score	NA
Score		NA	Total Score	NA
Recommendations	No Further Actions Required			Risk
				NA

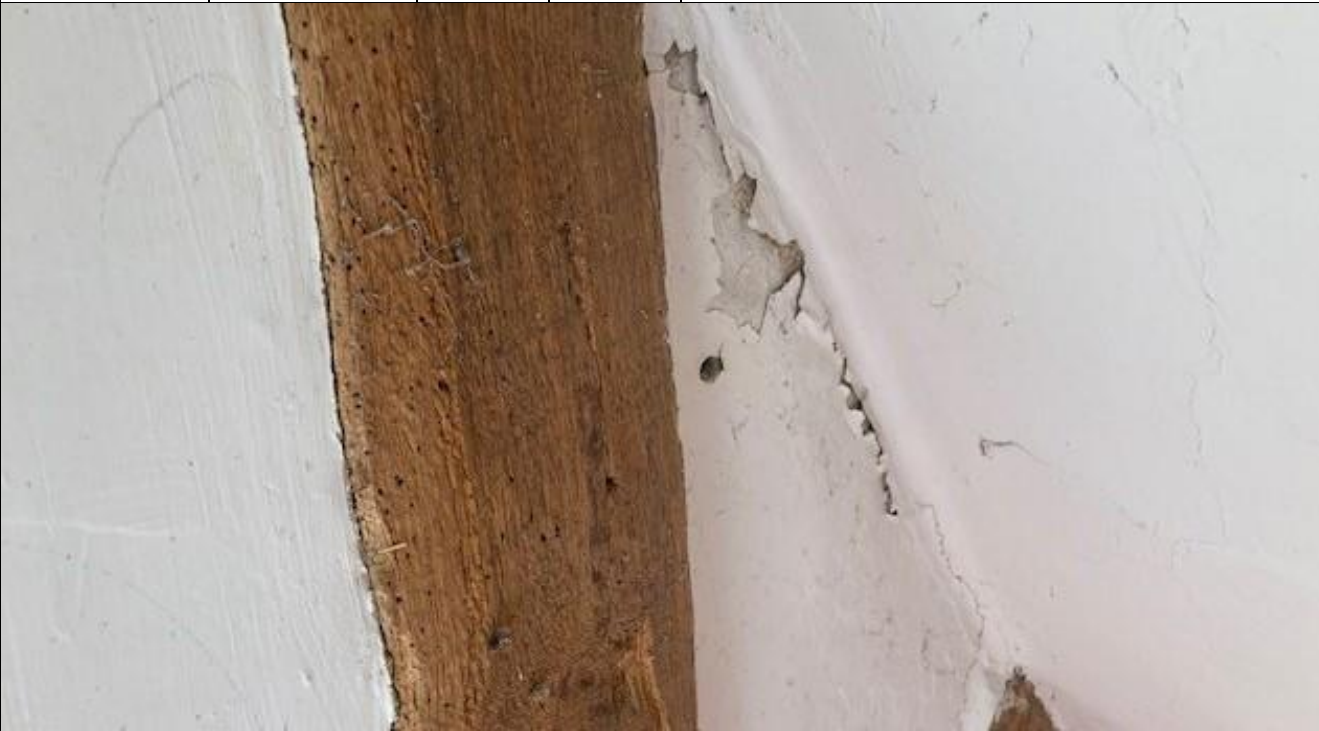
15.1 - Material Assessment Notes

Description	Wall Plaster			
Sample Reference Number Sample TAL 04062 - S02			Location	Original House Loft Bedroom
			Area Size	NA
Material Assessment Score			Priority Assessment Score	
Product Type	NA	NA	Location	NA
Extent of Damage	NA	NA	Accessibility	NA
Surface Treatment	NA	NA	Extent/Amount	NA
Asbestos Type	NA	NA	Score	NA
Score		NA	Total Score	NA
Recommendations	No Further Actions Required			Risk
				NA

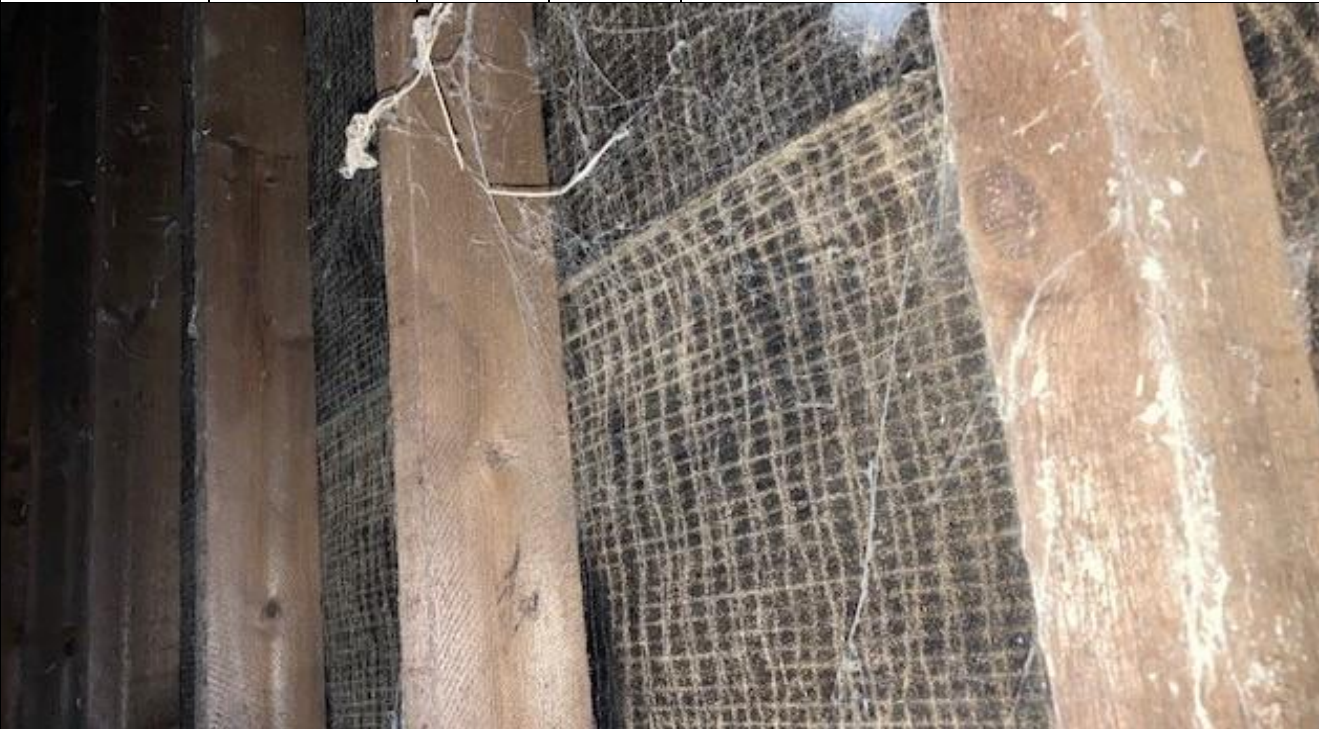
15.2 - Material Assessment Notes

Description	Roofing Felt			
Sample Reference Number Sample TAL 04062 - S03		Location	Original House Roof Loft	
		Area Size	NA	
Material Assessment Score		Priority Assessment Score		
Product Type	NA	NA	Location	NA
Extent of Damage	NA	NA	Accessibility	NA
Surface Treatment	NA	NA	Extent/Amount	NA
Asbestos Type	NA	NA	Score	NA
Score		NA	Total Score	NA
Recommendations	No Further Actions Required			Risk
				NA

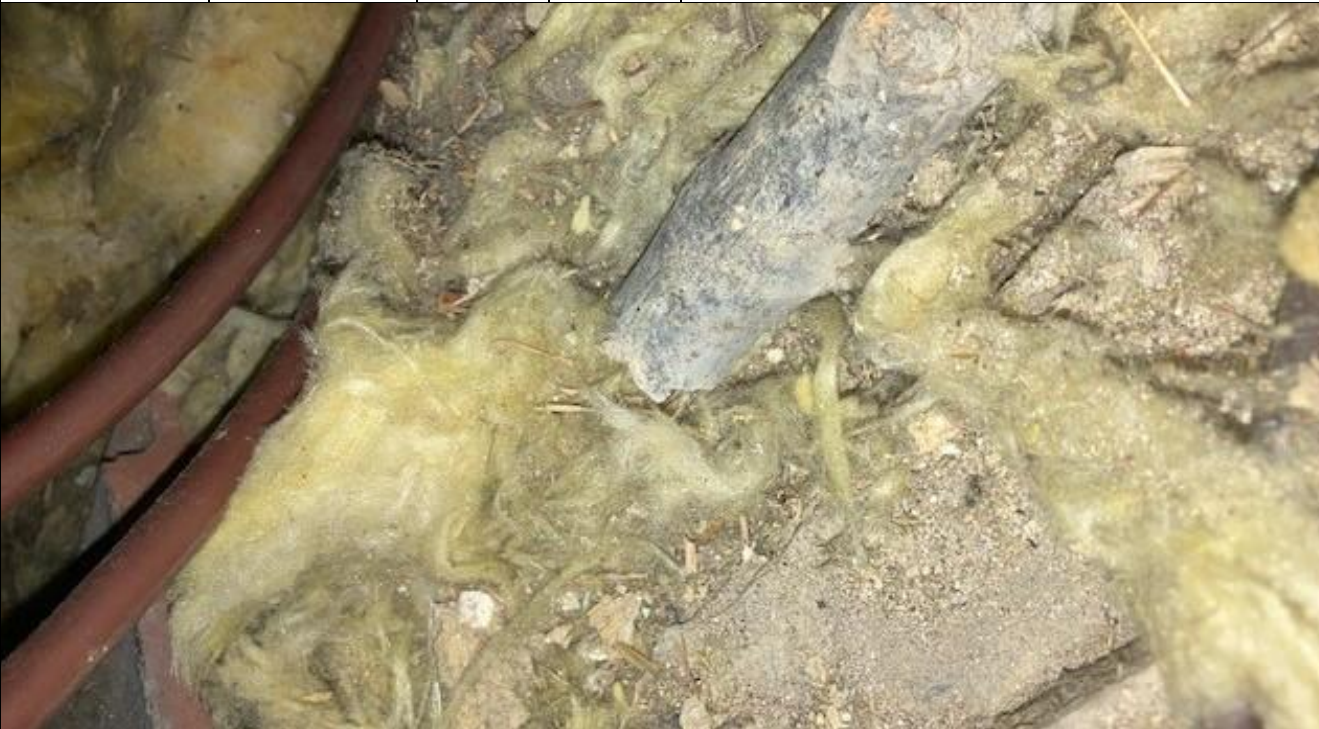
15.3 - Material Assessment Notes

Description	Floor Dust and Debris			
Sample Reference Number Sample TAL 04062 - S04		Location	Original House Roof Loft	
		Area Size	NA	
Material Assessment Score		Priority Assessment Score		
Product Type	NA	NA	Location	NA
Extent of Damage	NA	NA	Accessibility	NA
Surface Treatment	NA	NA	Extent/Amount	NA
Asbestos Type	NA	NA	Score	NA
Score		NA	Total Score	NA
Recommendations	No Further Actions Required			Risk
				NA

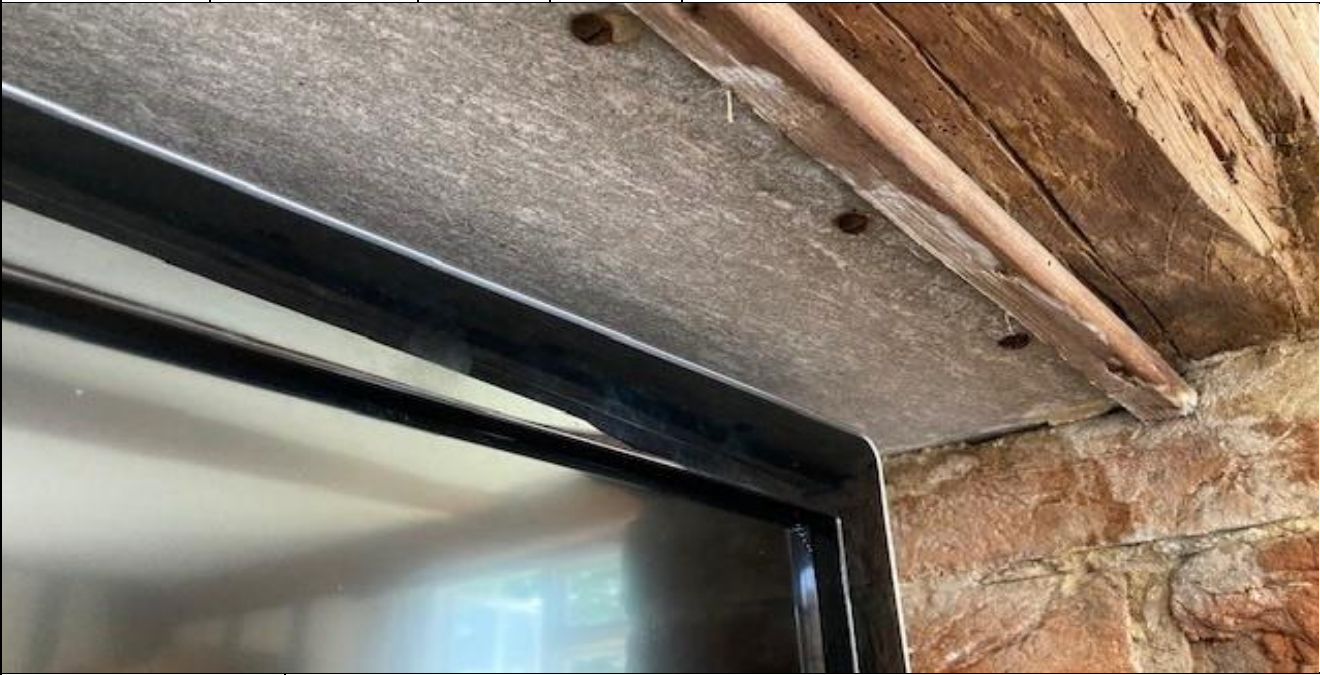
15.4 - Material Assessment Notes

Description	Fireplace Blanking Panel			
Sample Reference Number Sample TAL 04062 - S05			Location	Original House First Floor Master Bedroom
			Area Size	2 SQM.
Material Assessment Score			Priority Assessment Score	
Product Type	Cement Board	1	Location	2
Extent of Damage	Low	1	Accessibility	2
Surface Treatment	Composite	1	Extent/Amount	1
Asbestos Type	Chrysotile	1	Score	5
Score		4	Total Score	9
Recommendations	Encapsulate with ET150 by an Asbestos Contractor. Manage and Maintain Annually. If fireplace to is to be reinstated remove cement board by an Asbestos Contractor.			Risk MEDUIM

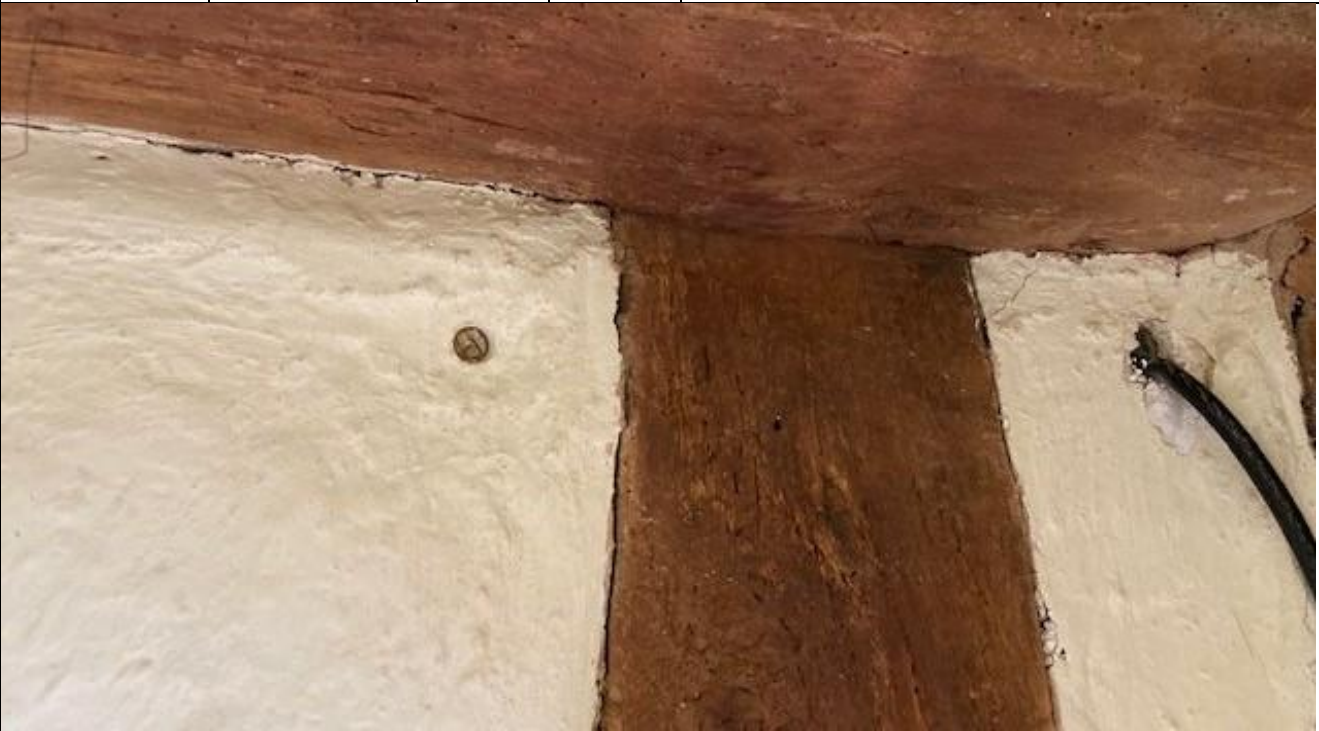
15.5 - Material Assessment Notes

Description	Wall Plaster			
Sample Reference Number Sample TAL 04062 - S06			Location	Original House First Floor Master Bedroom
			Area Size	NA
Material Assessment Score			Priority Assessment Score	
Product Type	NA	NA	Location	NA
Extent of Damage	NA	NA	Accessibility	NA
Surface Treatment	NA	NA	Extent/Amount	NA
Asbestos Type	NA	NA	Score	NA
Score		NA	Total Score	NA
Recommendations	No Further Actions Required			Risk
				NA

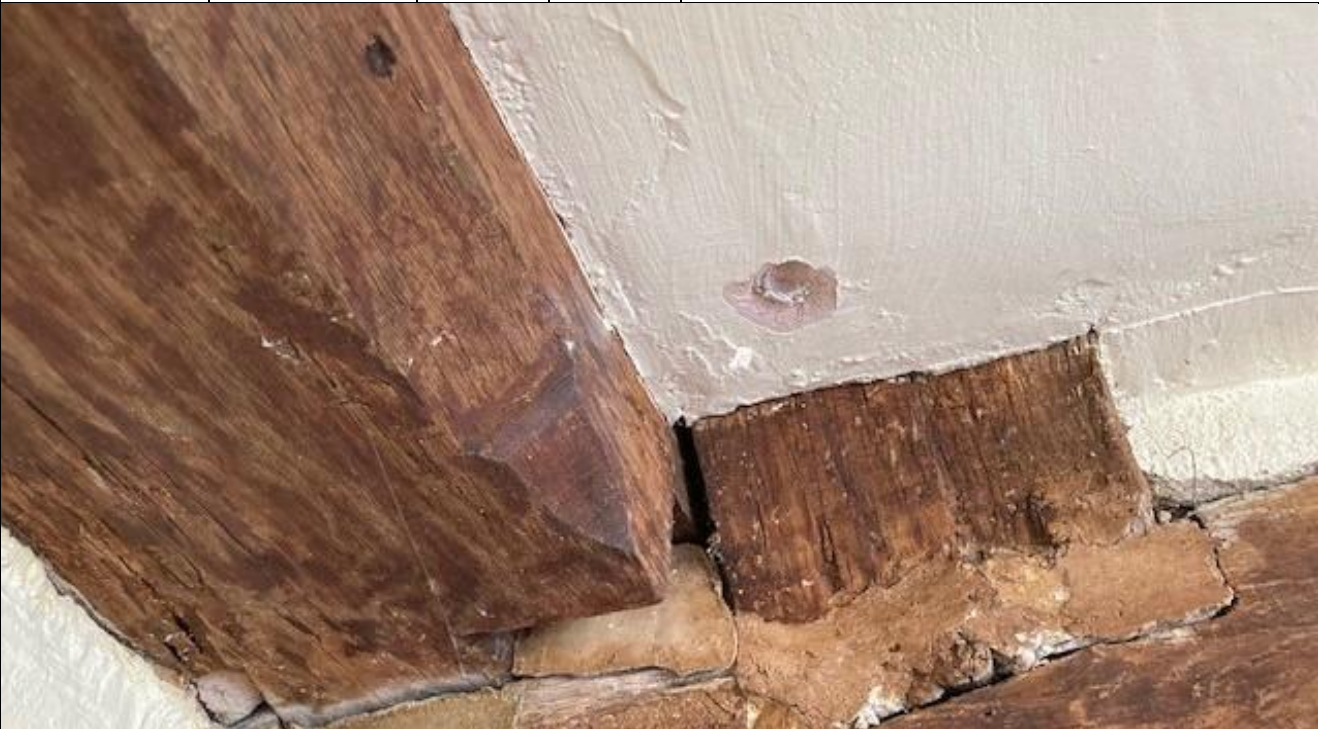
15.6 - Material Assessment Notes

Description	Ceiling Plaster			
Sample Reference Number Sample TAL 04062 - S07			Location	Original House First Floor Master Bedroom
			Area Size	NA
Material Assessment Score			Priority Assessment Score	
Product Type	NA	NA	Location	NA
Extent of Damage	NA	NA	Accessibility	NA
Surface Treatment	NA	NA	Extent/Amount	NA
Asbestos Type	NA	NA	Score	NA
Score		NA	Total Score	NA
Recommendations	No Further Actions Required			Risk
				NA

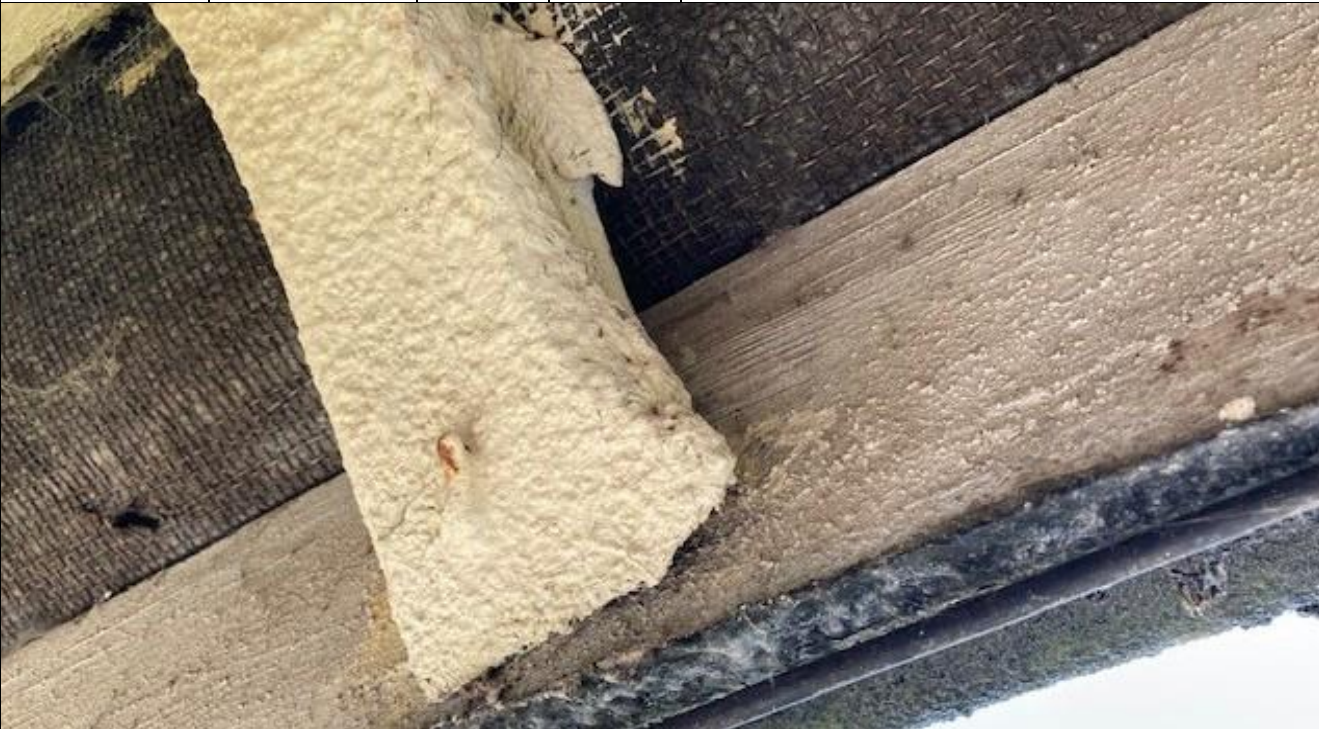
15.7 - Material Assessment Notes

Description	External Wall and Timber Joist Render			
Sample Reference Number Sample TAL 04062 - S08			Location	Original House External Front Elevation
			Area Size	NA
Material Assessment Score			Priority Assessment Score	
Product Type	NA	NA	Location	NA
Extent of Damage	NA	NA	Accessibility	NA
Surface Treatment	NA	NA	Extent/Amount	NA
Asbestos Type	NA	NA	Score	NA
Score		NA	Total Score	NA
Recommendations	No Further Actions Required			Risk
				NA

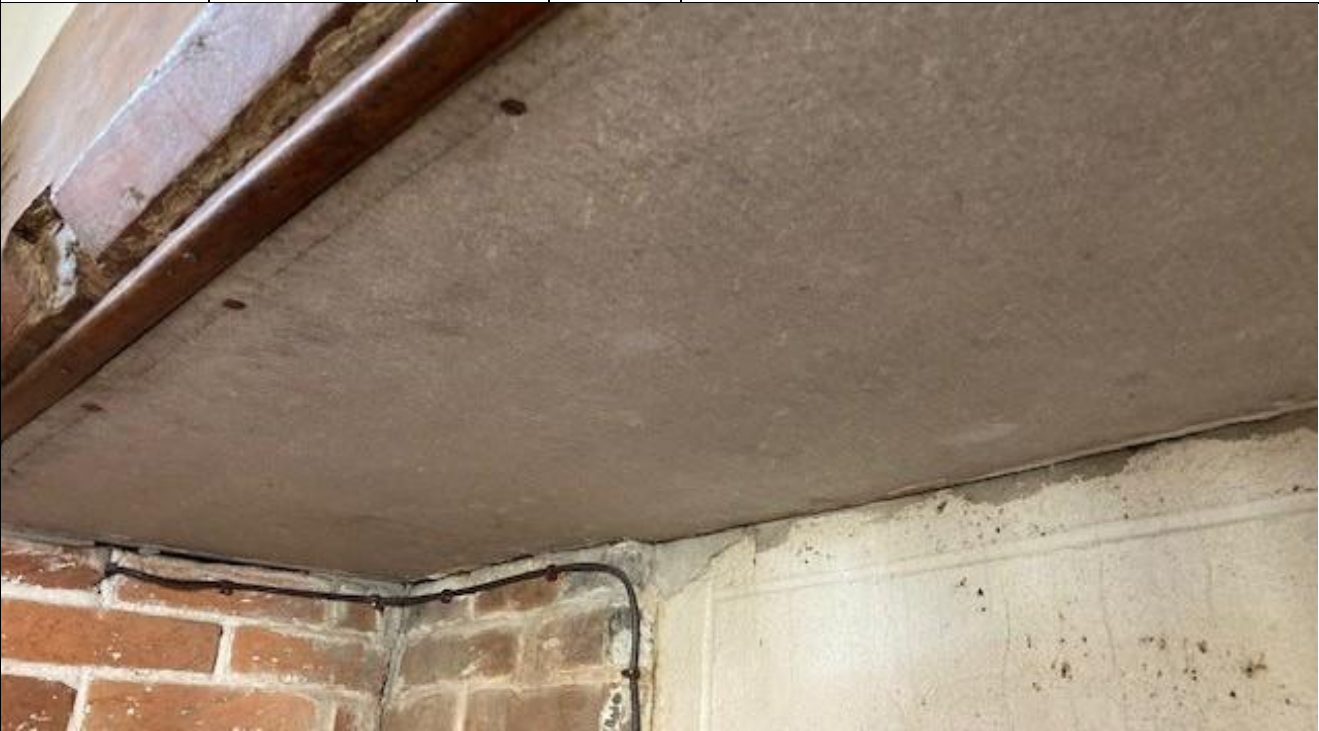
15.8 - Material Assessment Notes

Description	Fireplace Blanking Panel			
Sample Reference Number Sample TAL 04062 - S09			Location	Original House First Floor Bedroom 2
			Area Size	2.5 SQM.
Material Assessment Score			Priority Assessment Score	
Product Type	Cement Board	1	Location	2
Extent of Damage	Low	1	Accessibility	2
Surface Treatment	Composite	1	Extent/Amount	1
Asbestos Type	Chrysotile	1	Score	5
Score		4	Total Score	9
Recommendations	Encapsulate with ET150 by an Asbestos Contractor. Manage and Maintain Annually. If fireplace to is to be reinstated remove cement board by an Asbestos Contractor.			Risk
				MEDIUM

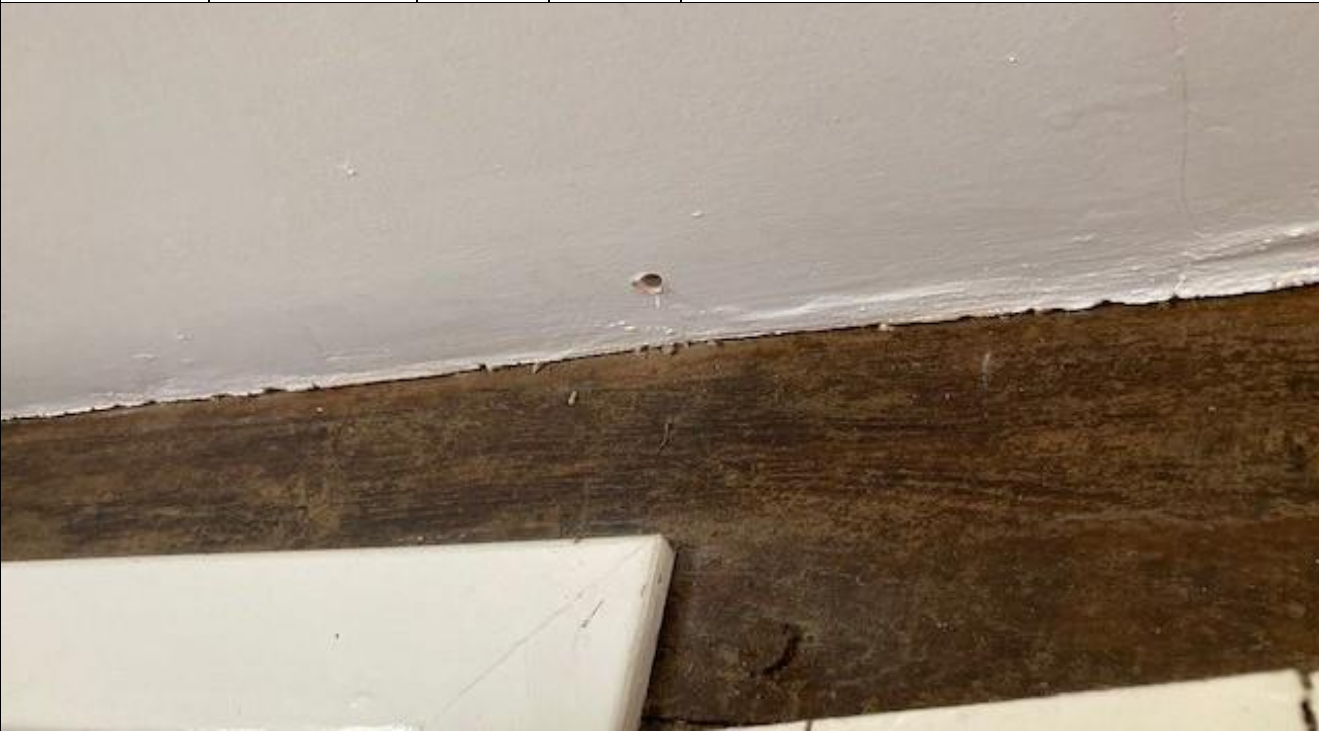
15.9 - Material Assessment Notes

Description	Ceiling Plaster			
Sample Reference Number Sample TAL 04062 - S010			Location	Original House First Floor Bedroom 2
			Area Size	NA
Material Assessment Score			Priority Assessment Score	
Product Type	NA	NA	Location	NA
Extent of Damage	NA	NA	Accessibility	NA
Surface Treatment	NA	NA	Extent/Amount	NA
Asbestos Type	NA	NA	Score	NA
Score		NA	Total Score	NA
Recommendations	No Further Actions Required			Risk
				NA

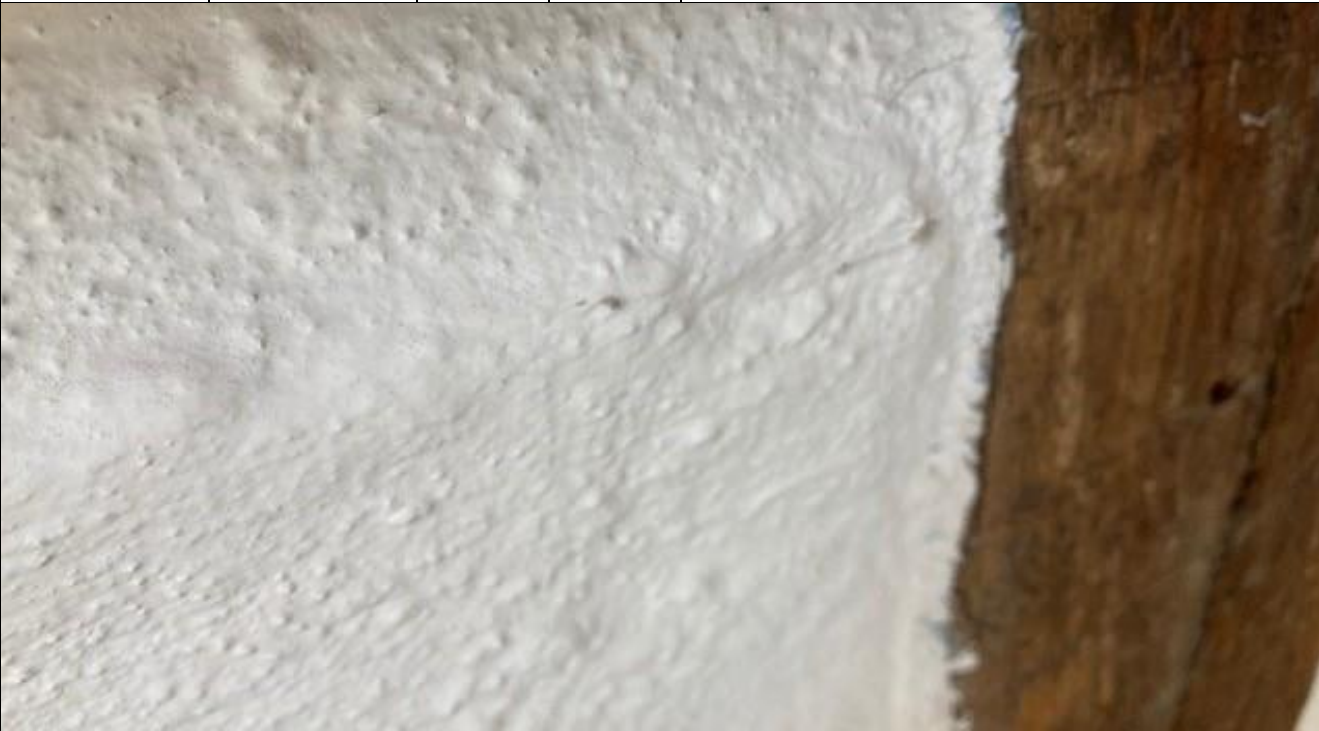
15.10 - Material Assessment Notes

Description	Wall Textured Coating			
Sample Reference Number Sample TAL 04062 - S011			Location	Original House First Floor Bathroom
			Area Size	NA
Material Assessment Score			Priority Assessment Score	
Product Type	NA	NA	Location	NA
Extent of Damage	NA	NA	Accessibility	NA
Surface Treatment	NA	NA	Extent/Amount	NA
Asbestos Type	NA	NA	Score	NA
Score		NA	Total Score	NA
Recommendations	No Further Actions Required			Risk
				NA

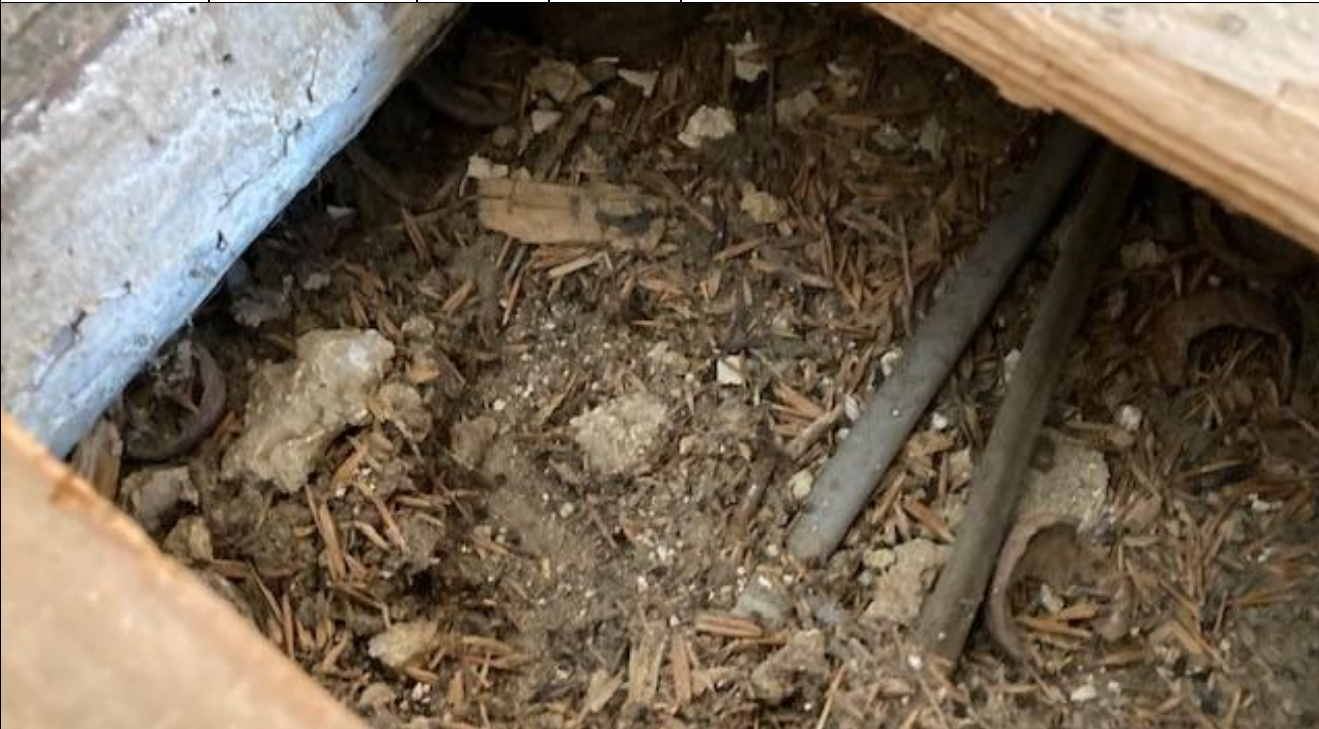
15.11 - Material Assessment Notes

Description	Floor Void Dust and Debris			
Sample Reference Number Sample TAL 04062 - S012			Location	Original House First Floor Landing
			Area Size	NA
Material Assessment Score			Priority Assessment Score	
Product Type	NA	NA	Location	NA
Extent of Damage	NA	NA	Accessibility	NA
Surface Treatment	NA	NA	Extent/Amount	NA
Asbestos Type	NA	NA	Score	NA
Score		NA	Total Score	NA
Recommendations	No Further Actions Required			Risk
				NA

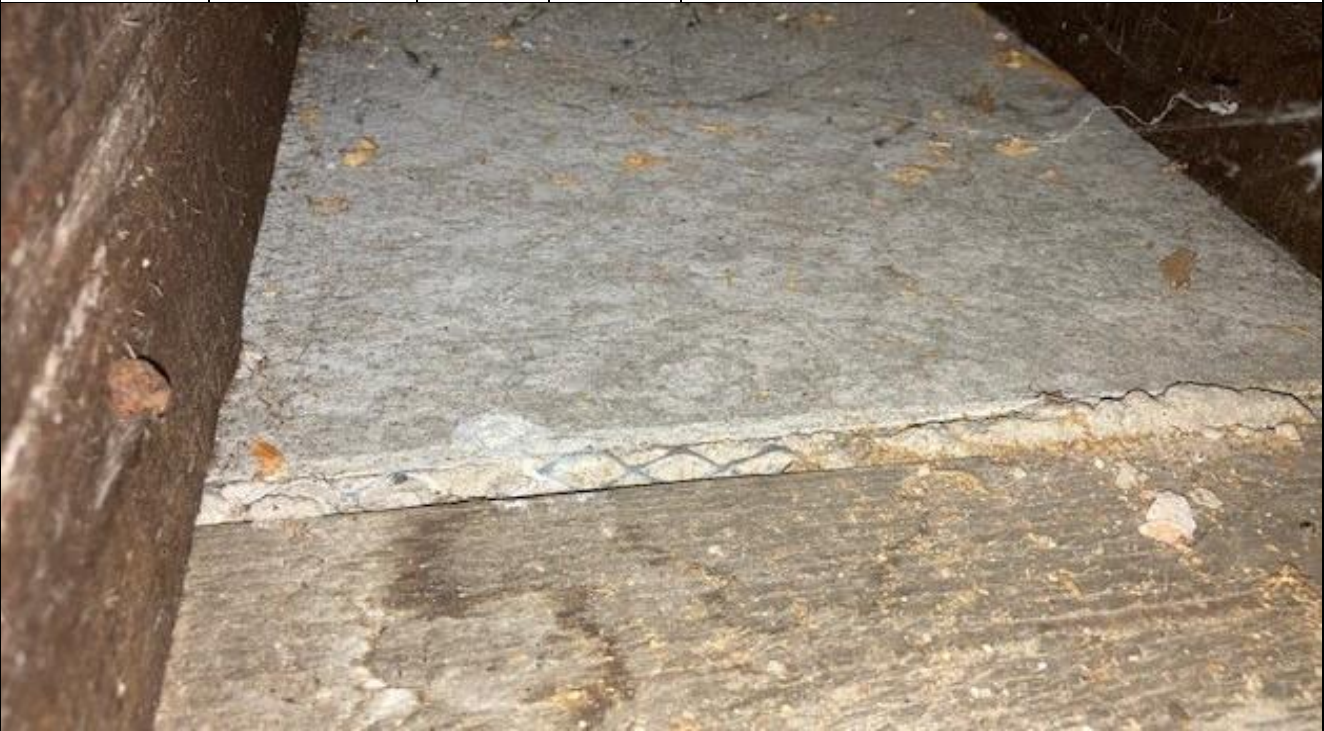
15.12 - Material Assessment Notes

Description	Under Hang Panel/Firebreak			
Sample Reference Number Sample TAL 04062 - S013		Location	New Wing First Floor Landing/Corridor	
		Area Size	6 SQM.	
Material Assessment Score			Priority Assessment Score	
Product Type	Cement Board	1	Location	2
Extent of Damage	Low	1	Accessibility	2
Surface Treatment	Composite	1	Extent/Amount	1
Asbestos Type	Chrysotile	1	Score	5
Score		4	Total Score	9
Recommendations	Manage and Maintain Annually.			Risk
				MEDIUM

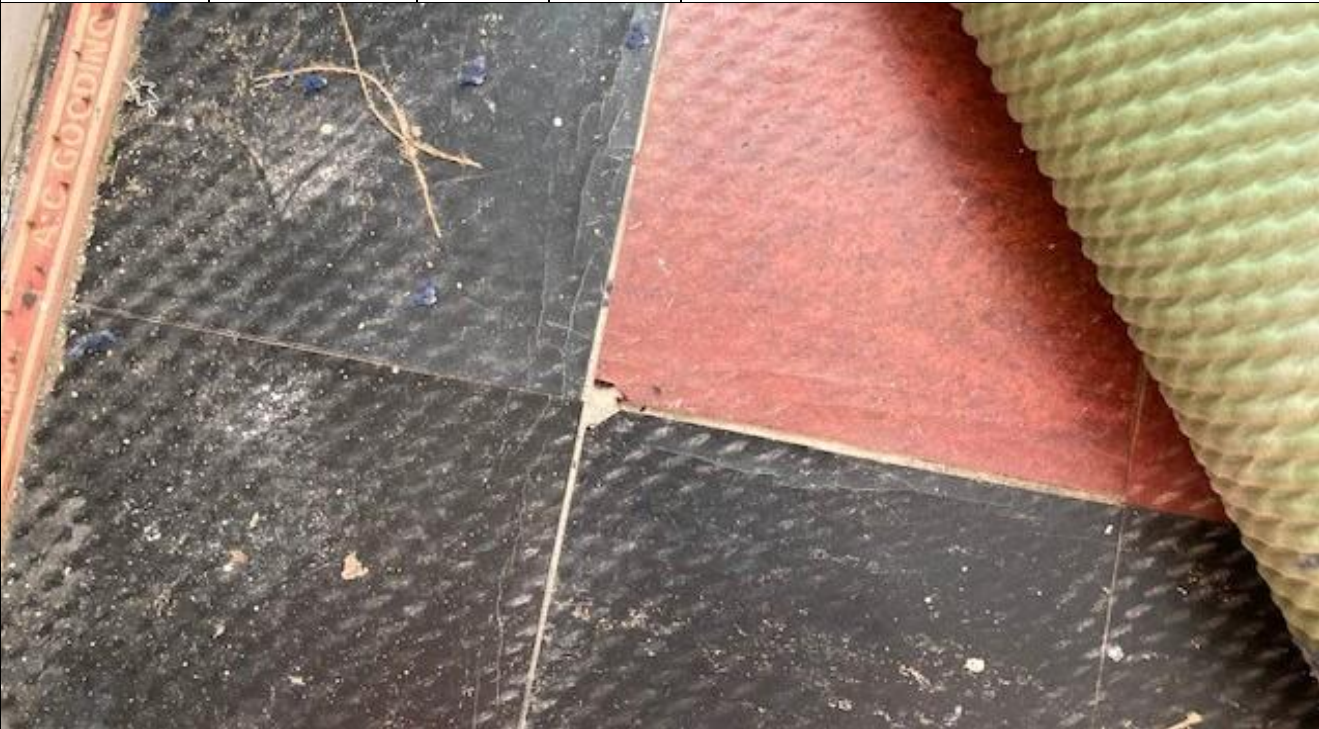
15.13 - Material Assessment Notes

Description	Floor Tiles			
Sample Reference Number Sample TAL 04062 - S014			Location	New Wing Ground Floor Bedroom
			Area Size	NA
Material Assessment Score			Priority Assessment Score	
Product Type	NA	NA	Location	NA
Extent of Damage	NA	NA	Accessibility	NA
Surface Treatment	NA	NA	Extent/Amount	NA
Asbestos Type	NA	NA	Score	NA
Score		NA	Total Score	NA
Recommendations	No Further Actions Required			Risk NA

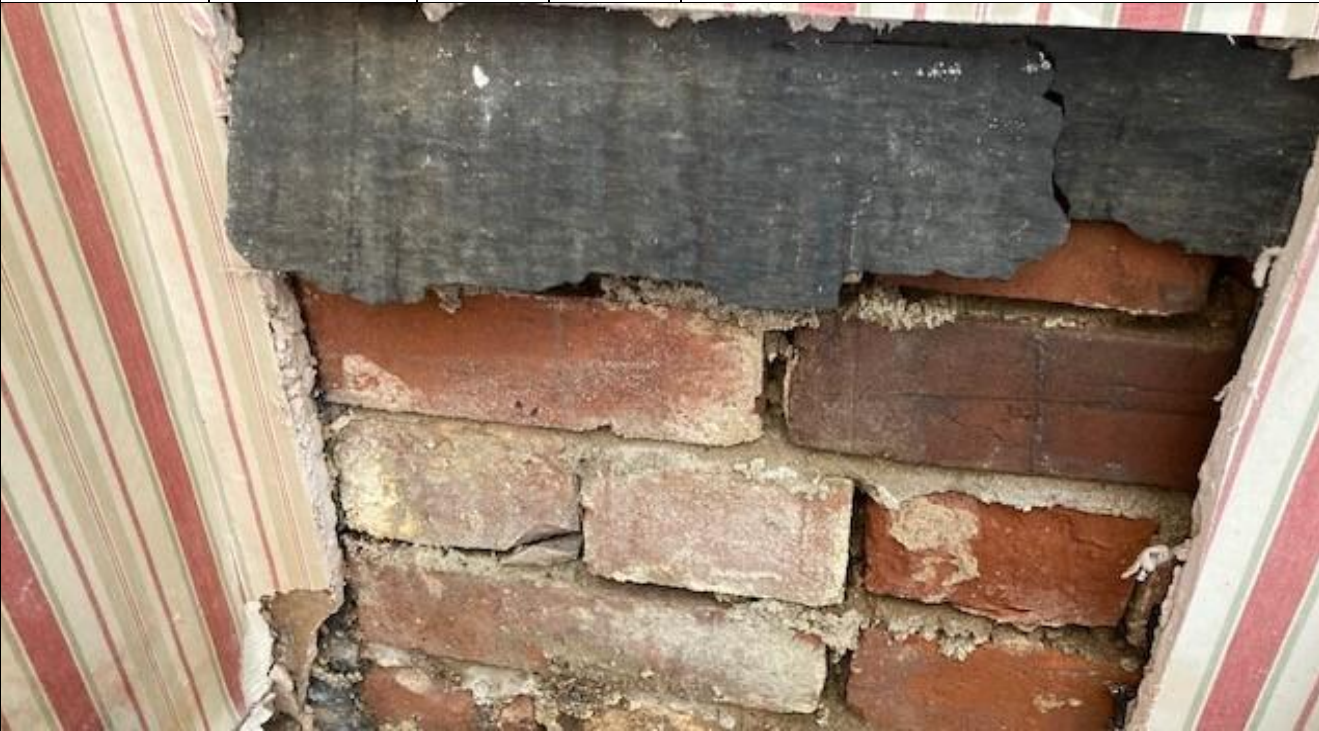
15.14 - Material Assessment Notes

Description	Wall Bitumen Damp Proof Membrane			
Sample Reference Number Sample TAL 04062 - S015			Location	New Wing Ground Floor Bedroom
			Area Size	NA
Material Assessment Score			Priority Assessment Score	
Product Type	NA	NA	Location	NA
Extent of Damage	NA	NA	Accessibility	NA
Surface Treatment	NA	NA	Extent/Amount	NA
Asbestos Type	NA	NA	Score	NA
Score		NA	Total Score	NA
Recommendations	No Further Actions Required			Risk
				NA

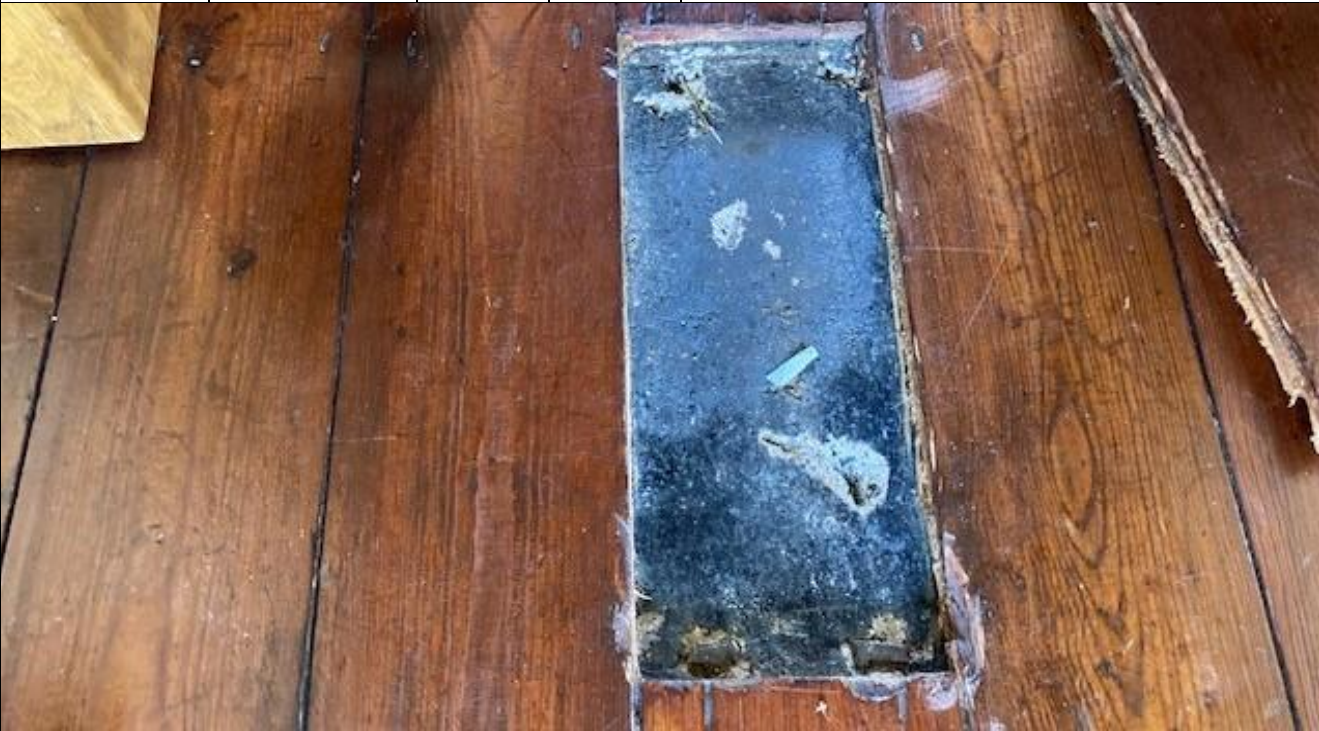
15.16 - Material Assessment Notes

Description	Floor Bitumen			
Sample Reference Number Sample TAL 04062 - S017			Location	Original House Ground Floor Dining
			Area Size	NA
Material Assessment Score			Priority Assessment Score	
Product Type	NA	NA	Location	NA
Extent of Damage	NA	NA	Accessibility	NA
Surface Treatment	NA	NA	Extent/Amount	NA
Asbestos Type	NA	NA	Score	NA
Score		NA	Total Score	NA
Recommendations	No Further Actions Required			Risk
				NA

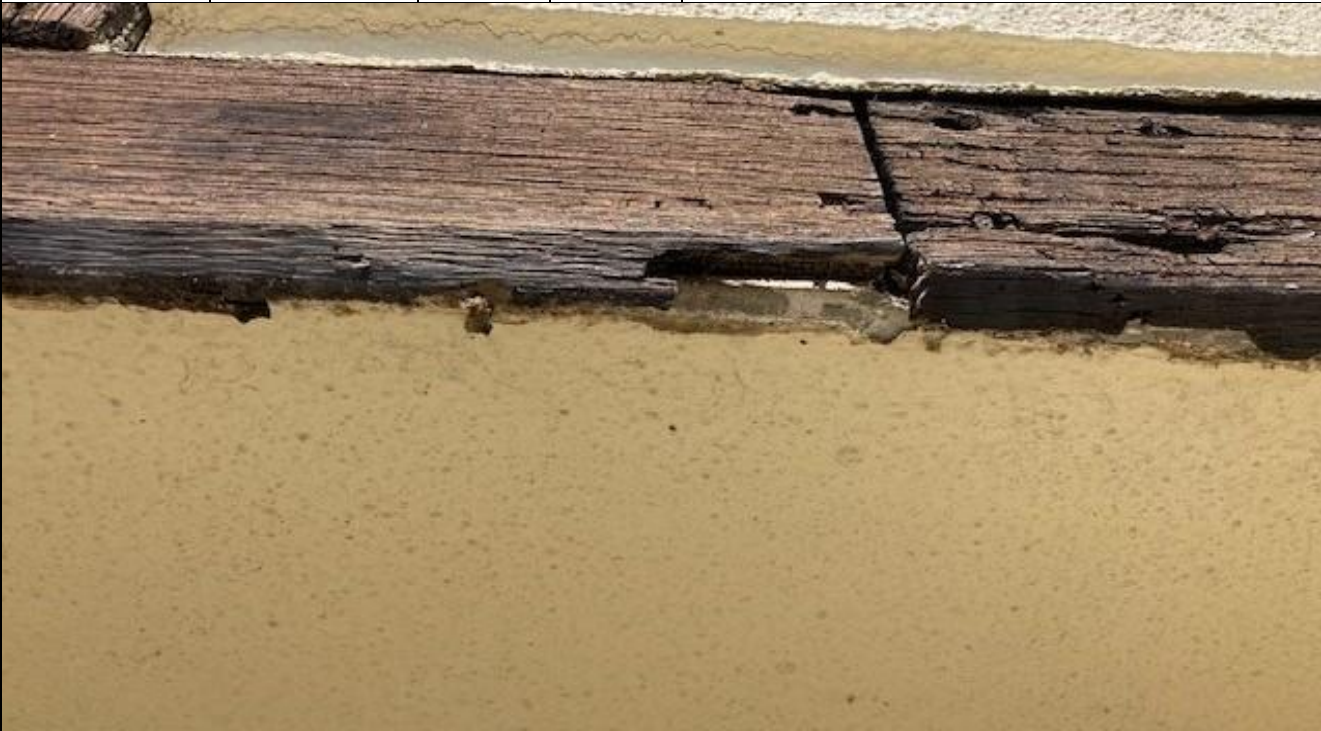
15.17 - Material Assessment Notes

Description	Under Cloaking Panel/Firebreak			
Sample Reference Number Sample TAL 04062 - S018 (As SO13)			Location	External New Wing Side Elevation
			Area Size	8 SQM.
Material Assessment Score			Priority Assessment Score	
Product Type	Cement Board	1	Location	2
Extent of Damage	Low	1	Accessibility	2
Surface Treatment	Composite	1	Extent/Amount	1
Asbestos Type	Chrysotile	1	Score	5
Score		4	Total Score	9
Recommendations	Manage and Maintain Annually.			Risk
				MEDIUM

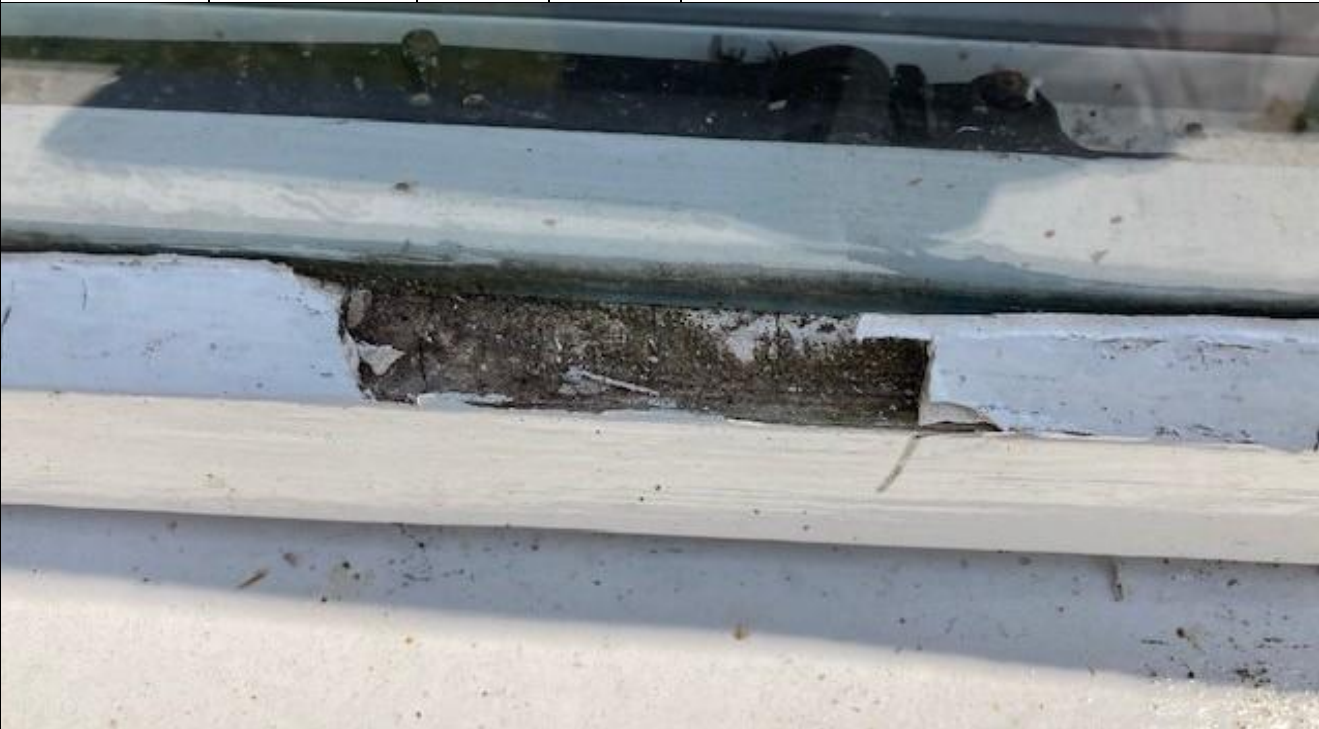
15.18 - Material Assessment Notes

Description	Window Glazing Putty			
Sample Reference Number Sample TAL 04062 - S019			Location	External New Wing Ground Floor
			Area Size	NA
Material Assessment Score			Priority Assessment Score	
Product Type	NA	NA	Location	NA
Extent of Damage	NA	NA	Accessibility	NA
Surface Treatment	NA	NA	Extent/Amount	NA
Asbestos Type	NA	NA	Score	NA
Score		NA	Total Score	NA
Recommendations	No Further Actions Required			Risk
				NA

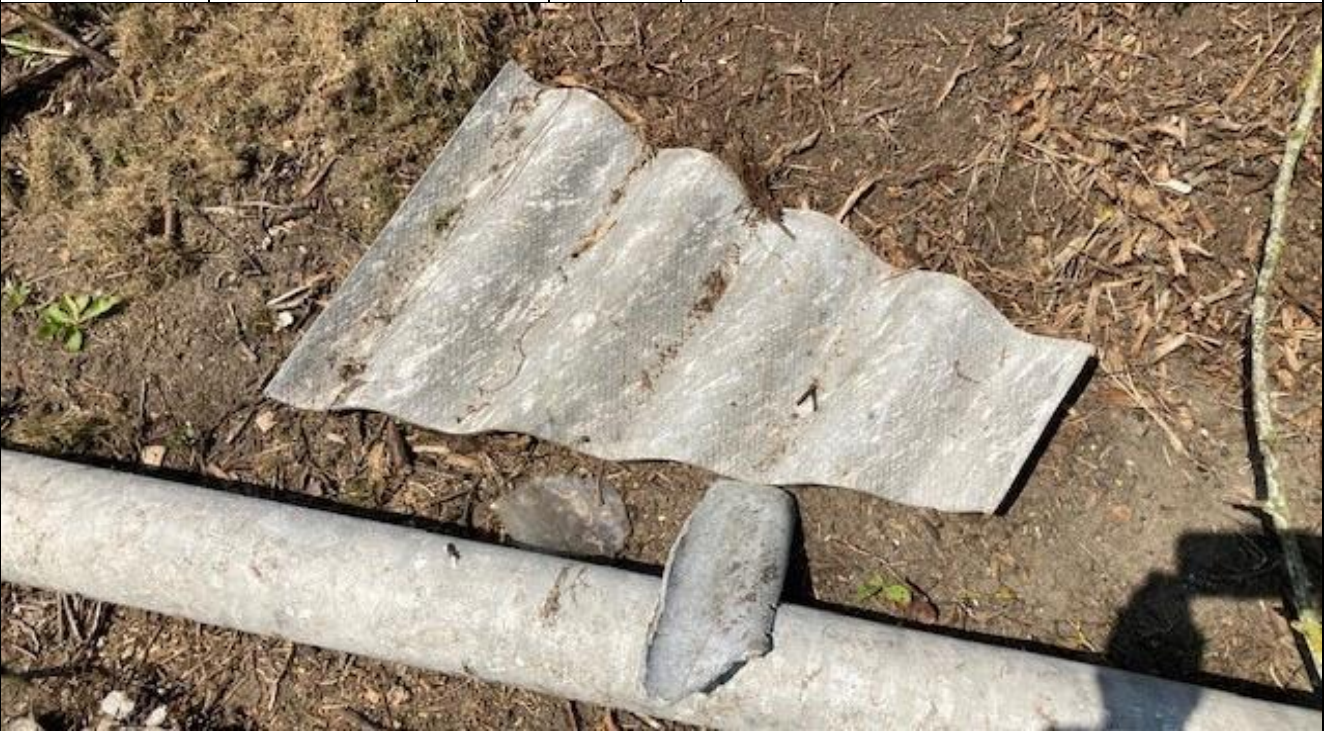
15.19 - Material Assessment Notes

Description	Barn Downpipe Debris			
Sample Reference Number Sample TAL 04062 - S020			Location	External Garden/Grounds
			Area Size	Unquantifiable
Material Assessment Score			Priority Assessment Score	
Product Type	Cement	1	Location	0
Extent of Damage	High	3	Accessibility	2
Surface Treatment	Composite	1	Extent/Amount	2
Asbestos Type	Chrysotile	1	Score	4
Score		6	Total Score	10
Recommendations	Remove all debris by an Asbestos Contractor.			Risk
				HIGH

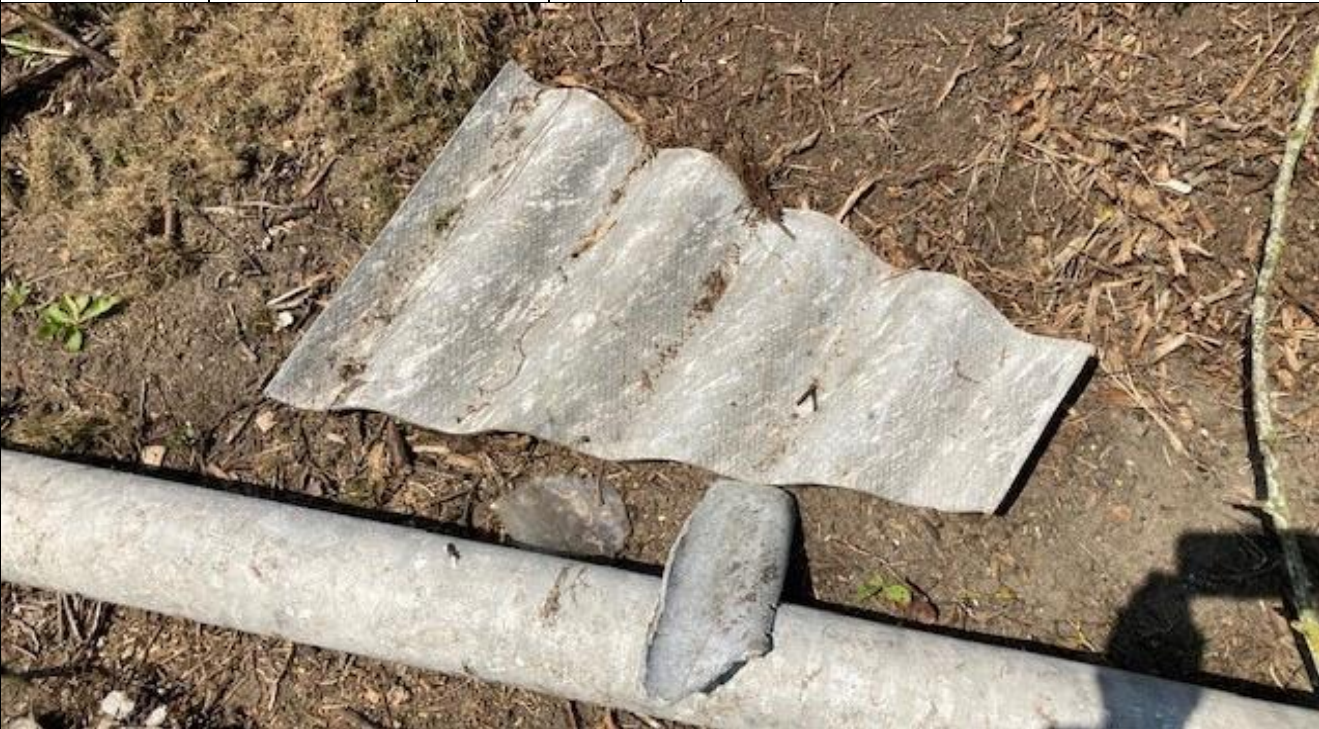
15.20 - Material Assessment Notes

Description	Roof Cladding Sheet Debris			
Sample Reference Number Sample TAL 04062 - S021			Location	External Garden/Grounds
			Area Size	Unquantifiable
Material Assessment Score			Priority Assessment Score	
Product Type	Cement Board	1	Location	0
Extent of Damage	High	3	Accessibility	2
Surface Treatment	Composite	1	Extent/Amount	2
Asbestos Type	Chrysotile	1	Score	4
Score		6	Total Score	10
Recommendations	Remove all debris by an Asbestos Contractor.			Risk
				HIGH

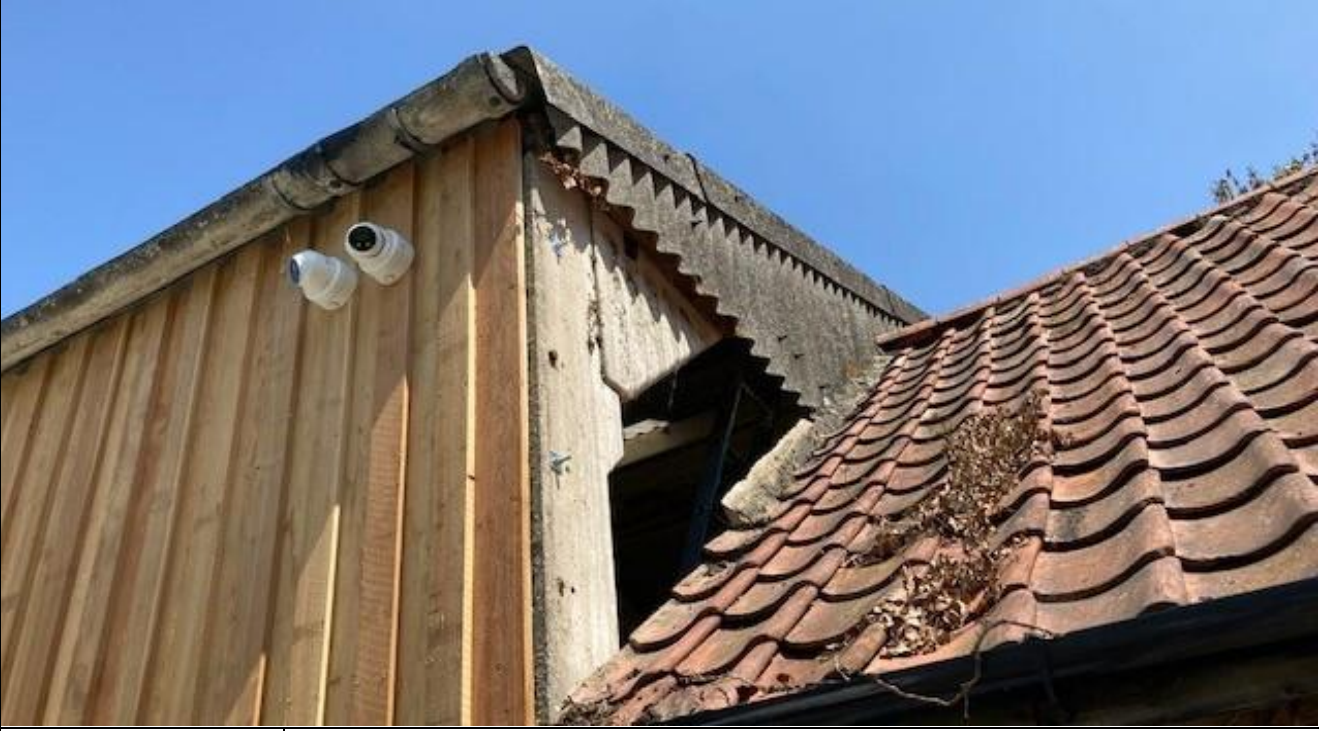
15.23 - Material Assessment Notes

Description	Facia Cladding Sheets			
Sample Reference Number Sample TAL 04062 - S024		Location	Barn Rear Gable End	
		Area Size	Unquantifiable	
Material Assessment Score		Priority Assessment Score		
Product Type	Cement Board	1	Location	0
Extent of Damage	High	3	Accessibility	2
Surface Treatment	Composite	1	Extent/Amount	3
Asbestos Type	Chrysotile	1	Score	5
Score		6	Total Score	11
Recommendations	Remove by an Asbestos Contractor.			Risk
				HIGH
