Asbestos Pre-Refurbishment and Pre-Demolition Survey 2021

WOODLAND FARM RINSHALL STOWMARKET SUFFOLK, IP14 2LY

Survey Type Asbestos Pre-Refurbishment and Pre-Demolition Survey

Project Number TAL 04062

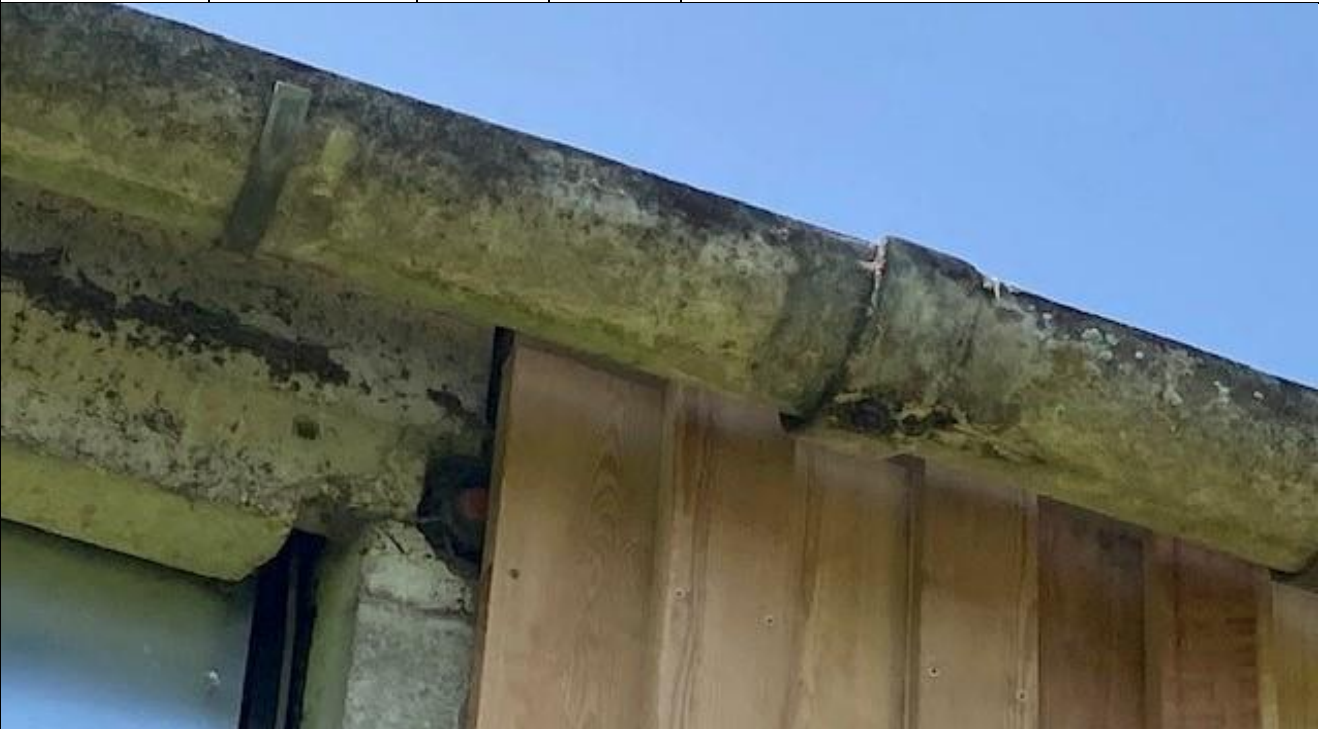
15.24 - Material Assessment Notes

Description	Rainwater Gutters			
Sample Reference Number Sample TAL 04062 - S025		Location	Barn Side Elevations	
		Area Size	Unquantifiable	
Material Assessment Score		Priority Assessment Score		
Product Type	Cement	1	Location	0
Extent of Damage	Medium	2	Accessibility	2
Surface Treatment	Composite	1	Extent/Amount	3
Asbestos Type	Chrysotile	1	Score	4
Score		5	Total Score	9
Recommendations	Manage and Maintain Annually.			Risk
				MEDIUM

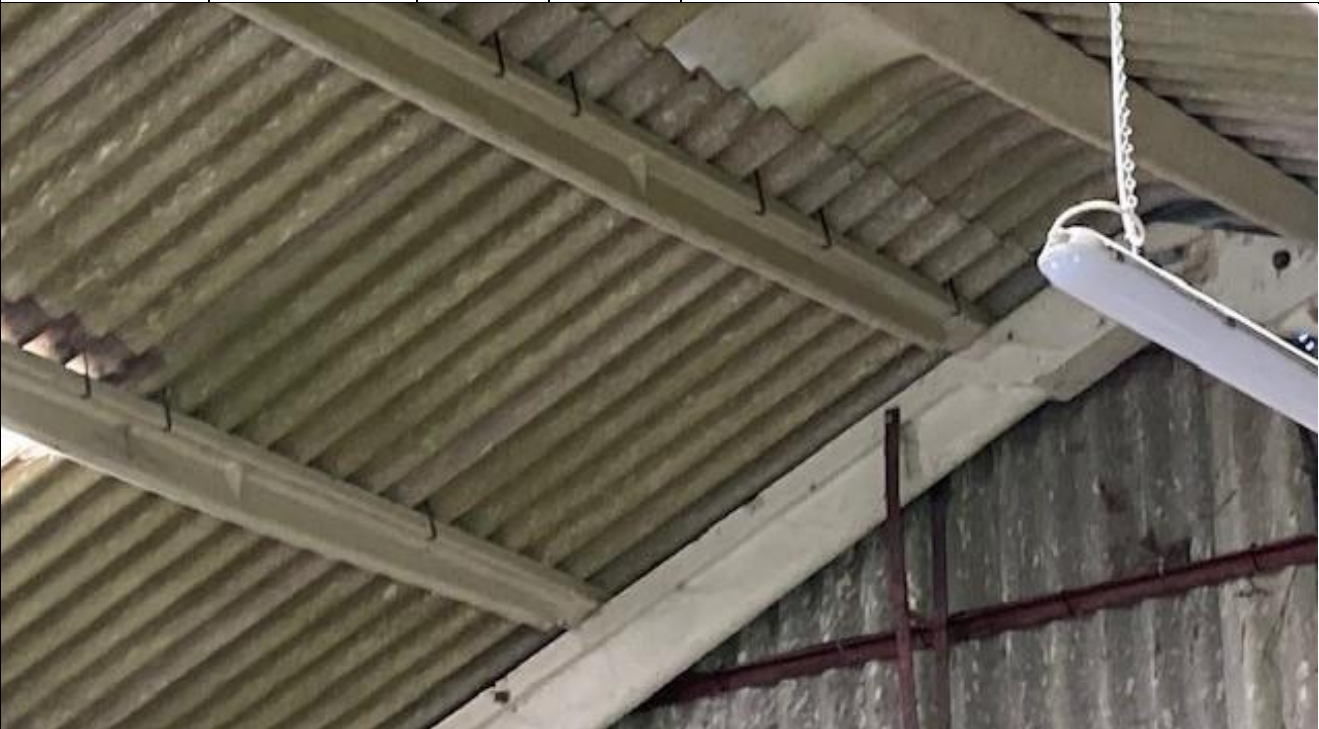
15.25 - Material Assessment Notes

Description	Roof Cladding Sheets			
Sample Reference Number Sample TAL 04062 - S026		Location	Barn Roof	
		Area Size	Unquantifiable	
Material Assessment Score		Priority Assessment Score		
Product Type	Cement Board	1	Location	0
Extent of Damage	Low	1	Accessibility	2
Surface Treatment	Composite	1	Extent/Amount	4
Asbestos Type	Chrysotile	1	Score	5
Score		4	Total Score	9
Recommendations	Manage and Maintain Annually.			Risk
				Medium

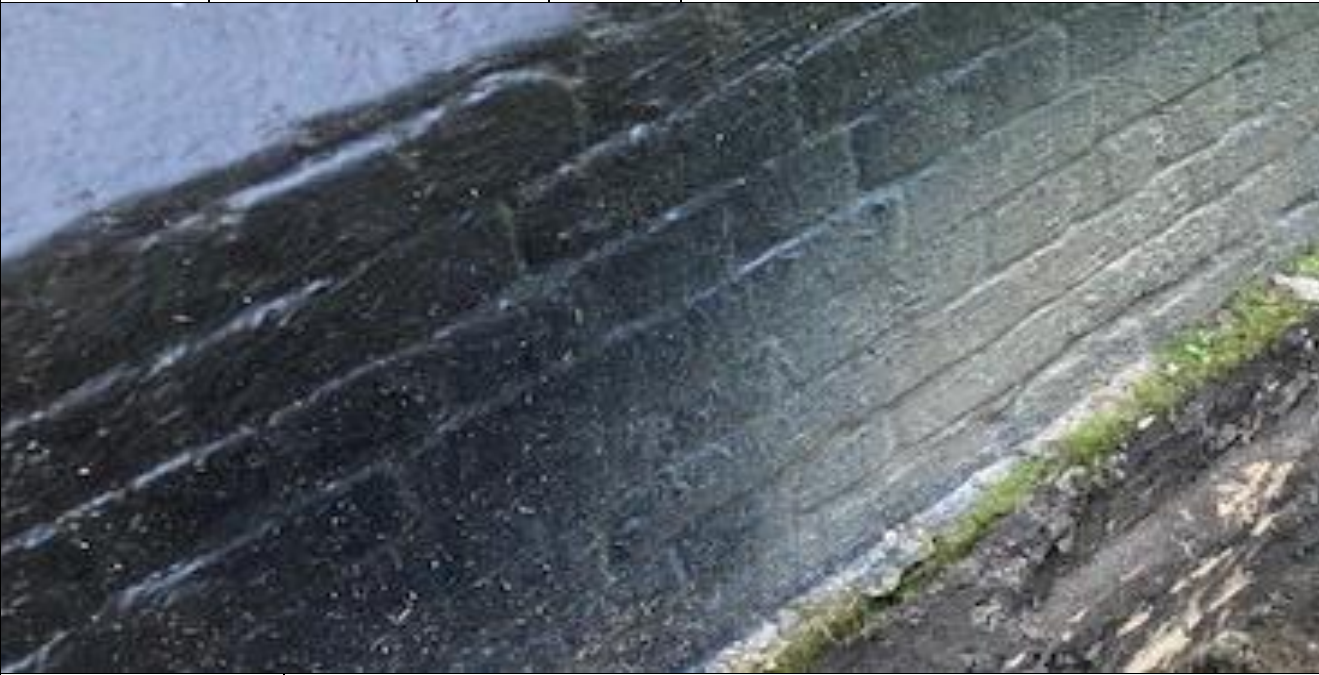
15.26 - Material Assessment Notes

Description	Bitumen Damp Proof Bitumen/Paint			
Sample Reference Number Sample TAL 04062 - S027			Location	External Ground Floor New Wing All Elevations
			Area Size	NA
Material Assessment Score			Priority Assessment Score	
Product Type	NA	NA	Location	NA
Extent of Damage	NA	NA	Accessibility	NA
Surface Treatment	NA	NA	Extent/Amount	NA
Asbestos Type	NA	NA	Score	NA
Score		NA	Total Score	NA
Recommendations	No Further Actions Required			Risk
				NA

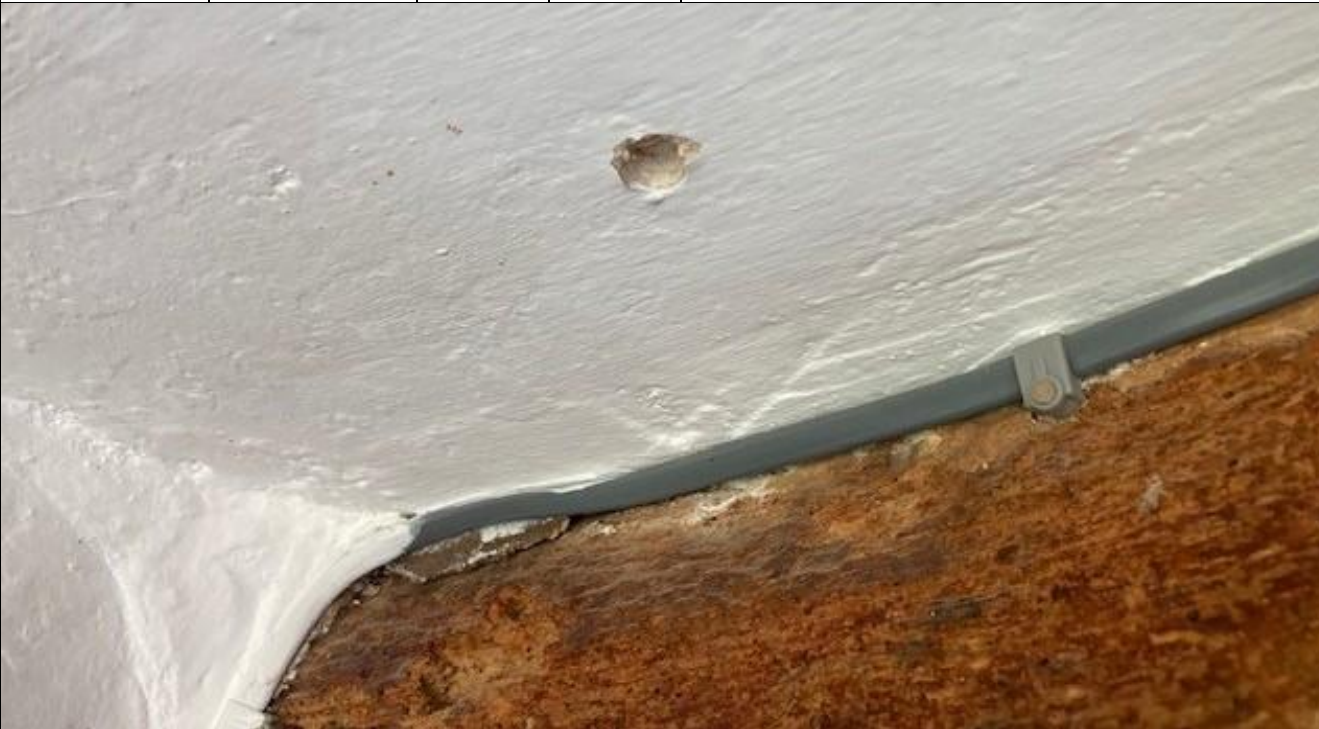
15.27 - Material Assessment Notes

Description	Ceiling Plaster			
Sample Reference Number Sample TAL 04062 - S028			Location	Original House Ground Floor Kitchen
			Area Size	NA
Material Assessment Score			Priority Assessment Score	
Product Type	NA	NA	Location	NA
Extent of Damage	NA	NA	Accessibility	NA
Surface Treatment	NA	NA	Extent/Amount	NA
Asbestos Type	NA	NA	Score	NA
Score		NA	Total Score	NA
Recommendations	No Further Actions Required			Risk
				NA

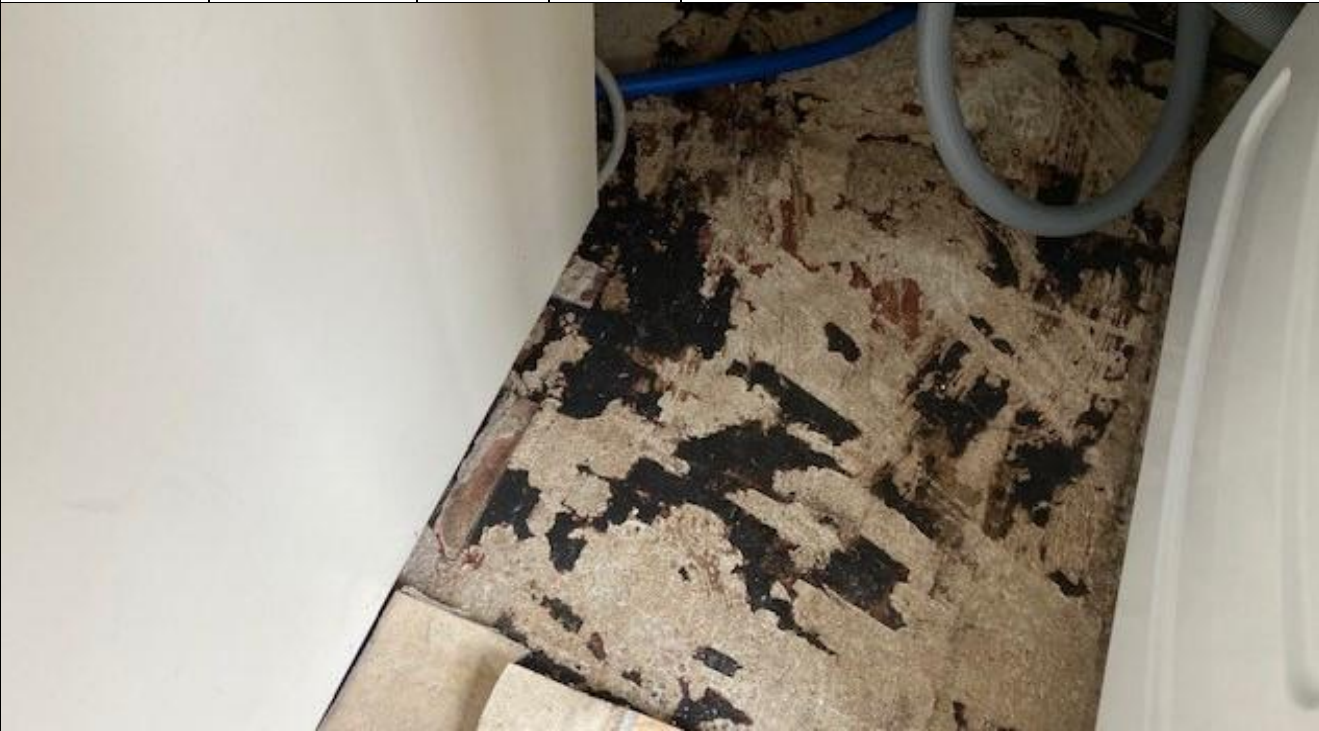
15.28 - Material Assessment Notes

Description	Floor Bitumen Debris			
Sample Reference Number Sample TAL 04062 - S029			Location	Original House Ground Floor Kitchen
			Area Size	NA
Material Assessment Score			Priority Assessment Score	
Product Type	NA	NA	Location	NA
Extent of Damage	NA	NA	Accessibility	NA
Surface Treatment	NA	NA	Extent/Amount	NA
Asbestos Type	NA	NA	Score	NA
Score		NA	Total Score	NA
Recommendations	No Further Actions Required			Risk
				NA
